Test report - Spreader

Item name/type:

Advance Thun AG

Spreaderbar - soft

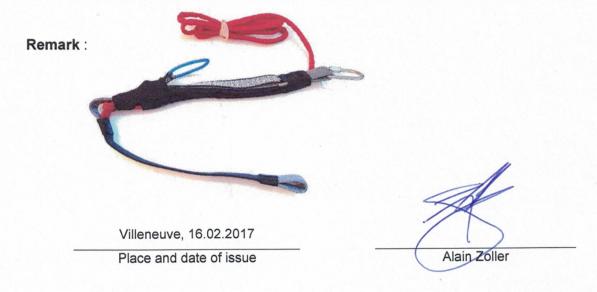
Structural strength test result

The sample has been tested for a maximum load of 230 [kg] during 10 [s] at 9 [g].

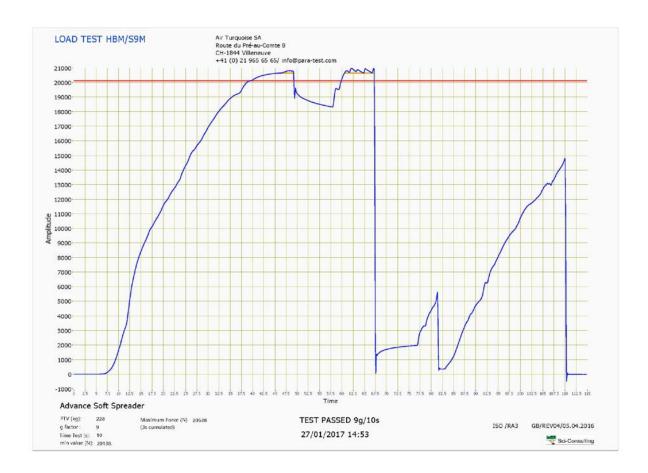
Test 1:

The load has been induced from pilot- and the first (long) passenger attachment to the main attachment point of glider.

Tested successfully, up to 20638 [N] more as 10 seconds

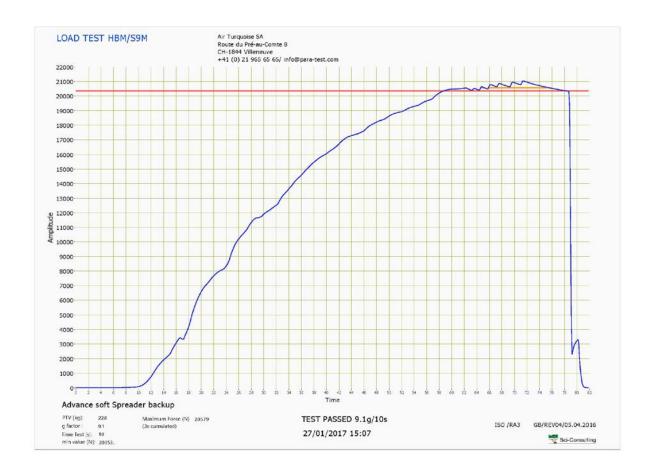
Test 2:

The load has been induced from pilot- and the second passenger attachment to the main attachment point to glider.

Tested successfully, up to 20579 [N] more as 10 seconds
