## Harness Structural test Report

Inspection certificate number: **PH\_237.2018**

Name: **AMX 2**  
 Type: **ABS**  
 Size: **L**  
 Serial number: **23491**  
 Impact pad type: <sup>(1)</sup> **Foam**  
 Clip-in weight [kg]: **120**

### Summary of Structural test

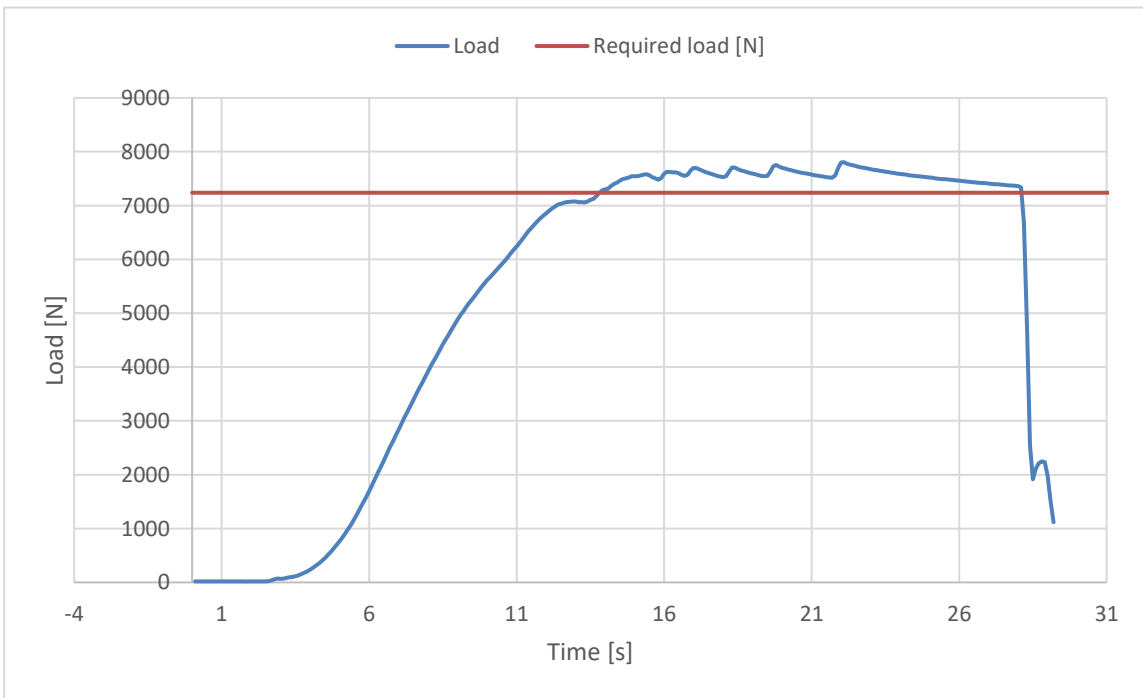
**Test ID R0**

Reference in standard	<b>5.3.2.1</b>	
Test setup	<b>Default flying position</b>	
Attachment points	<b>Both main riser attachment (3,4)</b>	
Anchor points	<b>Dummy (B1, B2)</b>	
Required load [g]	<b>6</b>	
Required load [N]	<b>7200</b>	
Minimum test duration [s]	<b>10</b>	
<b>Result</b>		
Test duration [s]	<b>14.3</b>	
Any signs of structural failure	<b>No</b>	
Test results	<b>POSITIVE</b>

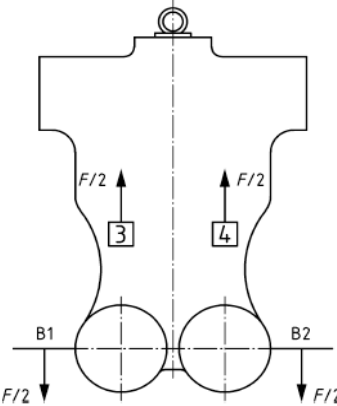
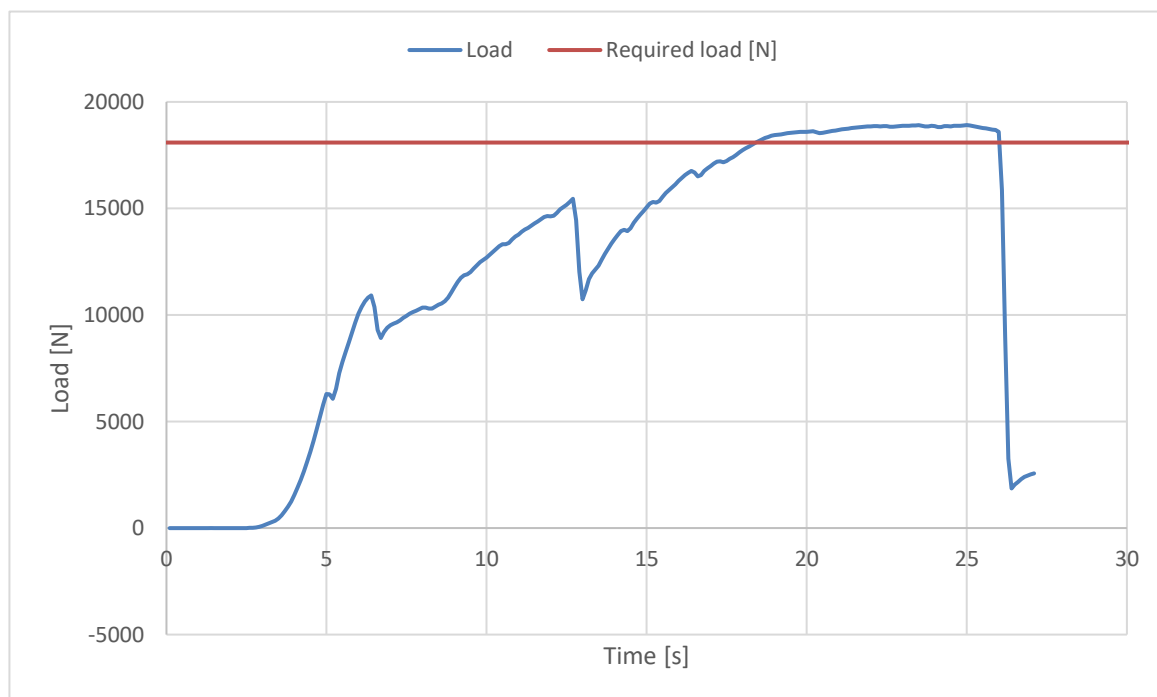
**Test ID R2**

Standard	<b>EN 1651:1999</b>
Reference in standard	<b>5.3.2.2</b>
Test setup	<b>Default flying position</b>
Attachment points	<b>Both main riser attachment (3,4)</b>
Anchor points	<b>Dummy (B1, B2)</b>
Required load [g]	<b>15</b>
Required load [N]	<b>18000</b>
Minimum test duration [s]	<b>5</b>
<b>Result</b>	
Test duration [s]	<b>7.6</b>
Any signs of structural failure	<b>No</b>
Test results	<b>POSITIVE</b>

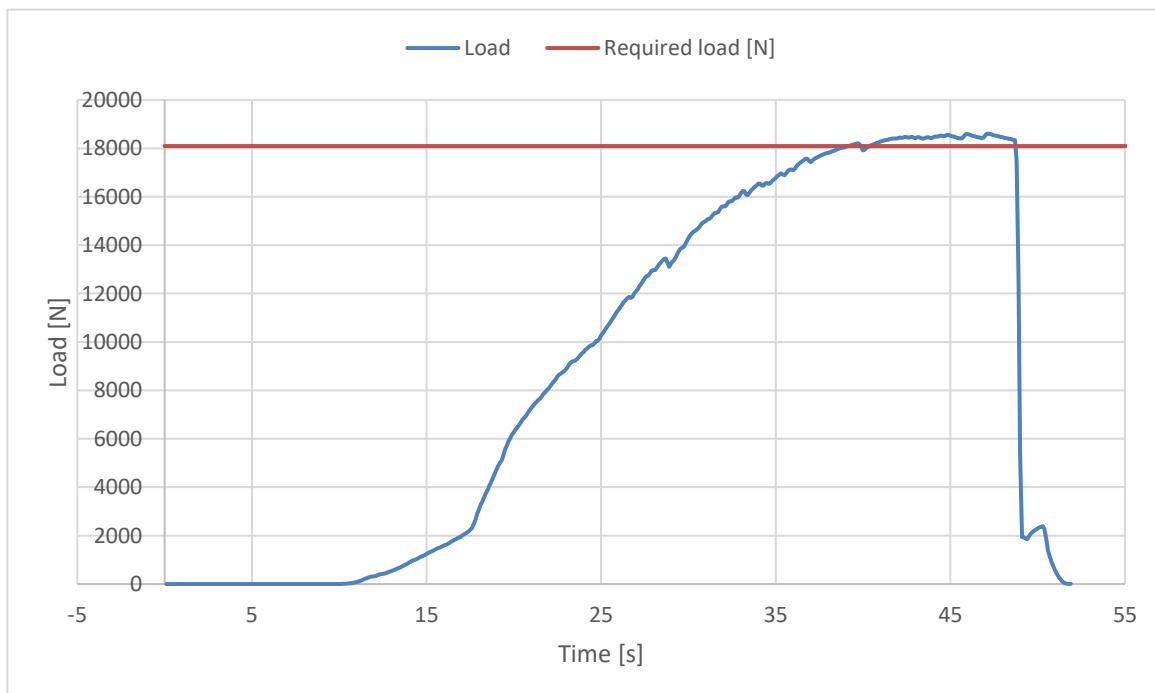
**Test ID R4**

Standard	<b>EN 1651:1999</b>
Reference in standard	<b>5.3.2.7</b>
Test setup	<b>Flying position before landing</b>
Attachment points	<b>Both main riser attachment (3,4)</b>
Anchor points	<b>Dummy (7,8)</b>
Required load [g]	<b>15</b>
Required load [N]	<b>18000</b>
Minimum test duration [s]	<b>5</b>
<b>Result</b>	
Test duration [s]	<b>8.4</b>
Any signs of structural failure	<b>No</b>
Test results	<b>POSITIVE</b>

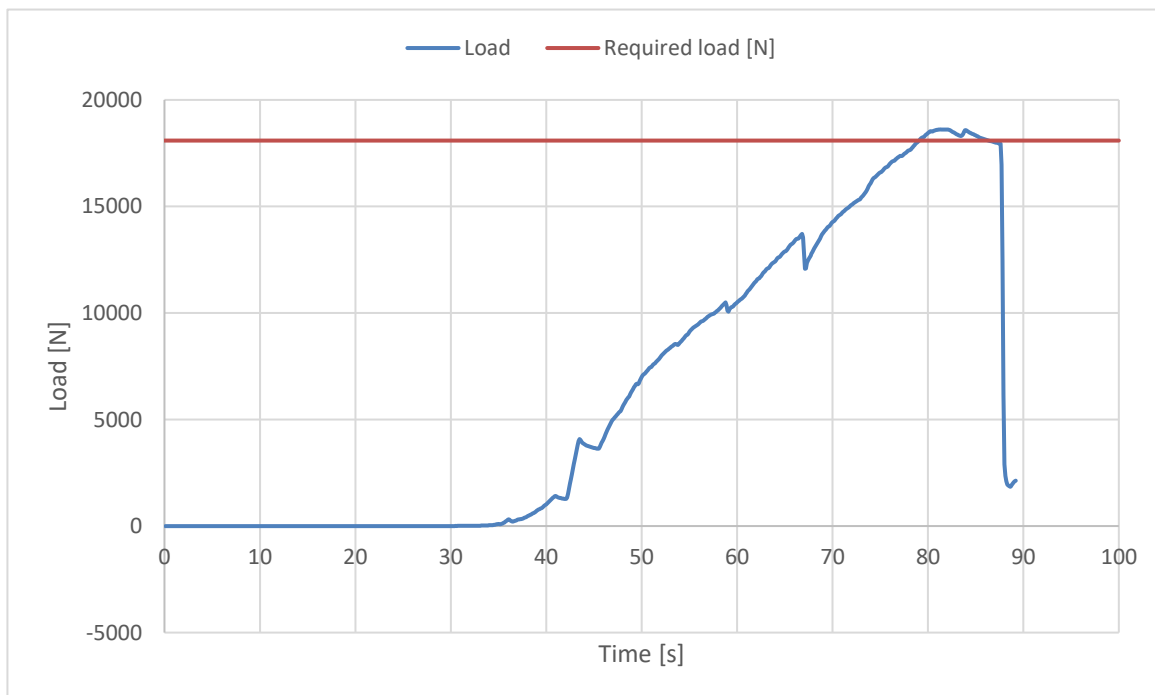
**Test ID R6**

Standard	<b>EN 1651:1999</b>
Reference in standard	<b>5.3.2.4</b>
Test setup	<b>Rescue attachments</b>
Attachment points	<b>Rescue riser attachment (1,2)</b>
Anchor points	<b>Dummy (B1,B2)</b>
Required load [g]	<b>15</b>
Required load [N]	<b>18000</b>
Minimum test duration [s]	<b>5</b>
<b>Result</b>	
Test duration [s]	<b>7.3</b>
Any signs of structural failure	<b>No</b>
Test results	<b>POSITIVE</b>

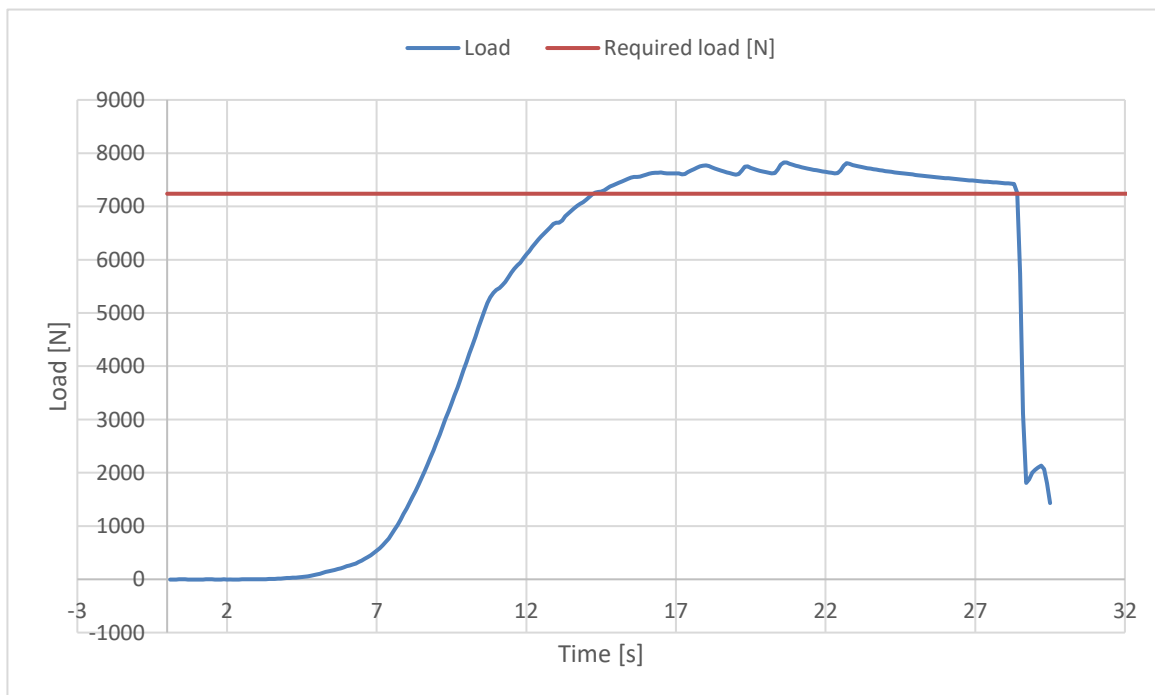
**Test ID R8**

Standard	<b>EN 1651:1999</b>	
Reference in standard	<b>5.3.2.3</b>	
Test setup	<b>Asymmetric, one riser</b>	
Attachment points	<b>One main riser attachment (3)</b>	
Anchor points	<b>Dummy (B1,B2)</b>	
Required load [g]	<b>6</b>	
Required load [N]	<b>7200</b>	
Minimum test duration [s]	<b>10</b>	
<b>Result</b>		
Test duration [s]	<b>14.2</b>	
Any signs of structural failure	<b>No</b>	
Test results	<b>POSITIVE</b>

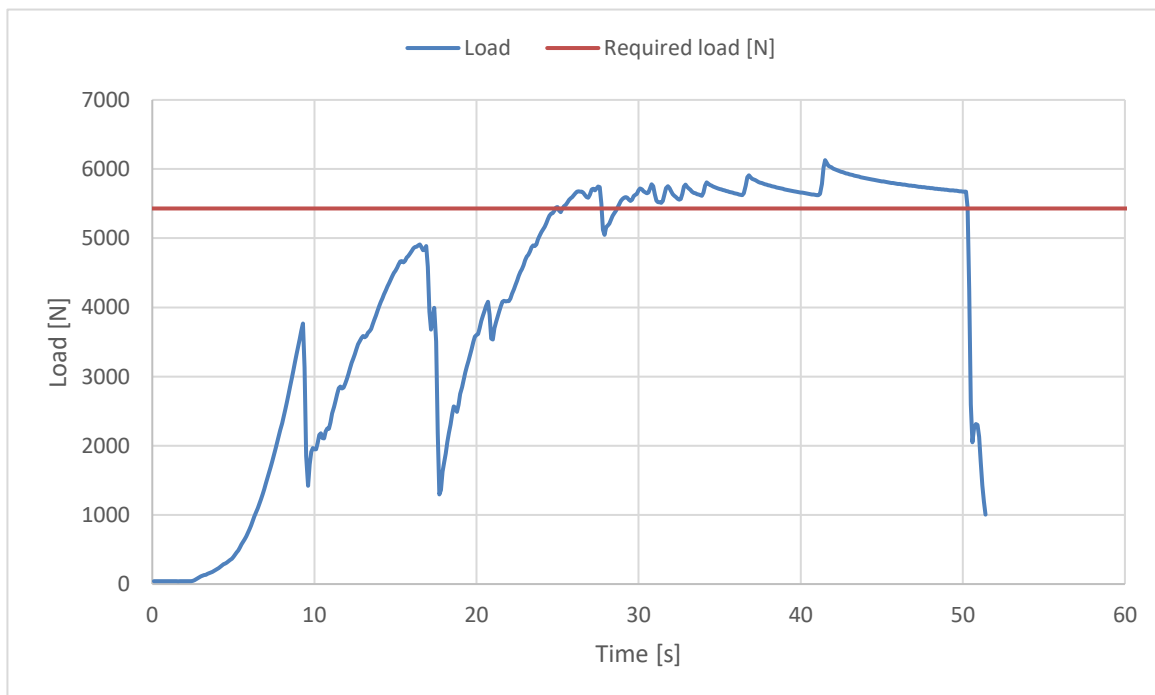
**Test ID R10**

Reference in standard	<b>5.3.2.6</b>	
Test setup	<b>Asymmetric, negative</b>	
Attachment points	<b>One main riser attachment (3 or 4) downwards</b>	
Anchor points	<b>Dummy (9)</b>	
Required load [g]	<b>4.5</b>	
Required load [N]	<b>5400</b>	
Minimum test duration [s]	<b>10</b>	
<b>Result</b>		
Test duration [s]	<b>21.7</b>	
Any signs of structural failure	<b>No</b>	
Test results	<b>POSITIVE</b>

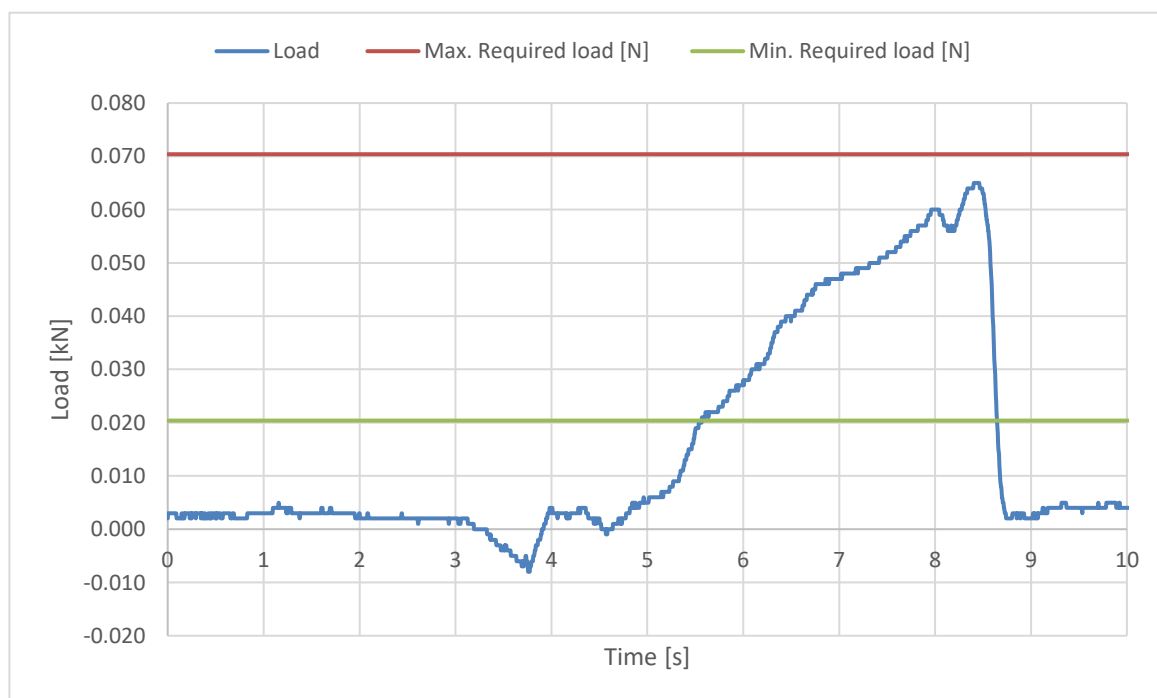
**Test ID RRDT**

Standard	<b>LTF NfL II 91/09</b>
Reference in standard	<b>6.1.5</b>
Test setup	<b>Default flying position</b>
Attachment points	<b>Sensor connect to handle, and pull in opening direction</b>
	The test is to simulate the load required to open the emergency parachute(1st action).
Min. Required load [N]	<b>20</b>
Max. Required load [N]	<b>70</b>
<b>Result</b>	
Load for first action [N]	<b>64.61</b>
Test results	<b>POSITIVE</b>

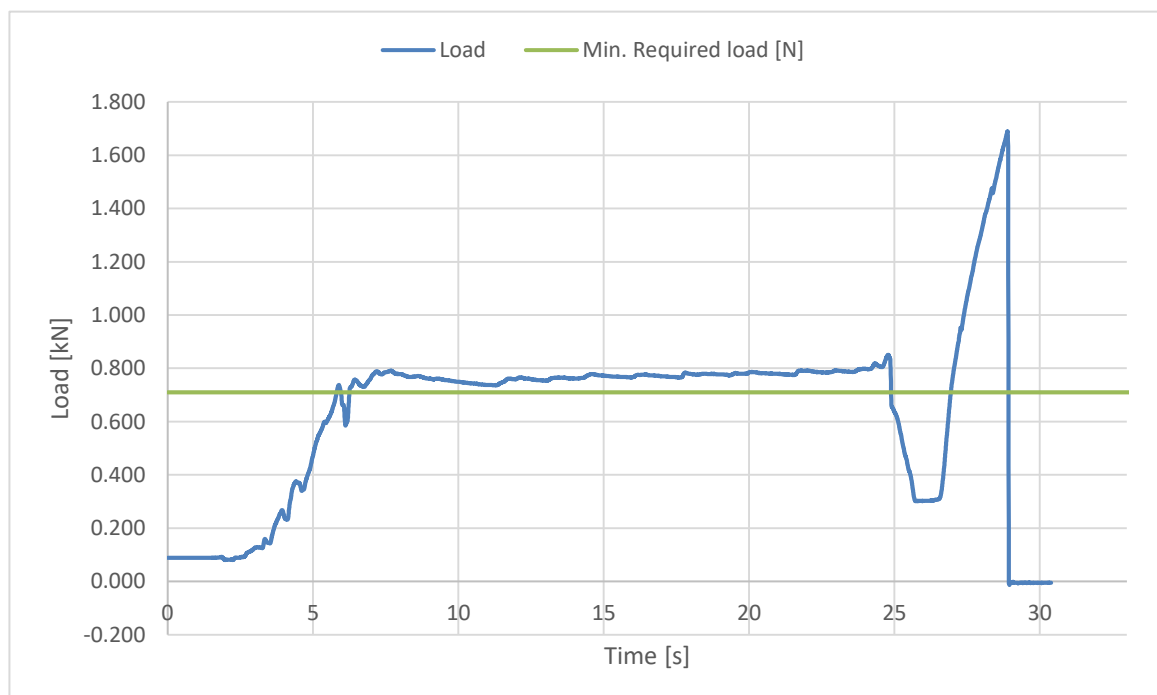
**Test ID RRST**

Standard	<b>EN12491:2015</b>
Reference in standard	<b>5.3.2</b>
Test setup	<b>Two end points of handle</b>
Attachment points	<b>Sensor connect to end of handle, pull on the other side</b>
	The handle must support min 700 N for 10 s, after measure breaking strength
Min. Required load [N]	<b>700</b>
Minimum test duration [s]	<b>10</b>
<b>Result</b>	
Test duration [s]:	<b>18.4</b>
Breaking strength [N]	<b>1678.85</b>
Test results	<b>POSITIVE</b>
