# Harness Structural test Report

Inspection certificate number: **PH\_228.018**
**Manufacturer data:**

Name: **Pogo 3 2R**  
 Type: **ABS**  
 Size: **M**  
 Serial number: **H-05985**  
 Impact pad type: <sup>(1)</sup> **Foam**  
 Clip-in weight [kg]: **100**

**Summary of Structural test**

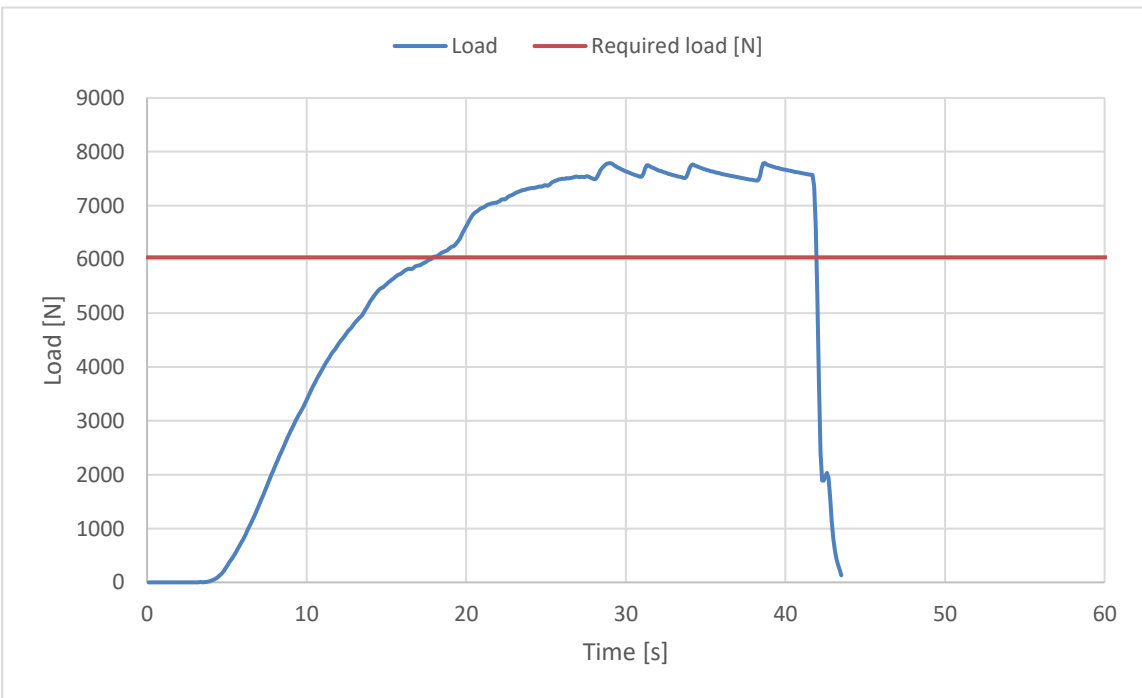
**Test ID R0**

Reference in standard	<b>5.3.2.1</b>	
Test setup	<b>Default flying position</b>	
Attachment points	<b>Both main riser attachment (3,4)</b>	
Anchor points	<b>Dummy (B1, B2)</b>	
Required load [g]	<b>6</b>	
Required load [N]	<b>6000</b>	
Minimum test duration [s]	<b>10</b>	
<b>Result</b>		
Test duration [s]	<b>24</b>	
Any signs of structural failure	<b>No</b>	
Test results	<b>POSITIVE</b>

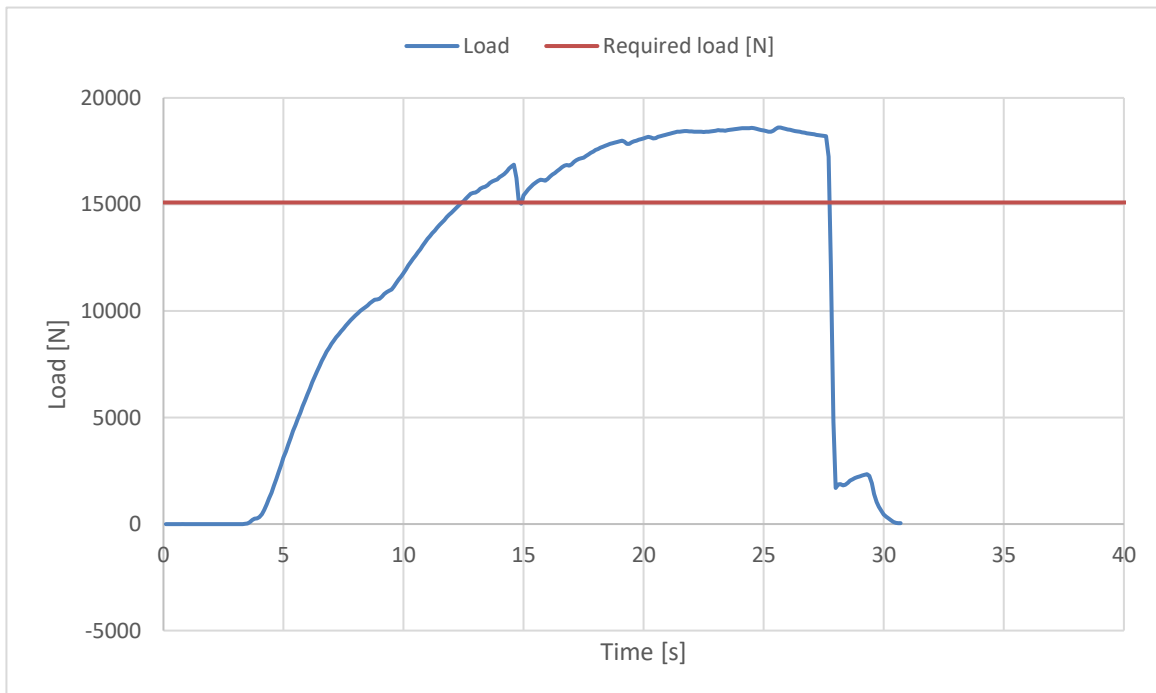
**Test ID R2**

Reference in standard	<b>5.3.2.2</b>	
Test setup	<b>Default flying position</b>	
Attachment points	<b>Both main riser attachment (3,4)</b>	
Anchor points	<b>Dummy (B1, B2)</b>	
Required load [g]	<b>15</b>	
Required load [N]	<b>15000</b>	
Minimum test duration [s]	<b>5</b>	
<b>Result</b>		
Test duration [s]	<b>12.8</b>	
Any signs of structural failure	<b>No</b>	
Test results	<b>POSITIVE</b>

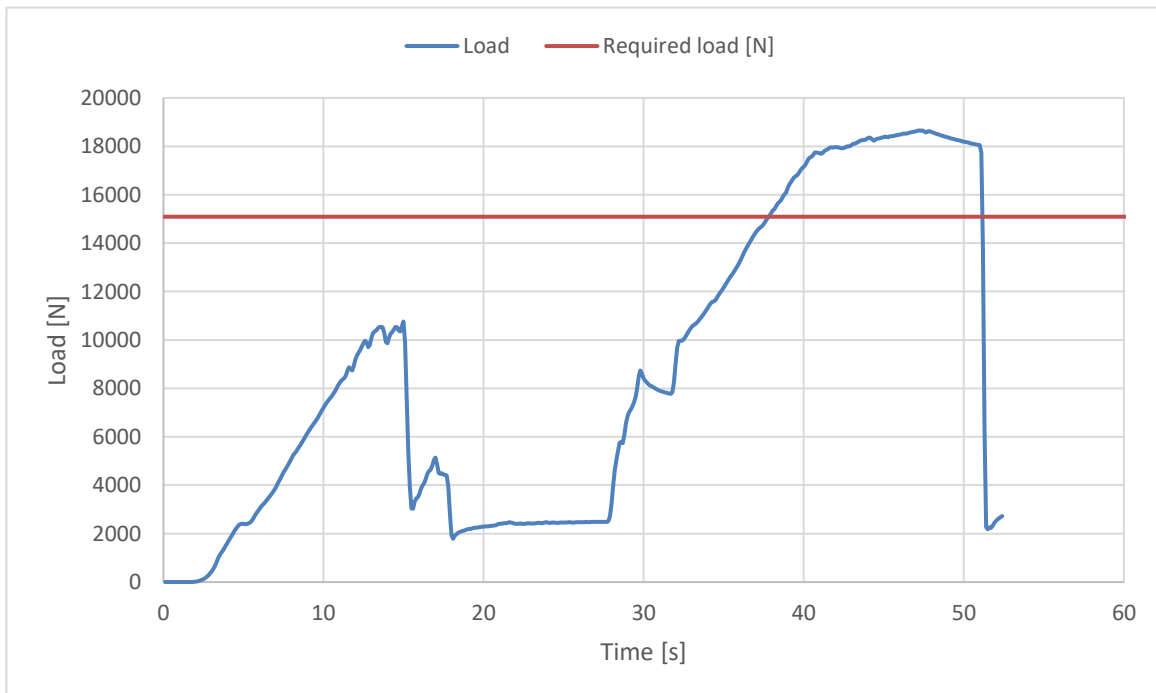
**Test ID R4**

Standard	<b>EN 1651:1999</b>
Reference in standard	<b>5.3.2.7</b>
Test setup	<b>Flying position before landing</b>
Attachment points	<b>Both main riser attachment (3,4)</b>
Anchor points	<b>Dummy (7,8)</b>
Required load [g]	<b>15</b>
Required load [N]	<b>15000</b>
Minimum test duration [s]	<b>5</b>
<b>Result</b>	
Test duration [s]	<b>13.3</b>
Any signs of structural failure	<b>No</b>
Test results	<b>POSITIVE</b>

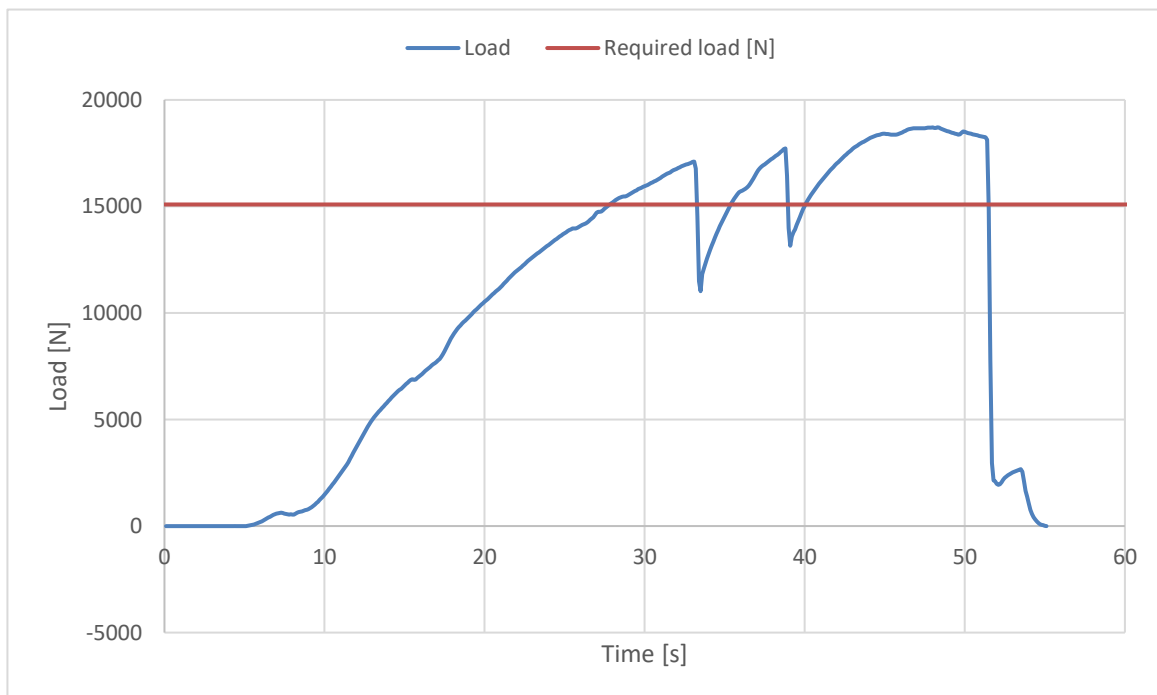
**Test ID R6**

Standard	<b>EN 1651:1999</b>
Reference in standard	<b>5.3.2.4</b>
Test setup	<b>Rescue attachments</b>
Attachment points	<b>Rescue riser attachment (1,2)</b>
Anchor points	<b>Dummy (B1,B2)</b>
Required load [g]	<b>15</b>
Required load [N]	<b>15000</b>
Minimum test duration [s]	<b>5</b>
<b>Result</b>	
Test duration [s]	<b>11.4</b>
Any signs of structural failure	<b>No</b>
Test results	<b>POSITIVE</b>

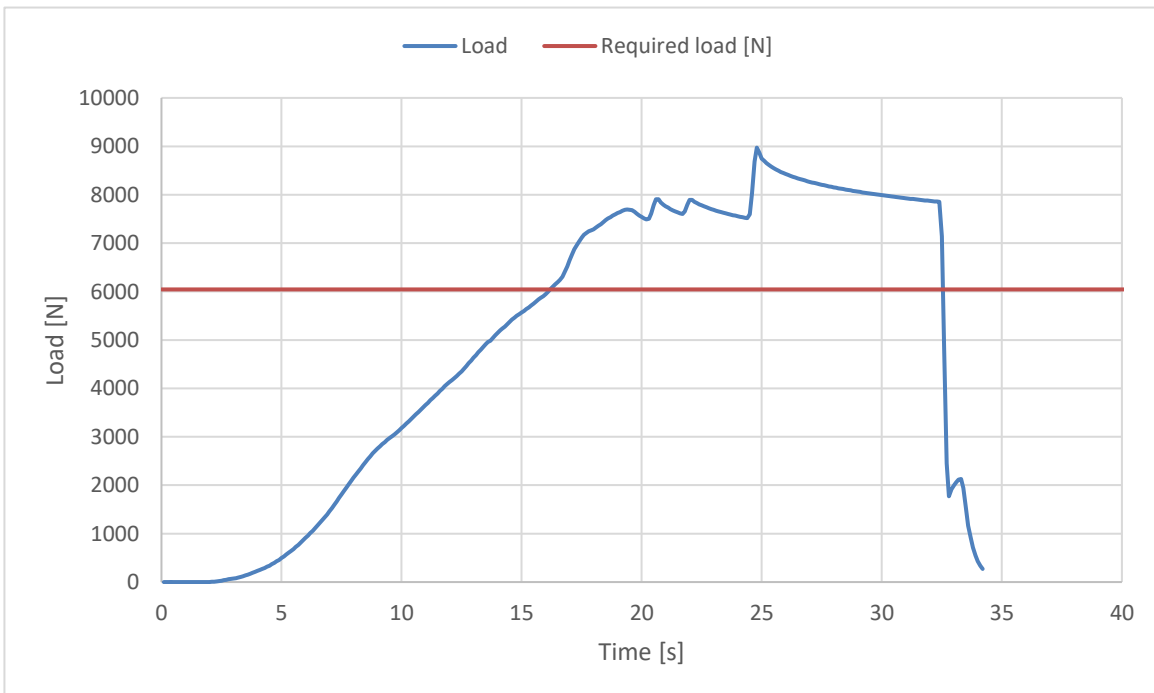
**Test ID R8**

Standard	<b>EN 1651:1999</b>	
Reference in standard	<b>5.3.2.3</b>	
Test setup	<b>Asymmetric, one riser</b>	
Attachment points	<b>One main riser attachment (3)</b>	
Anchor points	<b>Dummy (B1,B2)</b>	
Required load [g]	<b>6</b>	
Required load [N]	<b>6000</b>	
Minimum test duration [s]	<b>10</b>	
<b>Result</b>		
Test duration [s]	<b>16.4</b>	
Any signs of structural failure	<b>No</b>	
Test results	<b>POSITIVE</b>

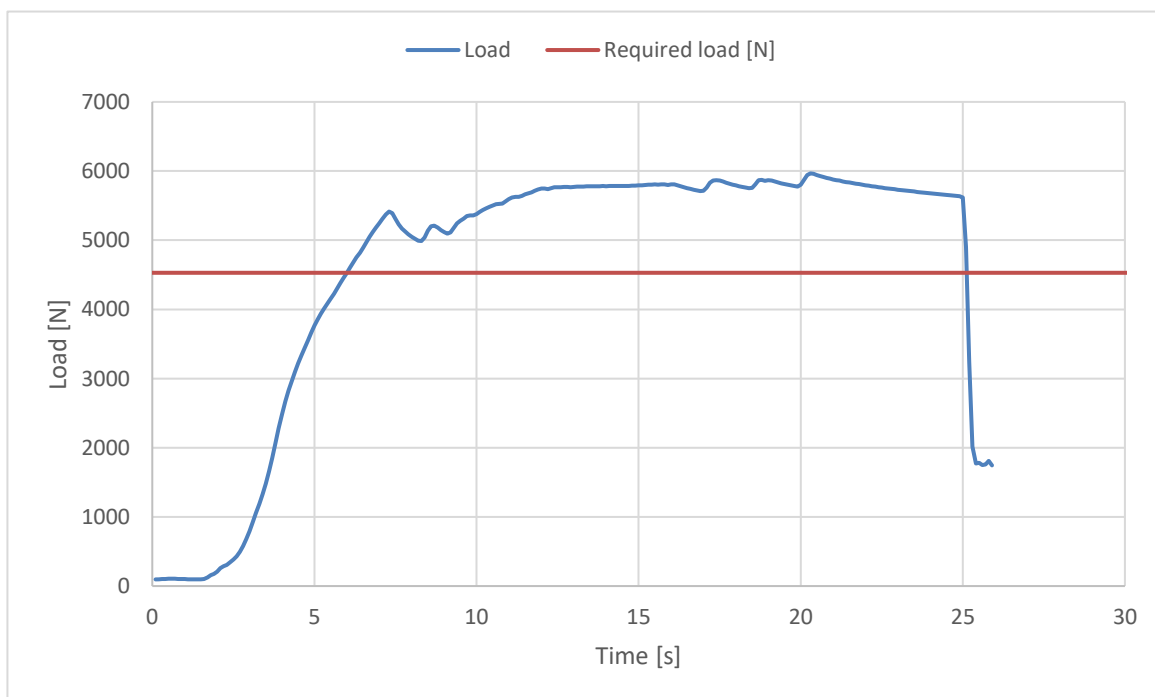
**Test ID R10**

Reference in standard	<b>5.3.2.6</b>	
Test setup	<b>Asymmetric, negative</b>	
Attachment points	<b>One main riser attachment (3 or 4) downwards</b>	
Anchor points	<b>Dummy (9)</b>	
Required load [g]	<b>4.5</b>	
Required load [N]	<b>4500</b>	
Minimum test duration [s]	<b>10</b>	
<b>Result</b>		
Test duration [s]	<b>19.1</b>	
Any signs of structural failure	<b>No</b>	
Test results	<b>POSITIVE</b>

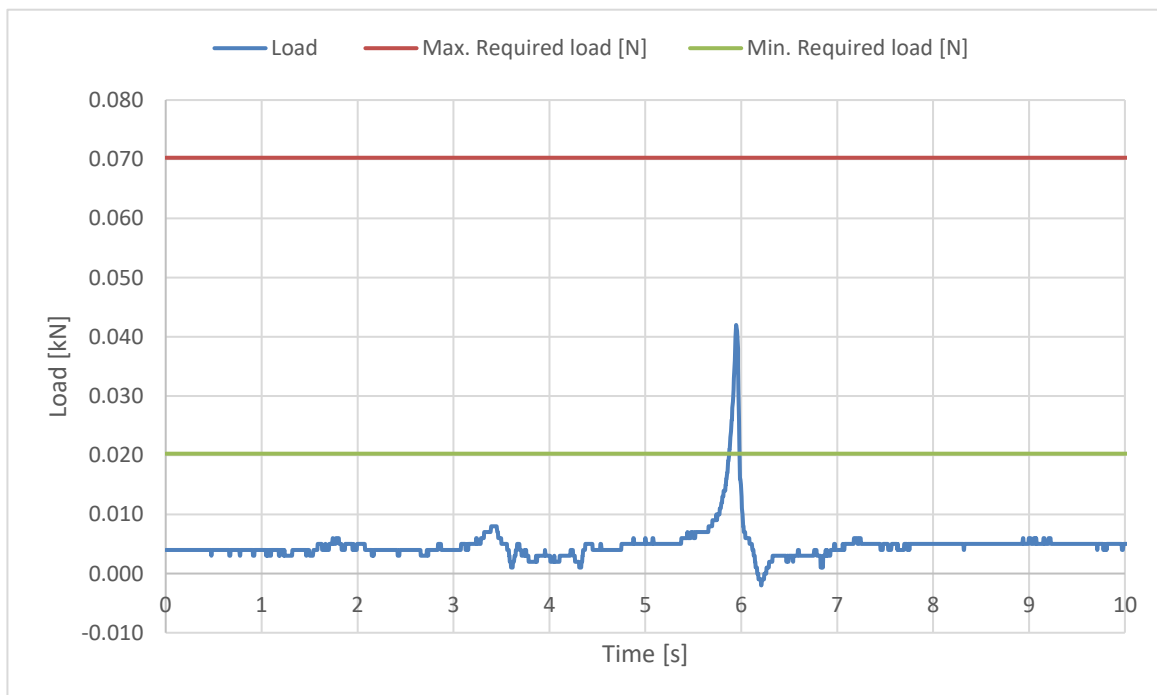
**Test ID RRDT**

Standard	<b>LTF NfL II 91/09</b>
Reference in standard	<b>6.1.5</b>
Test setup	<b>Default flying position</b>
Attachment points	<b>Sensor connect to handle, and pull in opening direction</b>
	The test is to simulate the load required to open the emergency parachute(1st action).
Min. Required load [N]	<b>20</b>
Max. Required load [N]	<b>70</b>
<b>Result</b>	
Load for first action [N]	<b>41.75</b>
Test results	<b>POSITIVE</b>

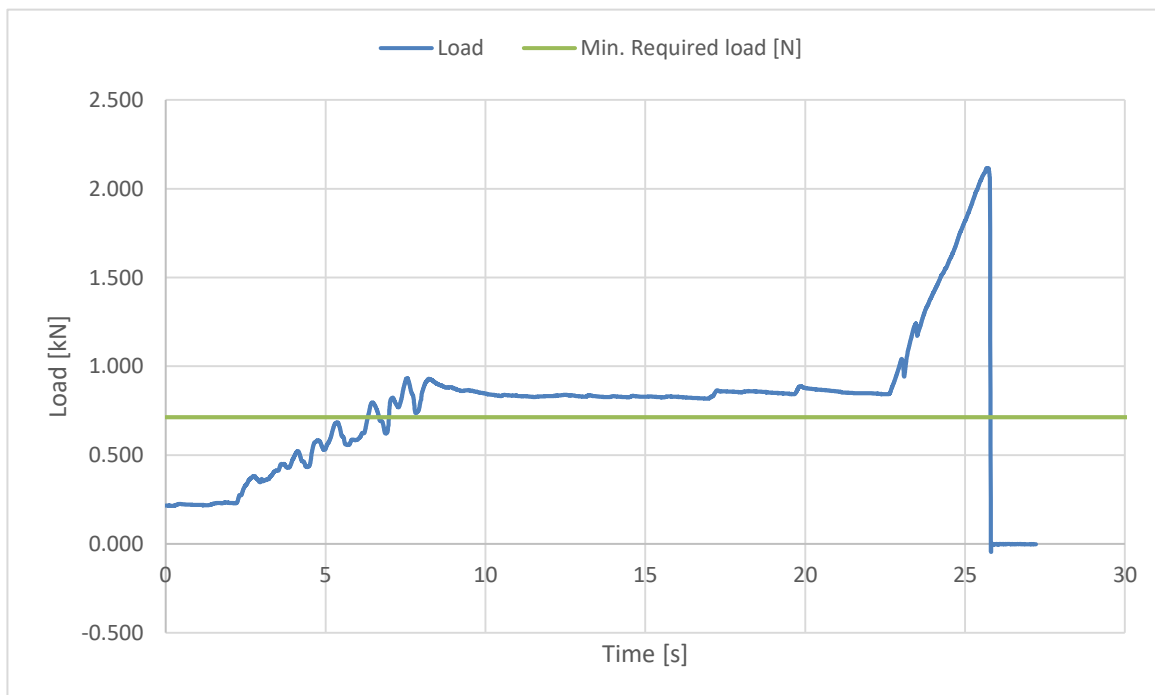
**Test ID RRST**

Standard	<b>EN12491:2015</b>
Reference in standard	<b>5.3.2</b>
Test setup	<b>Two end points of handle</b>
Attachment points	<b>Sensor connect to end of handle, pull on the other side</b>
	The handle must support min 700 N for 10 s, after measure breaking strength
Min. Required load [N]	<b>700</b>
Minimum test duration [s]	<b>10</b>
<b>Result</b>	
Test duration [s]:	<b>18.7</b>
Breaking strength [N]	<b>2102.29</b>
Test results	<b>POSITIVE</b>
