Harness Structural test Report

Inspection certificate number: **PH_215.2017**
Manufacturer data:

Name: **Transformer**
 Type: **ABS**
 Size: **L**
 Serial number: **2261-13-7236**
 Impact pad type: ⁽¹⁾ **Foam**
 Clip-in weight [kg]: **120**

Date of test: **24.11.2017**
Atmosphere AGL:

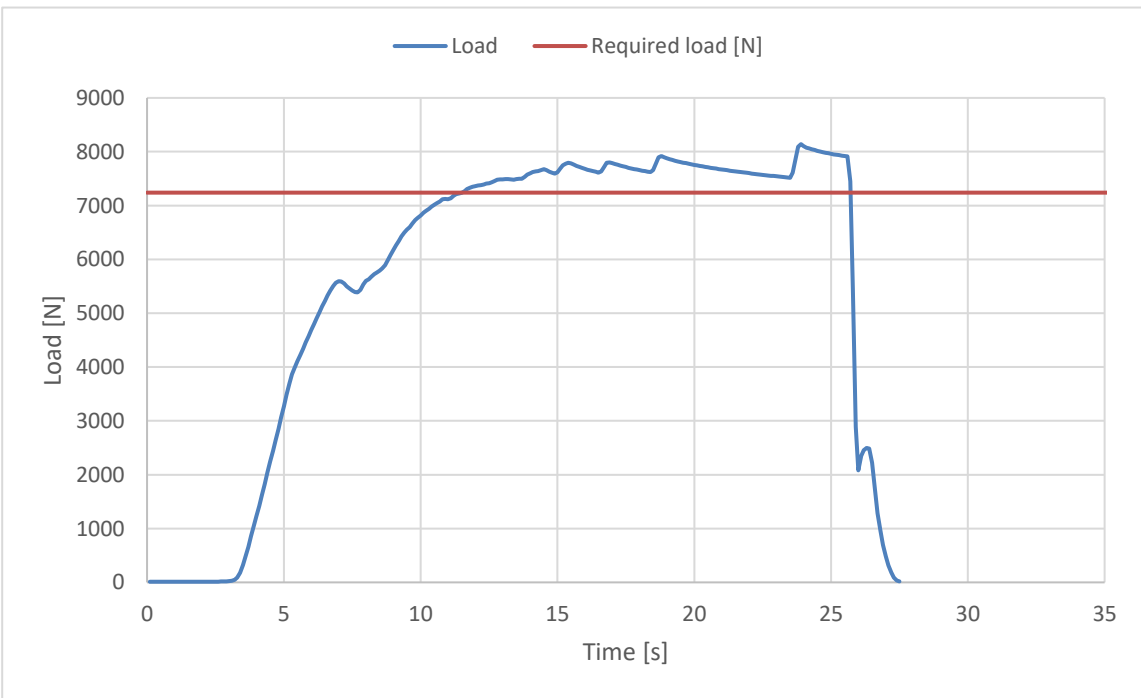
Test ID R0

Standard	EN 1651:1999
Reference in standard	5.3.2.1
Test setup	Default flying position
Attachment points	Both main riser attachment (3,4)
Anchor points	Dummy (B1, B2)
Required load [g]	6
Required load [N]	7200
Minimum test duration [s]	10
Result	
Test duration [s]	14.2
Any signs of structural failure	No
Test results	POSITIVE

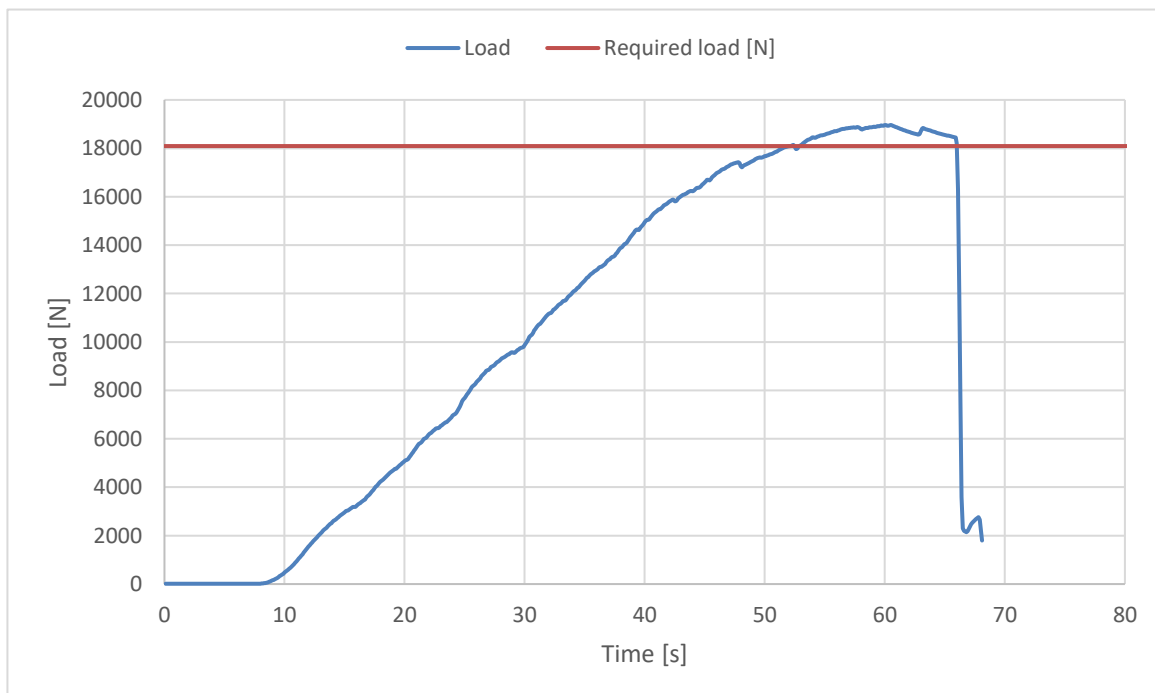
Test ID R2

Reference in standard	5.3.2.2	
Test setup	Default flying position	
Attachment points	Both main riser attachment (3,4)	
Anchor points	Dummy (B1, B2)	
Required load [g]	15	
Required load [N]	18000	
Minimum test duration [s]	5	
Result		
Test duration [s]	13.2	
Any signs of structural failure	No	
Test results	POSITIVE

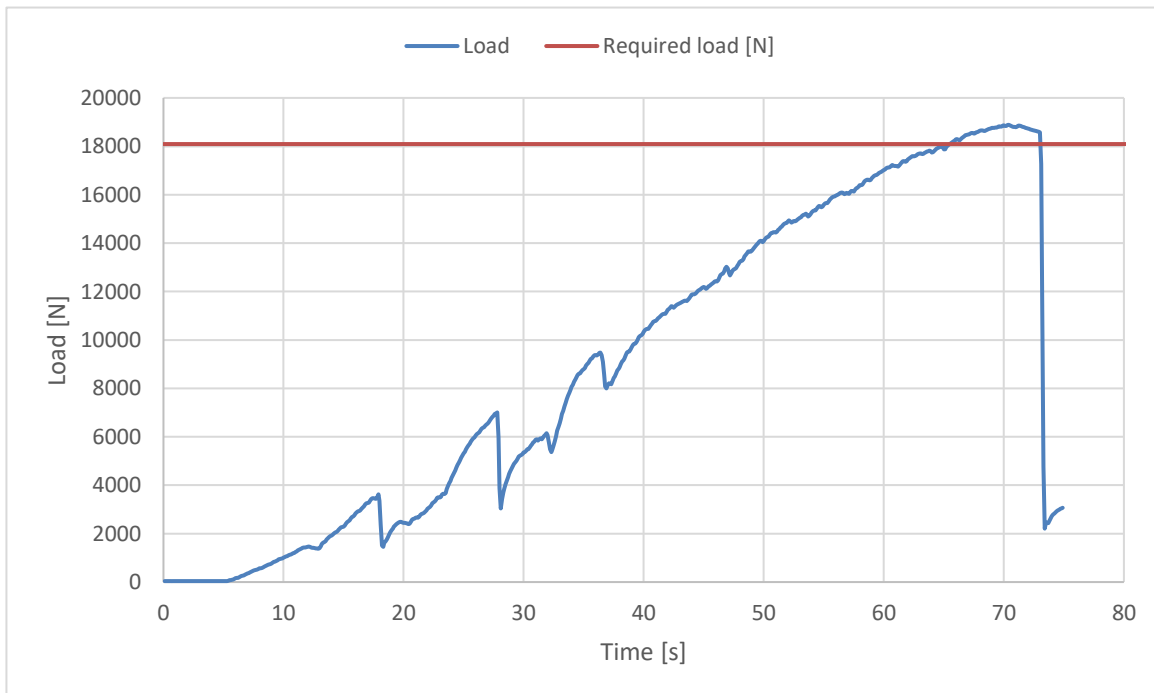
Test ID R4

Standard	EN 1651:1999
Reference in standard	5.3.2.7
Test setup	Flying position before landing
Attachment points	Both main riser attachment (3,4)
Anchor points	Dummy (7,8)
Required load [g]	15
Required load [N]	18000
Minimum test duration [s]	5
Result	
Test duration [s]	7.6
Any signs of structural failure	No
Test results	POSITIVE

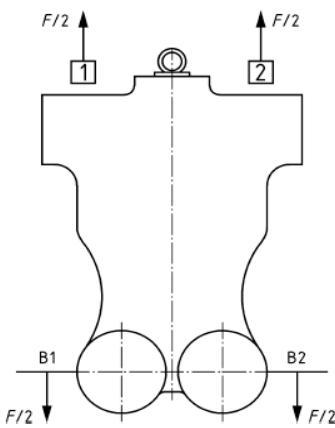
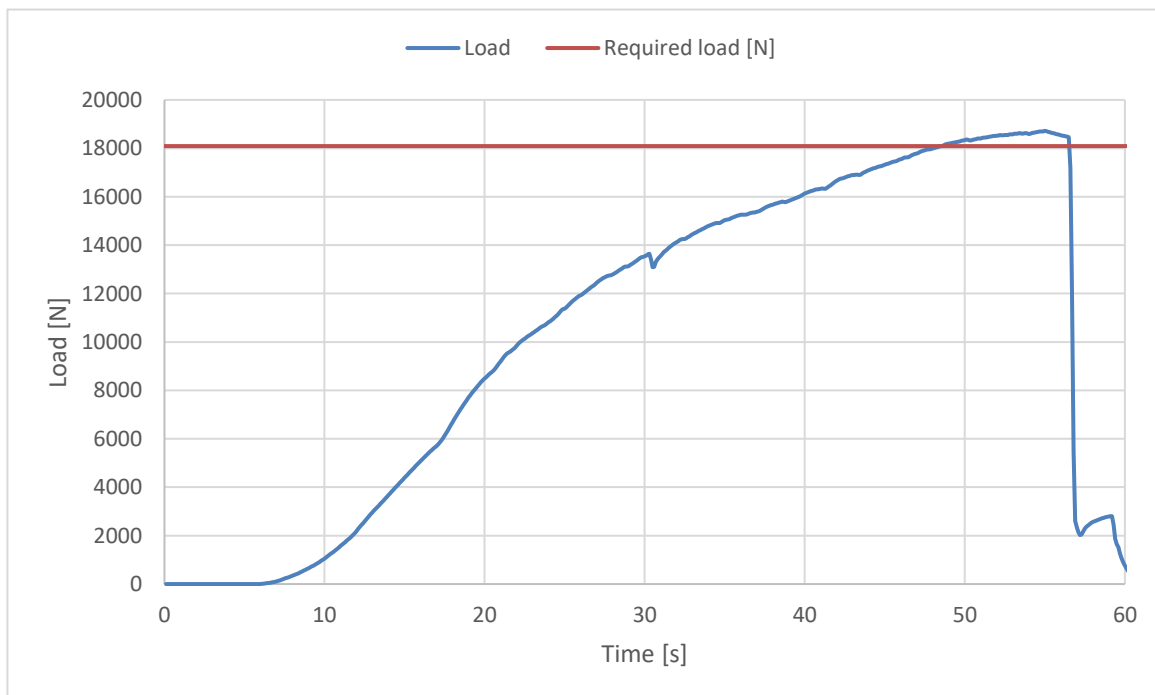
Test ID R6

Reference in standard	5.3.2.4	
Test setup	Rescue attachments	
Attachment points	Rescue riser attachment (1,2)	
Anchor points	Dummy (B1,B2)	
Required load [g]	15	
Required load [N]	18000	
Minimum test duration [s]	5	
Result		
Test duration [s]	8	
Any signs of structural failure	No	
Test results	POSITIVE

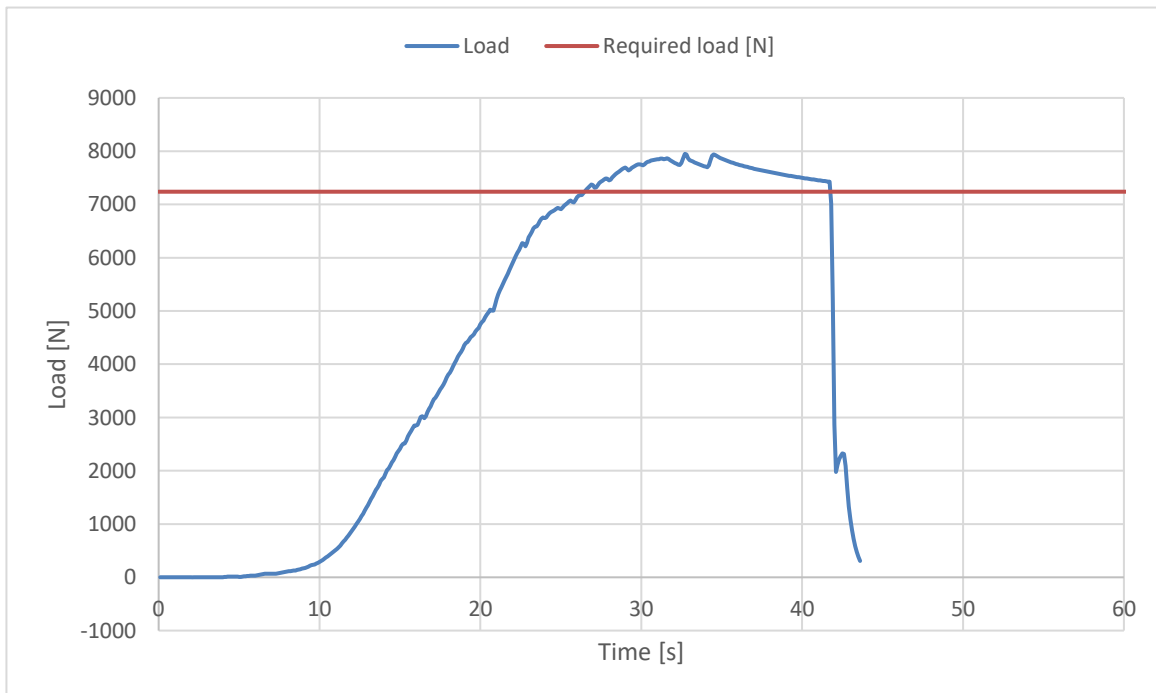
Test ID R8

Standard	EN 1651:1999
Reference in standard	5.3.2.3
Test setup	Asymmetric, one riser
Attachment points	One main riser attachment (3)
Anchor points	Dummy (B1,B2)
Required load [g]	6
Required load [N]	7200
Minimum test duration [s]	10
Result	
Test duration [s]	15.3
Any signs of structural failure	No
Test results	POSITIVE

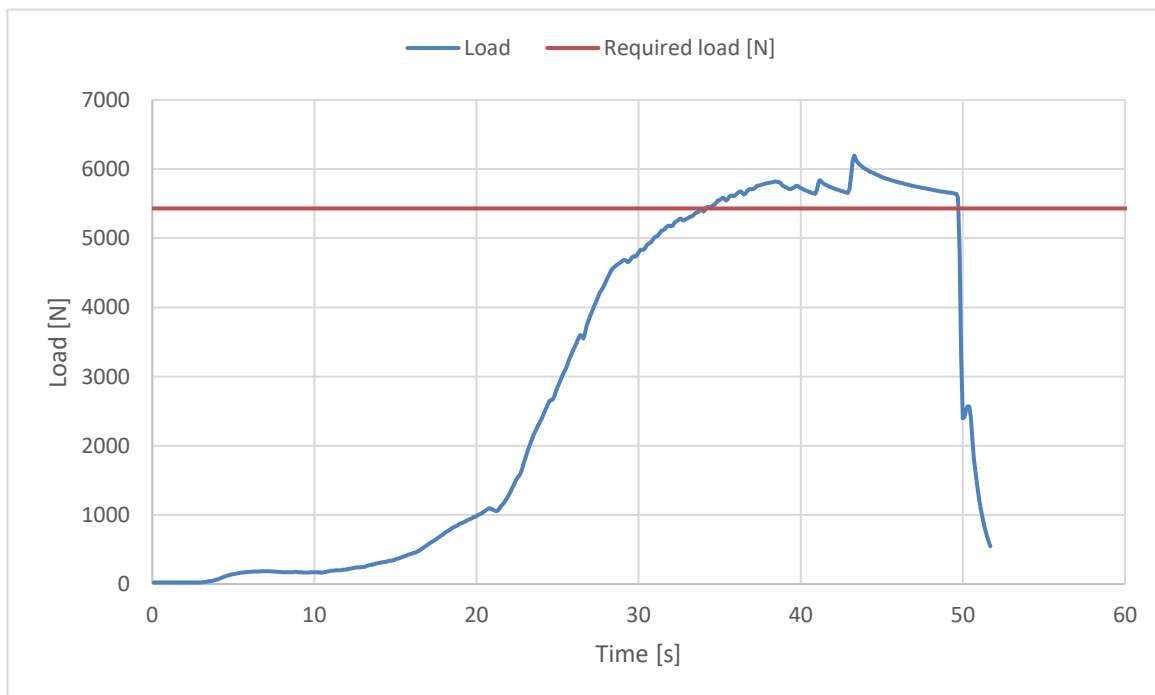
Test ID R10

Reference in standard	5.3.2.6	
Test setup	Asymmetric, negative	
Attachment points	One main riser attachment (3 or 4) downwards	
Anchor points	Dummy (9)	
Required load [g]	4.5	
Required load [N]	5400	
Minimum test duration [s]	10	
Result		
Test duration [s]	15.6	
Any signs of structural failure	No	
Test results	POSITIVE

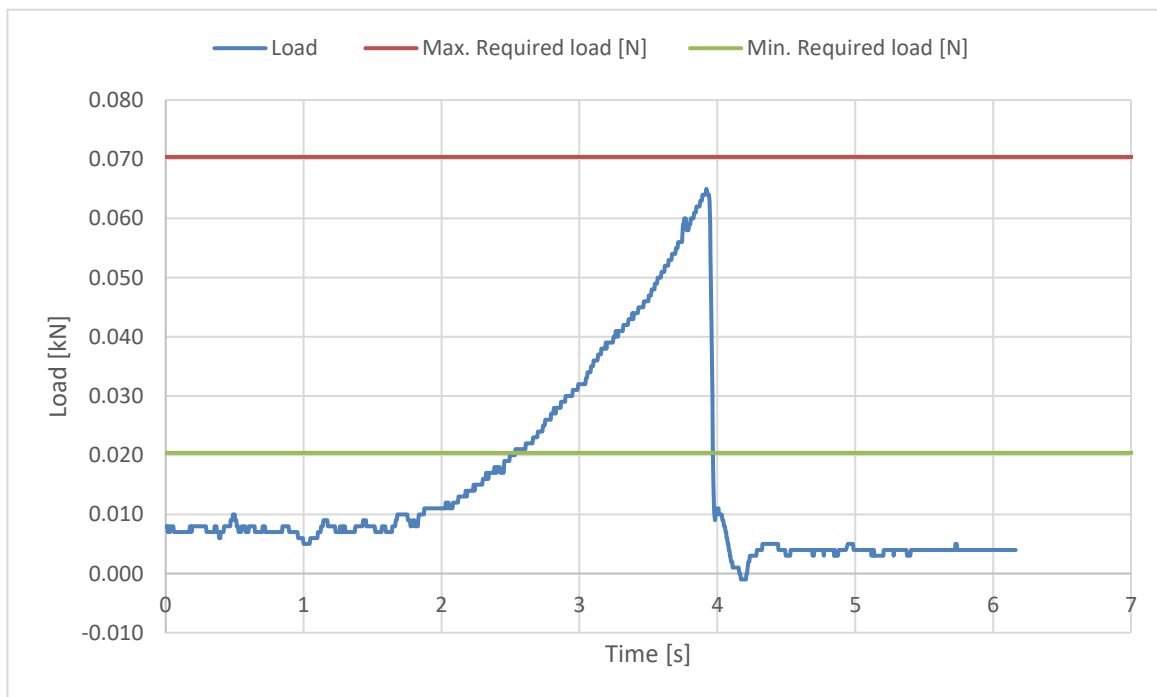
Test ID RRDT

Standard	LTF NfL II 91/09
Reference in standard	6.1.5
Test setup	Default flying position
Attachment points	Sensor connect to handle, and pull in opening direction
	The test is to simulate the load required to open the emergency parachute(1st action).
Min. Required load [N]	20
Max. Required load [N]	70
Result	
Load for first action [N]	64.61
Test results	POSITIVE

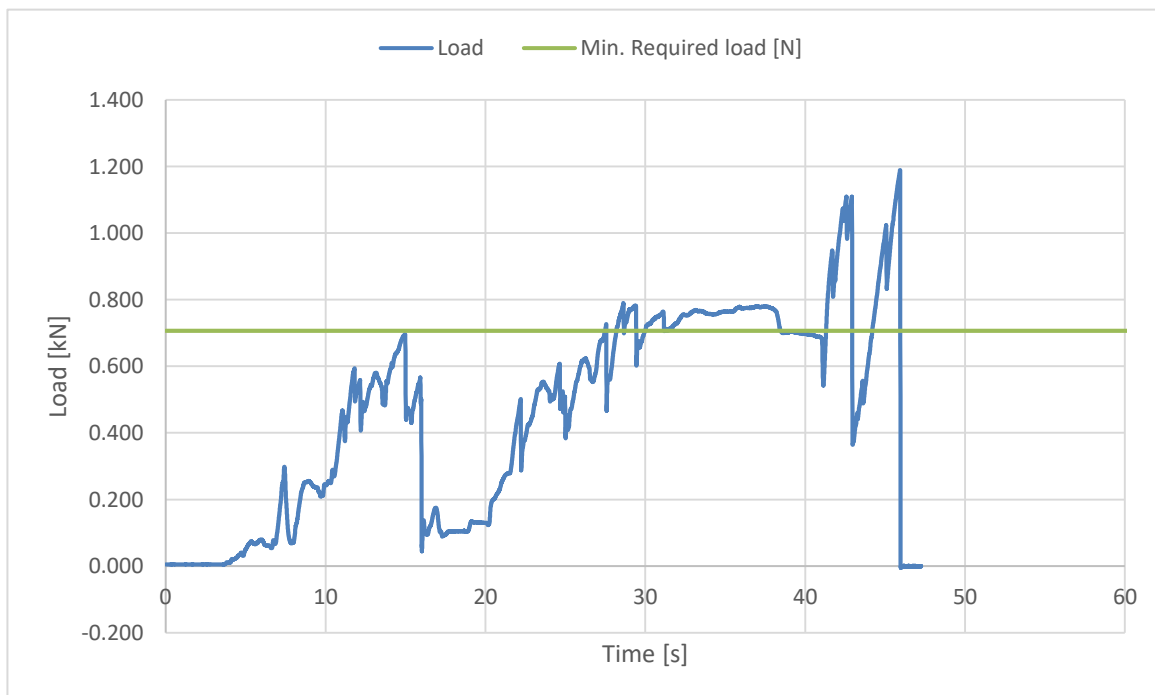
Test ID RRST

Standard	EN12491:2015
Reference in standard	5.3.2
Test setup	Two end points of handle
Attachment points	Sensor connect to end of handle, pull on the other side
	The handle must support min 700 N for 10 s, after measure breaking strength
Min. Required load [N]	700
Minimum test duration [s]	10
Result	
Test duration [s]:	7.0
Breaking strength [N]	1181.86
Test results	POSITIVE
