# Harness Structural test Report

Inspection certificate number: **PH\_240.2018**
**Manufacturer data:**

Name: **Sky-1012**  
 Type: **ABS**  
 Size: **L**  
 Serial number: **Lot#01/07.18**  
 Impact pad type: <sup>(1)</sup> **n/a**  
 Clip-in weight [kg]: **136**

**Skyline harness (Tyrolienne), not for paragliding !**

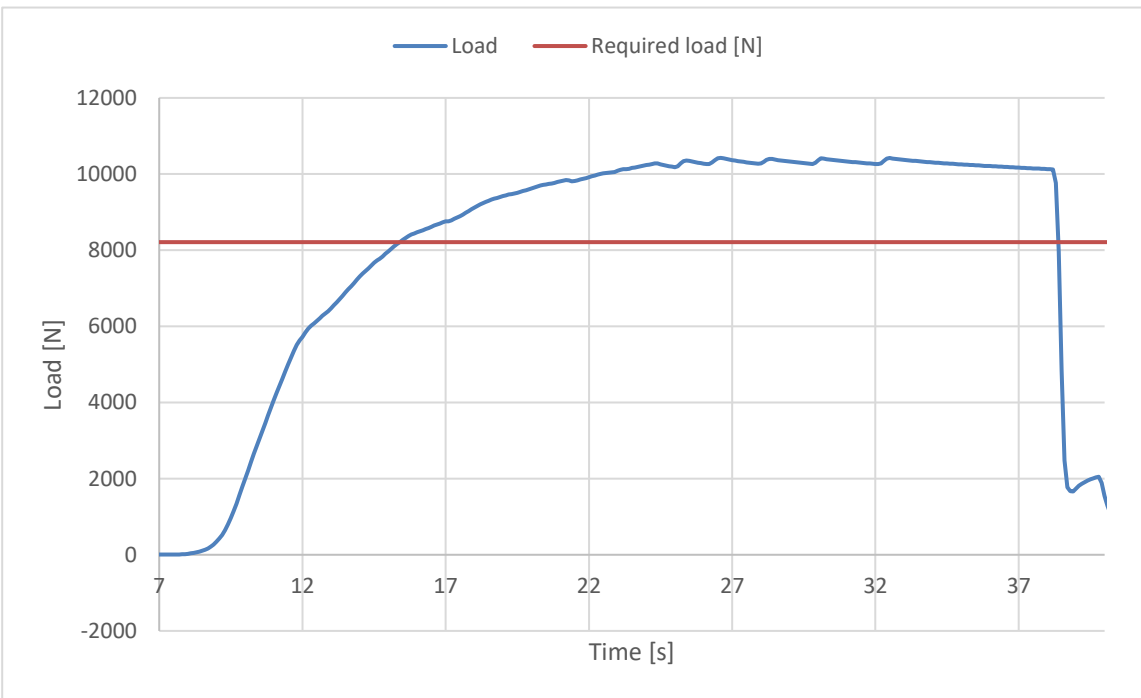
**Test ID R0**

| Any signs of structural failure | <b>No</b> | |
| Test results | <b>POSITIVE</b> | |

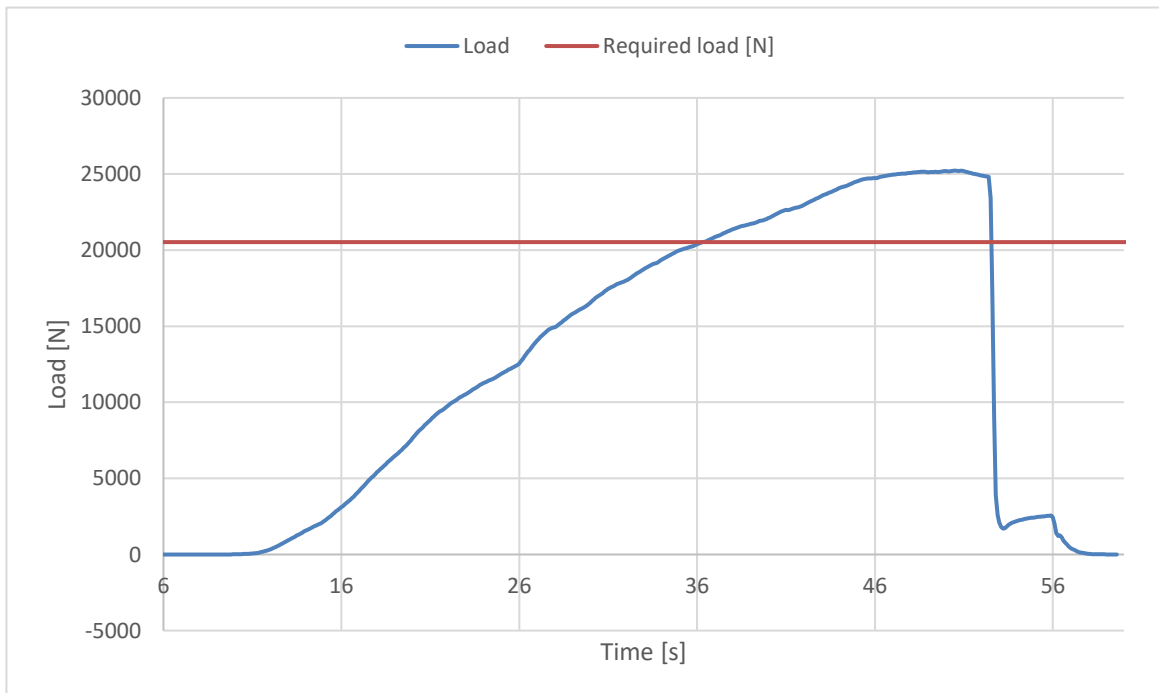
**Test ID R2**

| Any signs of structural failure | <b>No</b> | |
| Test results | <b>POSITIVE</b> | |

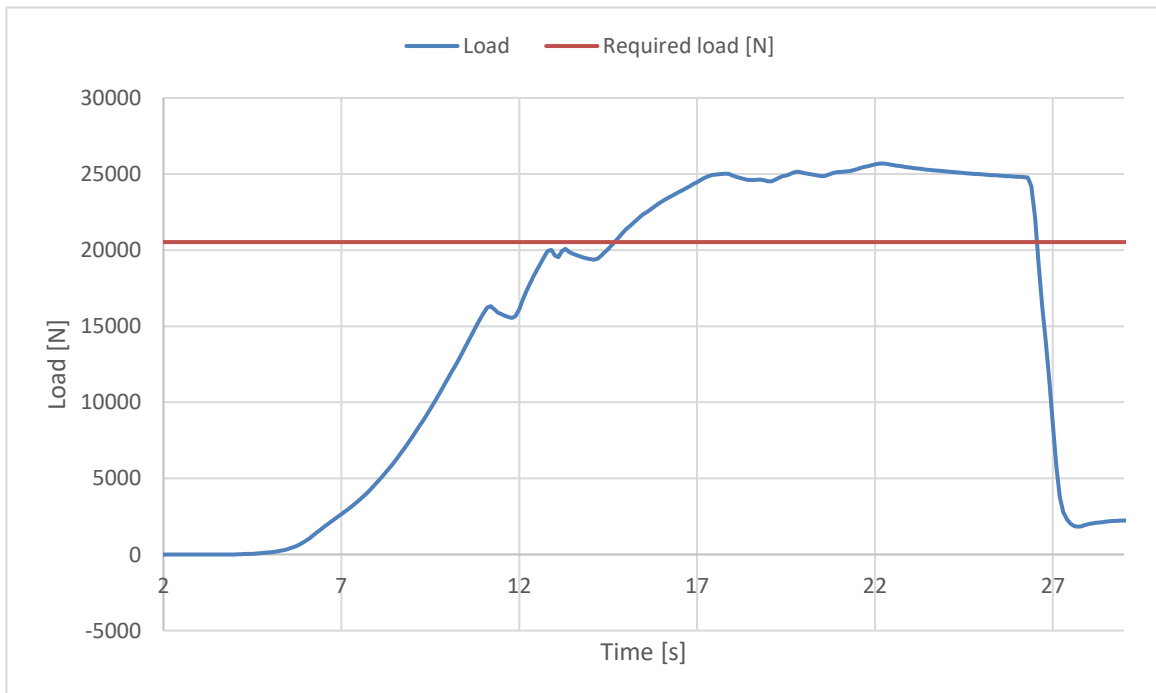
**Test ID R4**

| Any signs of structural failure | <b>No</b> |
| Test results | <b>POSITIVE</b> |

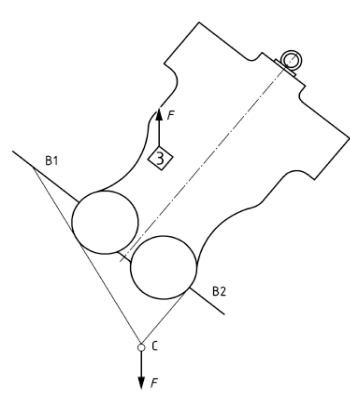
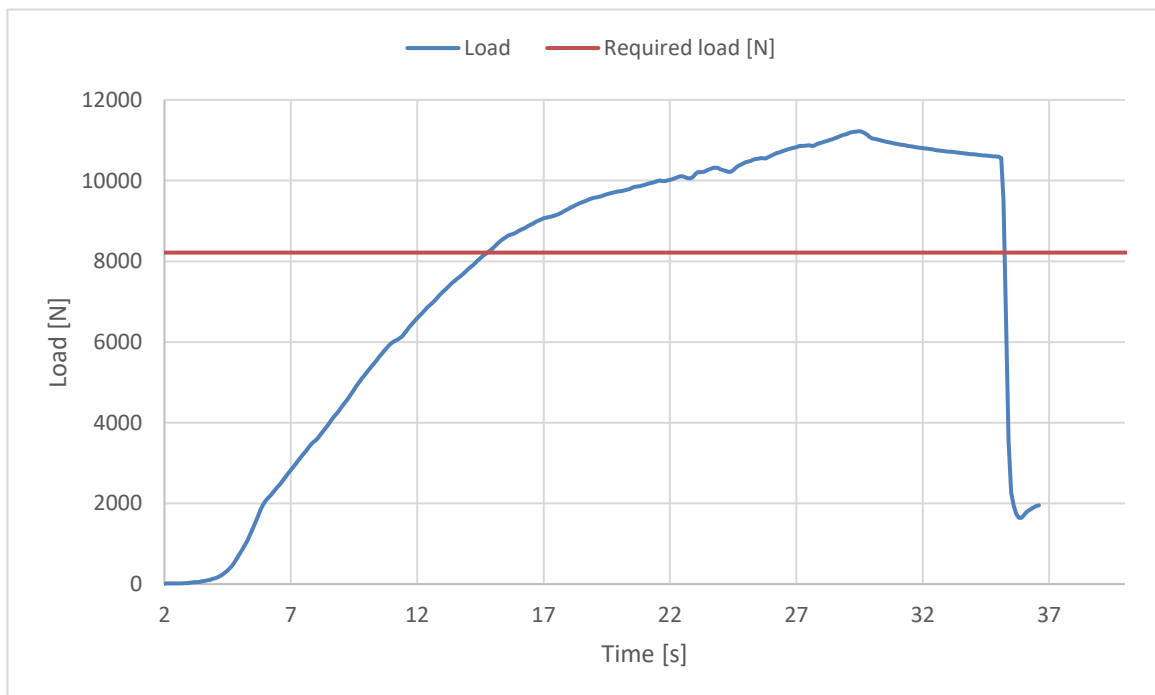
**Test ID R8**

| Any signs of structural failure | <b>No</b> | |
| Test results | <b>POSITIVE</b> | |
