Harness Structural test Report

Inspection certificate number: **PH_239.2018**
Manufacturer data:

Name: **Hike**
 Type: **ABS**
 Size: **M**
 Serial number: **13227**
 Impact pad type: ⁽¹⁾ **Airbag**
 Clip-in weight [kg]: **120**

Date of test: **16.04.2018**

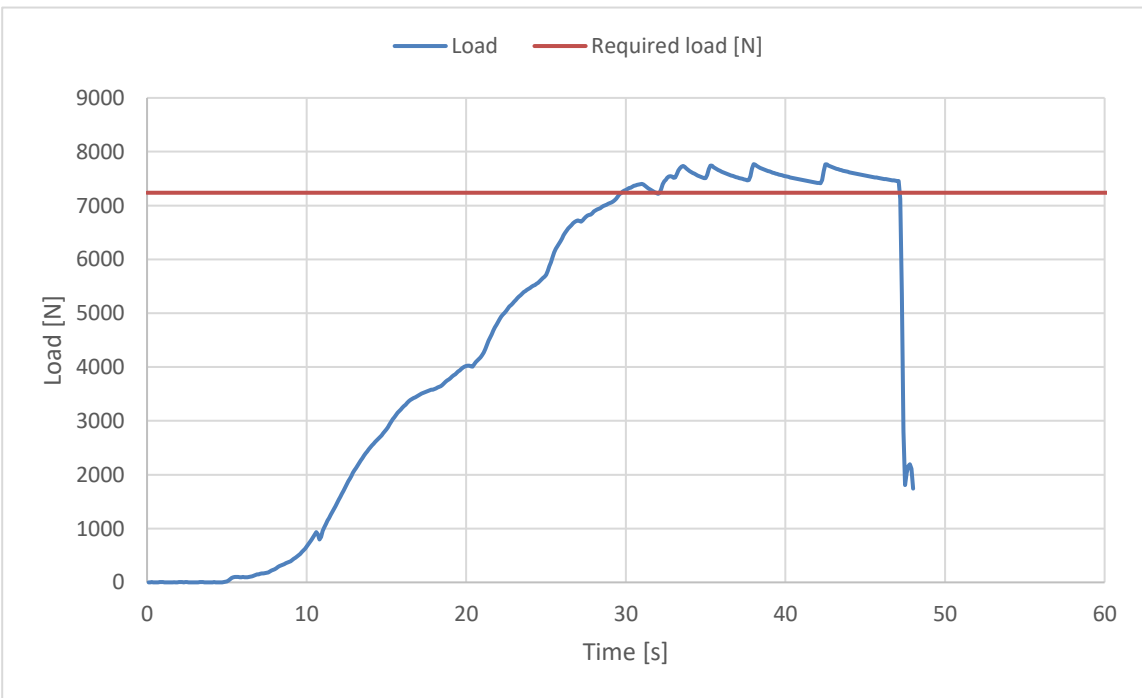
Test ID R0

Reference in standard	5.3.2.1	
Test setup	Default flying position	
Attachment points	Both main riser attachment (3,4)	
Anchor points	Dummy (B1, B2)	
Required load [g]	6	
Required load [N]	7200	
Minimum test duration [s]	10	
Result		
Test duration [s]	15	
Any signs of structural failure	No	
Test results	POSITIVE

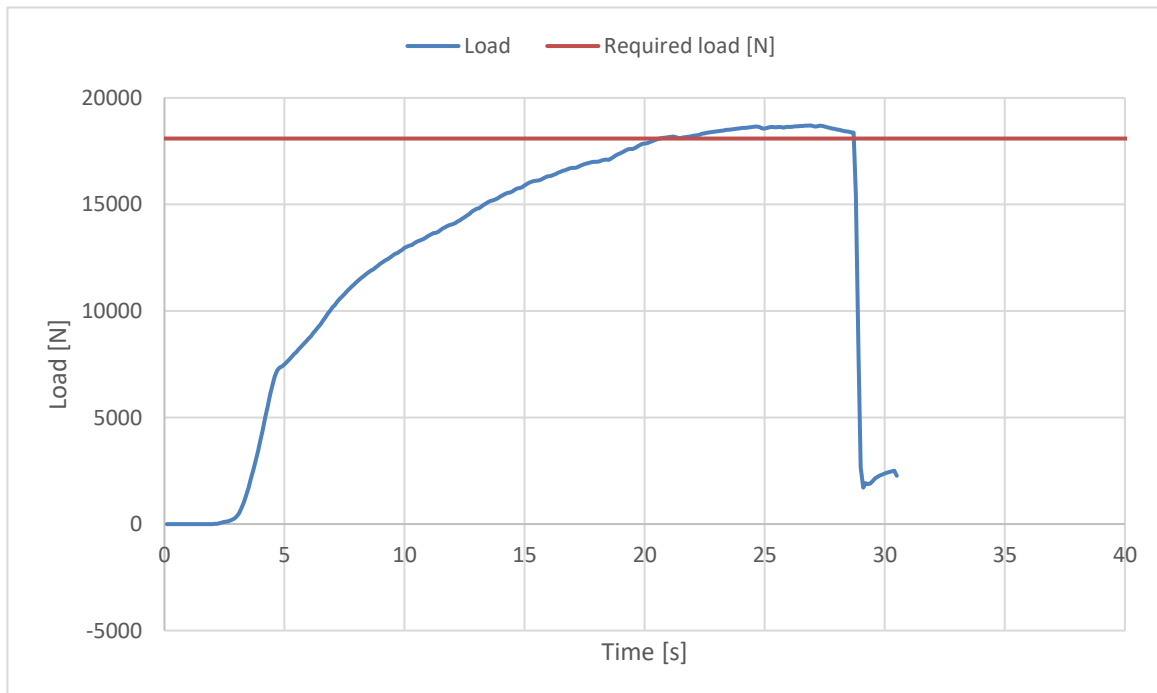
Test ID R2

Standard	EN 1651:1999
Reference in standard	5.3.2.2
Test setup	Default flying position
Attachment points	Both main riser attachment (3,4)
Anchor points	Dummy (B1, B2)
Required load [g]	15
Required load [N]	18000
Minimum test duration [s]	5
Result	
Test duration [s]	8.1
Any signs of structural failure	No
Test results	POSITIVE

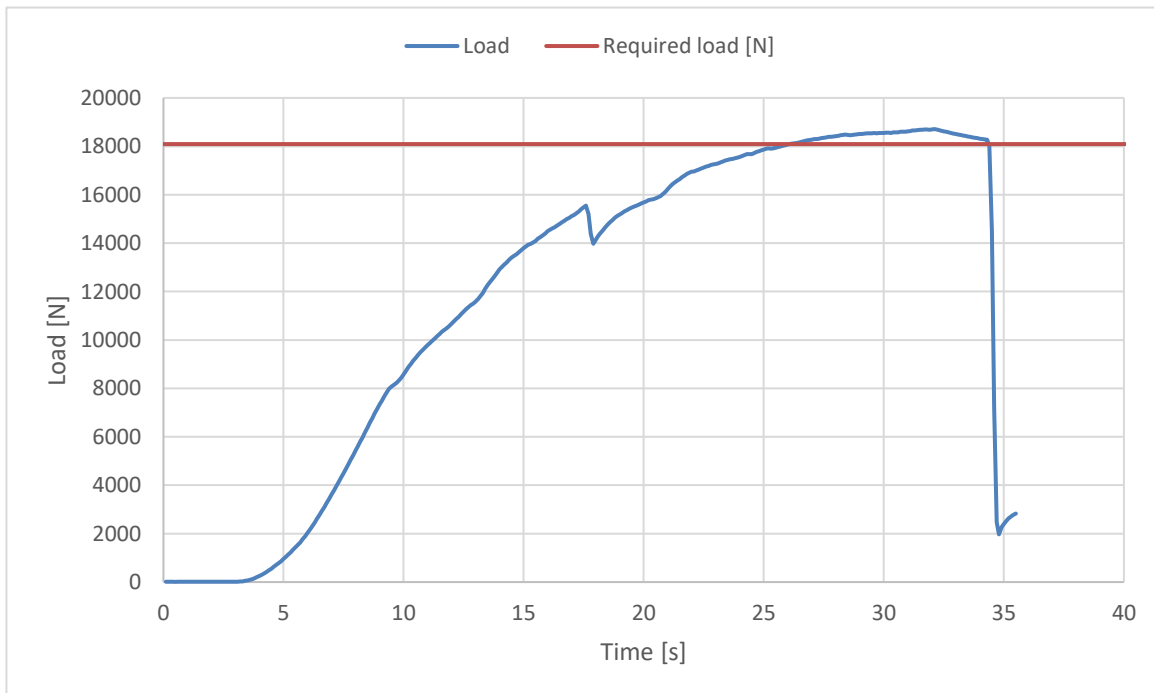
Test ID R4

Standard	EN 1651:1999
Reference in standard	5.3.2.7
Test setup	Flying position before landing
Attachment points	Both main riser attachment (3,4)
Anchor points	Dummy (7,8)
Required load [g]	15
Required load [N]	18000
Minimum test duration [s]	5
Result	
Test duration [s]	8.3
Any signs of structural failure	No
Test results	POSITIVE

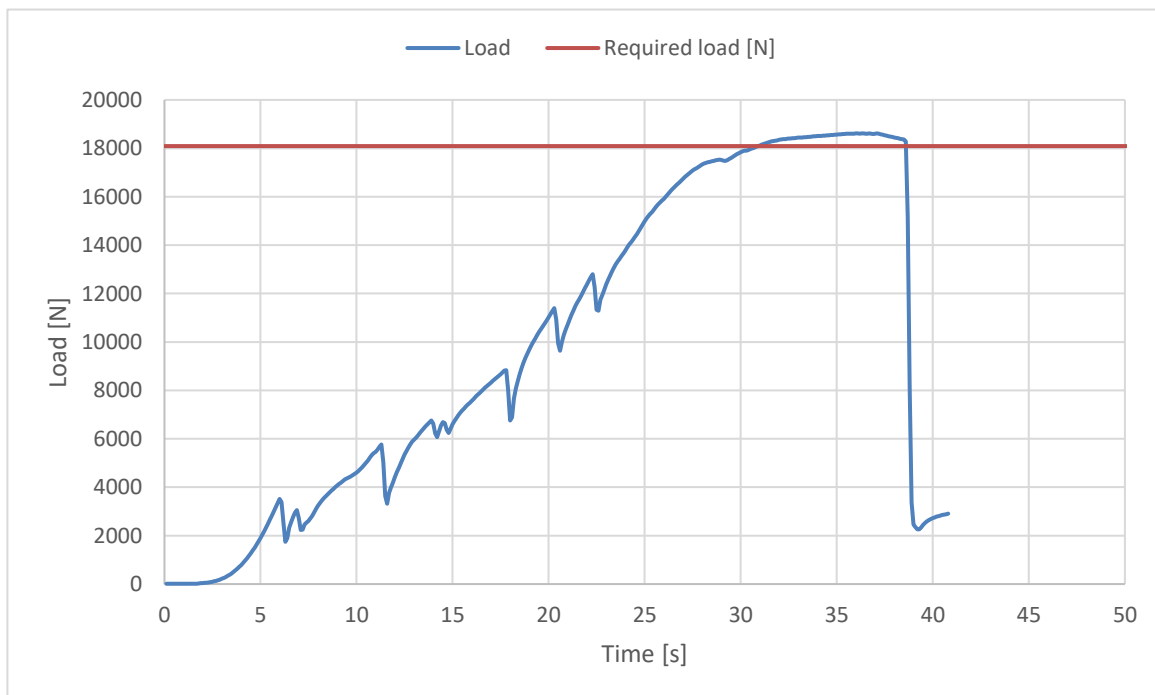
Test ID R6

Reference in standard	5.3.2.4	
Test setup	Rescue attachments	
Attachment points	Rescue riser attachment (1,2)	
Anchor points	Dummy (B1,B2)	
Required load [g]	15	
Required load [N]	18000	
Minimum test duration [s]	5	
Result		
Test duration [s]	7.7	
Any signs of structural failure	No	
Test results	POSITIVE

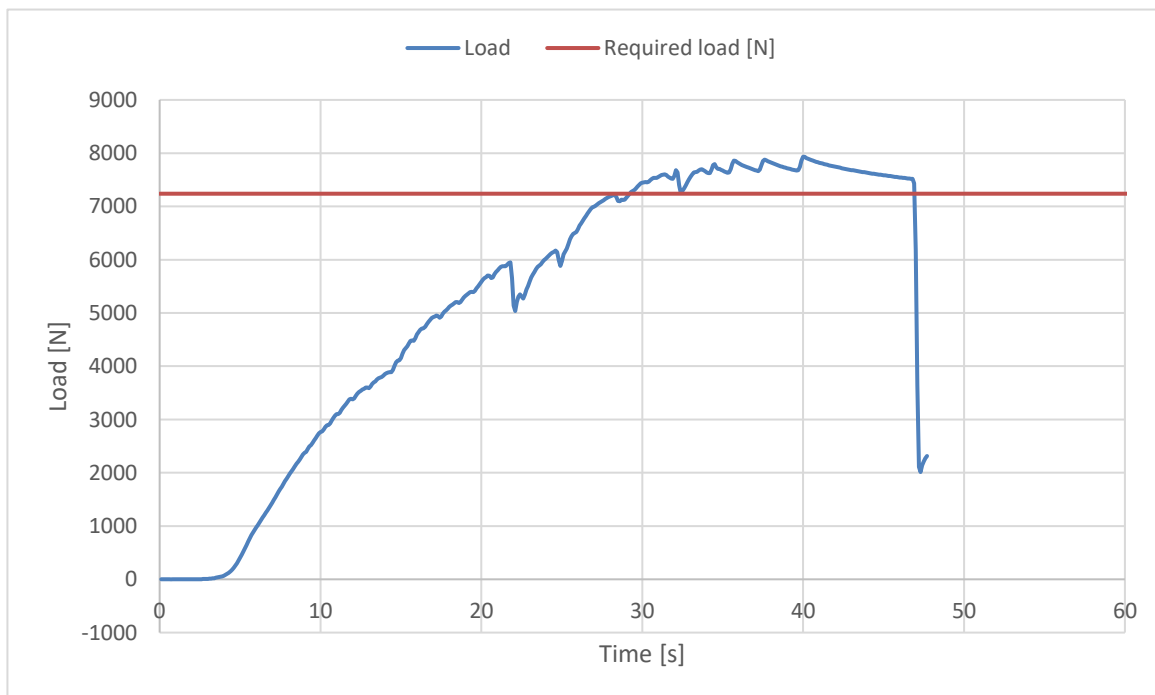
Test ID R8

Standard	EN 1651:1999	
Reference in standard	5.3.2.3	
Test setup	Asymmetric, one riser	
Attachment points	One main riser attachment (3)	
Anchor points	Dummy (B1,B2)	
Required load [g]	6	
Required load [N]	7200	
Minimum test duration [s]	10	
Result		
Test duration [s]	17.7	
Any signs of structural failure	No	
Test results	POSITIVE

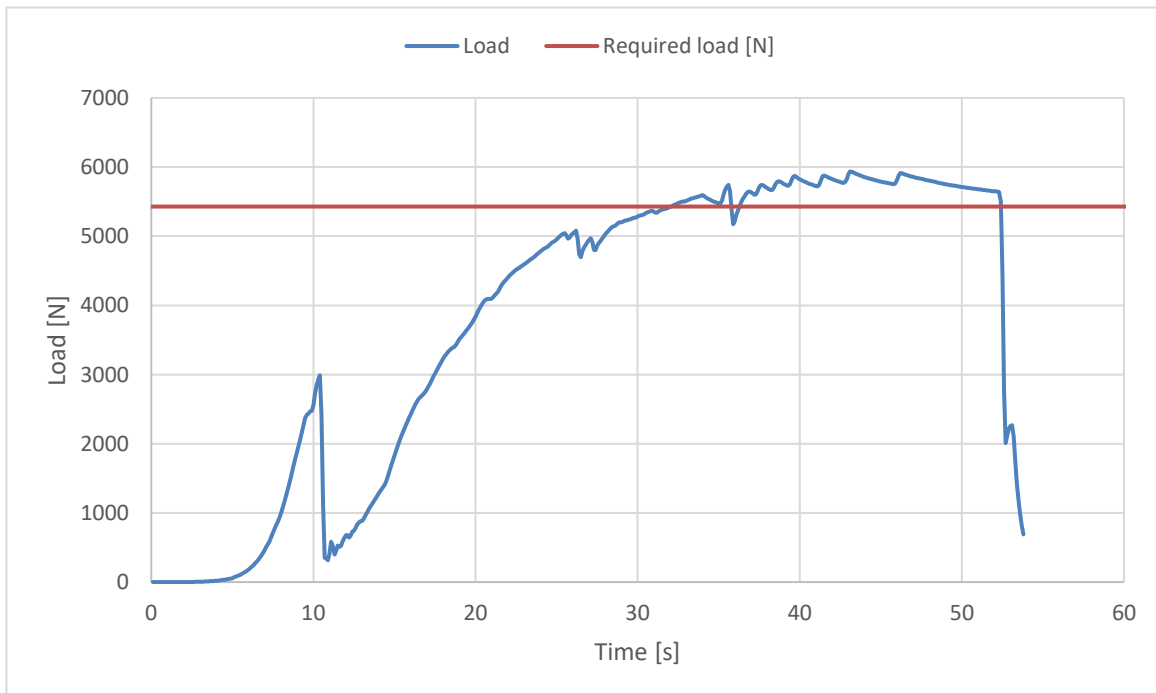
Test ID R10

Reference in standard	5.3.2.6	
Test setup	Asymmetric, negative	
Attachment points	One main riser attachment (3 or 4) downwards	
Anchor points	Dummy (9)	
Required load [g]	4.5	
Required load [N]	5400	
Minimum test duration [s]	10	
Result		
Test duration [s]	16.2	
Any signs of structural failure	No	
Test results	POSITIVE
