Harness Structural test Report

Inspection certificate number: **PH_251.2018**
Manufacturer data:

Name: **Kliff 2**
 Type: **ABS**
 Size: **L**
 Serial number: **S071801**
 Impact pad type: ⁽¹⁾ **n/a**
 Clip-in weight [kg]: **120**

Date of test: **23.10.2018**

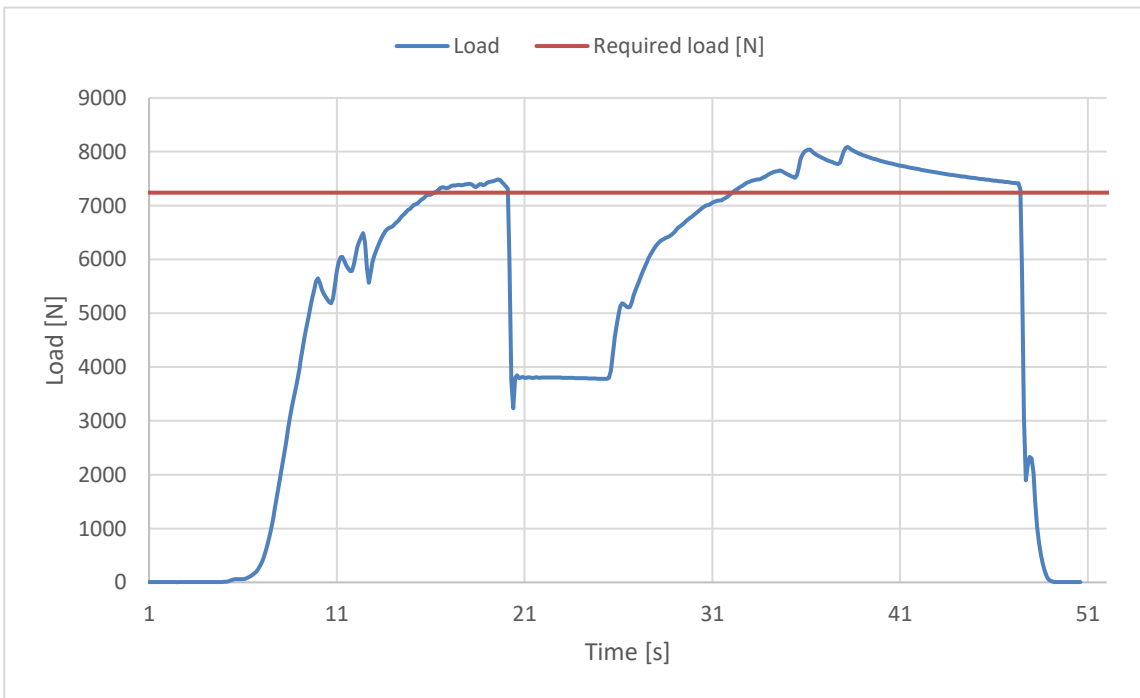
Test ID R0

Standard	EN 1651:1999	
Reference in standard	5.3.2.1	
Test setup	Default flying position	
Attachment points	Both main riser attachment (3,4)	
Anchor points	Dummy (B1, B2)	
Required load [g]	6	
Required load [N]	7200	
Minimum test duration [s]	10	
Result		
Test duration [s]	15.4	
Any signs of structural failure	No	
Test results	POSITIVE

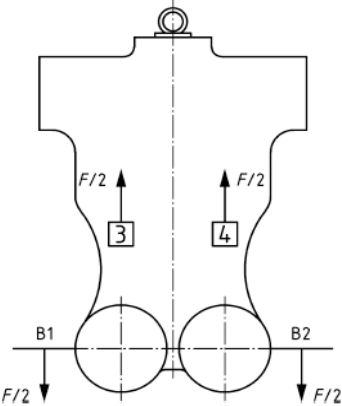
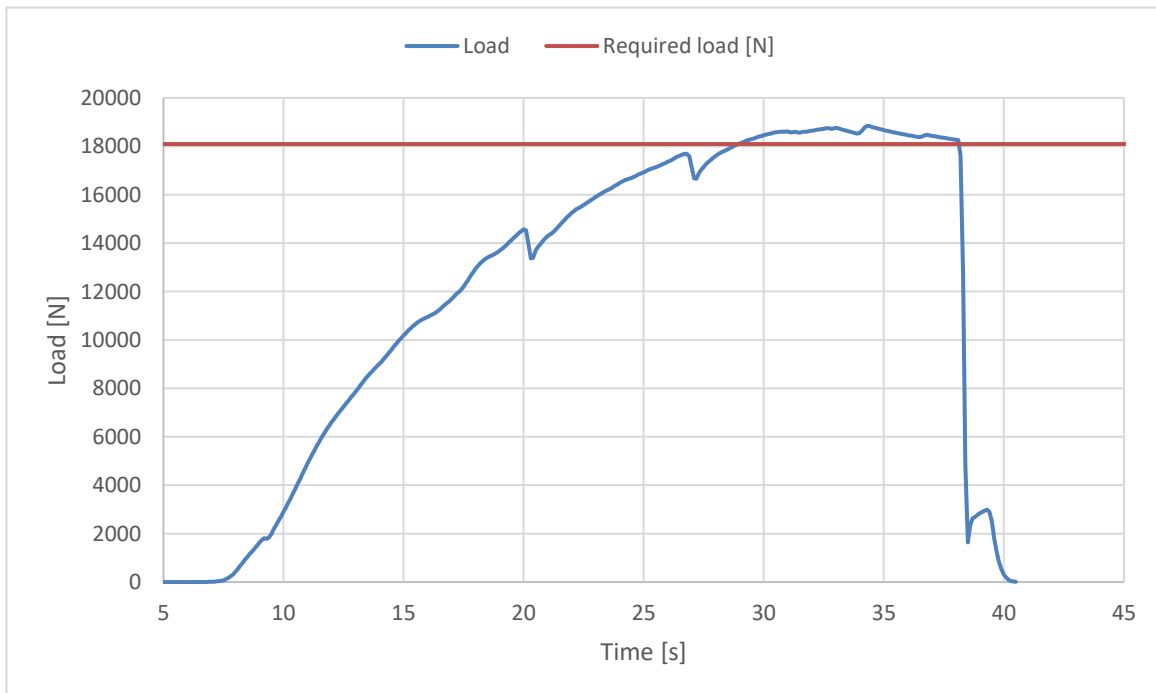
Test ID R2

Standard	EN 1651:1999
Reference in standard	5.3.2.2
Test setup	Default flying position
Attachment points	Both main riser attachment (3,4)
Anchor points	Dummy (B1, B2)
Required load [g]	15
Required load [N]	18000
Minimum test duration [s]	5
Result	
Test duration [s]	9.2
Any signs of structural failure	No
Test results	POSITIVE

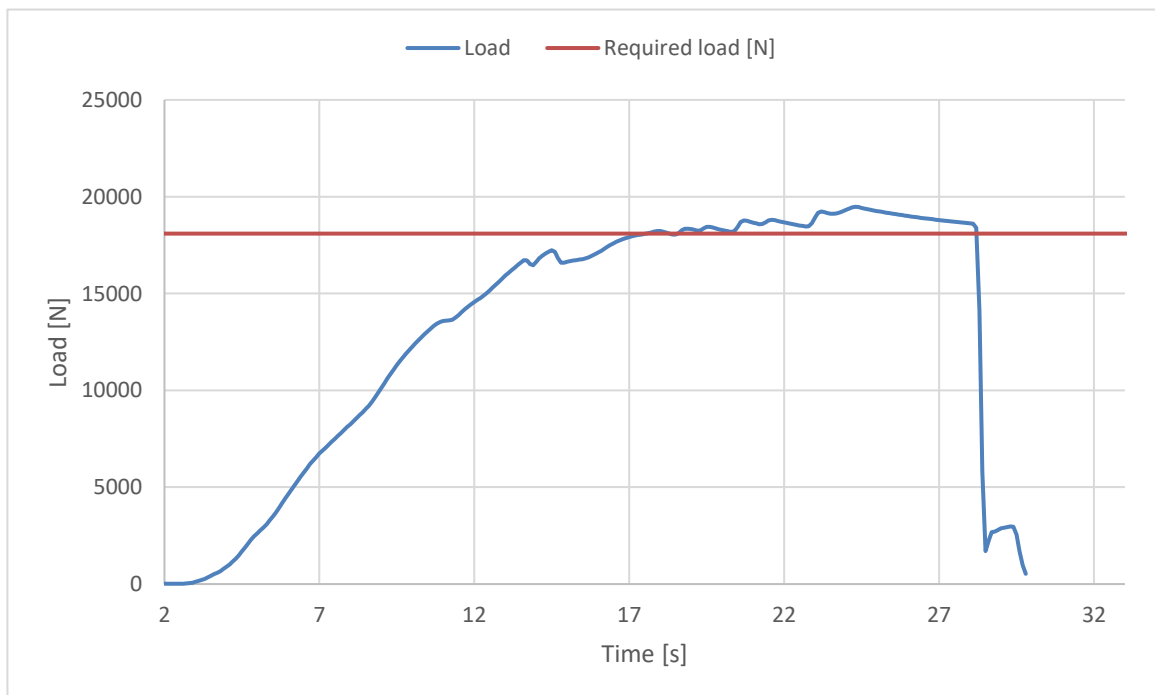
Test ID R4

Standard	EN 1651:1999
Reference in standard	5.3.2.7
Test setup	Flying position before landing
Attachment points	Both main riser attachment (3,4)
Anchor points	Dummy (7,8)
Required load [g]	15
Required load [N]	18000
Minimum test duration [s]	5
Result	
Test duration [s]	9.7
Any signs of structural failure	No
Test results	POSITIVE

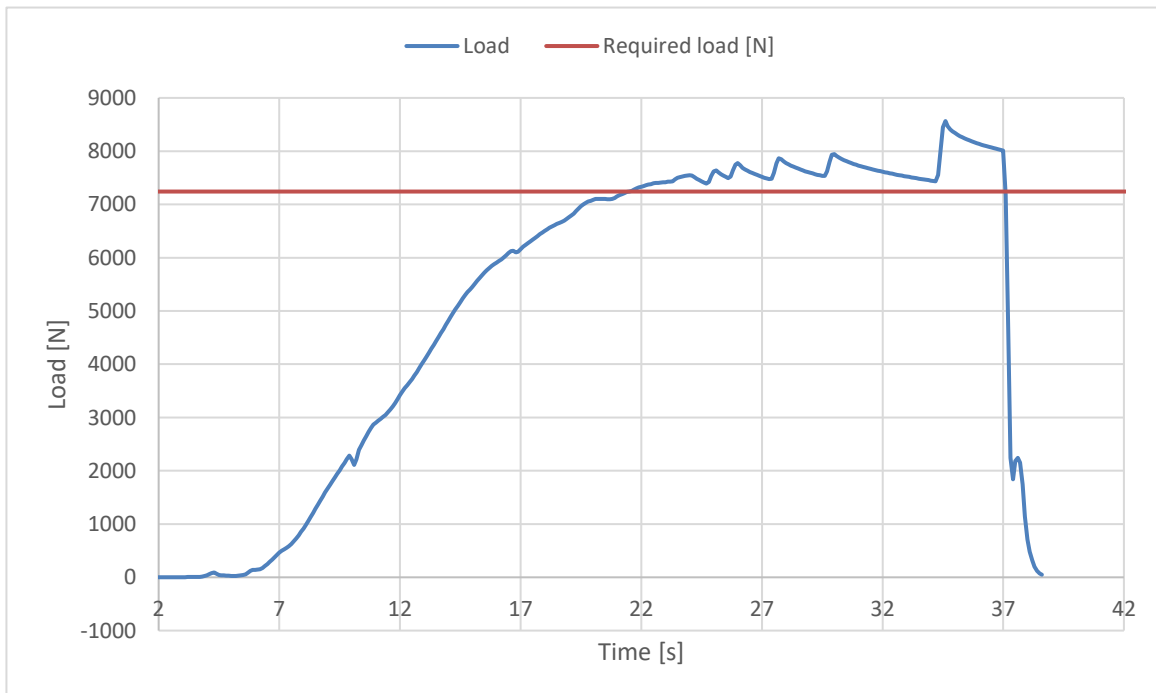
Test ID R8

Standard	EN 1651:1999	
Reference in standard	5.3.2.3	
Test setup	Asymmetric, one riser	
Attachment points	One main riser attachment (3)	
Anchor points	Dummy (B1,B2)	
Required load [g]	6	
Required load [N]	7200	
Minimum test duration [s]	10	
Result		
Test duration [s]	15.5	
Any signs of structural failure	No	
Test results	POSITIVE

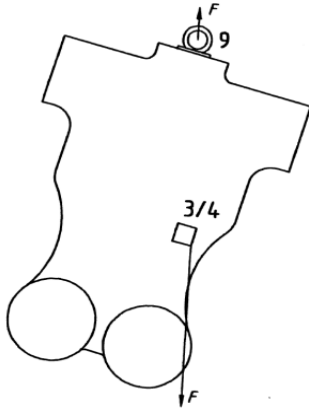
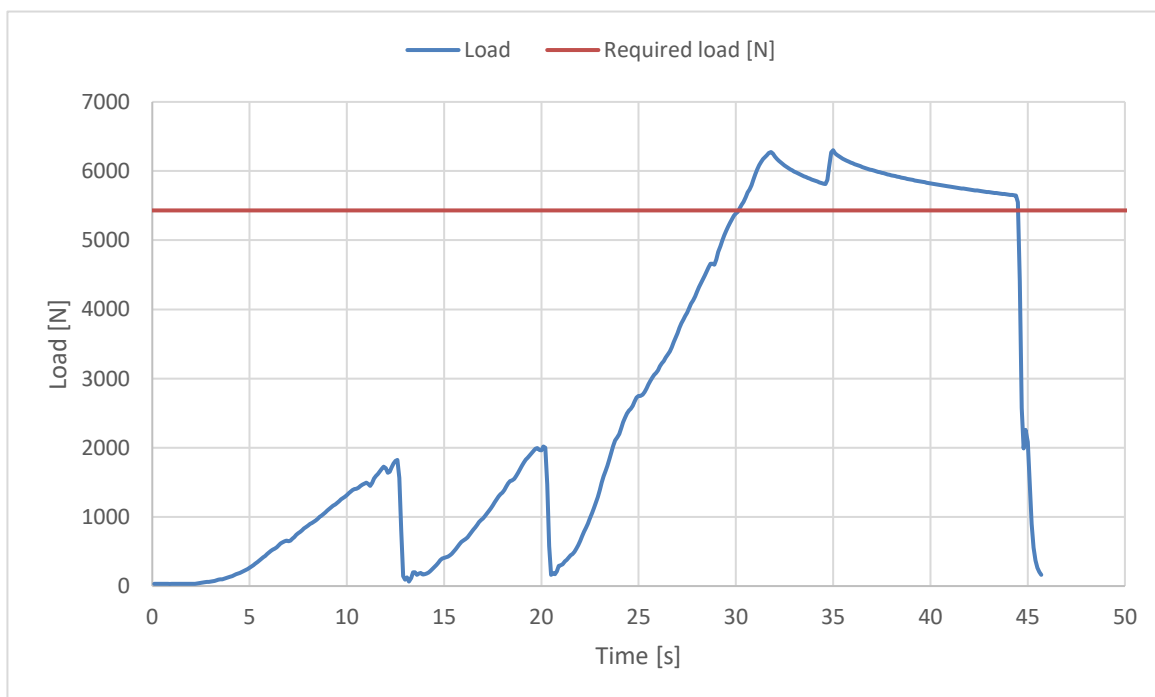
Test ID R10

Reference in standard	5.3.2.6	
Test setup	Asymmetric, negative	
Attachment points	One main riser attachment (3 or 4) downwards	
Anchor points	Dummy (9)	
Required load [g]	4.5	
Required load [N]	5400	
Minimum test duration [s]	10	
Result		
Test duration [s]	14.4	
Any signs of structural failure	No	
Test results	POSITIVE
