Harness Structural test Report

Inspection certificate number: **PH_246.2018**
Manufacturer data:

Manufacturer name: **SkyBean Ltd.**
 Representative: **Martin Daricek**
 Street: **Opalova 5/A**
 Post code place: **85110 Bratislava**
 Country: **Slovakia**

Name: **BNF1**
 Type: **ABS**
 Size: **L**
 Serial number: **002**
 Impact pad type: ⁽¹⁾ **n/a**
 Clip-in weight [kg]: **120**

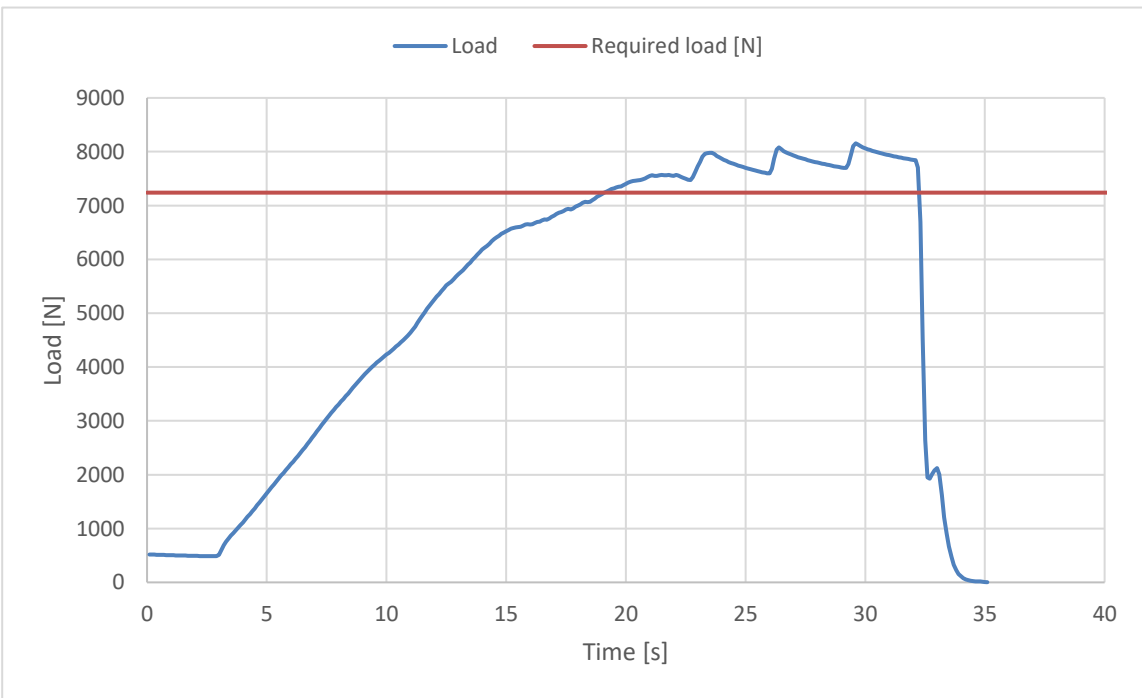
Test ID R0

Standard	EN 1651:1999
Reference in standard	5.3.2.1
Test setup	Default flying position
Attachment points	Both main riser attachment (3,4)
Anchor points	Dummy (B1, B2)
Required load [g]	6
Required load [N]	7200
Minimum test duration [s]	10
Result	
Test duration [s]	13.2
Any signs of structural failure	No
Test results	POSITIVE

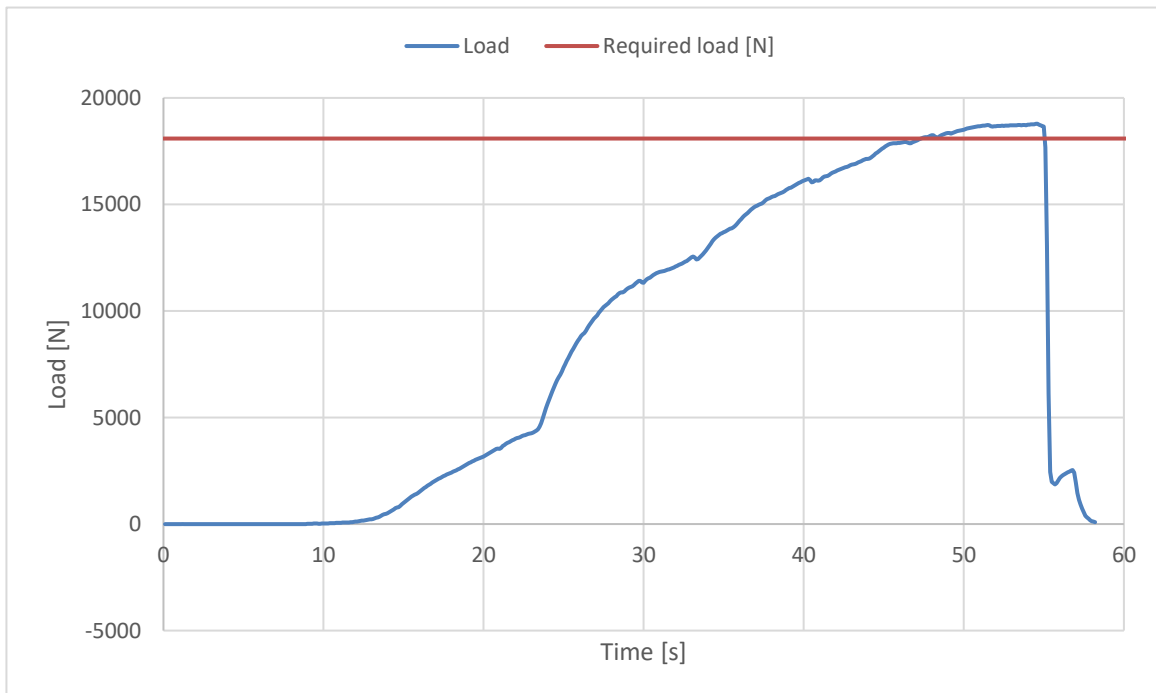
Test ID R2

Reference in standard	5.3.2.2	
Test setup	Default flying position	
Attachment points	Both main riser attachment (3,4)	
Anchor points	Dummy (B1, B2)	
Required load [g]	15	
Required load [N]	18000	
Minimum test duration [s]	5	
Result		
Test duration [s]	7.7	
Any signs of structural failure	No	
Test results	POSITIVE

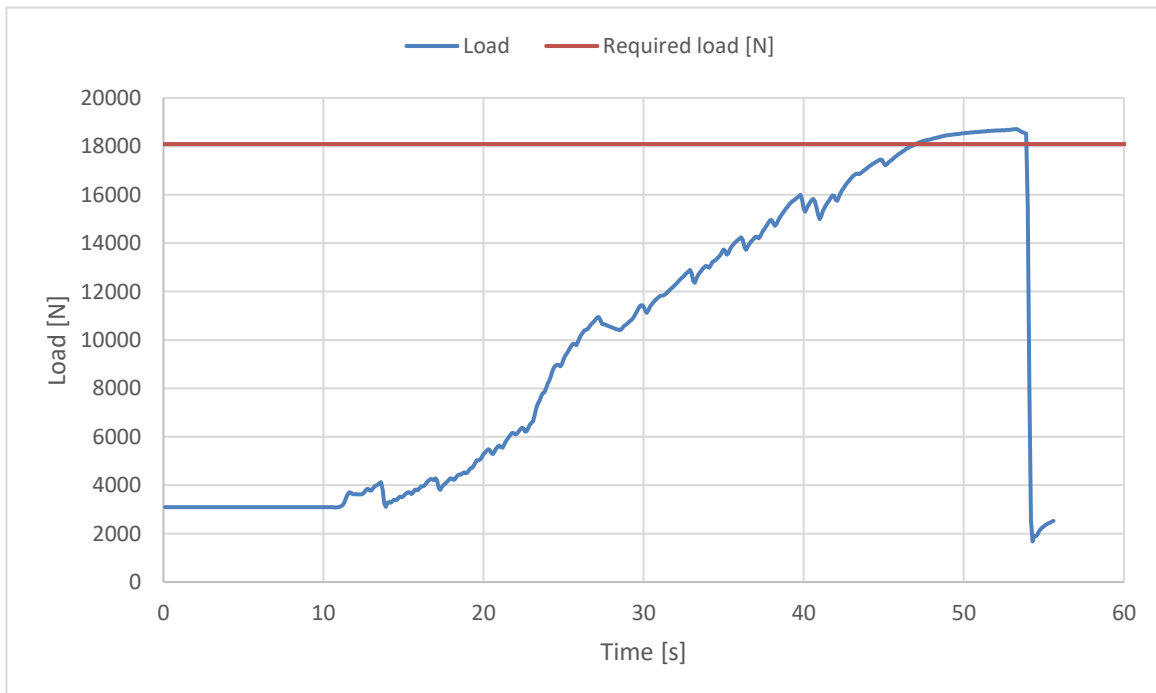
Test ID R4

Standard	EN 1651:1999
Reference in standard	5.3.2.7
Test setup	Flying position before landing
Attachment points	Both main riser attachment (3,4)
Anchor points	Dummy (7,8)
Required load [g]	15
Required load [N]	18000
Minimum test duration [s]	5
Result	
Test duration [s]	6.9
Any signs of structural failure	No
Test results	POSITIVE

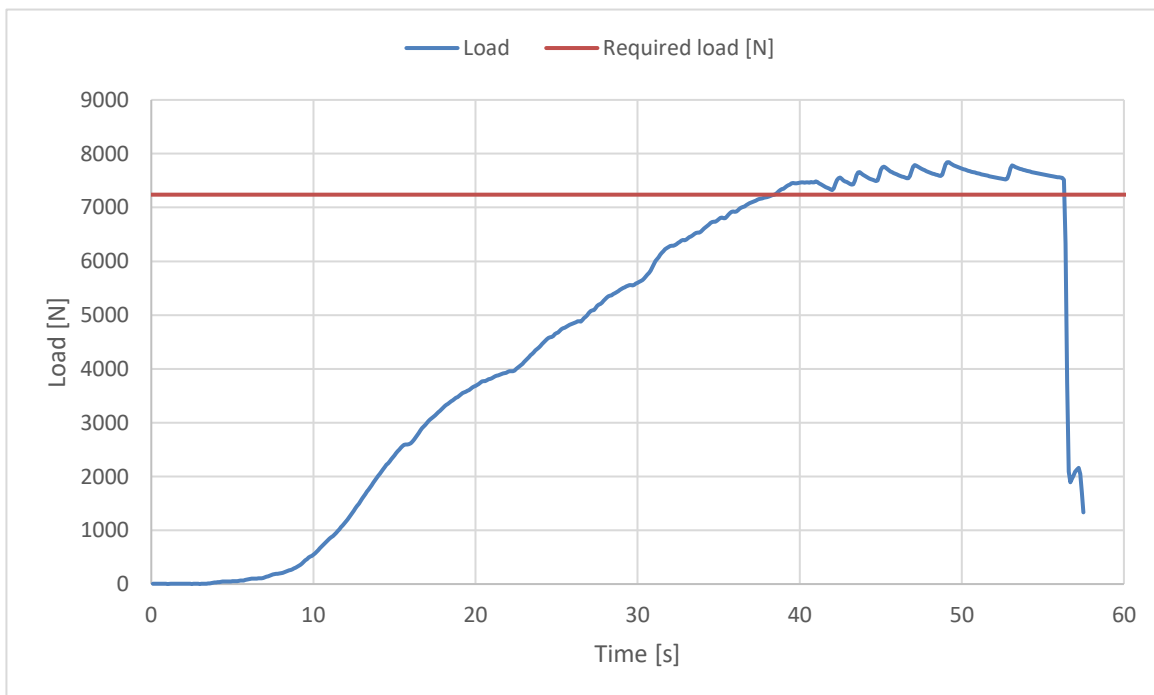
Test ID R8

Standard	EN 1651:1999	
Reference in standard	5.3.2.3	
Test setup	Asymmetric, one riser	
Attachment points	One main riser attachment (3)	
Anchor points	Dummy (B1,B2)	
Required load [g]	6	
Required load [N]	7200	
Minimum test duration [s]	10	
Result		
Test duration [s]	17.9	
Any signs of structural failure	No	
Test results	POSITIVE

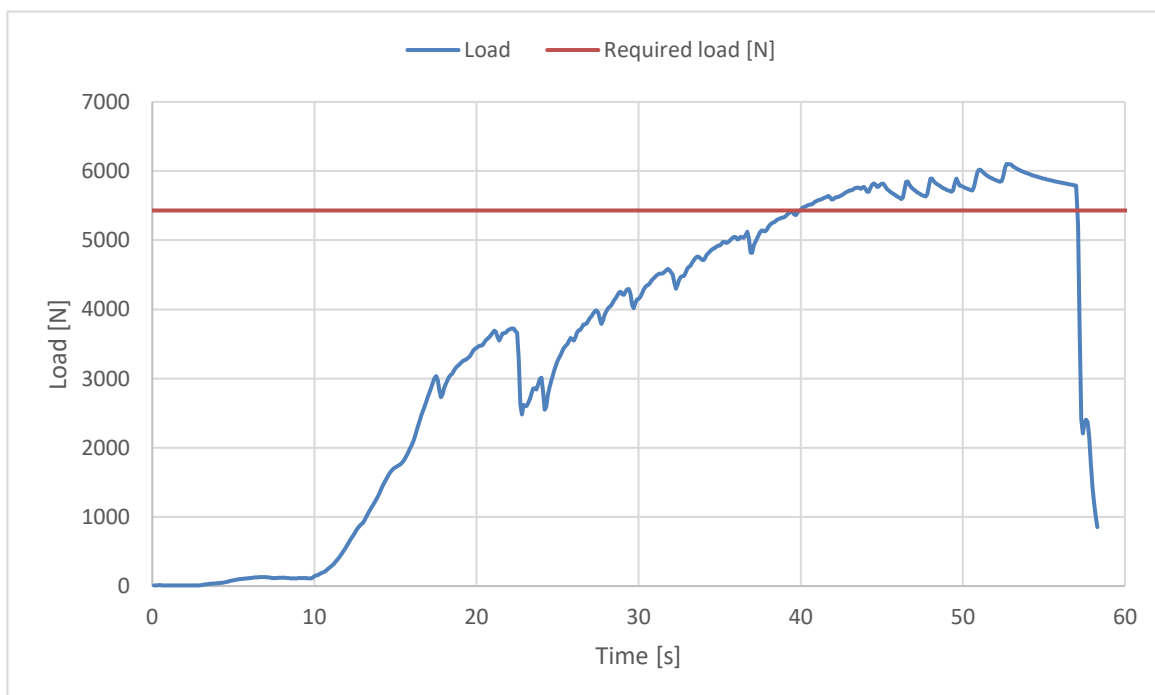
Test ID R10

Reference in standard	5.3.2.6	
Test setup	Asymmetric, negative	
Attachment points	One main riser attachment (3 or 4) downwards	
Anchor points	Dummy (9)	
Required load [g]	4.5	
Required load [N]	5400	
Minimum test duration [s]	10	
Result		
Test duration [s]	17.1	
Any signs of structural failure	No	
Test results	POSITIVE
