Harness Structural test Report

Inspection certificate number: **PH_260.2019**
Manufacturer data:

Name: **Altirando Lite**
 Type: **ABS**
 Size: **L**
 Serial number: **ATL_L_VS.1**
 Impact pad type: ⁽¹⁾ **Airbag**
 Clip-in weight [kg]: **120**

Summary of Structural test

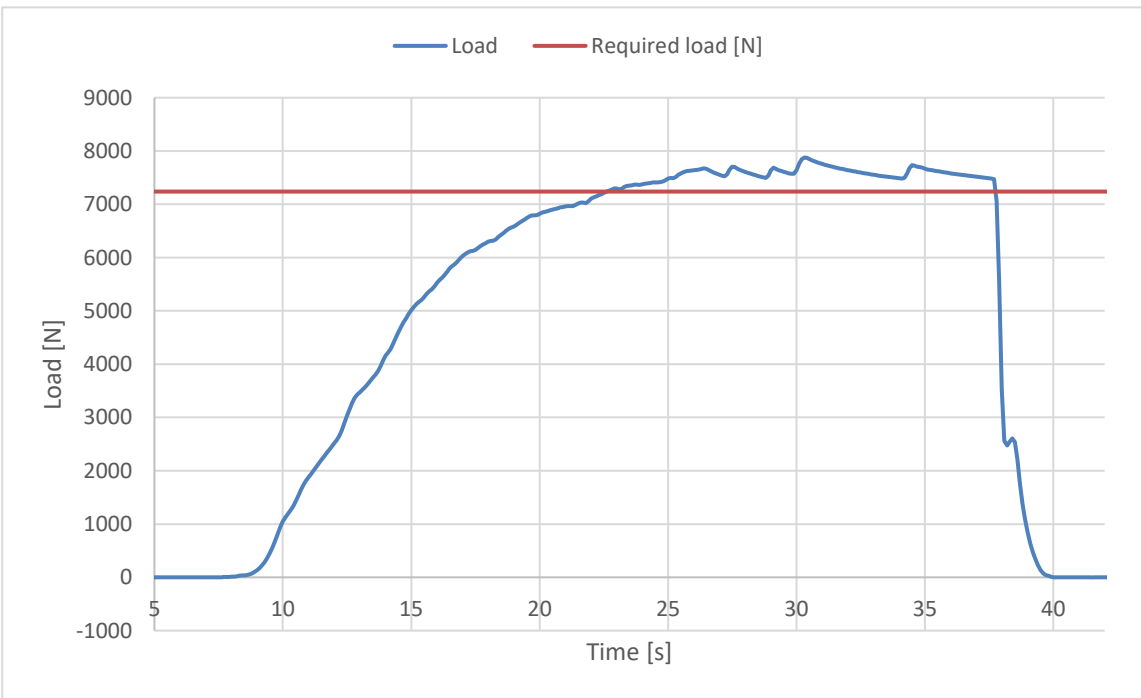
Test ID R0

Standard	EN 1651:1999	120
Reference in standard	5.3.2.1	
Test setup	Default flying position	
Attachment points	Both main riser attachment (3,4)	
Anchor points	Dummy (B1, B2)	
Required load [g]	6	
Required load [N]	7200	
Minimum test duration [s]	10	
Result		
Test duration [s]	15.1	
Any signs of structural failure	No	
Test results	POSITIVE

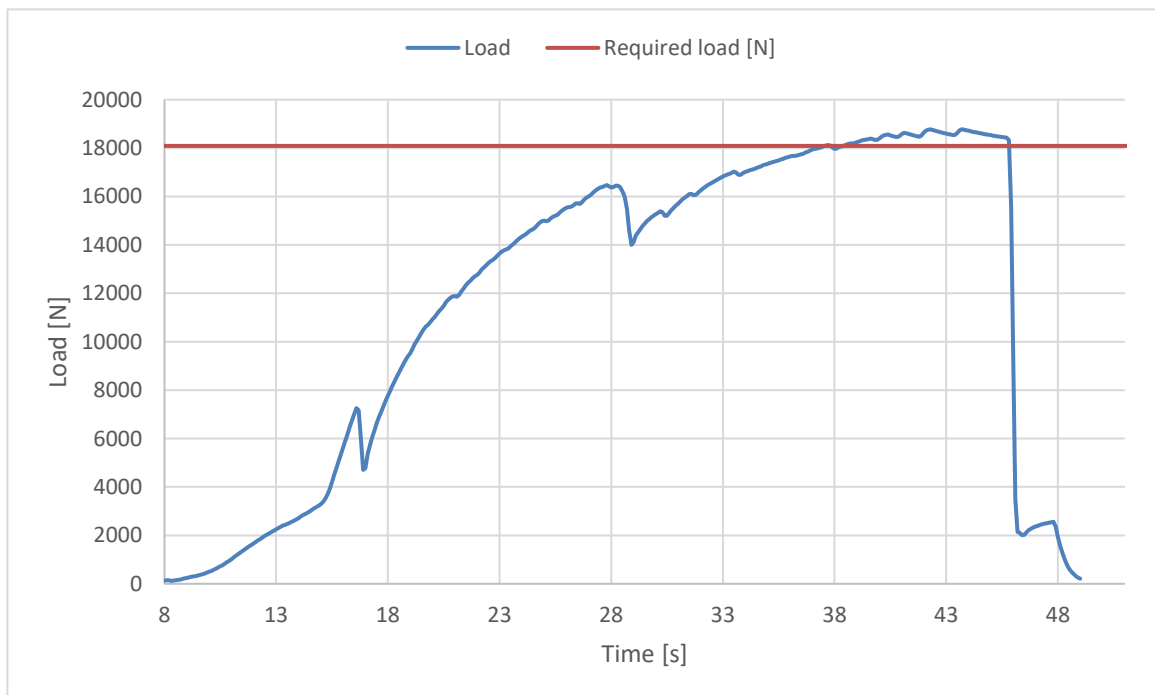
Test ID R2

Standard	EN 1651:1999		120
Reference in standard	5.3.2.2		
Test setup	Default flying position		
Attachment points	Both main riser attachment (3,4)		
Anchor points	Dummy (B1, B2)		
Required load [g]	15		
Required load [N]	18000		
Minimum test duration [s]	5		
Result			
Test duration [s]	7.5		
Any signs of structural failure	No		
Test results	POSITIVE

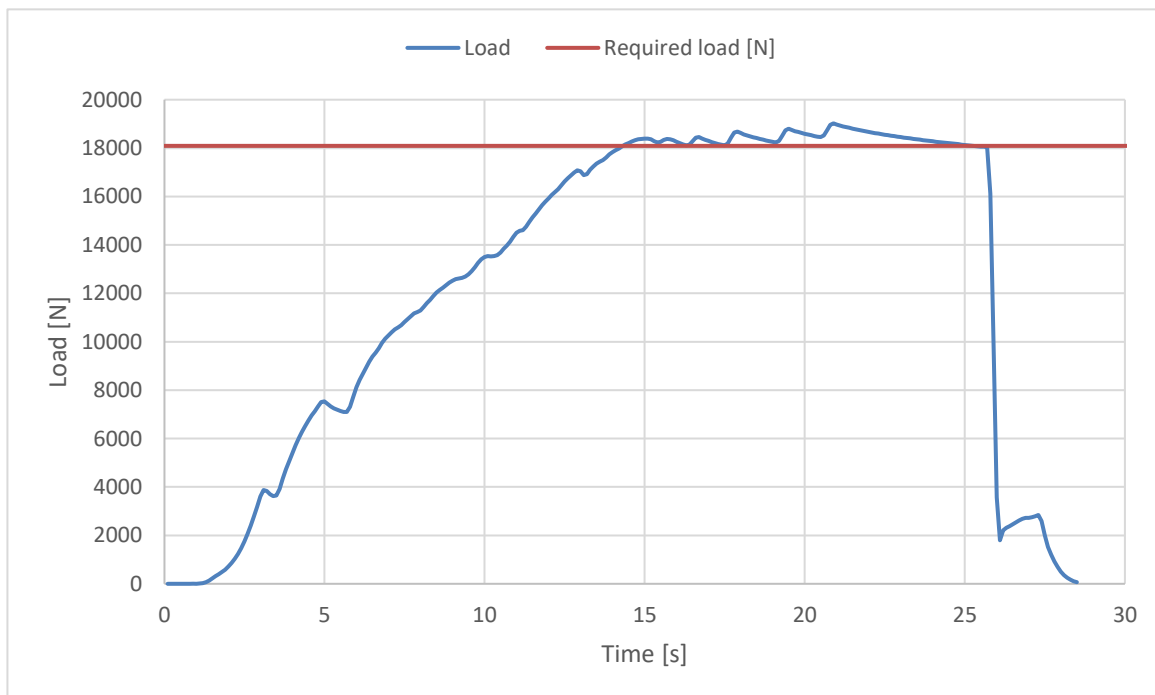
Test ID R4

Standard	EN 1651:1999
Reference in standard	5.3.2.7
Test setup	Flying position before landing
Attachment points	Both main riser attachment (3,4)
Anchor points	Dummy (7,8)
Required load [g]	15
Required load [N]	18000
Minimum test duration [s]	5
Result	
Test duration [s]	10.9
Any signs of structural failure	No
Test results	POSITIVE

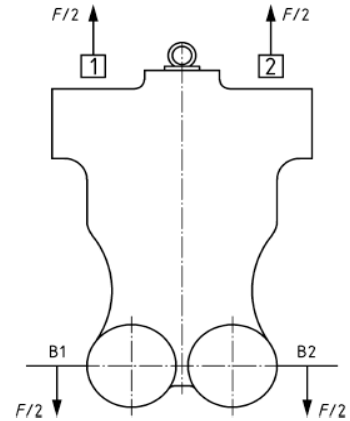
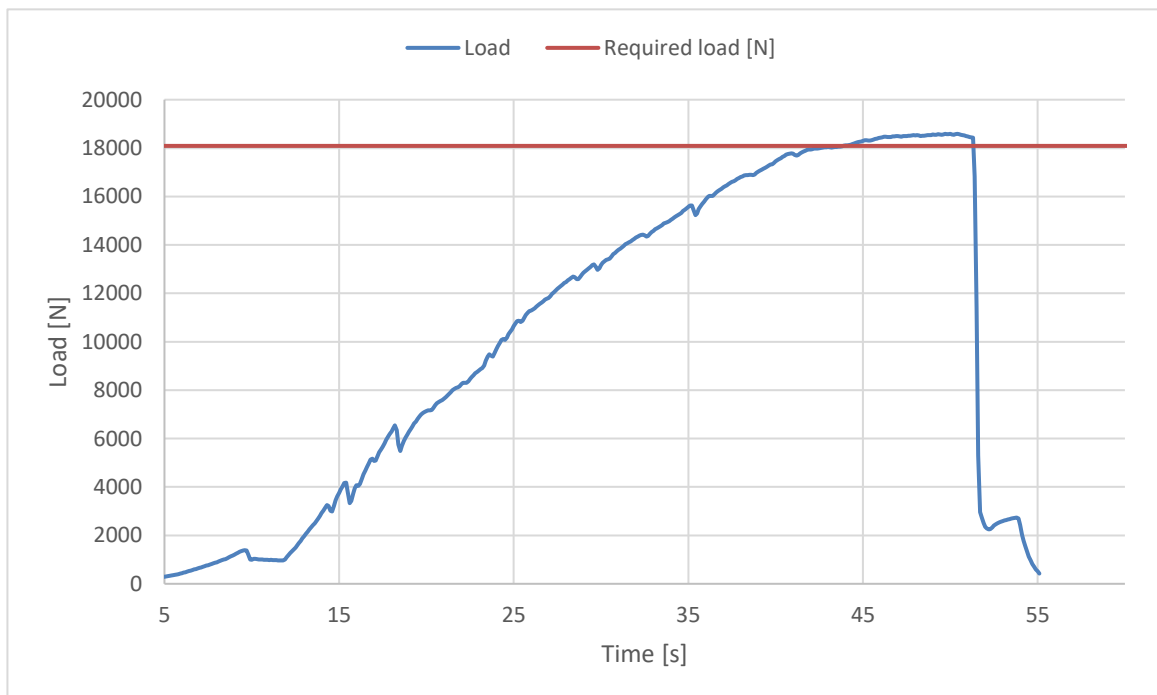
Test ID R6

Standard	EN 1651:1999
Reference in standard	5.3.2.4
Test setup	Rescue attachments
Attachment points	Rescue riser attachment (1,2)
Anchor points	Dummy (B1,B2)
Required load [g]	15
Required load [N]	18000
Minimum test duration [s]	5
Result	
Test duration [s]	7.5
Any signs of structural failure	No
Test results	POSITIVE

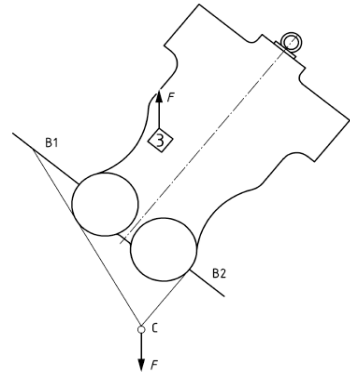
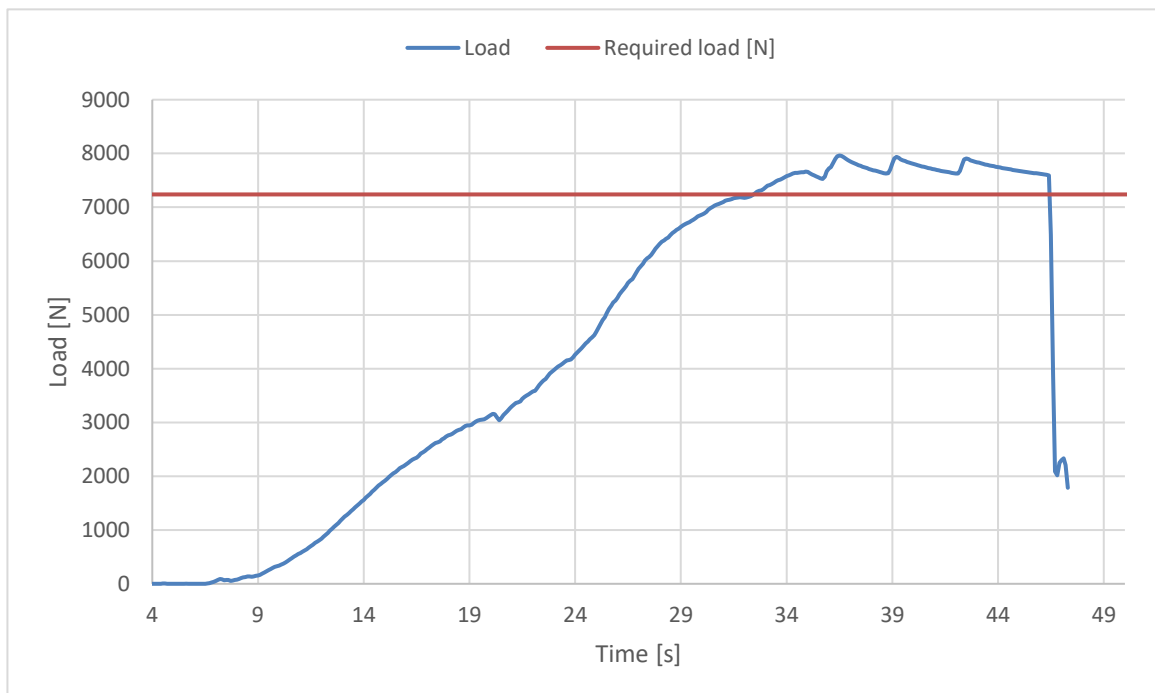
Test ID R8

Standard	EN 1651:1999
Reference in standard	5.3.2.3
Test setup	Asymmetric, one riser
Attachment points	One main riser attachment (3)
Anchor points	Dummy (B1,B2)
Required load [g]	6
Required load [N]	7200
Minimum test duration [s]	10
Result	
Test duration [s]	14
Any signs of structural failure	No
Test results	POSITIVE

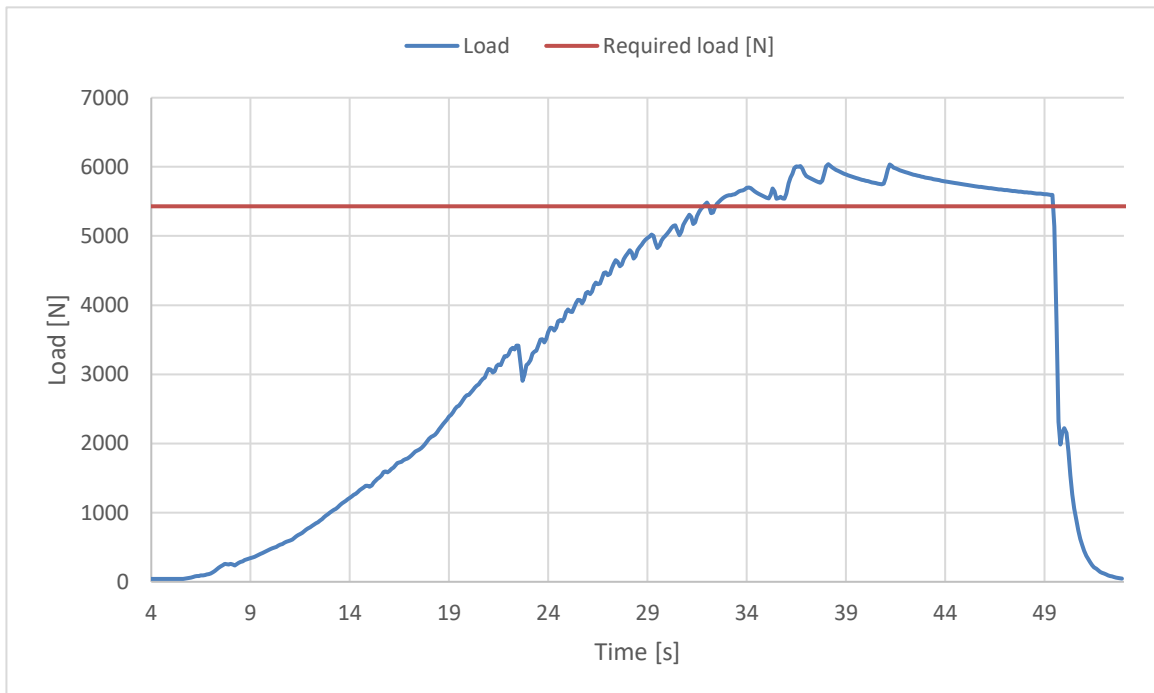
Test ID R10

Standard	EN 1651:1999	120
Reference in standard	5.3.2.6	
Test setup	Asymmetric, negative	
Attachment points	One main riser attachment (3 or 4) downwards	
Anchor points	Dummy (9)	
Required load [g]	4.5	
Required load [N]	5400	
Minimum test duration [s]	10	
Result		
Test duration [s]	17	
Any signs of structural failure	No	
Test results	POSITIVE

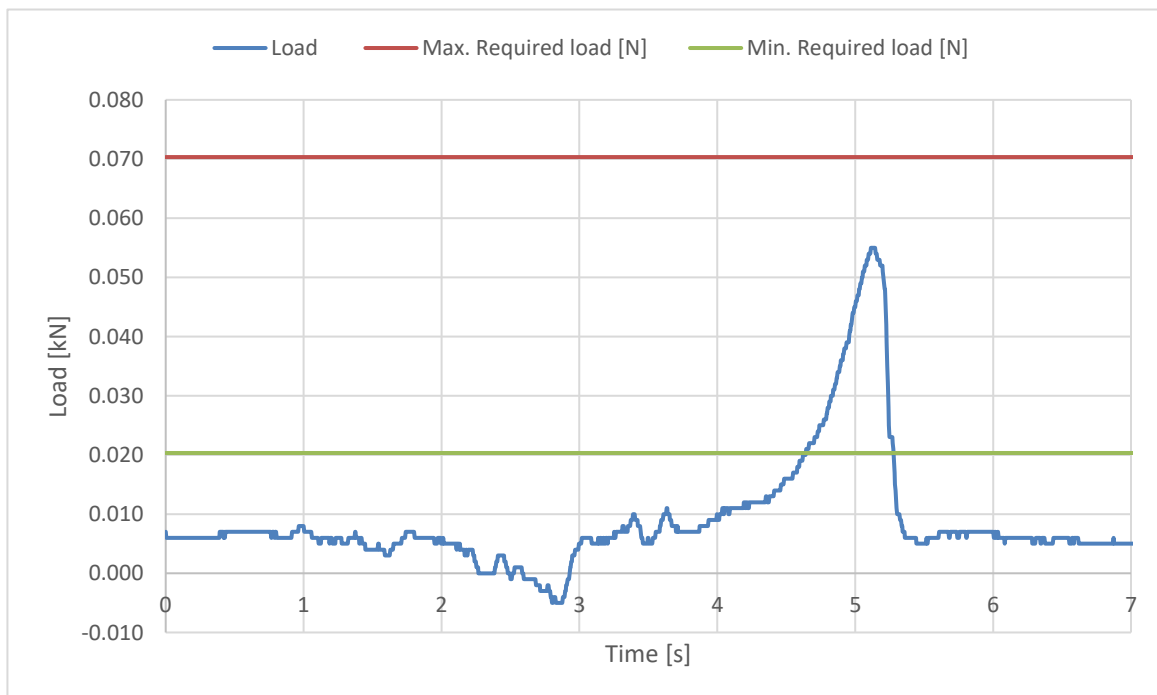
Test ID RRDT

Standard	LTF NfL II 91/09
Reference in standard	6.1.5
Test setup	Default flying position
Attachment points	Sensor connect to handle, and pull in opening direction
	The test is to simulate the load required to open the emergency parachute(1st action).
Min. Required load [N]	20
Max. Required load [N]	70
Result	
Load for first action [N]	54.67
Test results	POSITIVE

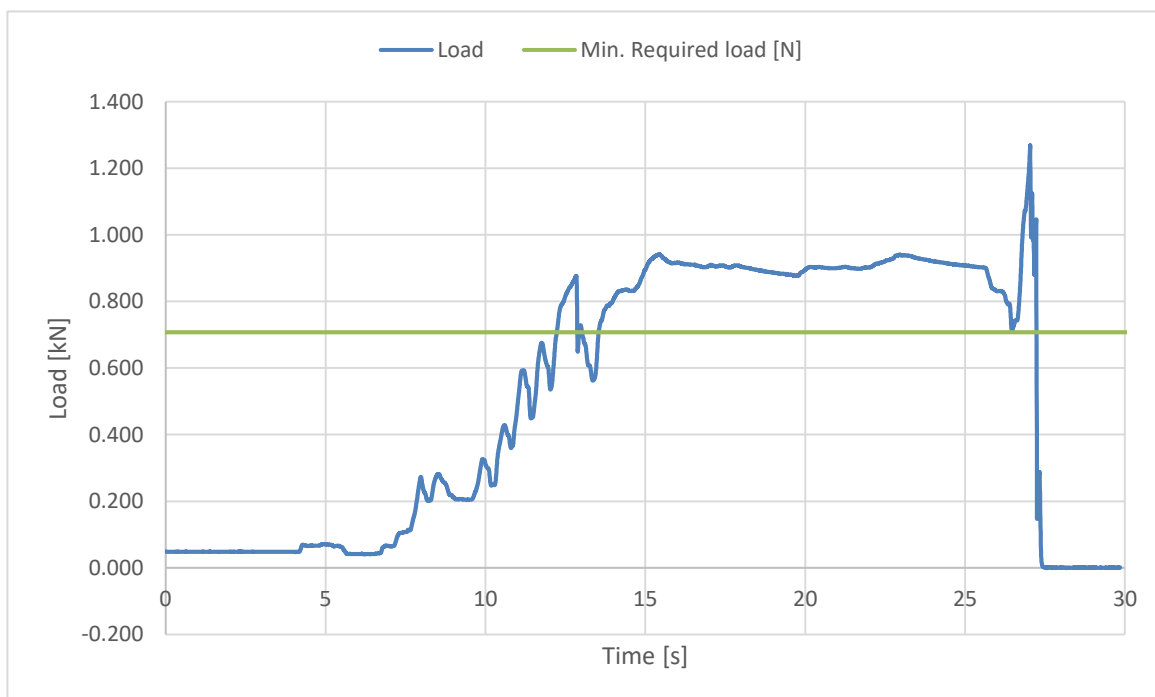
Test ID RRST

Standard	EN12491:2015
Reference in standard	5.3.2
Test setup	Two end points of handle
Attachment points	Sensor connect to end of handle, pull on the other side
	The handle must support min 700 N for 10 s, after measure breaking strength
Min. Required load [N]	700
Minimum test duration [s]	10
Result	
Test duration [s]:	13.6
Breaking strength [N]	1261.38
Test results	POSITIVE
