Harness Structural test Report

Inspection certificate number: **PH_220.2018**
Manufacturer data:

Name: **Prika**
 Type: **ABS**
 Size: **M**
 Serial number: **AVN-P-00001**
 Impact pad type: ⁽¹⁾ **Foam**
 Clip-in weight [kg]: **120**

Date of test: **26.01.2018**
Atmosphere AGL:

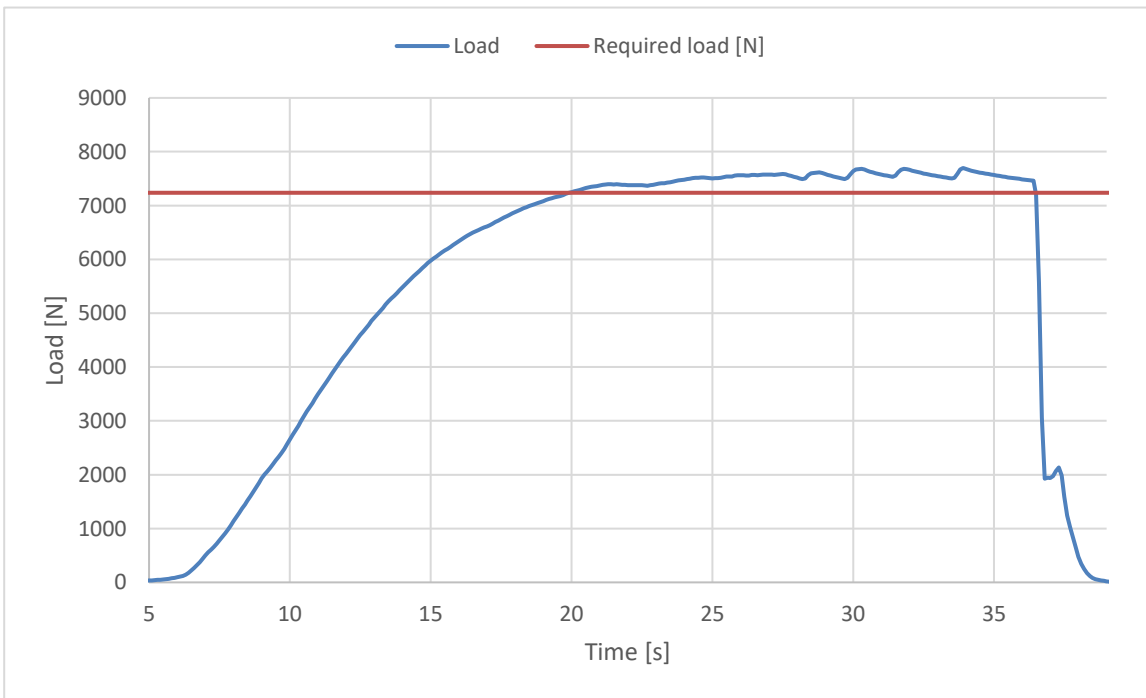
Test ID R0

Reference in standard	5.3.2.1	
Test setup	Default flying position	
Attachment points	Both main riser attachment (3,4)	
Anchor points	Dummy (B1, B2)	
Required load [g]	6	
Required load [N]	7200	
Minimum test duration [s]	10	
Result		
Test duration [s]	16.5	
Any signs of structural failure	No	
Test results	POSITIVE

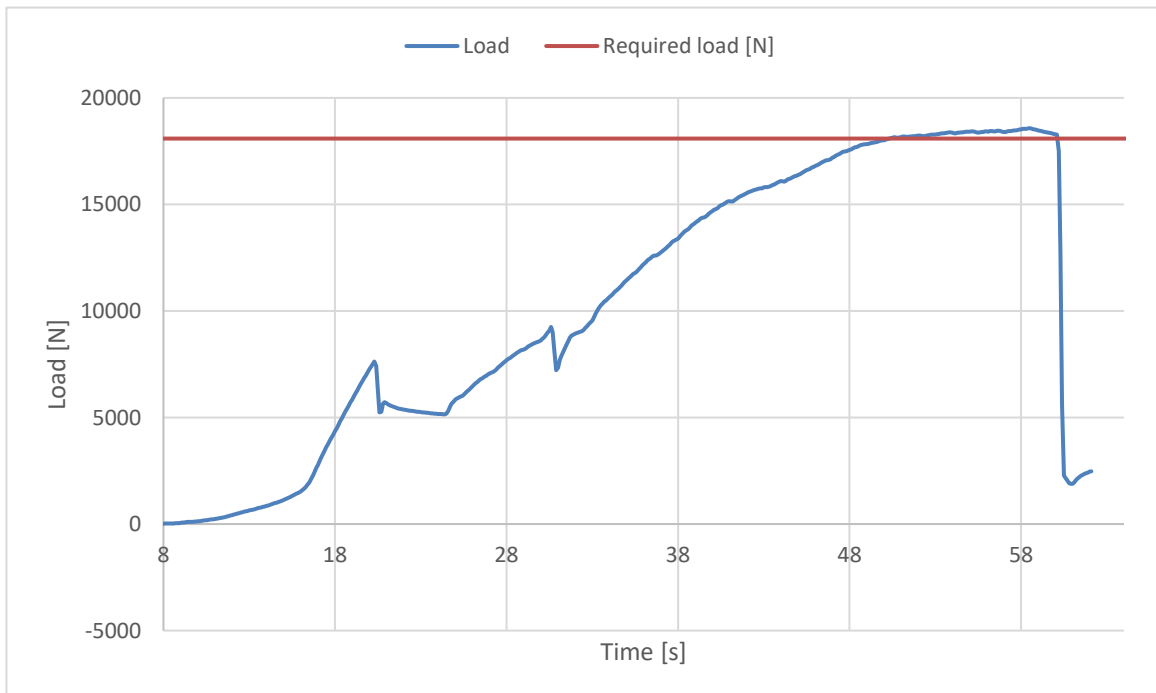
Test ID R2

Reference in standard	5.3.2.2	
Test setup	Default flying position	
Attachment points	Both main riser attachment (3,4)	
Anchor points	Dummy (B1, B2)	
Required load [g]	15	
Required load [N]	18000	
Minimum test duration [s]	5	
Result		
Test duration [s]	9.8	
Any signs of structural failure	No	
Test results	POSITIVE

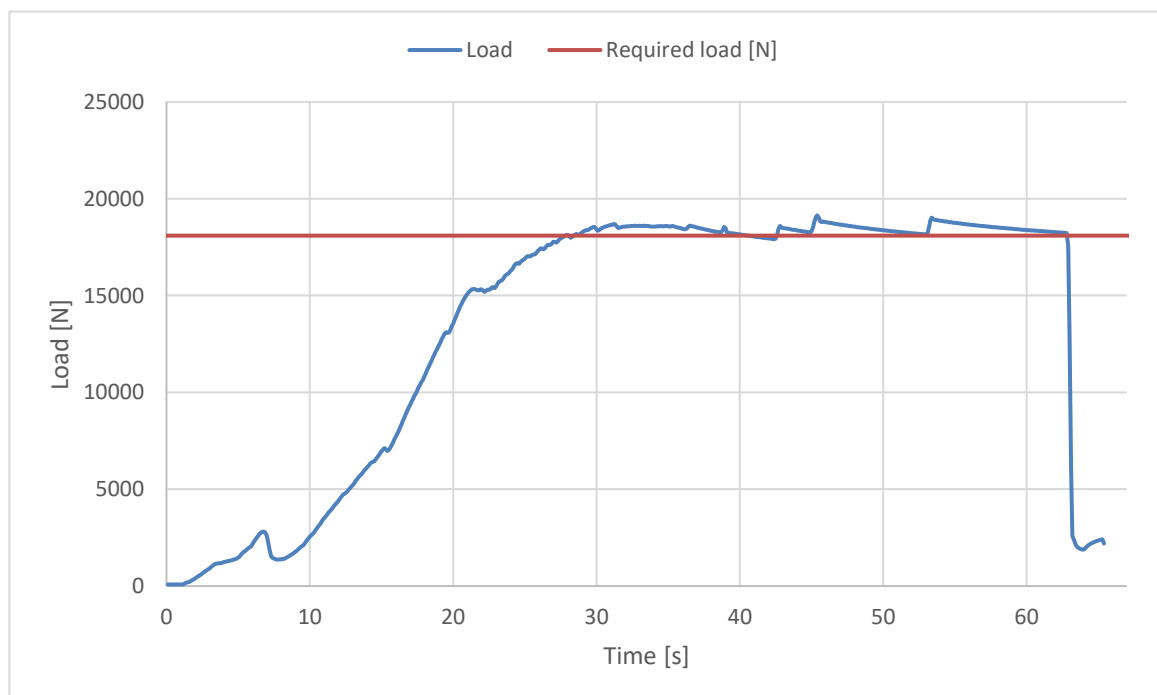
Test ID R4

Standard	EN 1651:1999
Reference in standard	5.3.2.7
Test setup	Flying position before landing
Attachment points	Both main riser attachment (3,4)
Anchor points	Dummy (7,8)
Required load [g]	15
Required load [N]	18000
Minimum test duration [s]	5
Result	
Test duration [s]	20.3
Any signs of structural failure	No
Test results	POSITIVE

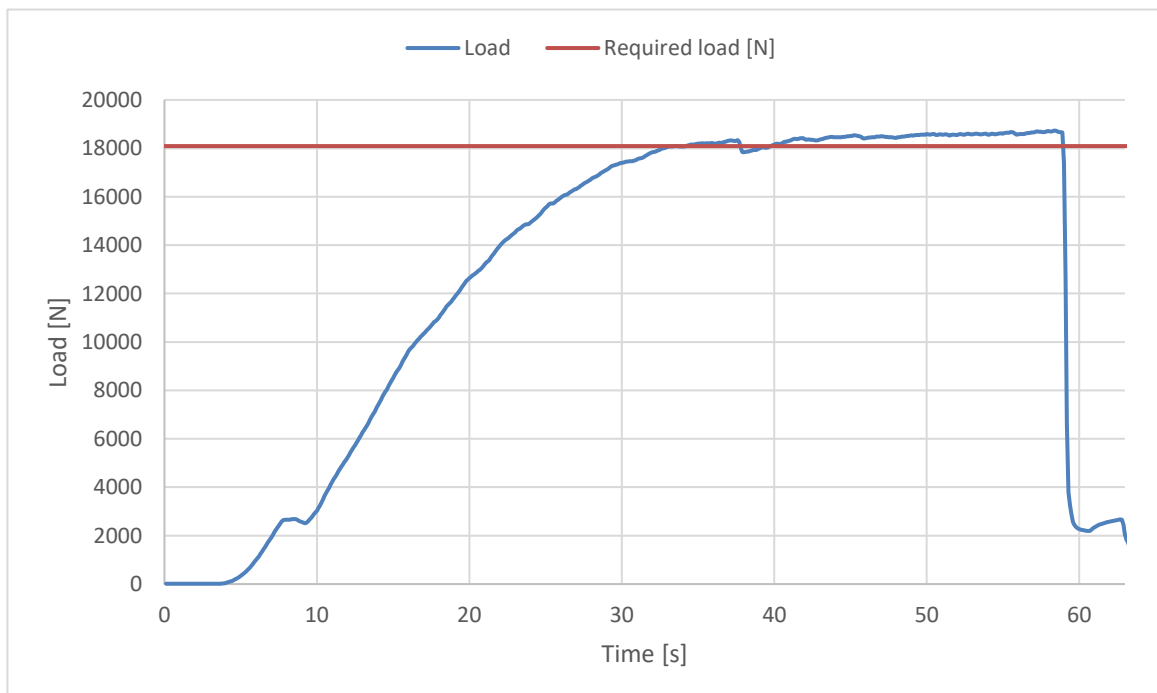
Test ID R6

Standard	EN 1651:1999
Reference in standard	5.3.2.4
Test setup	Rescue attachments
Attachment points	Rescue riser attachment (1,2)
Anchor points	Dummy (B1,B2)
Required load [g]	15
Required load [N]	18000
Minimum test duration [s]	5
Result	
Test duration [s]	19.2
Any signs of structural failure	No
Test results	POSITIVE

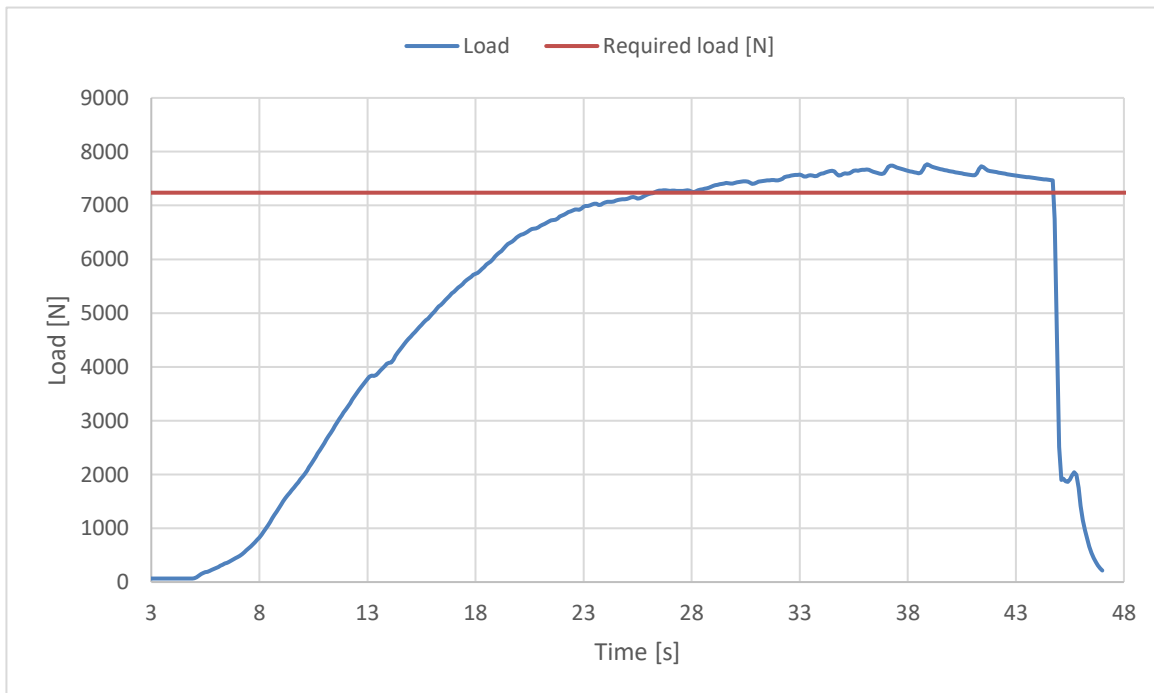
Test ID R8

Standard	EN 1651:1999
Reference in standard	5.3.2.3
Test setup	Asymmetric, one riser
Attachment points	One main riser attachment (3)
Anchor points	Dummy (B1,B2)
Required load [g]	6
Required load [N]	7200
Minimum test duration [s]	10
Result	
Test duration [s]	18.5
Any signs of structural failure	No
Test results	POSITIVE

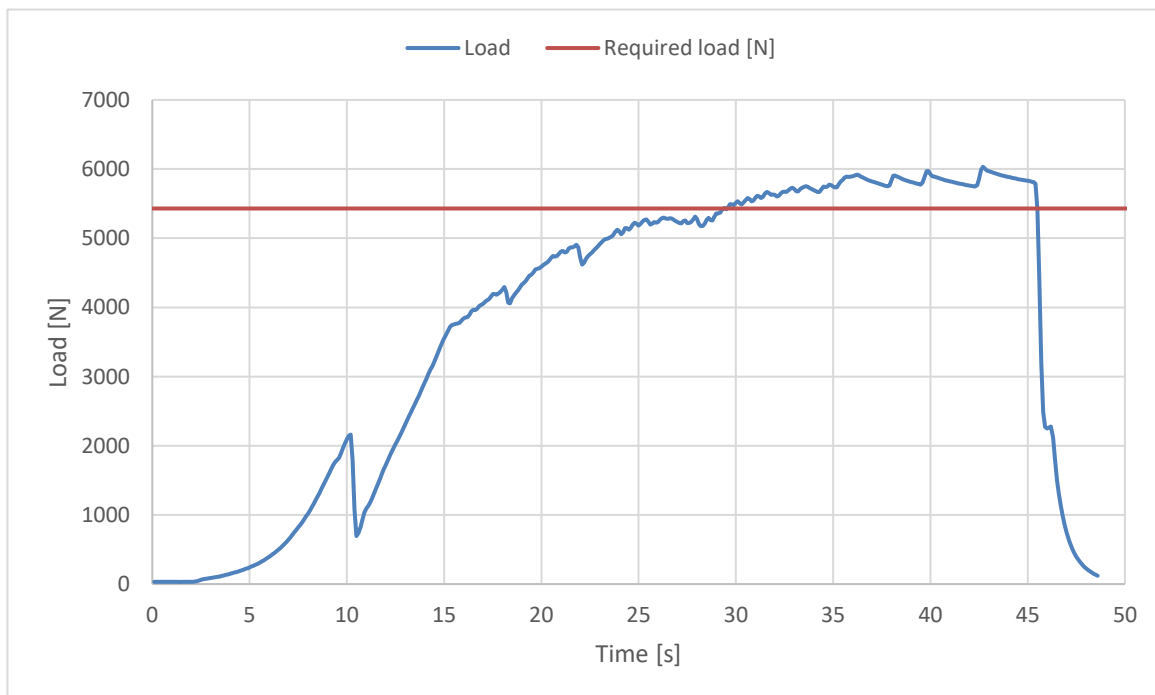
Test ID R10

Reference in standard	5.3.2.6	
Test setup	Asymmetric, negative	
Attachment points	One main riser attachment (3 or 4) downwards	
Anchor points	Dummy (9)	
Required load [g]	4.5	
Required load [N]	5400	
Minimum test duration [s]	10	
Result		
Test duration [s]	15.9	
Any signs of structural failure	No	
Test results	POSITIVE

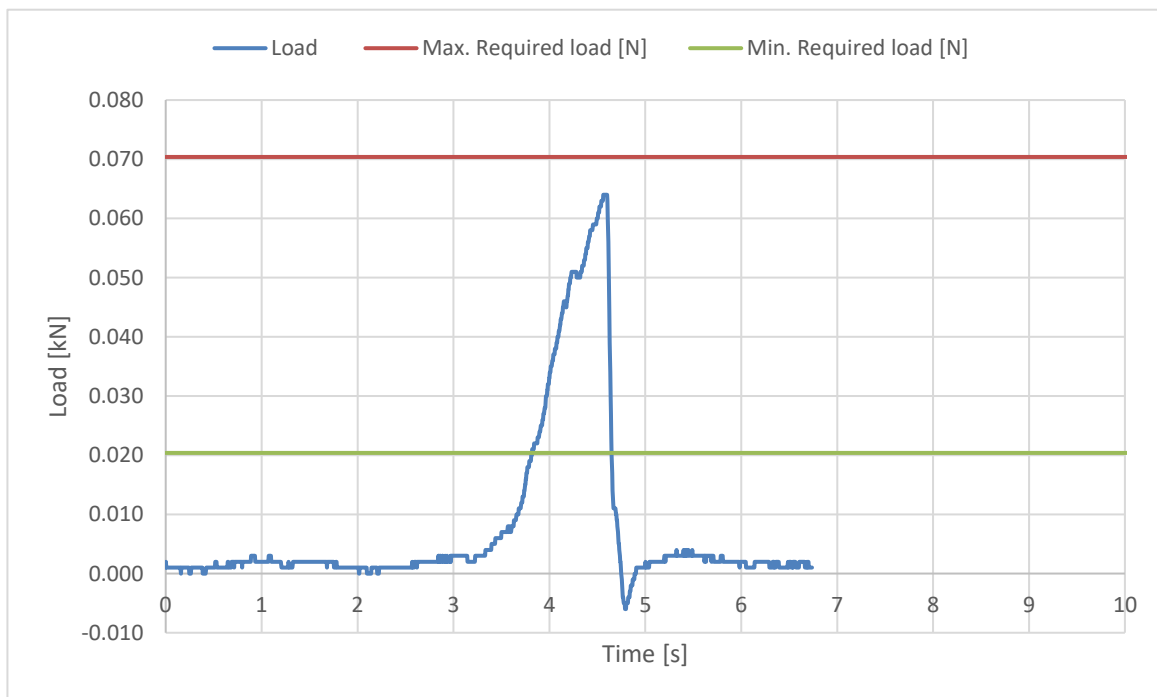
Test ID RRDT

Standard	LTF NfL II 91/09
Reference in standard	6.1.5
Test setup	Default flying position
Attachment points	Sensor connect to handle, and pull in opening direction
	The test is to simulate the load required to open the emergency parachute(1st action).
Min. Required load [N]	20
Max. Required load [N]	70
Result	
Load for first action [N]	63.62
Test results	POSITIVE

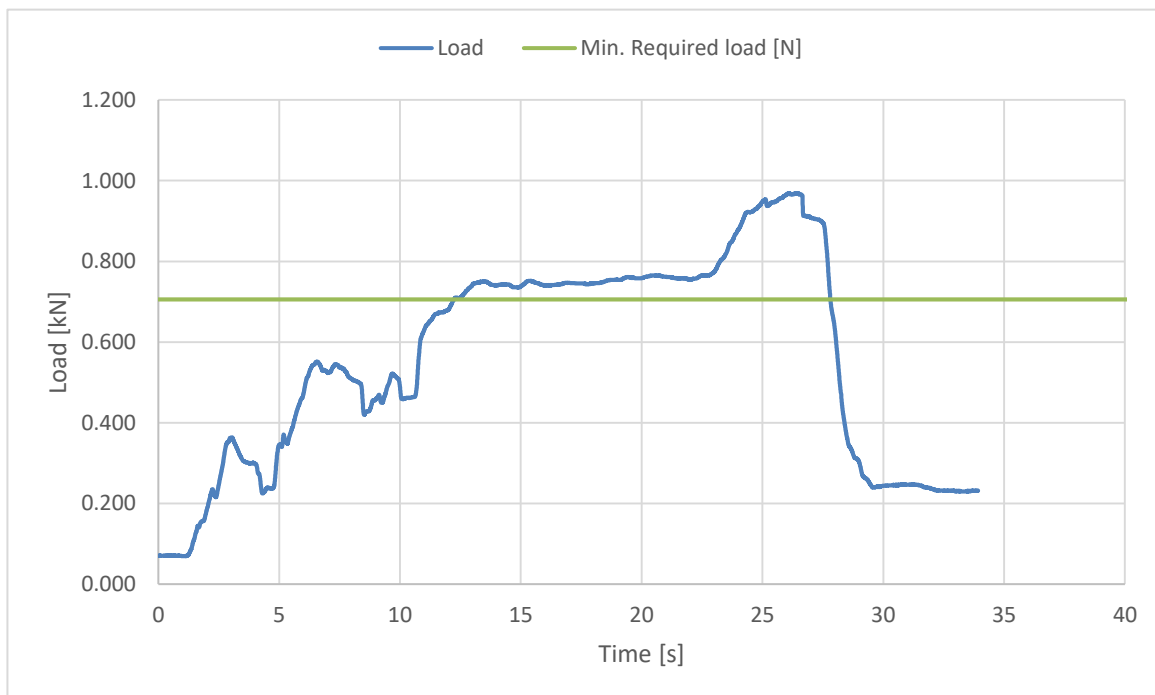
Test ID RRST

Standard	EN12491:2015
Reference in standard	5.3.2
Test setup	Two end points of handle
Attachment points	Sensor connect to end of handle, pull on the other side
	The handle must support min 700 N for 10 s, after measure breaking strength
Min. Required load [N]	700
Minimum test duration [s]	10
Result	
Test duration [s]:	15.5
Breaking strength [N]	963.18
Test results	POSITIVE
