Harness Structural test Report

Inspection certificate number: **PH_274.2019**

Name: **Harmony Passenger Air**
 Type: **ABS**
 Size: **Unique**
 Serial number: **HHA-100491**
 Impact pad type: ⁽¹⁾ **Airbag**
 Clip-in weight [kg]: **110**

Harness Structural test

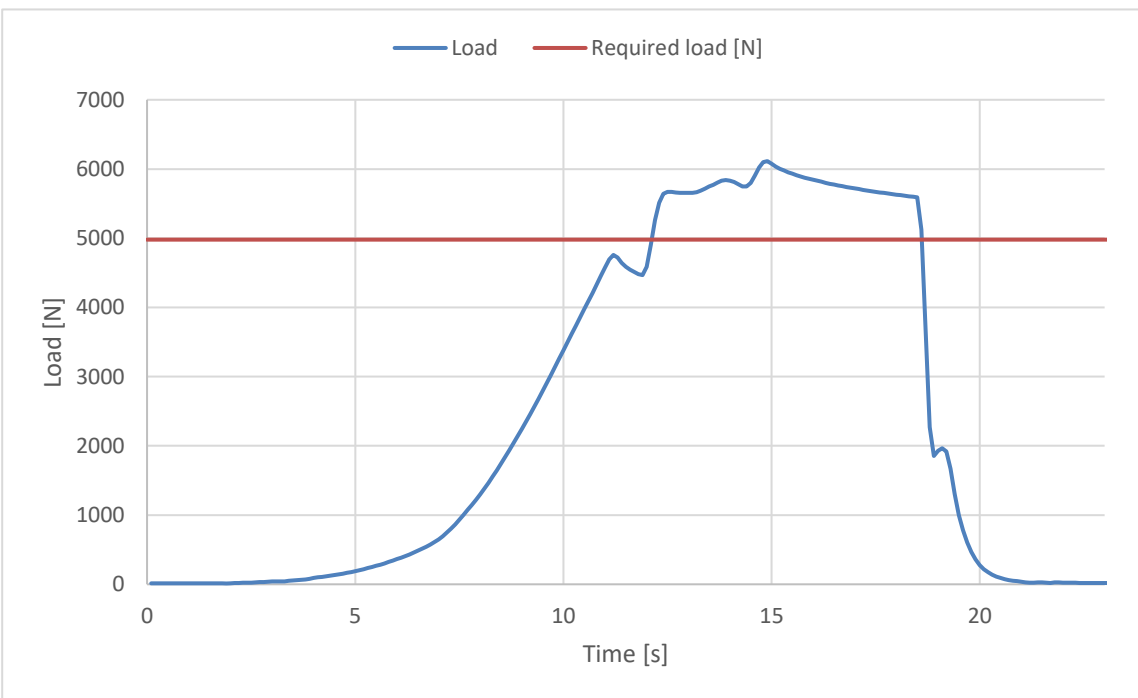
Test ID 1

Standard	EN 1651:2018	
Reference in standard	5.5.1.1	
Test setup	Positive symmetric load (Slippage)	
Attachment points	Both main riser attachment (3,4)	
Anchor points	Dummy (B1, B2)	
Required load [g]	4.5	
Required load [N]	4950	
Minimum test duration [s]	5	
Result		
Test duration [s]	6.5	
Any signs of structural failure	No	
Slippery test OK	n/a	
Test results	POSITIVE

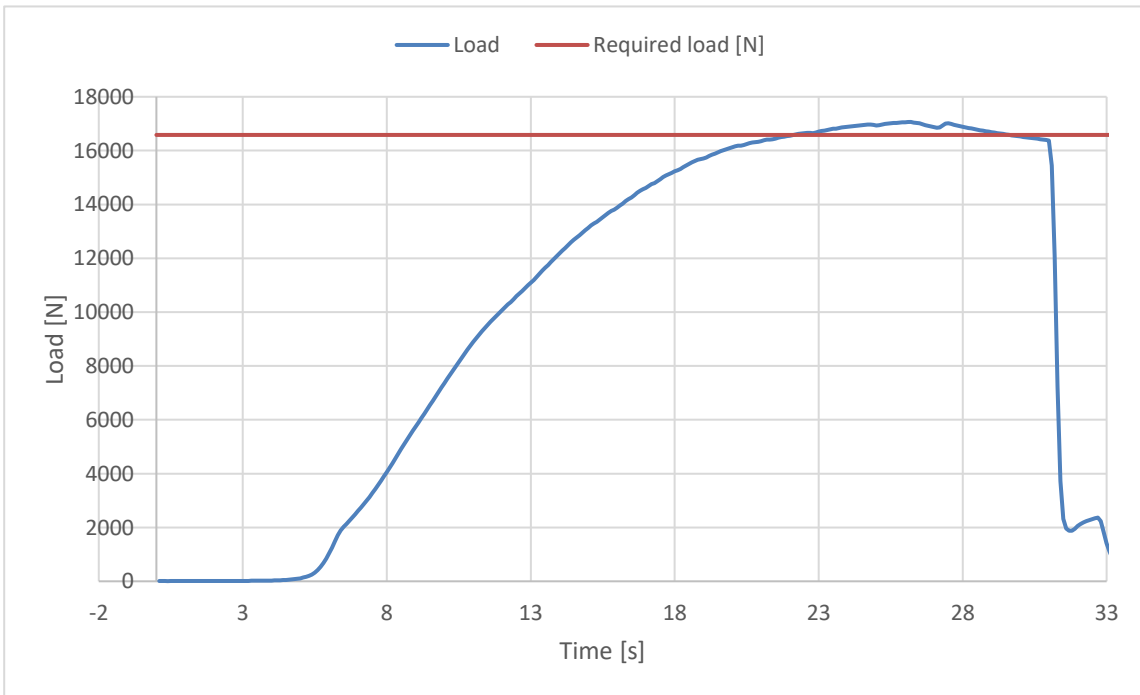
Test ID 1

Reference in standard	5.5.1.1b	
Test setup	Positive symmetric load	
Attachment points	Both main riser attachment (3,4)	
Anchor points	Dummy (B1, B2)	
Required load [g]	15	
Required load [N]	16500	
Minimum test duration [s]	5	
Result		
Test duration [s]	7.5	
Any signs of structural failure	No	
Slippery test OK	n/a	
Test results	POSITIVE

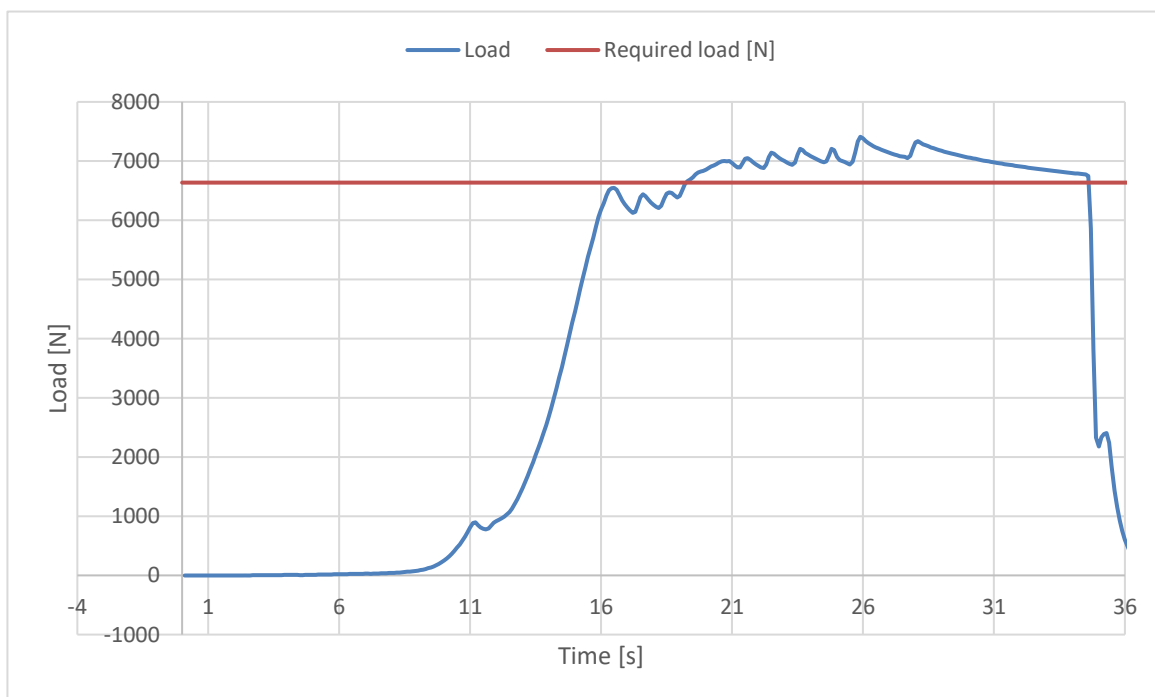
Test ID 2

Standard	EN 1651:2018
Reference in standard	5.5.1.2
Test setup	Positive asymmetric load
Attachment points	One riser attachment (3 or 4)
Anchor points	Dummy (C)
Required load [g]	6
Required load [N]	6600
Minimum test duration [s]	5
Result	
Test duration [s]	15.4
Any signs of structural failure	No
Test results	POSITIVE

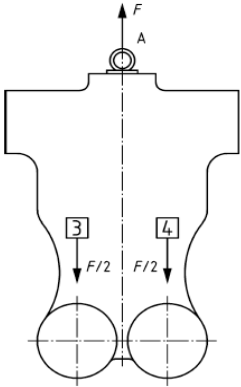
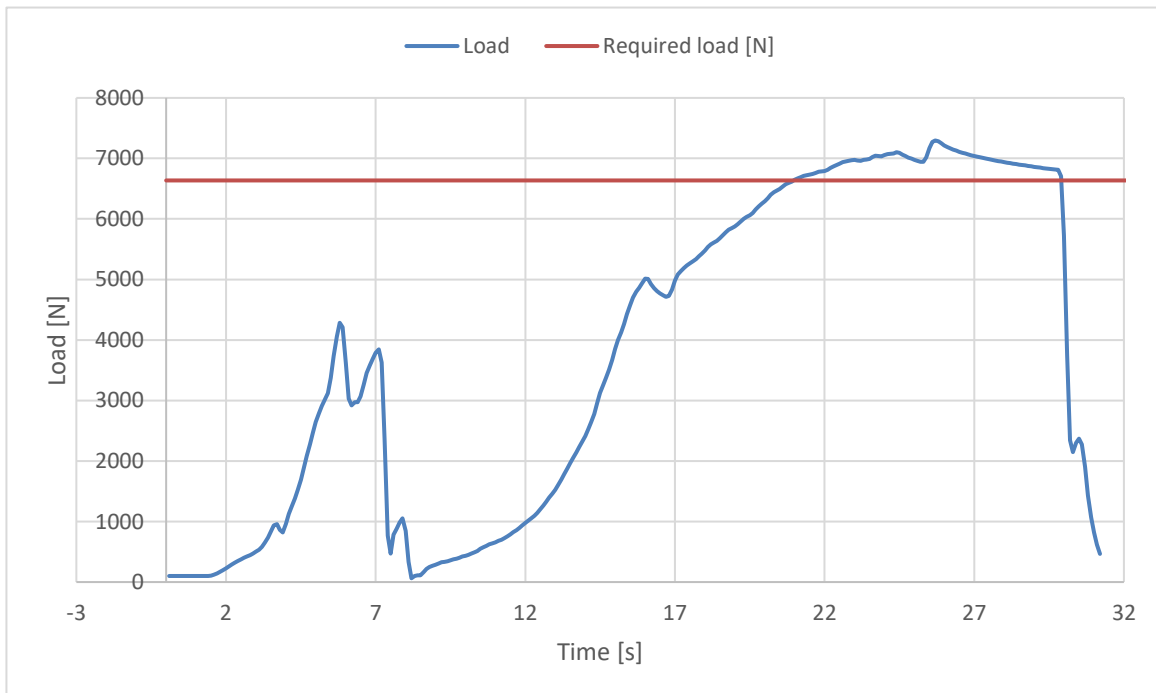
Test ID 6

Standard	EN 1651:2018
Reference in standard	5.5.1.6
Test setup	Negative symmetric load
Attachment points	Both main riser attachment (3,4)
Anchor points	Dummy (A)
Required load [g]	6
Required load [N]	6600
Minimum test duration [s]	5
Result	
Test duration [s]	9
Any signs of structural failure	No
Test results	POSITIVE

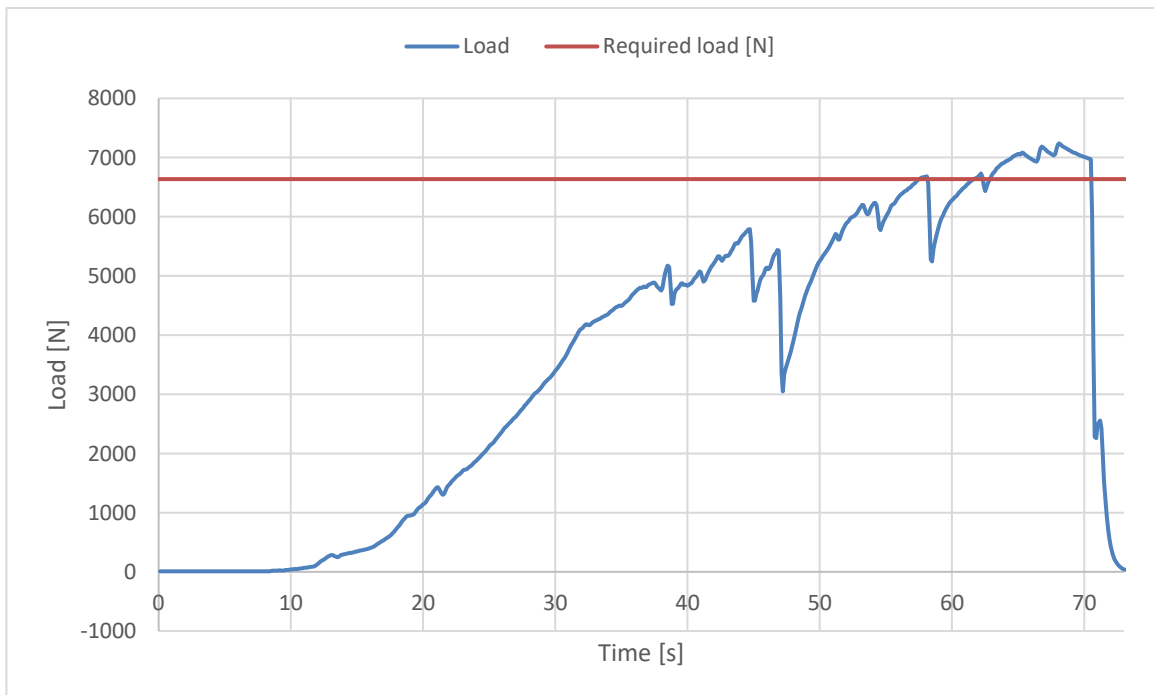
Test ID 7

Standard	EN 1651:2018
Reference in standard	5.5.1.7
Test setup	Upright (landing) position load
Attachment points	Both main riser attachment (3, 4)
Anchor points	Both legstrap of harness (no dummy)
Required load [g]	6
Required load [N]	6600
Minimum test duration [s]	5
Harness type	type a
Result	
Test duration [s]	7.7
Any signs of structural failure	No
Slippery test OK	n/a
Test results	POSITIVE

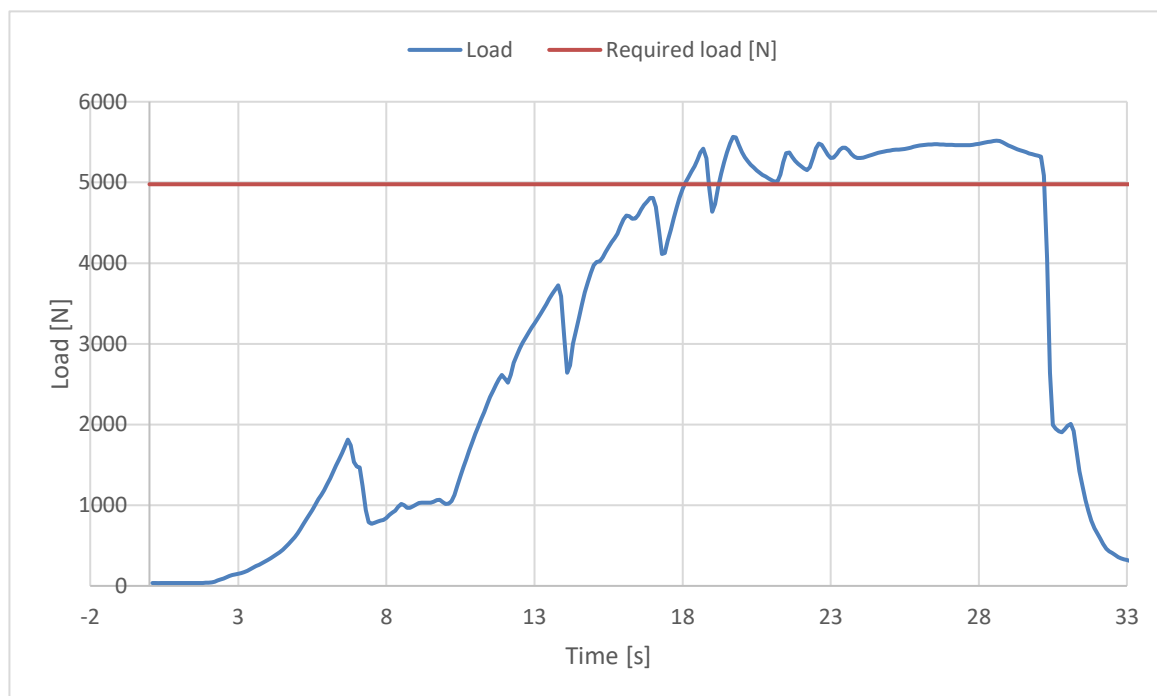
Test ID 9

Standard	EN 1651:2018
Reference in standard	5.5.1.9
Test setup	Anti falling-out system
Attachment points	Around anti falling-out system
Anchor points	Both main riser attachment (no dummy)
Required load [g]	4.5
Required load [N]	4950
Minimum test duration [s]	5
Result	
Test duration [s]	11
Any signs of structural failure	No
Test results	POSITIVE
