Harness Structural test Report

Inspection certificate number: **PH_248.2018**
Manufacturer data:

Manufacturer name: **Air Vuisa**
 Representative: **Sasa Vulic**
 Street: **Radeta Drainca 27**
 Post code place: **37201 Parunovac, Krusevac**
 Country: **Serbia**

model: **Passenger L**

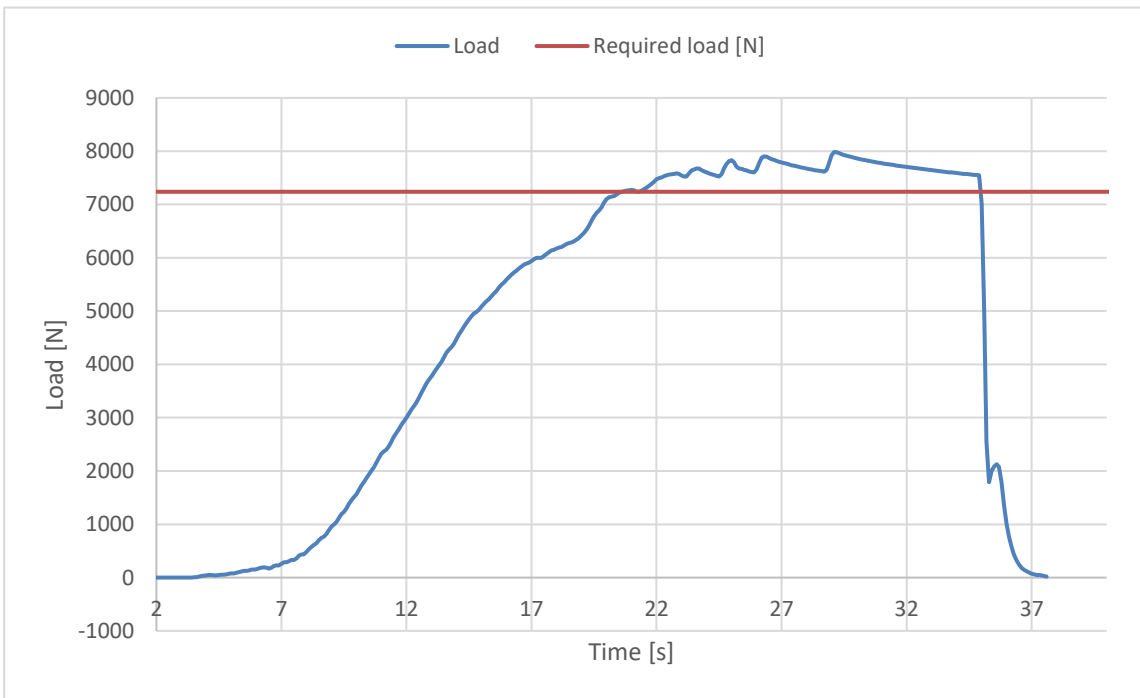
Test ID R0

Reference in standard	5.3.2.1	
Test setup	Default flying position	
Attachment points	Both main riser attachment (3,4)	
Anchor points	Dummy (B1, B2)	
Required load [g]	6	
Required load [N]	7200	
Minimum test duration [s]	10	
Result		
Test duration [s]	13.6	
Any signs of structural failure	No	
Test results	POSITIVE

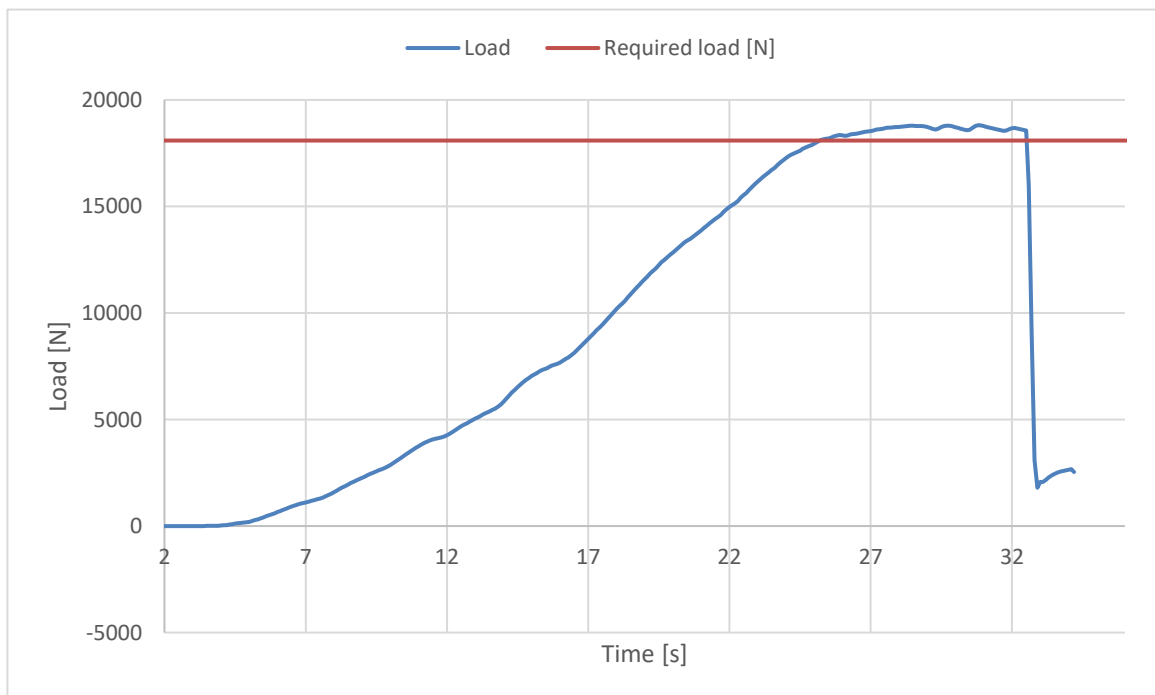
Test ID R2

Standard	EN 1651:1999
Reference in standard	5.3.2.2
Test setup	Default flying position
Attachment points	Both main riser attachment (3,4)
Anchor points	Dummy (B1, B2)
Required load [g]	15
Required load [N]	18000
Minimum test duration [s]	5
Result	
Test duration [s]	7.4
Any signs of structural failure	No
Test results	POSITIVE

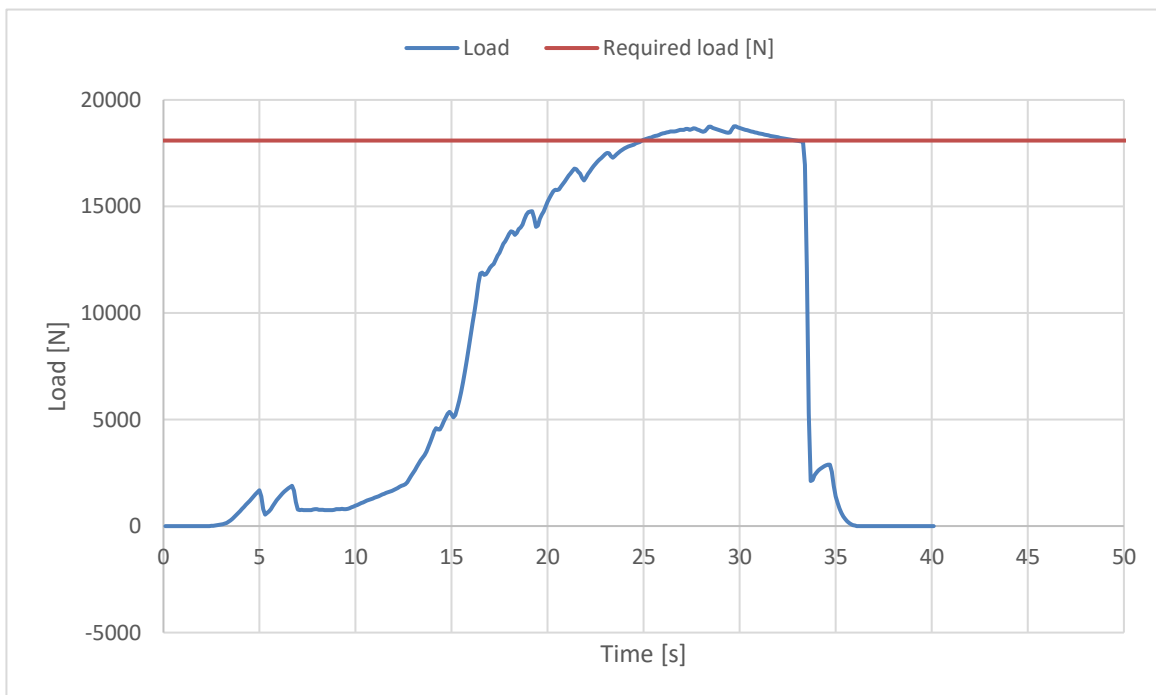
Test ID R4

Standard	EN 1651:1999
Reference in standard	5.3.2.7
Test setup	Flying position before landing
Attachment points	Both main riser attachment (3,4)
Anchor points	Dummy (7,8)
Required load [g]	15
Required load [N]	18000
Minimum test duration [s]	5
Result	
Test duration [s]	8
Any signs of structural failure	No
Test results	POSITIVE

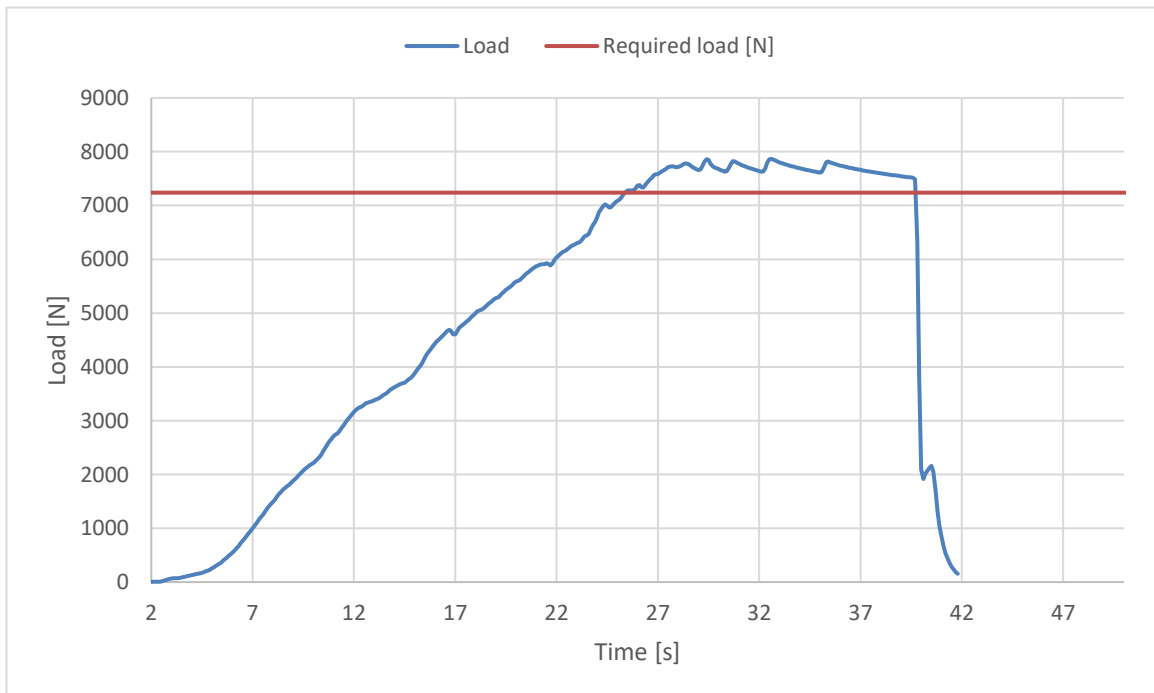
Test ID R8

Reference in standard	5.3.2.3	
Test setup	Asymmetric, one riser	
Attachment points	One main riser attachment (3)	
Anchor points	Dummy (B1,B2)	
Required load [g]	6	
Required load [N]	7200	
Minimum test duration [s]	10	
Result		
Test duration [s]	14.4	
Any signs of structural failure	No	
Test results	POSITIVE

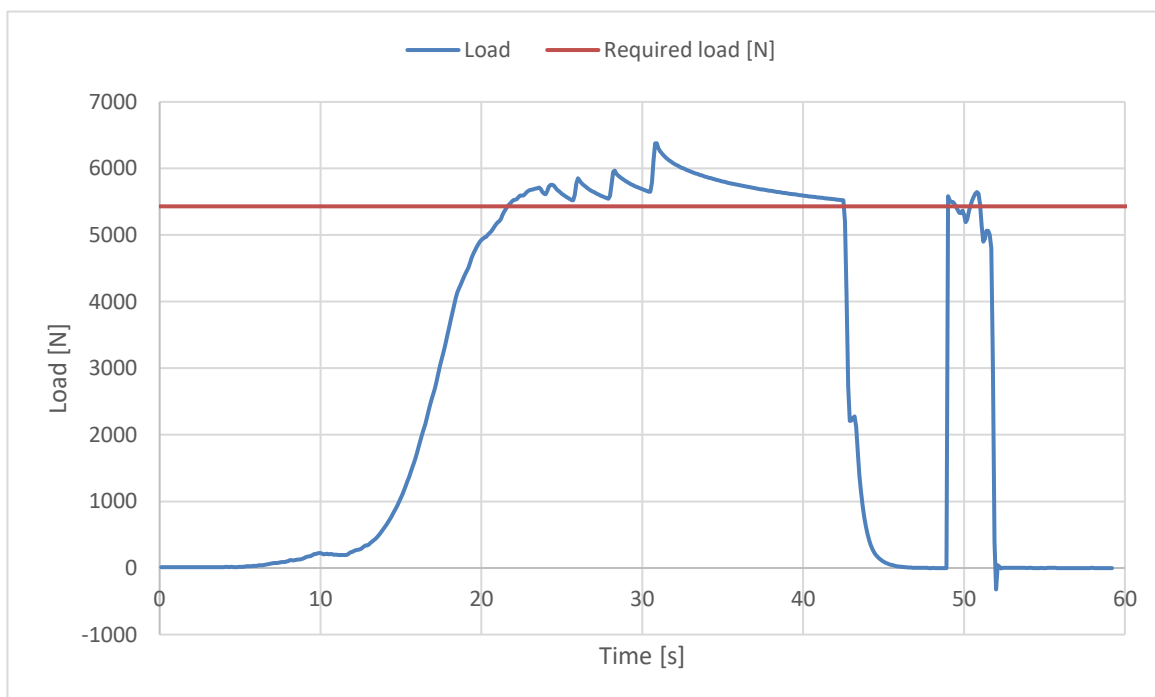
Test ID R10

Reference in standard	5.3.2.6	
Test setup	Asymmetric, negative	
Attachment points	One main riser attachment (3 or 4) downwards	
Anchor points	Dummy (9)	
Required load [g]	4.5	
Required load [N]	5400	
Minimum test duration [s]	10	
Result		
Test duration [s]	20.9	
Any signs of structural failure	No	
Test results	POSITIVE
