# Harness Structural test Report

Inspection certificate number: **PH\_273.2019**
**Manufacturer data:**

Name: **Fly-Line**  
 Type: **ABS**  
 Size: **ML**  
 Serial number: **001**  
 Impact pad type: <sup>(1)</sup> **n/a**  
 Clip-in weight [kg]: **120**

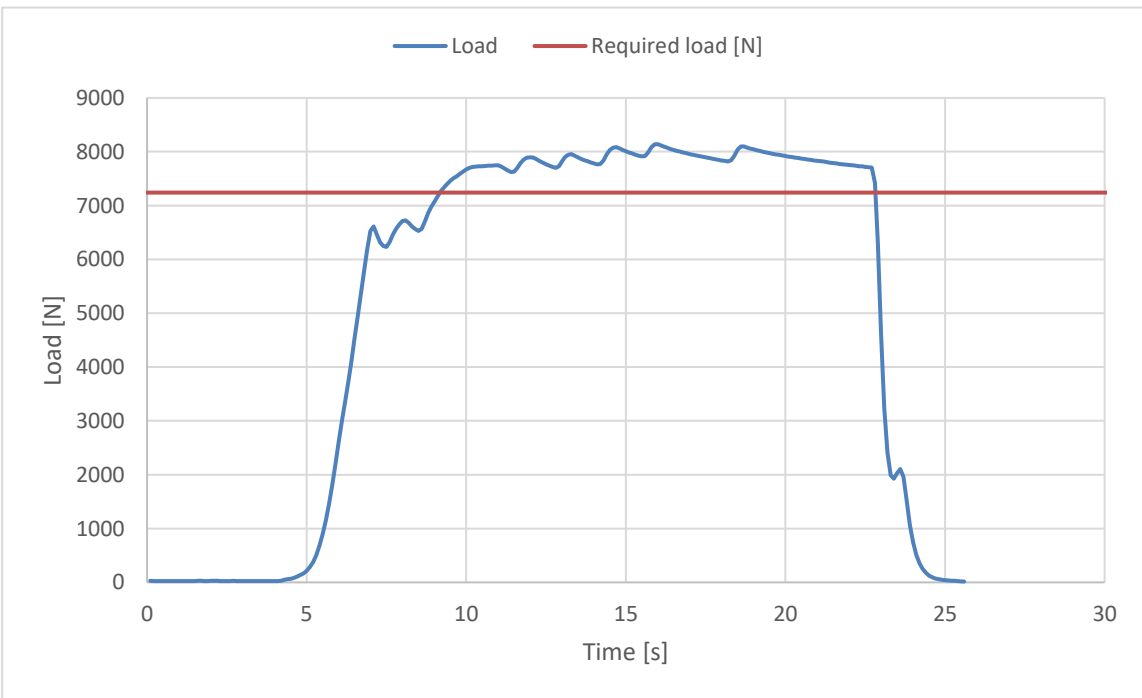
**Test ID R0**

Reference in standard	<b>5.3.2.1</b>	
Test setup	<b>Default flying position</b>	
Attachment points	<b>Both main riser attachment (3,4)</b>	
Anchor points	<b>Dummy (B1, B2)</b>	
Required load [g]	<b>6</b>	
Required load [N]	<b>7200</b>	
Minimum test duration [s]	<b>10</b>	
<b>Result</b>		
Test duration [s]	<b>13.7</b>	
Any signs of structural failure	<b>No</b>	
Test results	<b>POSITIVE</b>

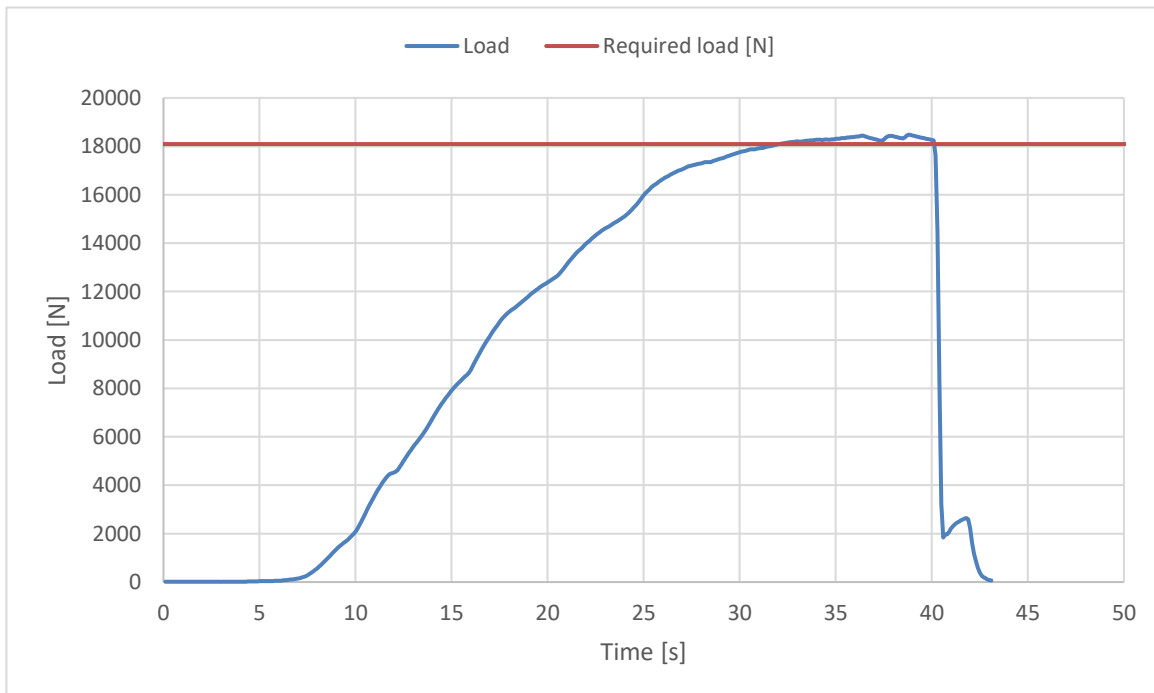
**Test ID R2**

Reference in standard	<b>5.3.2.2</b>	
Test setup	<b>Default flying position</b>	
Attachment points	<b>Both main riser attachment (3,4)</b>	
Anchor points	<b>Dummy (B1, B2)</b>	
Required load [g]	<b>15</b>	
Required load [N]	<b>18000</b>	
Minimum test duration [s]	<b>5</b>	
<b>Result</b>		
Test duration [s]	<b>8.1</b>	
Any signs of structural failure	<b>No</b>	
Test results	<b>POSITIVE</b>

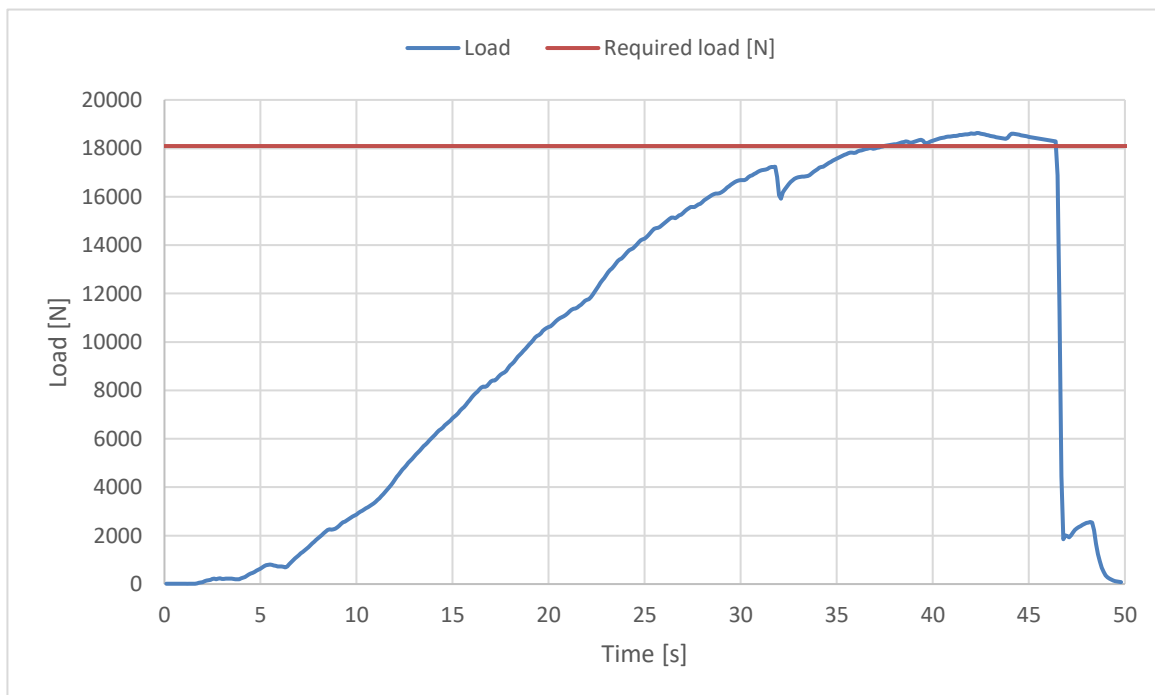
**Test ID R4**

Standard	<b>EN 1651:1999</b>
Reference in standard	<b>5.3.2.7</b>
Test setup	<b>Flying position before landing</b>
Attachment points	<b>Both main riser attachment (3,4)</b>
Anchor points	<b>Dummy (7,8)</b>
Required load [g]	<b>15</b>
Required load [N]	<b>18000</b>
Minimum test duration [s]	<b>5</b>
<b>Result</b>	
Test duration [s]	<b>9</b>
Any signs of structural failure	<b>No</b>
Test results	<b>POSITIVE</b>

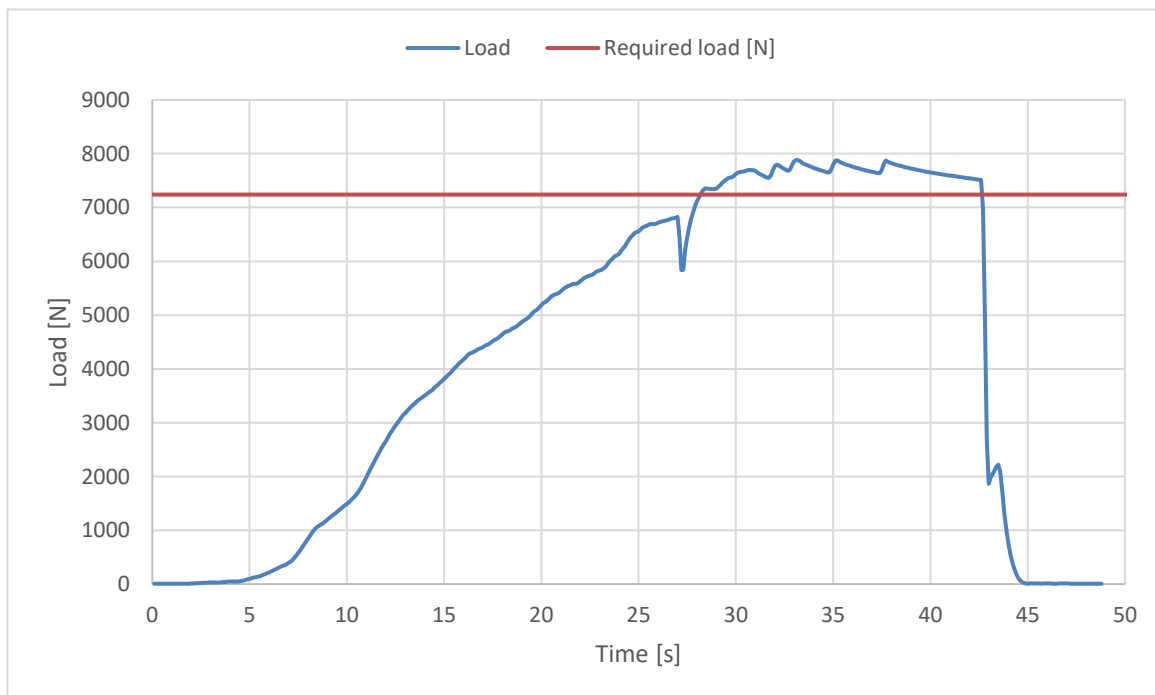
**Test ID R8**

Standard	<b>EN 1651:1999</b>	
Reference in standard	<b>5.3.2.3</b>	
Test setup	<b>Asymmetric, one riser</b>	
Attachment points	<b>One main riser attachment (3)</b>	
Anchor points	<b>Dummy (B1,B2)</b>	
Required load [g]	<b>6</b>	
Required load [N]	<b>7200</b>	
Minimum test duration [s]	<b>10</b>	
<b>Result</b>		
Test duration [s]	<b>14.5</b>	
Any signs of structural failure	<b>No</b>	
Test results	<b>POSITIVE</b>

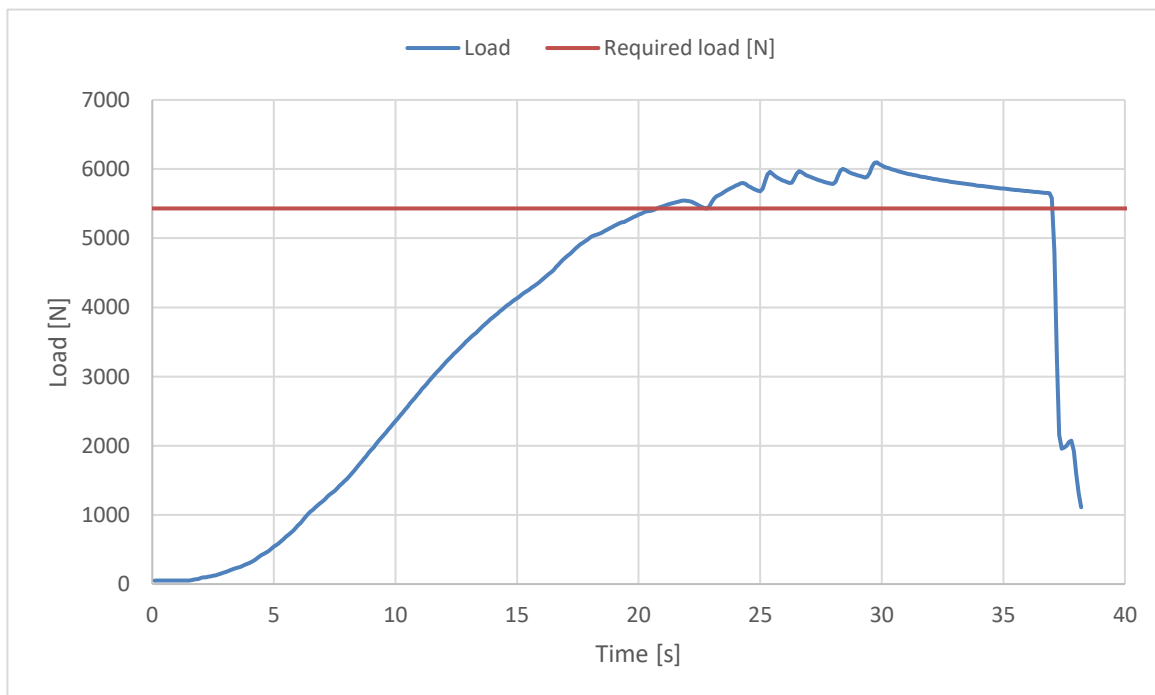
**Test ID R10**

Reference in standard	<b>5.3.2.6</b>	
Test setup	<b>Asymmetric, negative</b>	
Attachment points	<b>One main riser attachment (3 or 4) downwards</b>	
Anchor points	<b>Dummy (9)</b>	
Required load [g]	<b>4.5</b>	
Required load [N]	<b>5400</b>	
Minimum test duration [s]	<b>10</b>	
<b>Result</b>		
Test duration [s]	<b>14.2</b>	
Any signs of structural failure	<b>No</b>	
Test results	<b>POSITIVE</b>
