Harness Structural test Report

Inspection certificate number: **PH_286.2019**

Name: **Wani Light 2**
 Type: **ABS**
 Size: **M**
 Serial number: **0002**
 Impact pad type: ⁽¹⁾ **Airbag**
 Clip-in weight [kg]: **120**

Date of test: **04.10.2019**

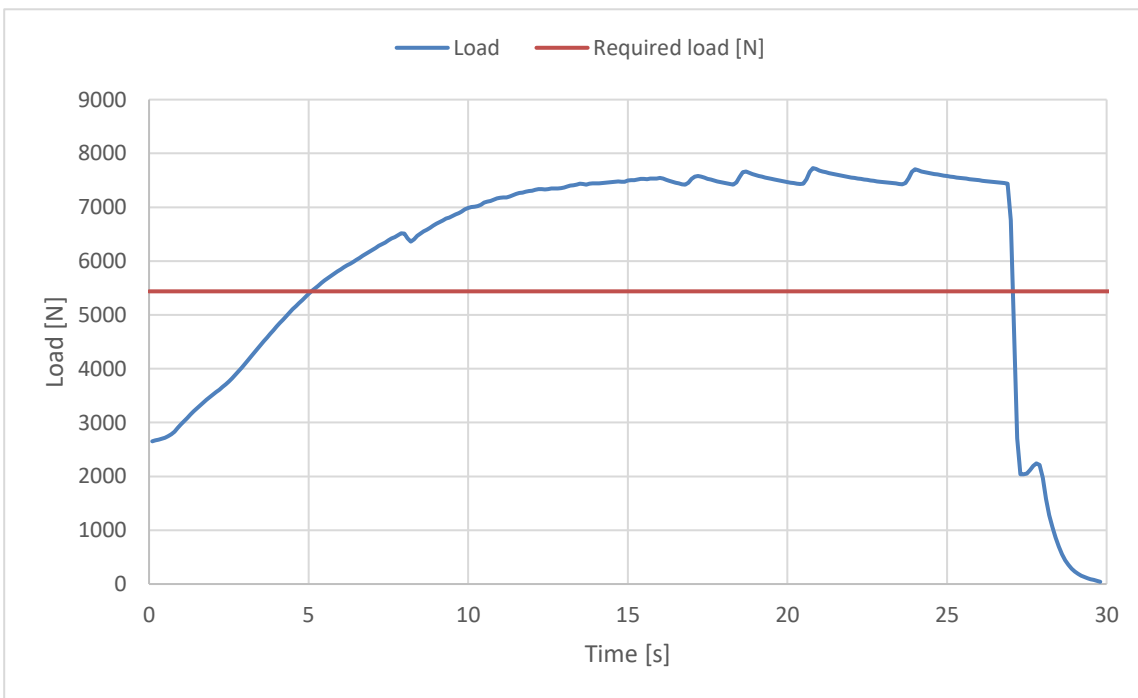
Test ID 1

Standard	EN 1651:2018	
Reference in standard	5.5.1.1	
Test setup	Positive symmetric load (Slippage)	
Attachment points	Both main riser attachment (3,4)	
Anchor points	Dummy (B1, B2)	
Required load [g]	4.5	
Required load [N]	5400	
Minimum test duration [s]	5	
Result		
Test duration [s]	22	
Any signs of structural failure	No	
Slippery test OK	n/a	
Test results	POSITIVE

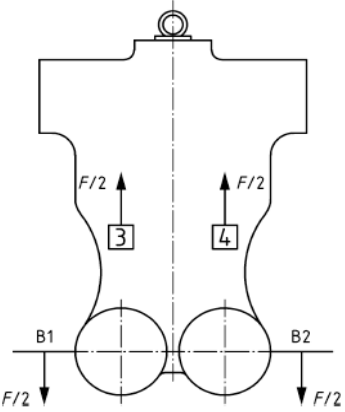
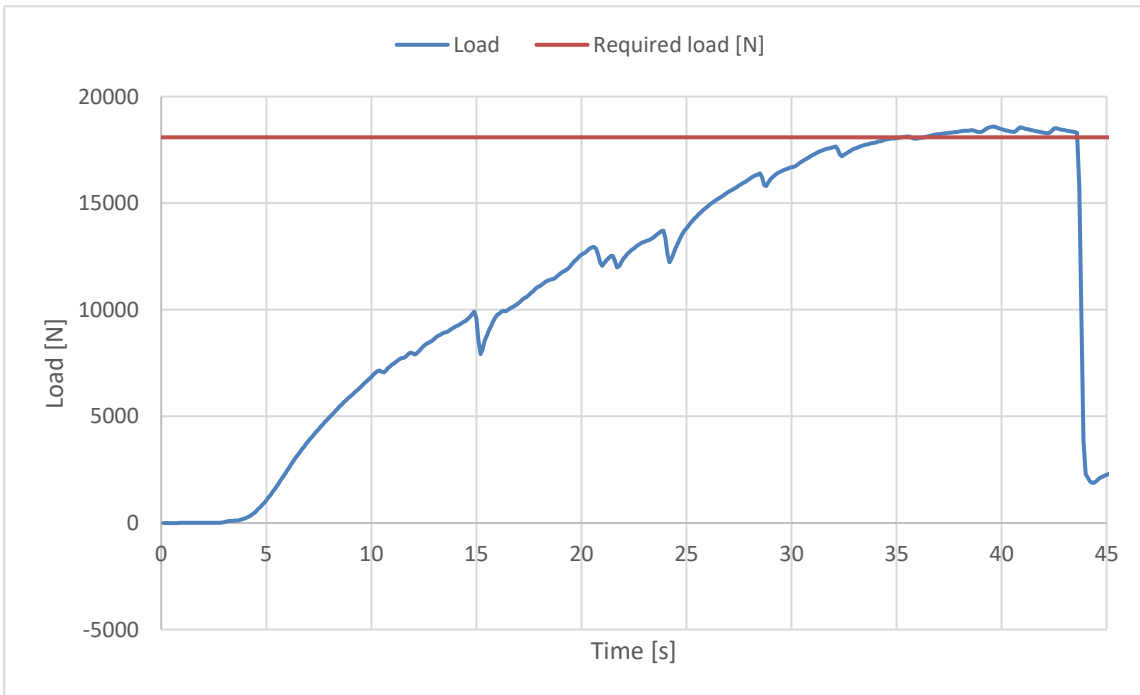
Test ID 1

Reference in standard	5.5.1.1b	
Test setup	Positive symmetric load	
Attachment points	Both main riser attachment (3,4)	
Anchor points	Dummy (B1, B2)	
Required load [g]	15	
Required load [N]	18000	
Minimum test duration [s]	5	
Result		
Test duration [s]	7.3	
Any signs of structural failure	No	
Slippery test OK	n/a	
Test results	POSITIVE

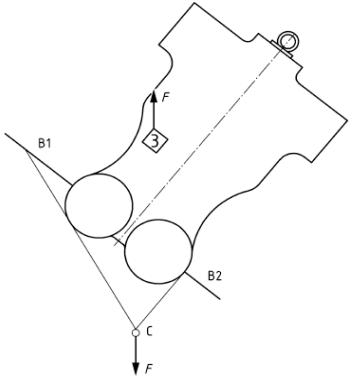
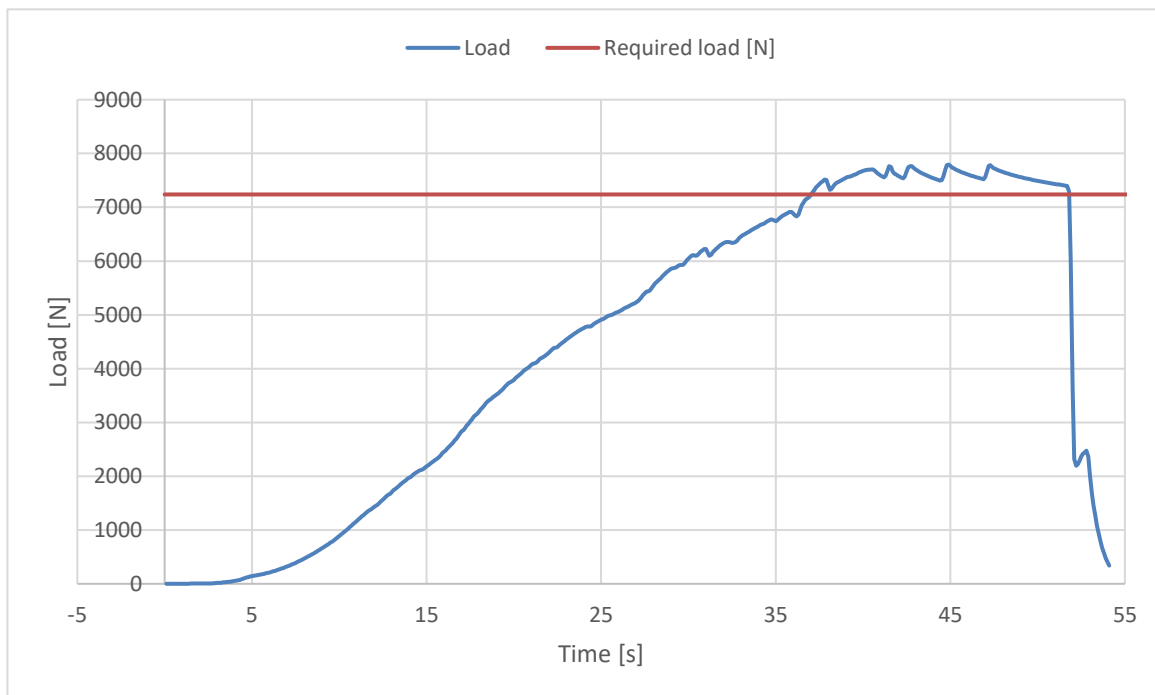
Test ID 2

Reference in standard	5.5.1.2	
Test setup	Positive asymmetric load	
Attachment points	One riser attachment (3 or 4)	
Anchor points	Dummy (C)	
Required load [g]	6	
Required load [N]	7200	
Minimum test duration [s]	5	
Result		
Test duration [s]	14.8	
Any signs of structural failure	No	
Test results	POSITIVE

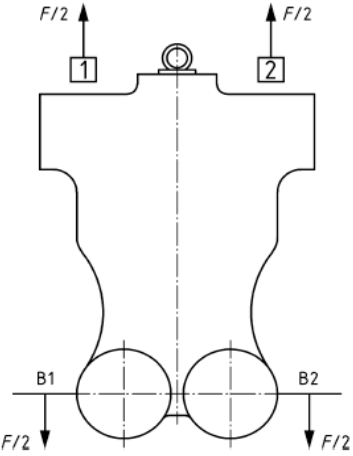
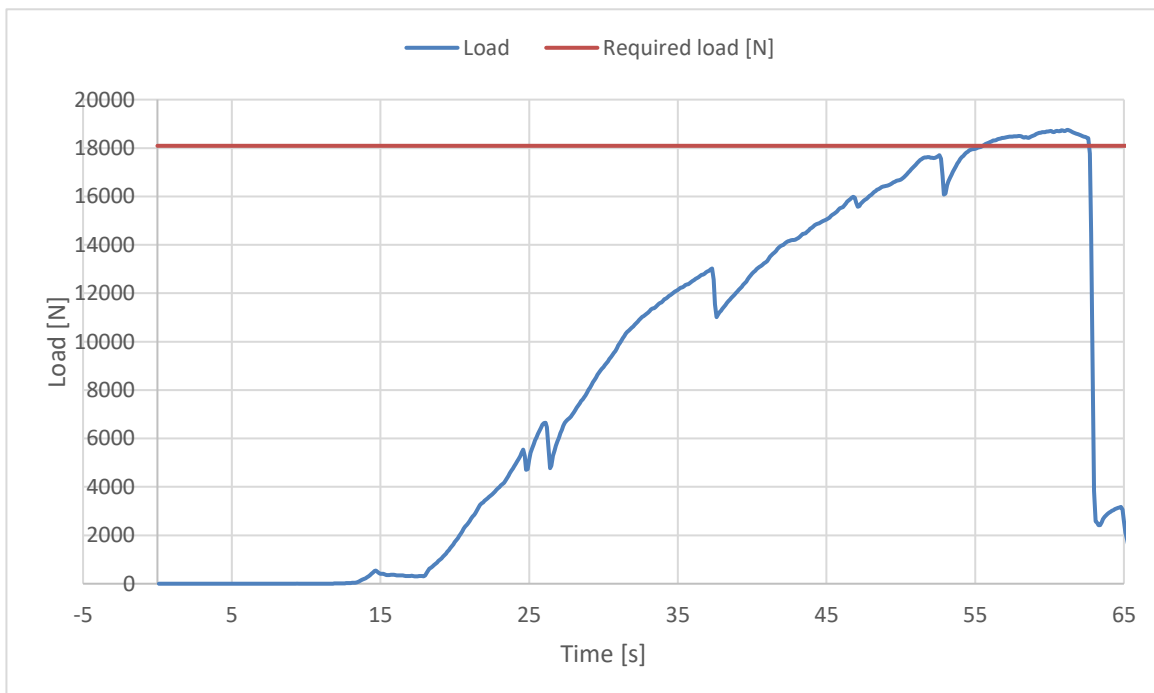
Test ID 3

Standard	EN 1651:2018
Reference in standard	5.5.1.3
Test setup	Positive symmetric load rescue points
Attachment points	Both main riser attachment (1,2)
Anchor points	Dummy (B1,B2)
Required load [g]	15
Required load [N]	18000
Minimum test duration [s]	5
Result	
Test duration [s]	7.1
Any signs of structural failure	No
Slippery test OK	Yes
Test results	POSITIVE

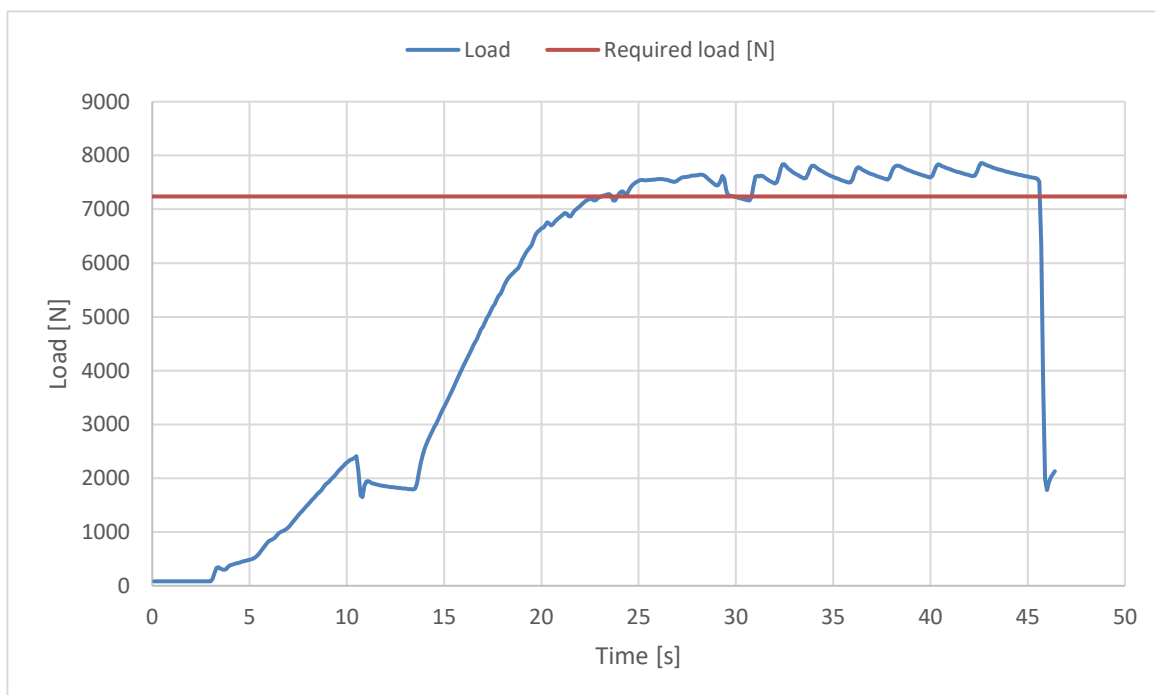
Test ID 6

Standard	EN 1651:2018
Reference in standard	5.5.1.6
Test setup	Negative symmetric load
Attachment points	Both main riser attachment (3,4)
Anchor points	Dummy (A)
Required load [g]	6
Required load [N]	7200
Minimum test duration [s]	5
Result	
Test duration [s]	14.8
Any signs of structural failure	No
Test results	POSITIVE

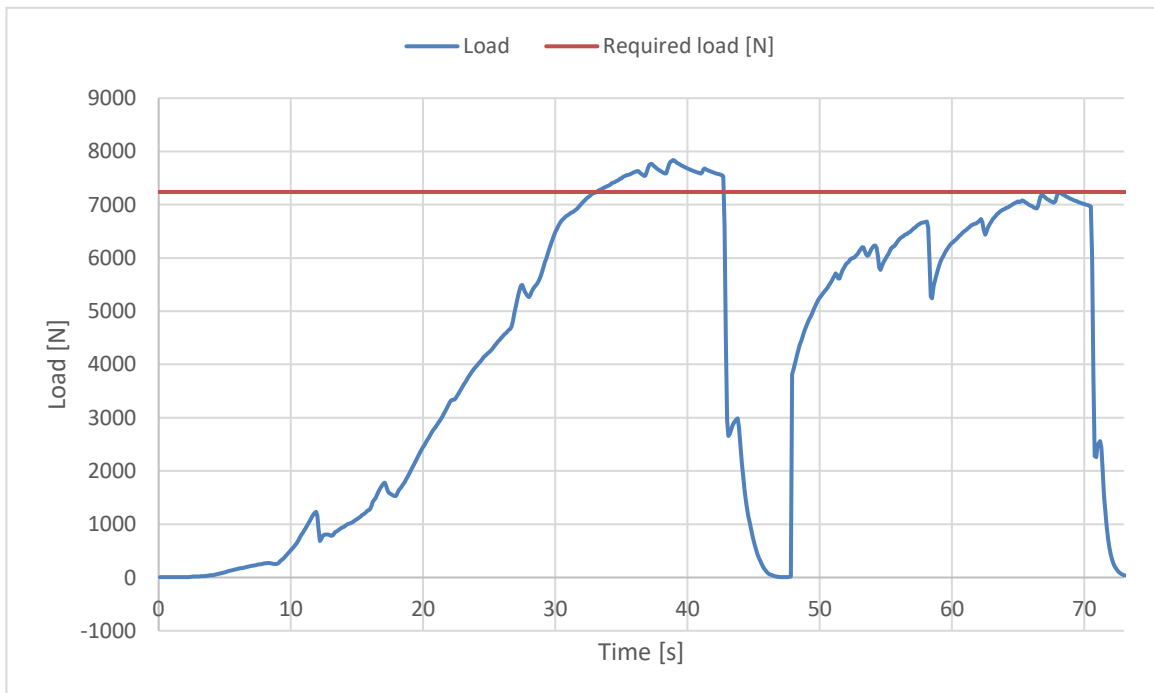
Test ID 7

Standard	EN 1651:2018
Reference in standard	5.5.1.7
Test setup	Upright (landing) position load
Attachment points	Both main riser attachment (3, 4)
Anchor points	Both legstrap of harness (no dummy)
Required load [g]	6
Required load [N]	7200
Minimum test duration [s]	5
Harness type	type a
Result	
Test duration [s]	9.6
Any signs of structural failure	No
Slippery test OK	Yes
Test results	POSITIVE

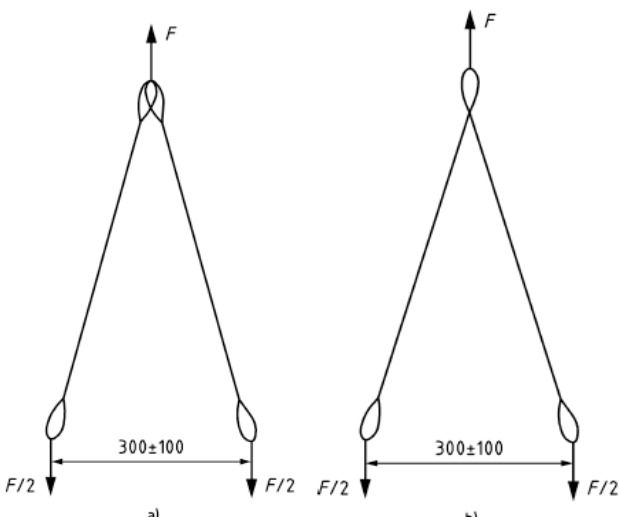
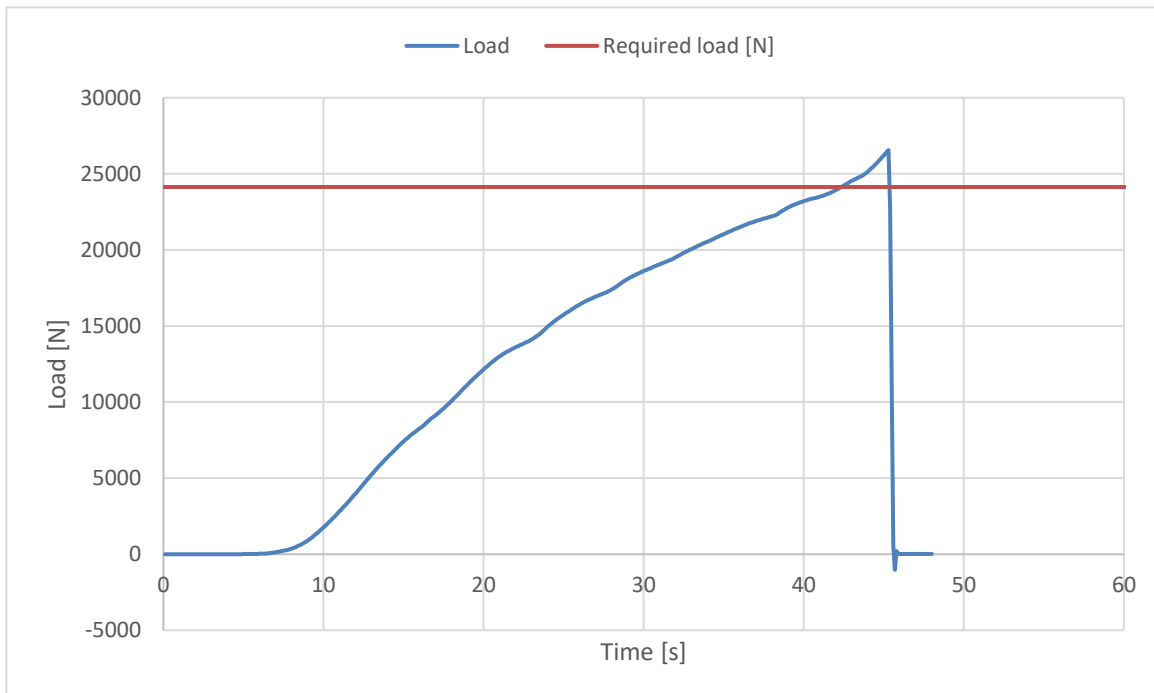
Test ID 8

Standard	EN 1651:2018
Reference in standard	5.5.1.8
Test setup	Connecting element for rescue
Attachment points	End point (emergency parachute)
Anchor points	Both attachment to harness
Required load [N]	24000
Minimum test duration [s]	0.3
Type of connecting element	n/a
Result	
Test duration [s]	3
Any signs of structural failure	No
Test results	POSITIVE

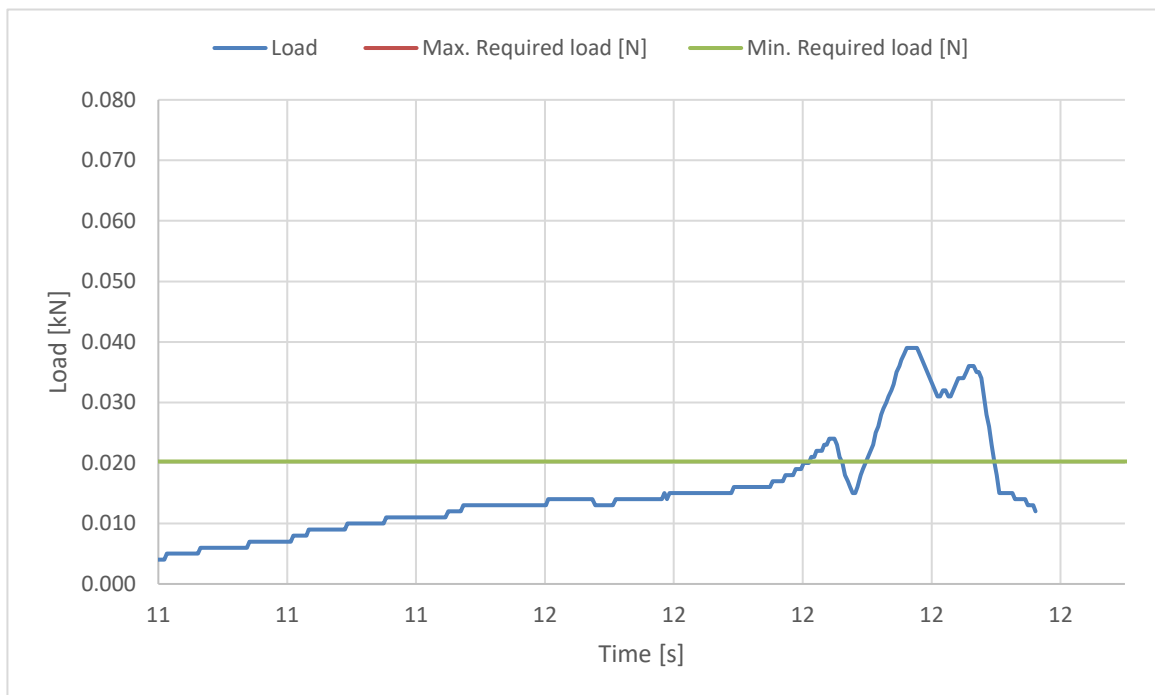
Test ID RRDT

Standard	LTF NfL II 91/09
Reference in standard	6.1.5
Test setup	Default flying position
Attachment points	Sensor connect to handle, and pull in opening direction
	The test is to simulate the load required to open the emergency parachute(1st action).
Min. Required load [N]	20
Max. Required load [N]	70
Result	
Load for first action [N]	38.77
Test results	POSITIVE

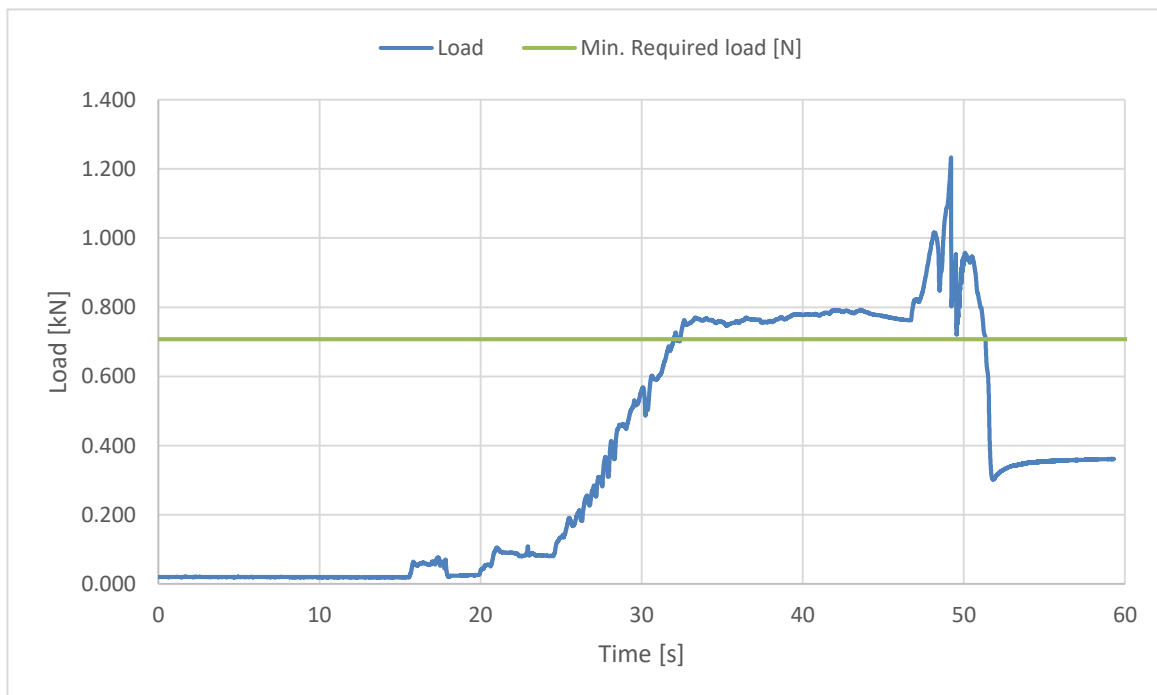
Test ID RRST

Standard	EN12491:2015
Reference in standard	5.3.2
Test setup	Two end points of handle
Attachment points	Sensor connect to end of handle, pull on the other side
	The handle must support min 700 N for 10 s, after measure breaking strength
Min. Required load [N]	700
Minimum test duration [s]	10
Result	
Test duration [s]:	18.9
Breaking strength [N]	1225.59
Test results	POSITIVE
