Harness Structural test Report

Inspection certificate number: **PH_286.2019**

Name: **Wani Light 2**
 Type: **ABS**
 Size: **M**
 Serial number: **0002**
 Impact pad type: ⁽¹⁾ **Airbag**
 Clip-in weight [kg]: **120**

Date of test: **17.09.2019**

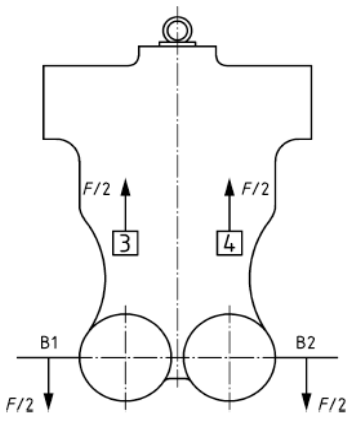
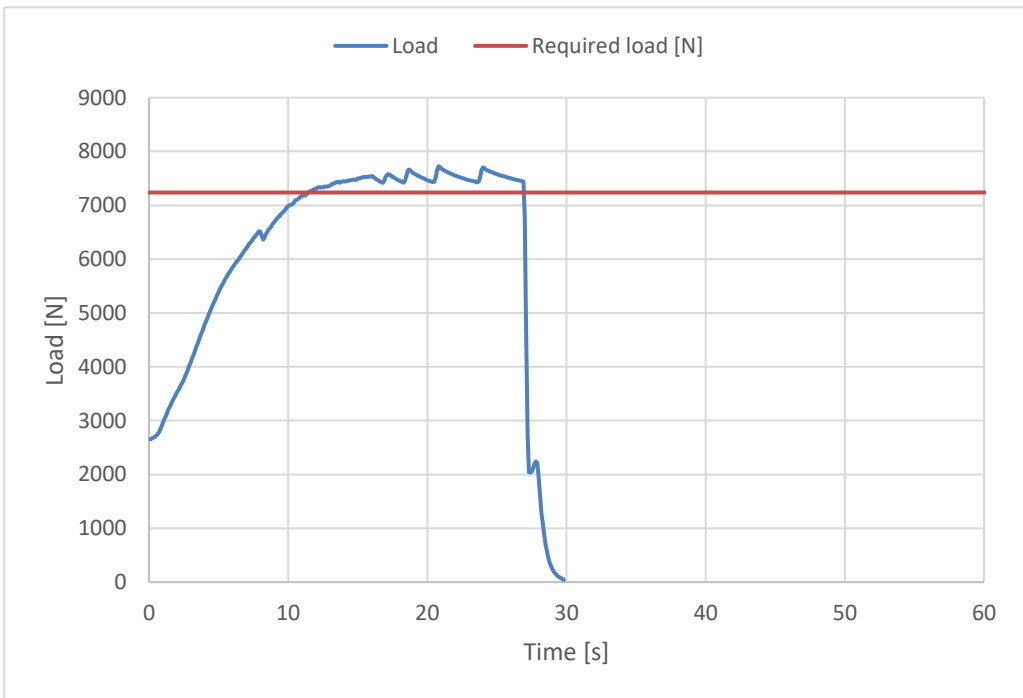
Test ID R0

Reference in standard	5.3.2.1	
Test setup	Default flying position	
Attachment points	Both main riser attachment (3,4)	
Anchor points	Dummy (B1, B2)	
Required load [g]	6	
Required load [N]	##	
Minimum test duration [s]	10	
Result		
Test duration [s]	16	
Any signs of structural failure	No	
Test results	IVE

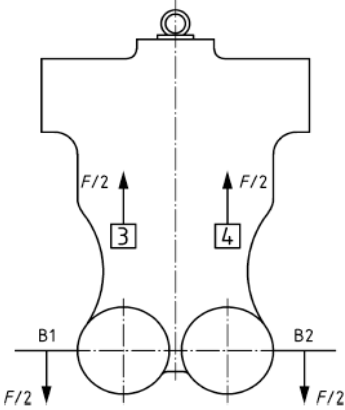
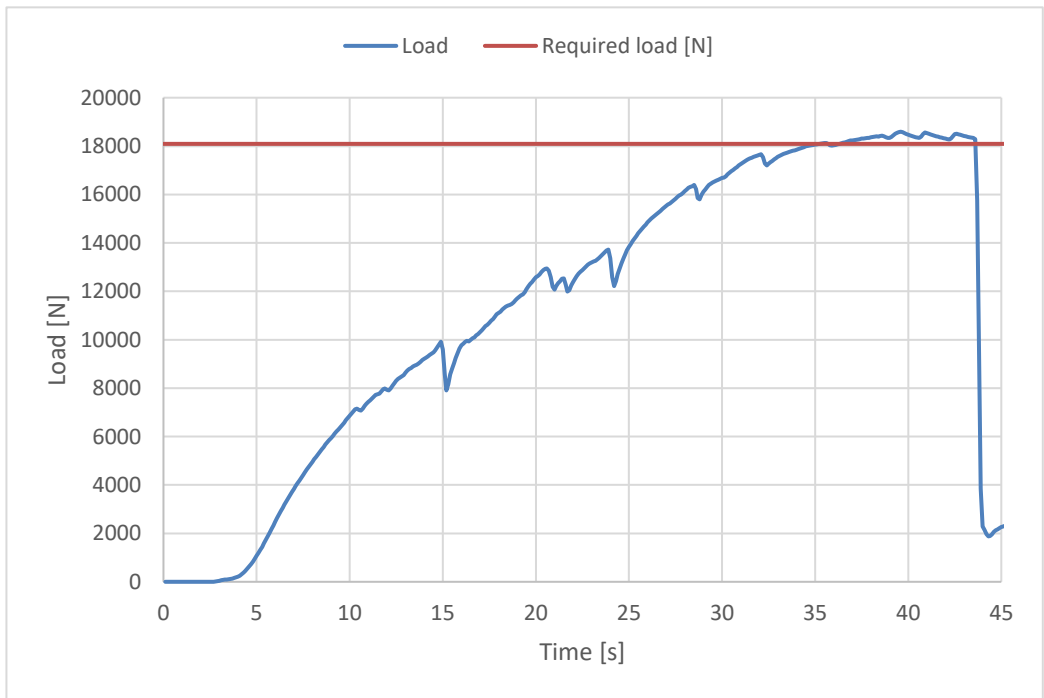
Test ID R2

Reference in standard	5.3.2.2	
Test setup	Default flying position	
Attachment points	Both main riser attachment (3,4)	
Anchor points	Dummy (B1, B2)	
Required load [g]	15	
Required load [N]	##	
Minimum test duration [s]	5	
Result		
Test duration [s]	7	
Any signs of structural failure	No	
Test results	IVE

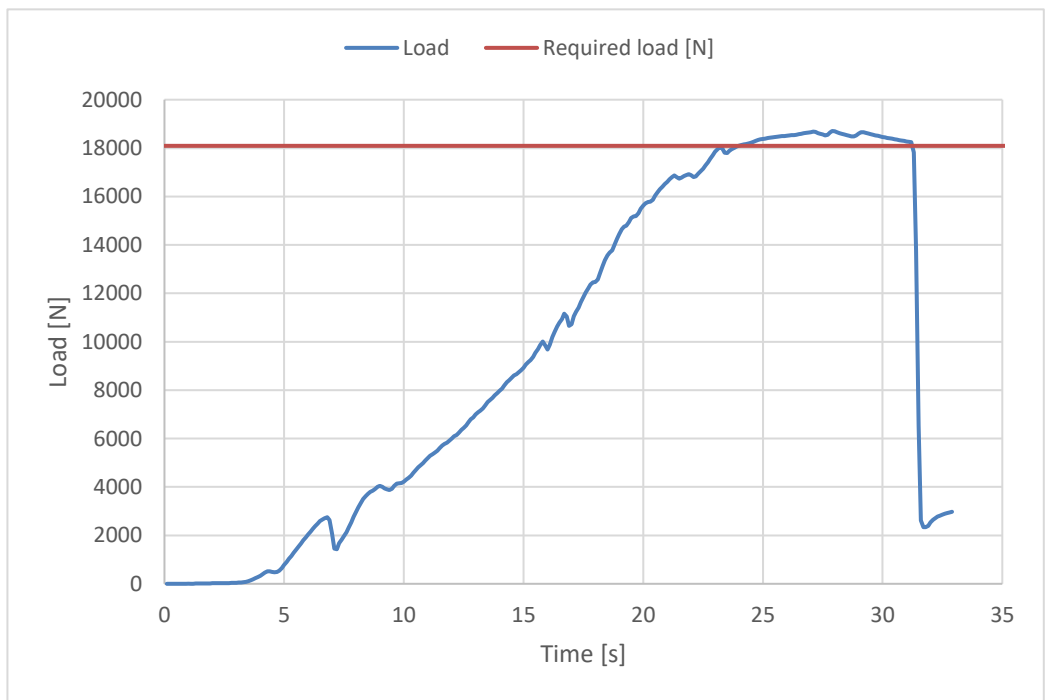
Test ID R4

Standard	EN 1651:1999
Reference in standard	5.3.2.7
Test setup	Flying position before landing
Attachment points	Both main riser attachment (3,4)
Anchor points	Dummy (7,8)
Required load [g]	15
Required load [N]	##
Minimum test duration [s]	5
Result	
Test duration [s]	7
Any signs of structural failure	No
Test results	IVE

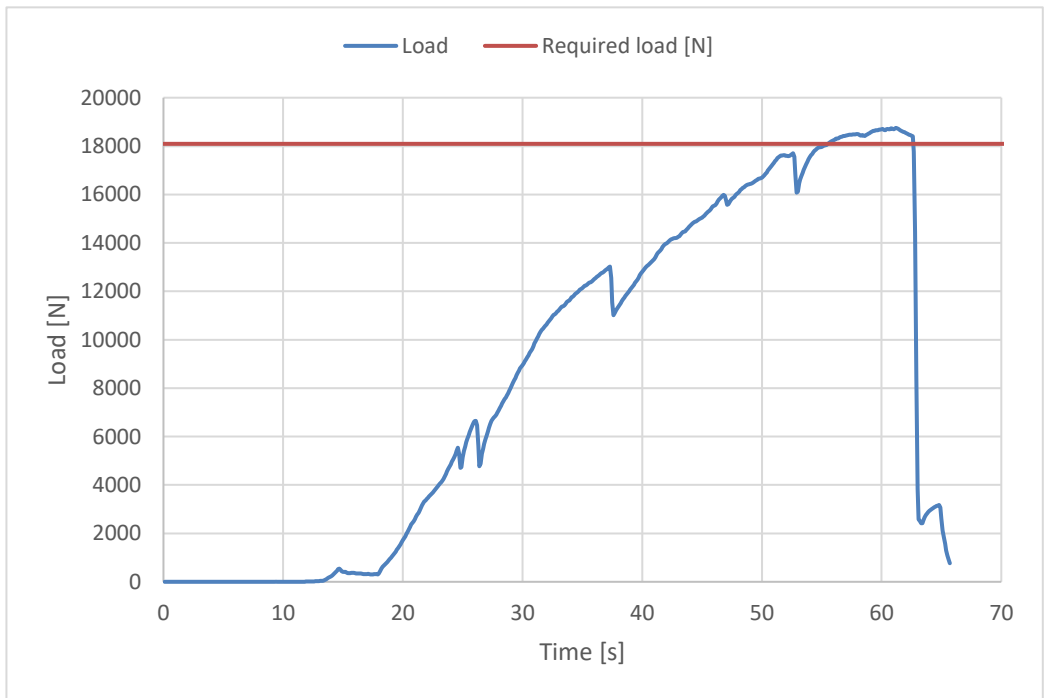
Test ID R6

Standard	EN 1651:1999
Reference in standard	5.3.2.4
Test setup	Rescue attachments
Attachment points	Rescue riser attachment (1,2)
Anchor points	Dummy (B1,B2)
Required load [g]	15
Required load [N]	##
Minimum test duration [s]	5
Result	
Test duration [s]	7
Any signs of structural failure	No
Test results	IVE

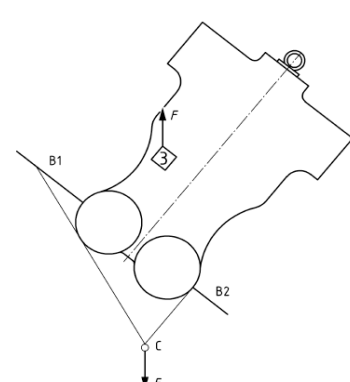
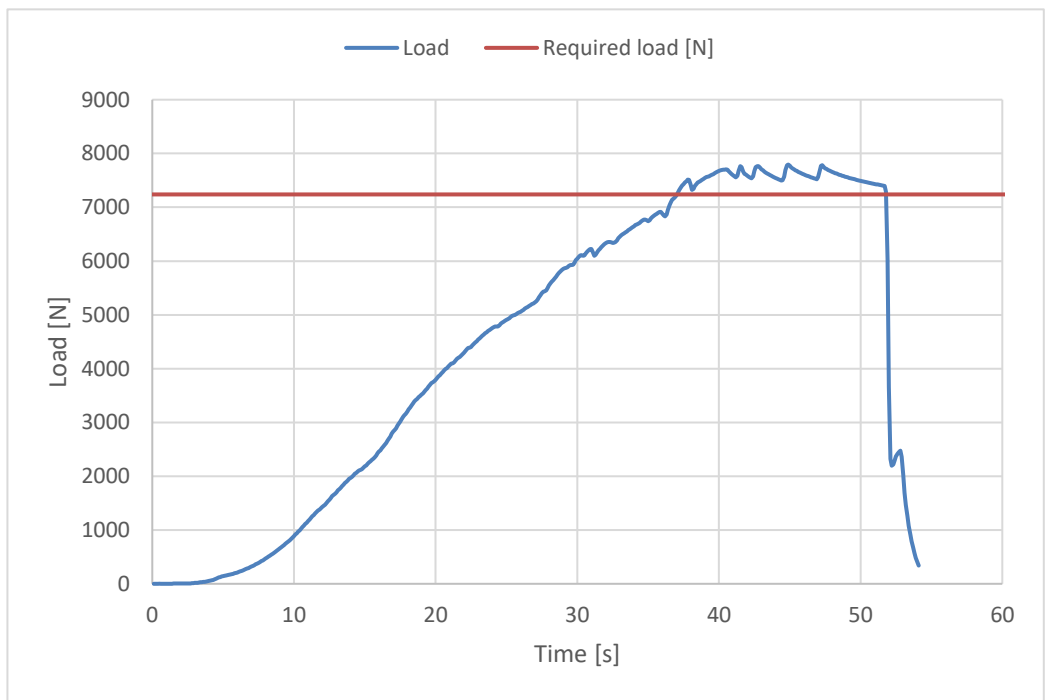
Test ID R8

Standard	EN 1651:1999
Reference in standard	5.3.2.3
Test setup	Asymmetric, one riser
Attachment points	One main riser attachment (3)
Anchor points	Dummy (B1,B2)
Required load [g]	6
Required load [N]	##
Minimum test duration [s]	10
Result	
Test duration [s]	15
Any signs of structural failure	No
Test results	IVE

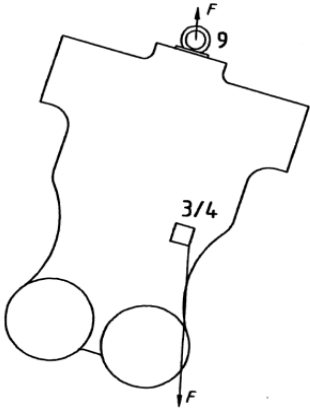
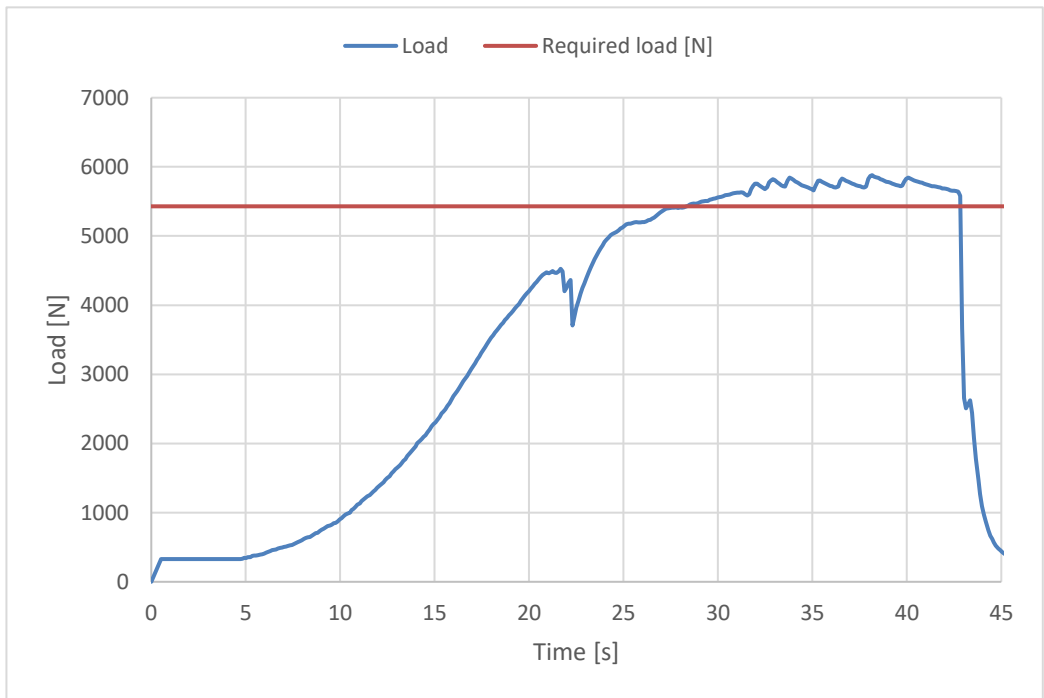
Test ID R10

Standard	EN 1651:1999
Reference in standard	5.3.2.6
Test setup	Asymmetric, negative
Attachment points	One main riser attachment (3 or 4) downwards
Anchor points	Dummy (9)
Required load [g]	5
Required load [N]	##
Minimum test duration [s]	10
Result	
Test duration [s]	14
Any signs of structural failure	No
Test results	IVE

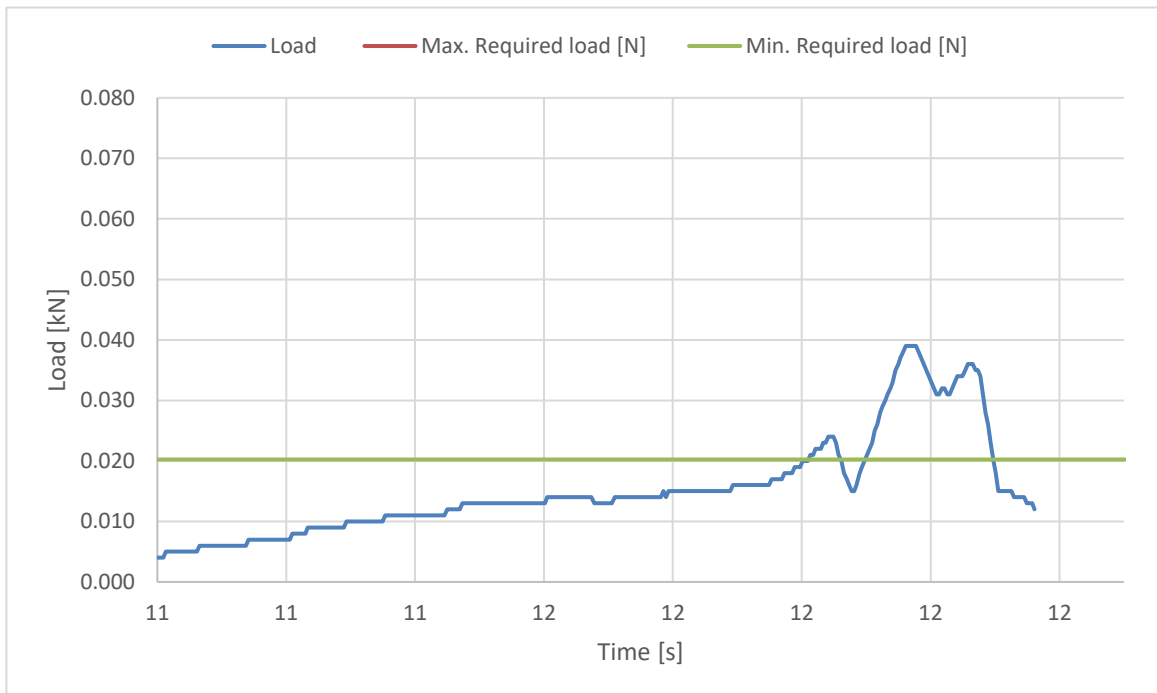
Test ID RRDT

Standard	LTF NfL II 91/09
Reference in standard	6.1.5
Test setup	Default flying position
Attachment points	Sensor connect to handle, and pull in opening direction
	The test is to simulate the load required to open the emergency parachute(1st action).
Min. Required load [N]	20
Max. Required load [N]	70
Result	
Load for first action [N]	38.77
Test results	POSITIVE

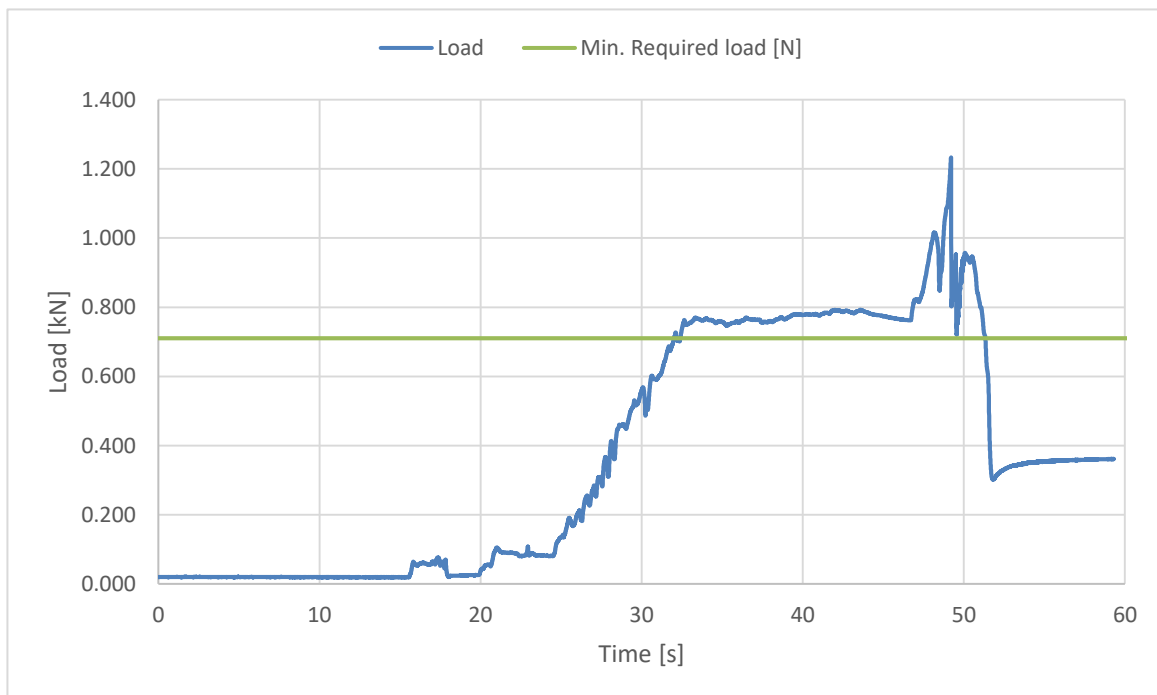
Test ID RRST

Standard	EN12491:2015
Reference in standard	5.3.2
Test setup	Two end points of handle
Attachment points	Sensor connect to end of handle, pull on the other side
	The handle must support min 700 N for 10 s, after measure breaking strength
Min. Required load [N]	700
Minimum test duration [s]	10
Result	
Test duration [s]:	18.9
Breaking strength [N]	1222.31
Test results	POSITIVE
