Harness Structural test Report

Inspection certificate number: **PH_283.2019**

Name: **Makan**
 Type: **ABS**
 Size: **M**
 Serial number: **School SM #0519**
 Impact pad type: ⁽¹⁾ **Yes**
 Clip-in weight [kg]: **120**

model: **Makan**

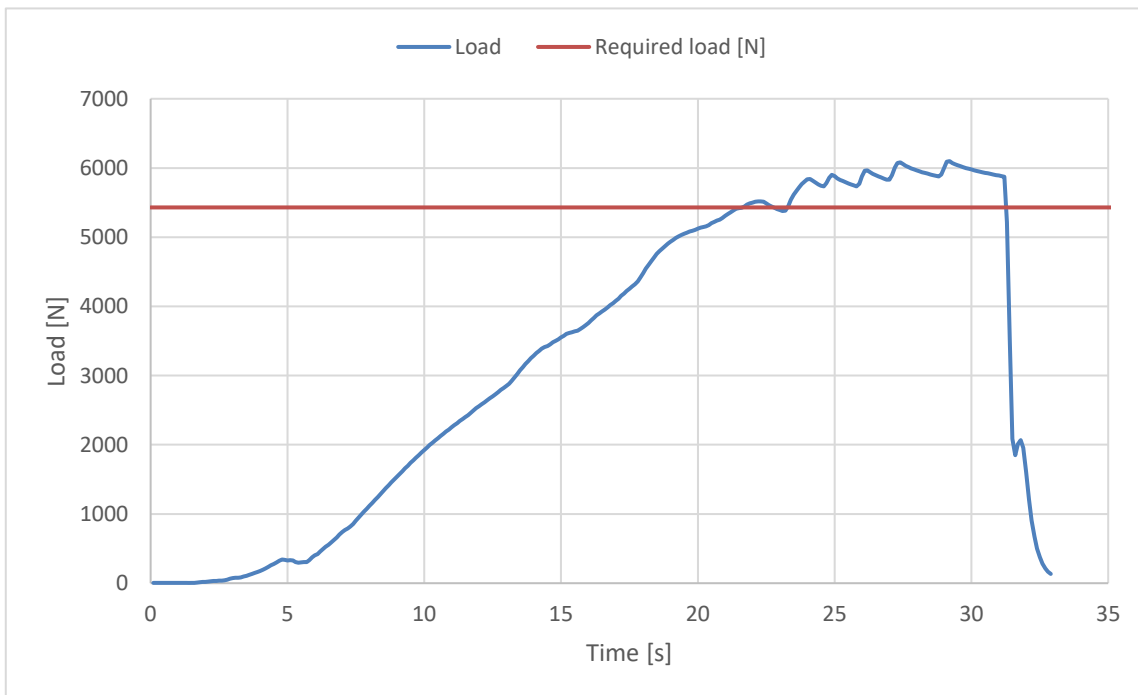
Test ID 01

Reference in standard	5.5.1.1	
Test setup	Positive symmetric load (Slippage)	
Attachment points	Both main riser attachment (3,4)	
Anchor points	Dummy (B1, B2)	
Required load [g]	4.5	
Required load [N]	5400	
Minimum test duration [s]	5	
Result		
Test duration [s]	8	
Any signs of structural failure	No	
Slippery test OK	Yes	
Test results	POSITIVE

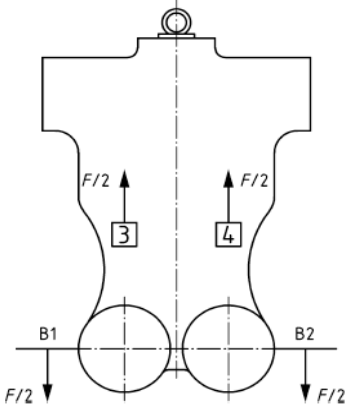
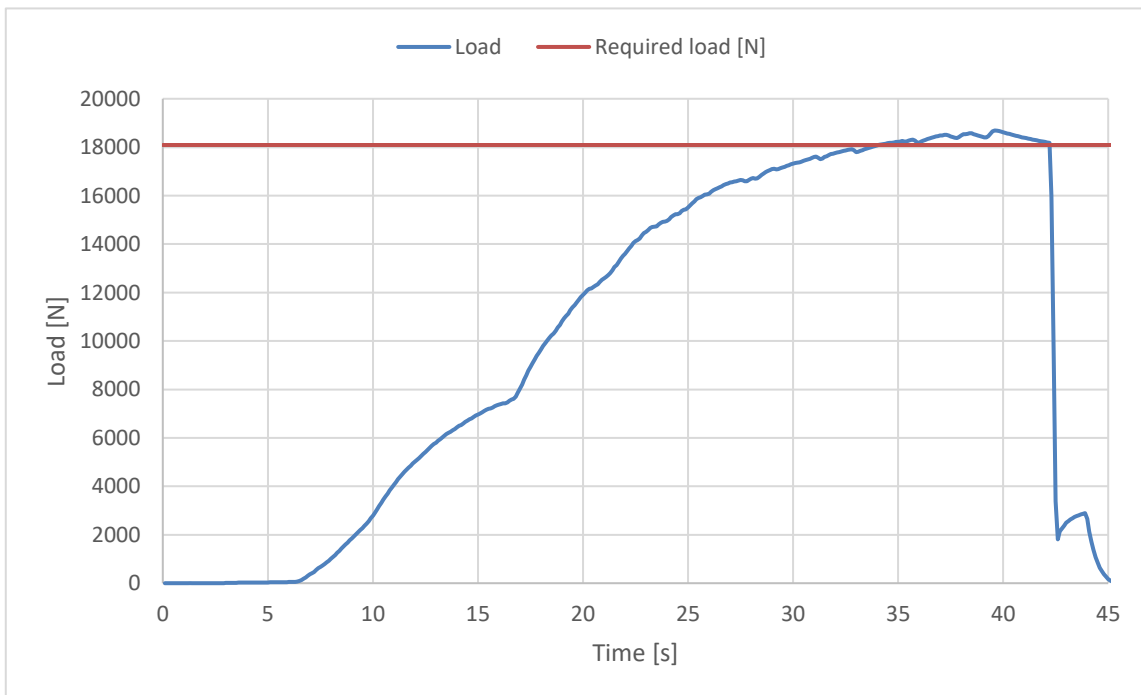
Test ID 03

Standard	EN 1651:2018
Reference in standard	5.5.1.1b
Test setup	Positive symmetric load
Attachment points	Both main riser attachment (3,4)
Anchor points	Dummy (B1, B2)
Required load [g]	15
Required load [N]	18000
Minimum test duration [s]	5
Result	
Test duration [s]	8.2
Any signs of structural failure	No
Slippery test OK	Yes
Test results	POSITIVE

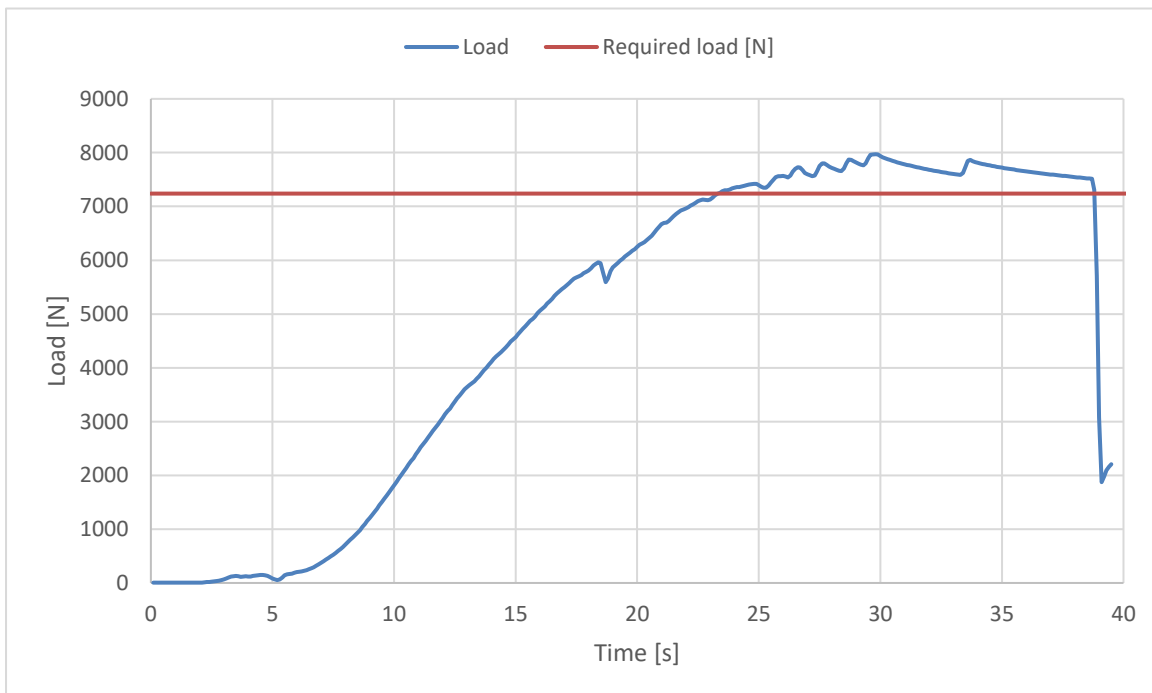
Test ID 05

Standard	EN 1651:2018
Reference in standard	5.5.1.2
Test setup	Positive asymmetric load
Attachment points	One riser attachment (3 or 4)
Anchor points	Dummy (C)
Required load [g]	6
Required load [N]	7200
Minimum test duration [s]	5
Result	
Test duration [s]	15.5
Any signs of structural failure	No
Test results	POSITIVE

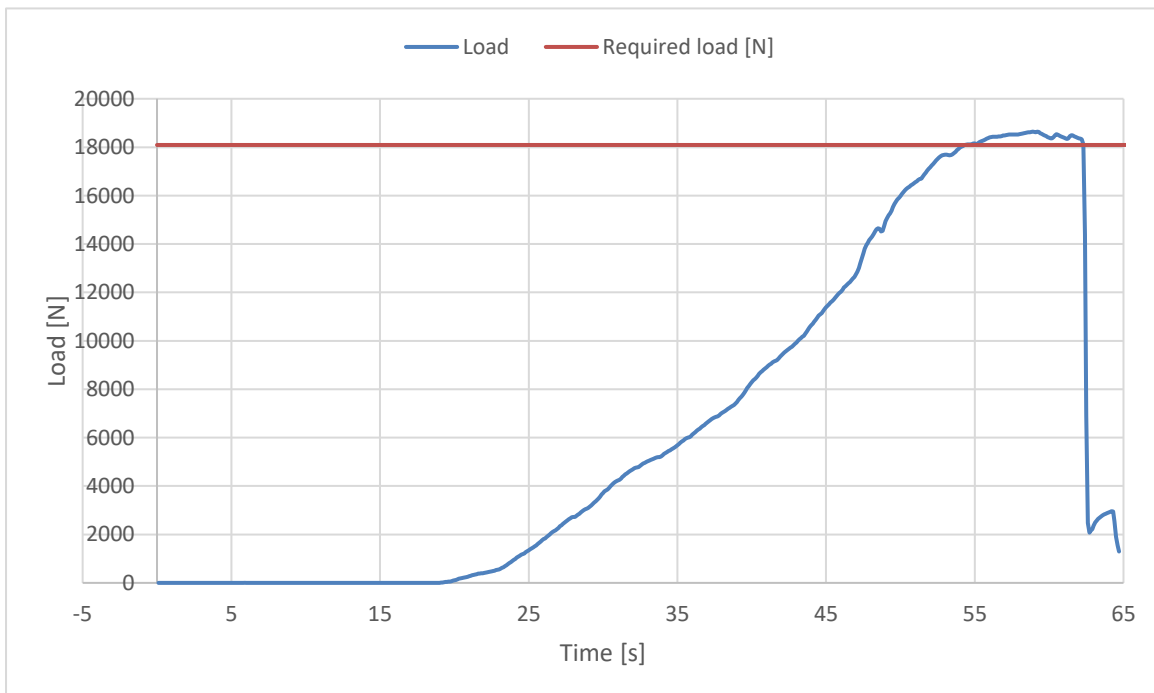
Test ID 09

Standard	EN 1651:2018
Reference in standard	5.5.1.3
Test setup	Positive symmetric load rescue points
Attachment points	Both main riser attachment (1,2)
Anchor points	Dummy (B1,B2)
Required load [g]	15
Required load [N]	18000
Minimum test duration [s]	5
Result	
Test duration [s]	8
Any signs of structural failure	No
Slippery test OK	Yes
Test results	POSITIVE

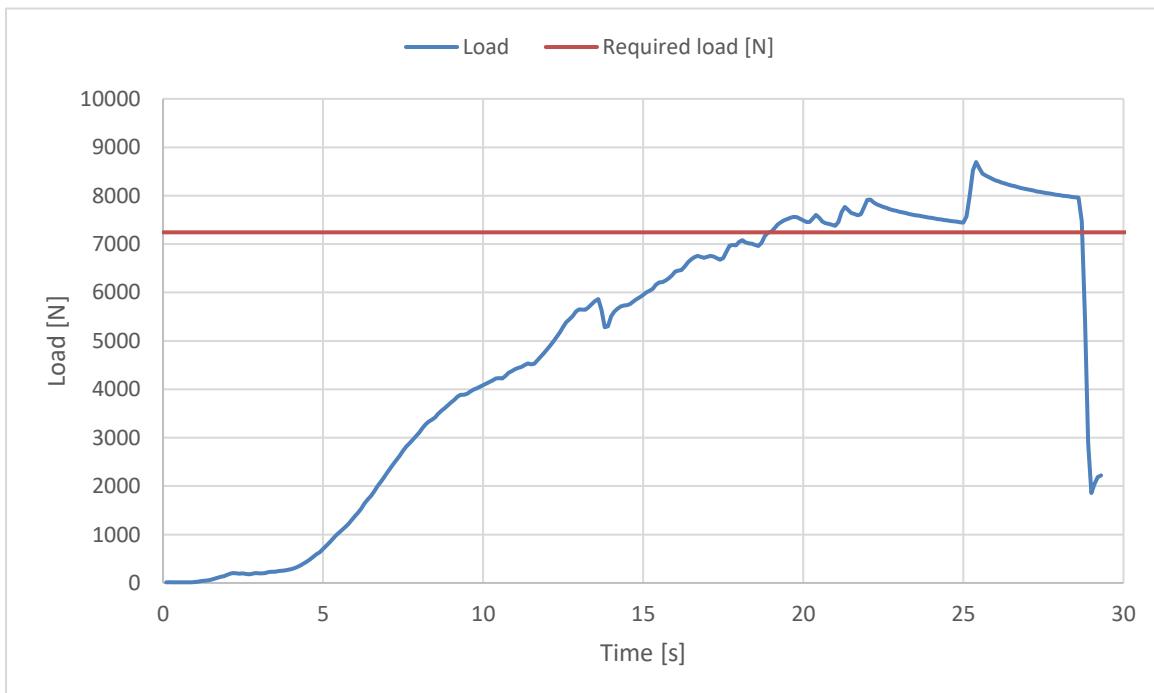
Test ID 06

Standard	EN 1651:2018
Reference in standard	5.5.1.6
Test setup	Negative symmetric load
Attachment points	Both main riser attachment (3,4)
Anchor points	Dummy (A)
Required load [g]	6
Required load [N]	7200
Minimum test duration [s]	5
Result	
Test duration [s]	9.8
Any signs of structural failure	No
Test results	POSITIVE

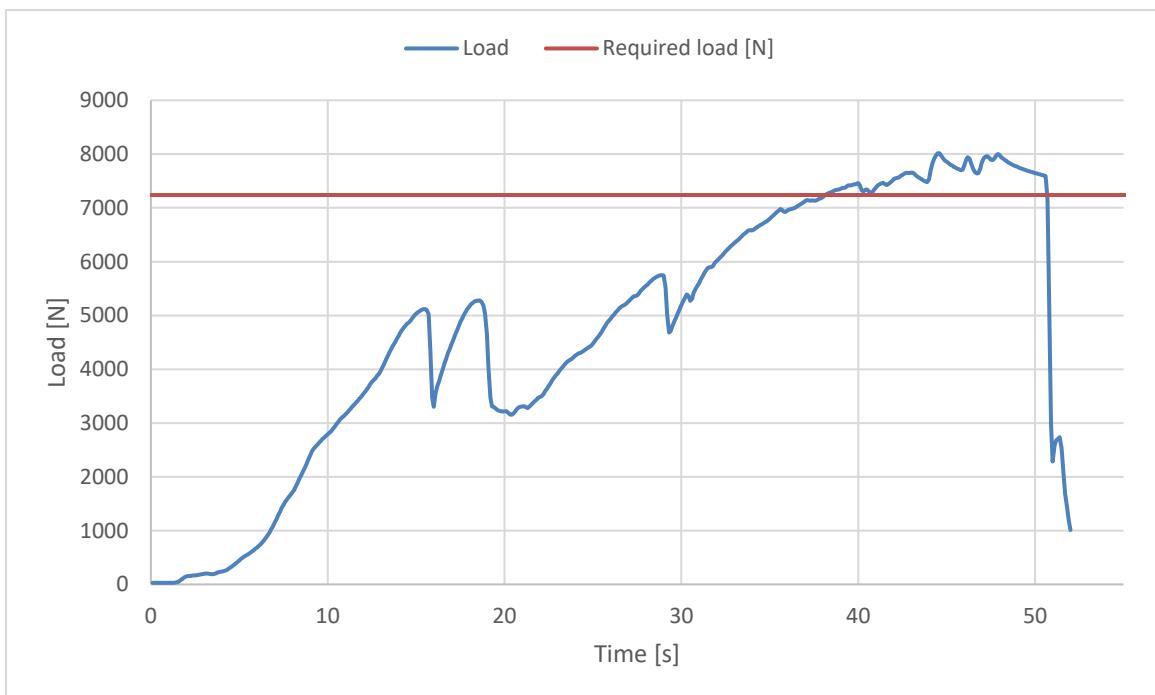
Test ID 12

Standard	EN 1651:2018
Reference in standard	5.5.1.7
Test setup	Upright (landing) position load
Attachment points	Both main riser attachment (3, 4)
Anchor points	Both legstrap of harness (no dummy)
Required load [g]	6
Required load [N]	7200
Minimum test duration [s]	5
Harness type	type a
Result	
Test duration [s]	12.5
Any signs of structural failure	No
Slippery test OK	Yes
Test results	POSITIVE

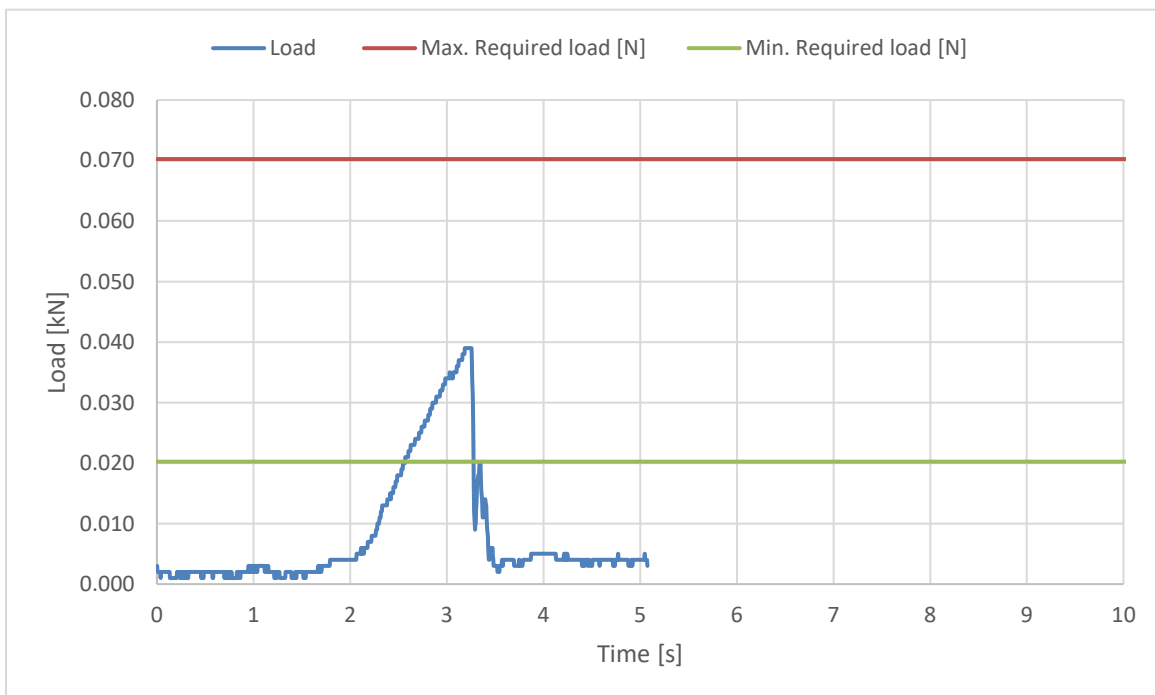
Test ID RRDT

Standard	LTF NfL II 91/09
Reference in standard	6.1.5
Test setup	Default flying position
Attachment points	Sensor connect to handle, and pull in opening direction
	The test is to simulate the load required to open the emergency parachute(1st action).
Min. Required load [N]	20
Max. Required load [N]	70
Result	
Load for first action [N]	38.77
Test results	POSITIVE

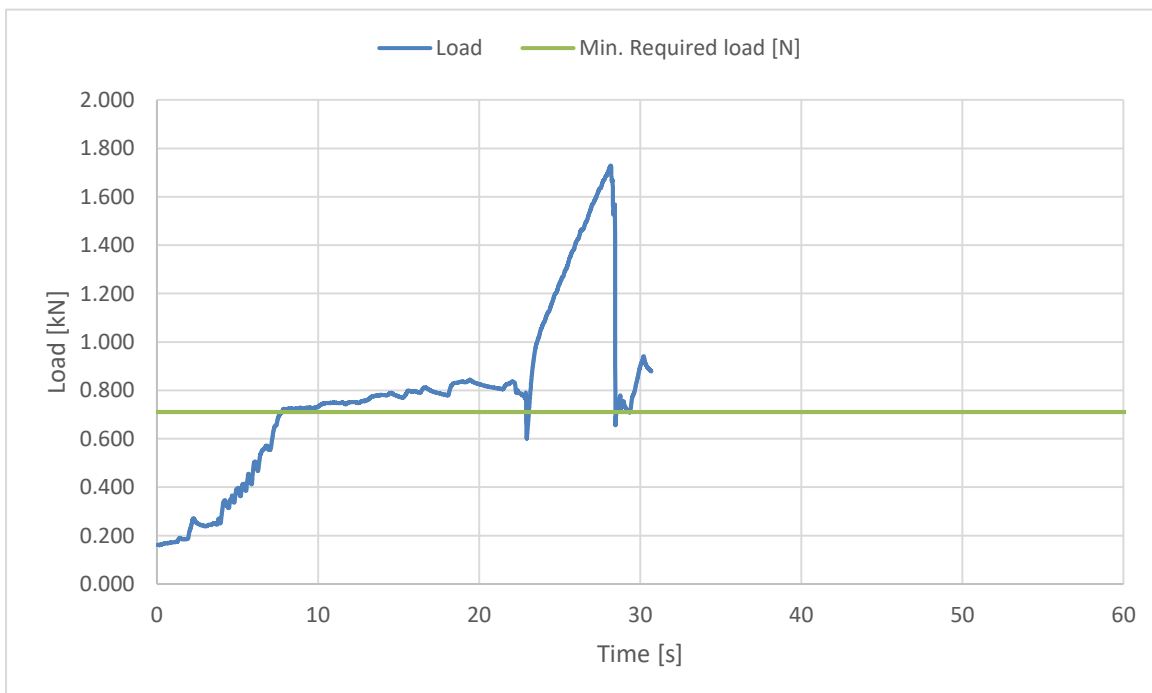
Test ID RRST

Standard	EN12491:2015
Reference in standard	5.3.2
Test setup	Two end points of handle
Attachment points	Sensor connect to end of handle, pull on the other side
	The handle must support min 700 N for 10 s, after measure breaking strength
Min. Required load [N]	700
Minimum test duration [s]	10
Result	
Test duration [s]:	15.1
Breaking strength [N]	1718.61
Test results	POSITIVE
