Harness Structural test Report

Inspection certificate number: **PH_283.2019**
Manufacturer data:

Name: **Makan**
 Type: **ABS**
 Size: **M**
 Serial number: **School SM #0519**
 Impact pad type: ⁽¹⁾ **Foam**
 Clip-in weight [kg]: **120**

Summary of Structural test

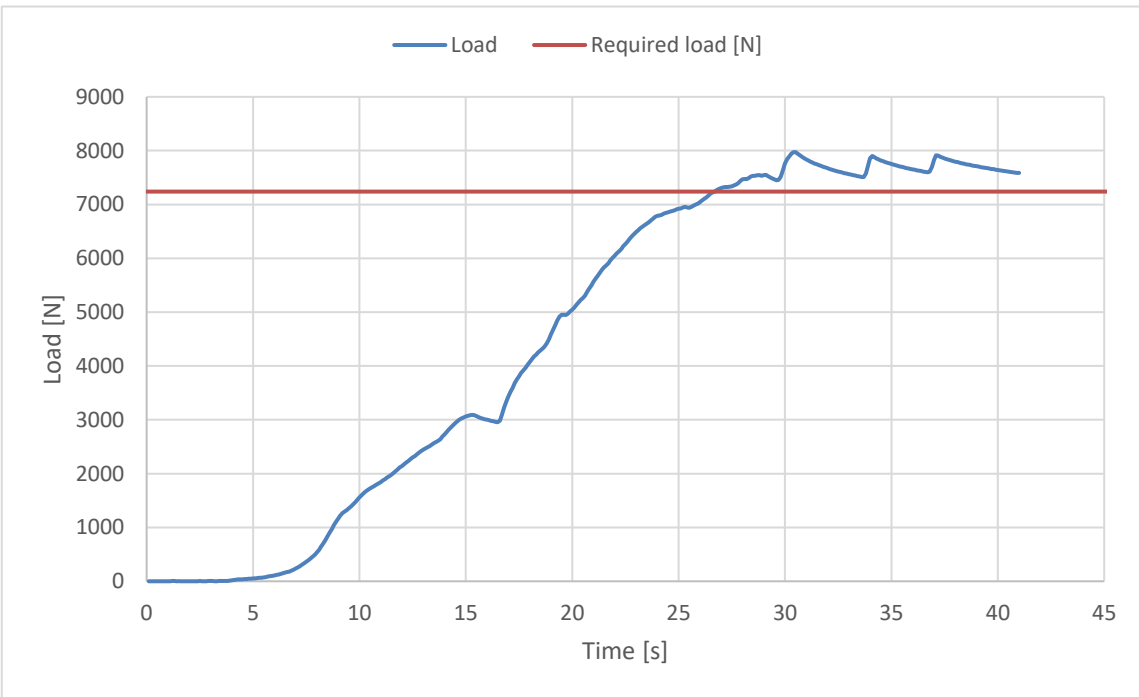
Test ID 02

Reference in standard	5.3.2.1	
Test setup	Default flying position	
Attachment points	Both main riser attachment (3,4)	
Anchor points	Dummy (B1, B2)	
Required load [g]	6	
Required load [N]	7200	
Minimum test duration [s]	10	
Result		
Test duration [s]	14.4	
Any signs of structural failure	No	
Test results	POSITIVE

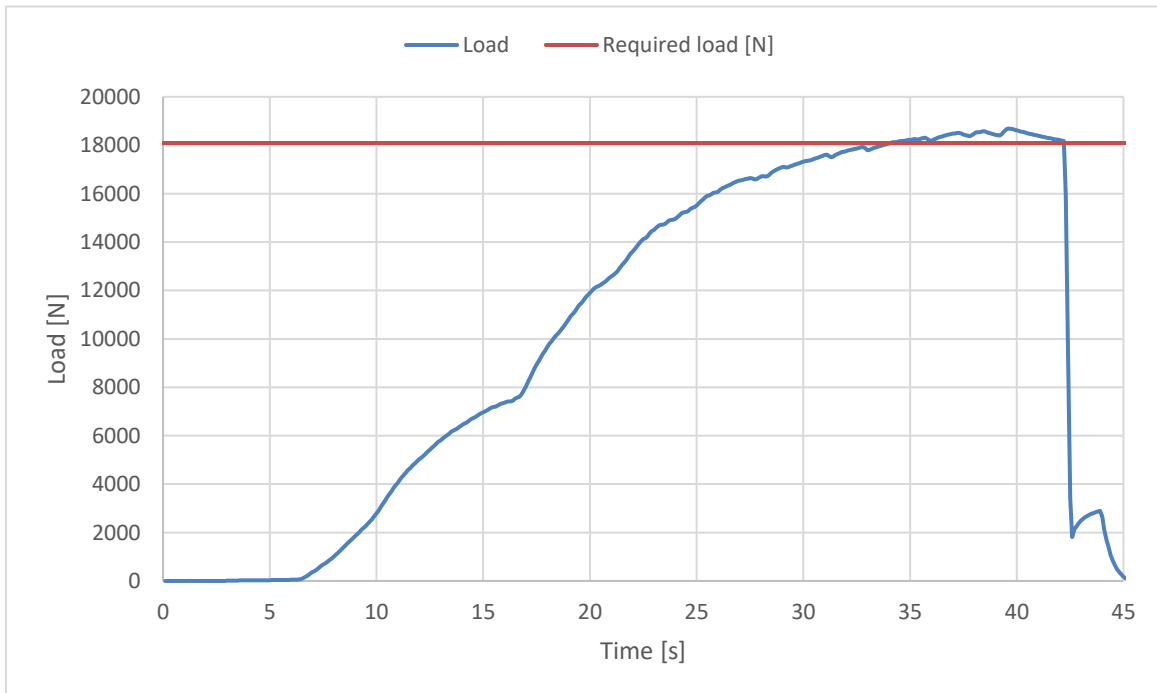
Test ID 03

Reference in standard	5.3.2.2	
Test setup	Default flying position	
Attachment points	Both main riser attachment (3,4)	
Anchor points	Dummy (B1, B2)	
Required load [g]	15	
Required load [N]	18000	
Minimum test duration [s]	5	
Result		
Test duration [s]	8.2	
Any signs of structural failure	No	
Test results	POSITIVE

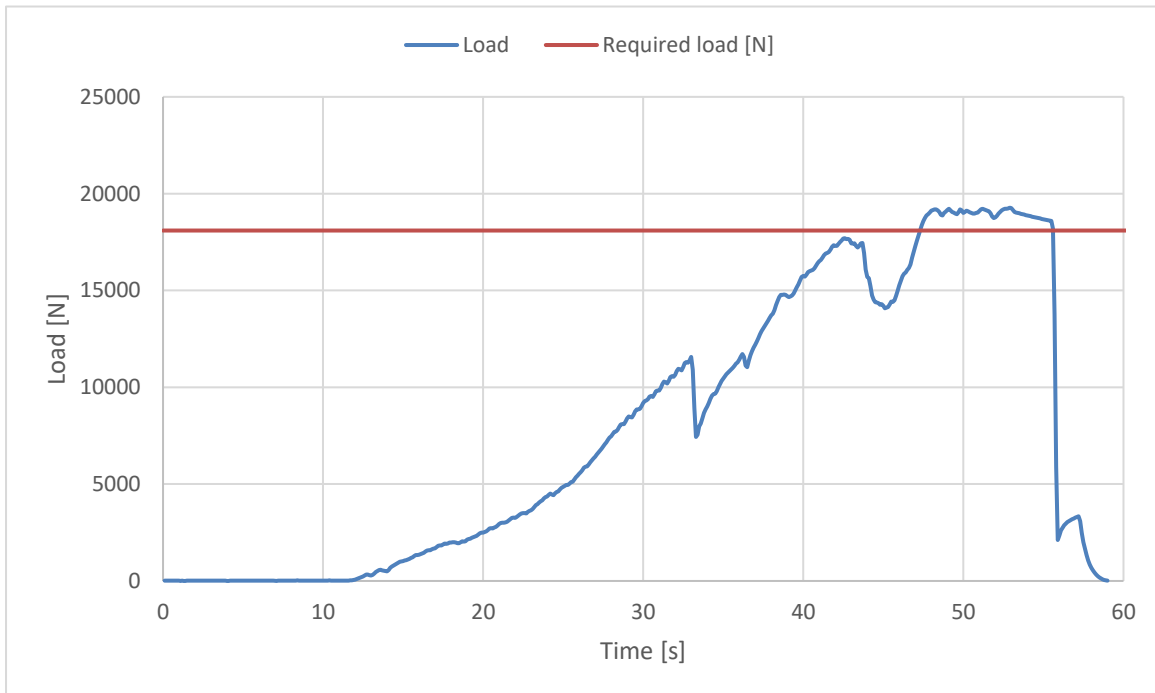
Test ID 13

Standard	EN 1651:1999
Reference in standard	5.3.2.7
Test setup	Flying position before landing
Attachment points	Both main riser attachment (3,4)
Anchor points	Dummy (7,8)
Required load [g]	15
Required load [N]	18000
Minimum test duration [s]	5
Result	
Test duration [s]	8.3
Any signs of structural failure	No
Test results	POSITIVE

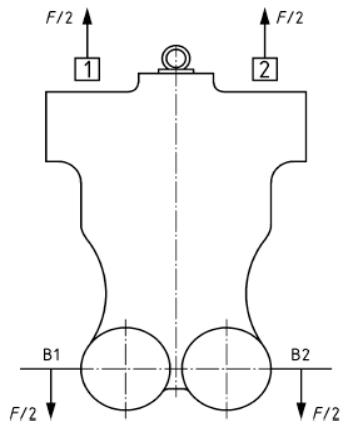
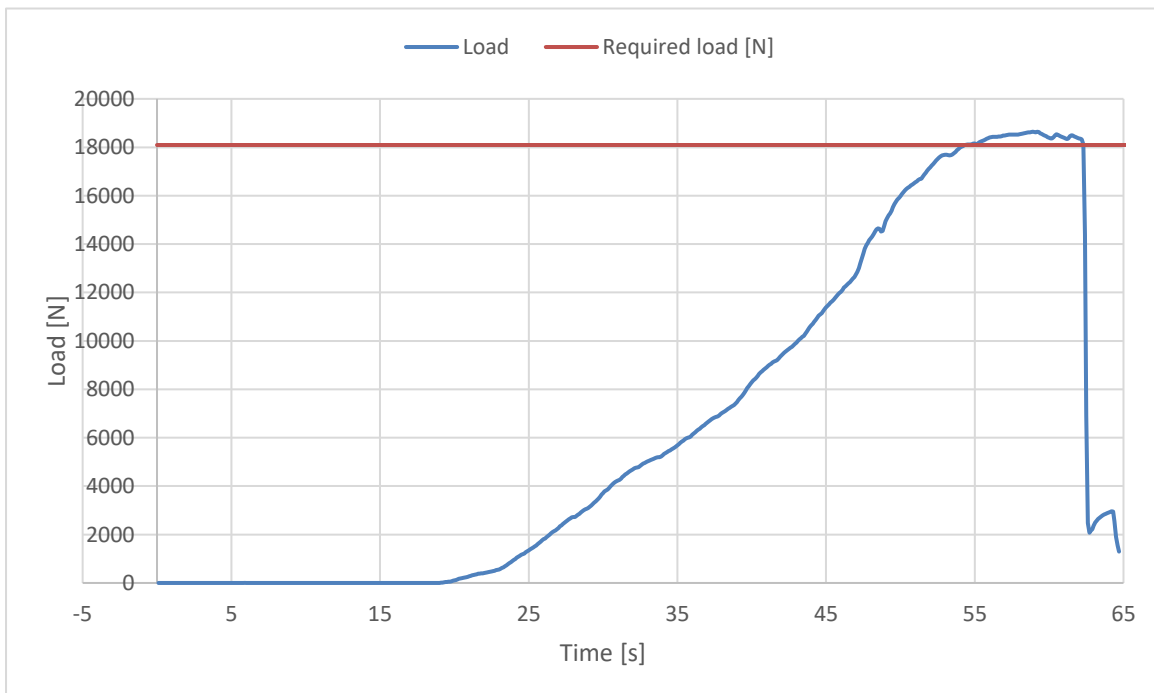
Test ID 09

Reference in standard	5.3.2.4	
Test setup	Rescue attachments	
Attachment points	Rescue riser attachment (1,2)	
Anchor points	Dummy (B1,B2)	
Required load [g]	15	
Required load [N]	18000	
Minimum test duration [s]	5	
Result		
Test duration [s]	8	
Any signs of structural failure	No	
Test results	POSITIVE

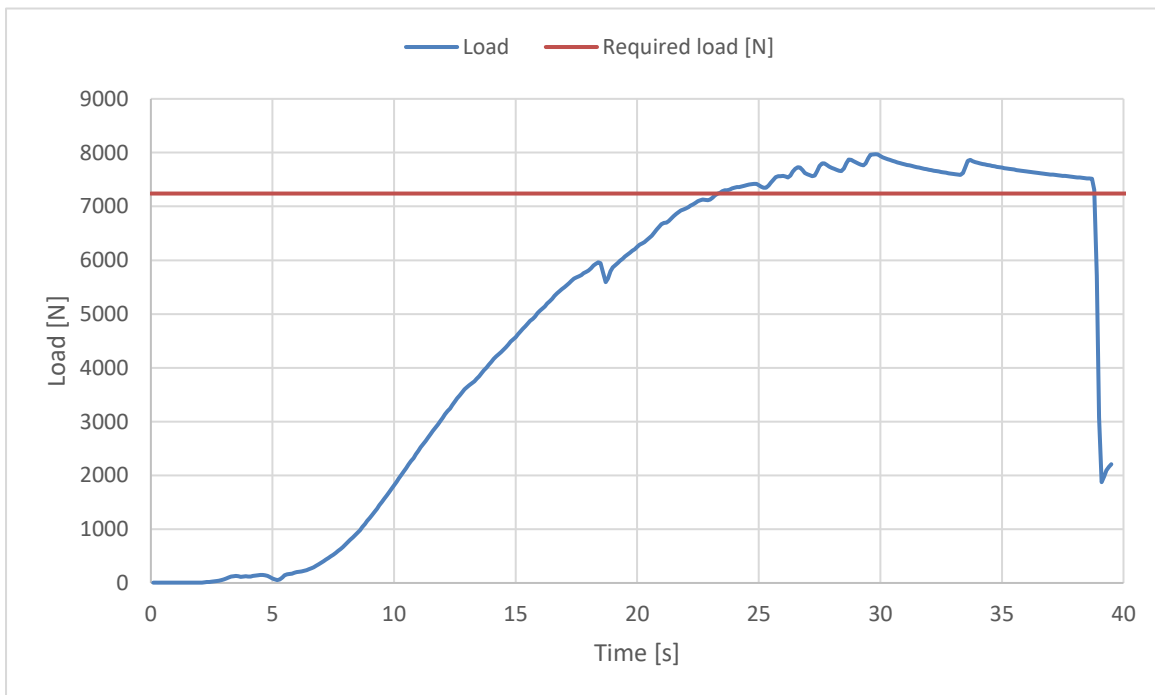
Test ID 04

Standard **EN 1651:1999**
 Reference in standard **5.3.2.3**
 Test setup **Asymmetric, one riser**
 Attachment points **One main riser attachment (3)**
 Anchor points **Dummy (B1,B2)**

Test duration [s] **15.5**
 Any signs of structural failure **No**
 Test results **POSITIVE**

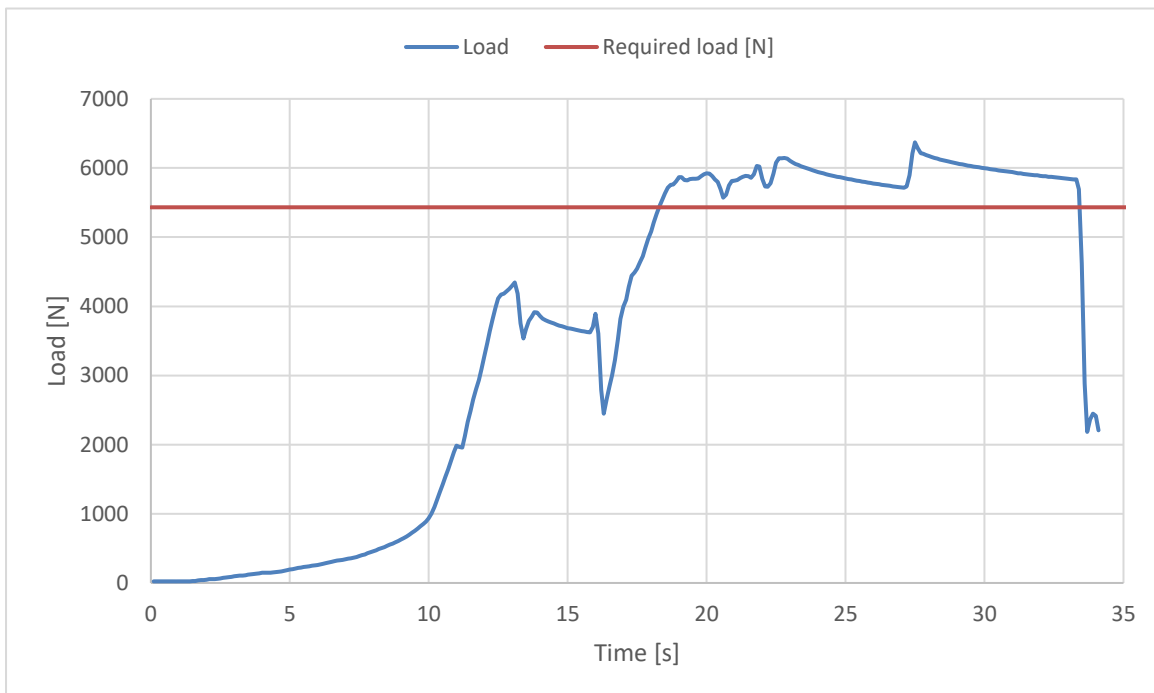
Test ID 07

Reference in standard	5.3.2.6	
Test setup	Asymmetric, negative	
Attachment points	One main riser attachment (3 or 4) downwards	
Anchor points	Dummy (9)	
Required load [g]	4.5	
Required load [N]	5400	
Minimum test duration [s]	10	
Result		
Test duration [s]	15.2	
Any signs of structural failure	No	
Test results	POSITIVE

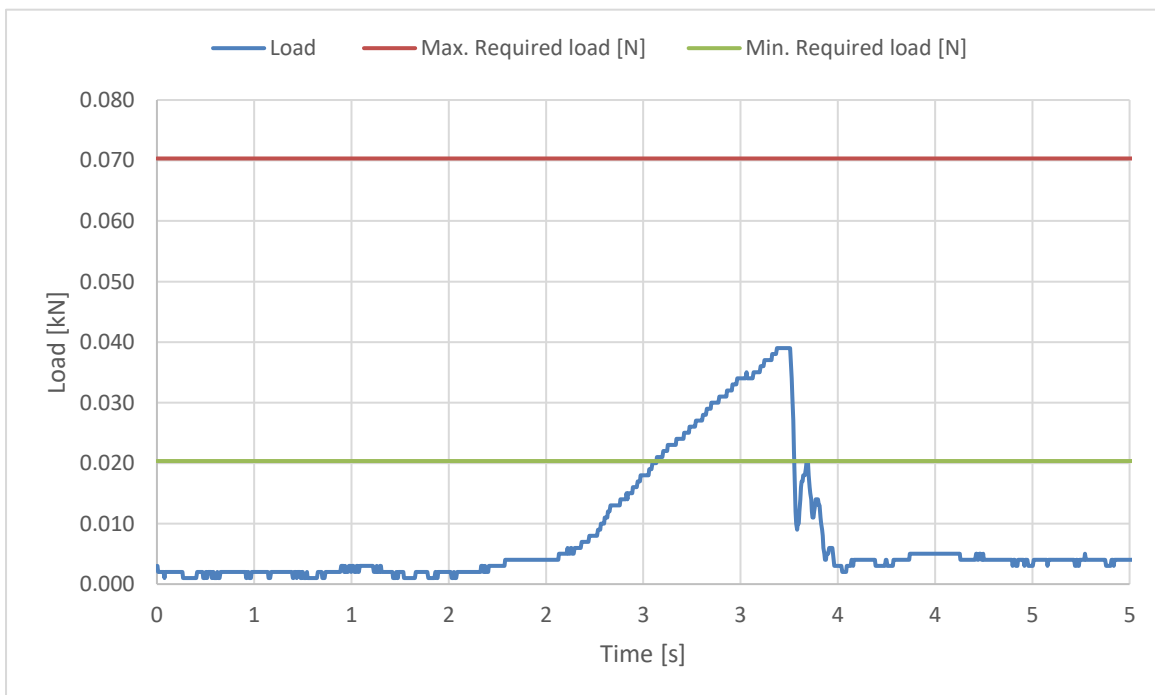
Test ID RRDT

Standard	LTF NfL II 91/09
Reference in standard	6.1.5
Test setup	Default flying position
Attachment points	Sensor connect to handle, and pull in opening direction
	The test is to simulate the load required to open the emergency parachute(1st action).
Min. Required load [N]	20
Max. Required load [N]	70
Result	
Load for first action [N]	38.66
Test results	POSITIVE

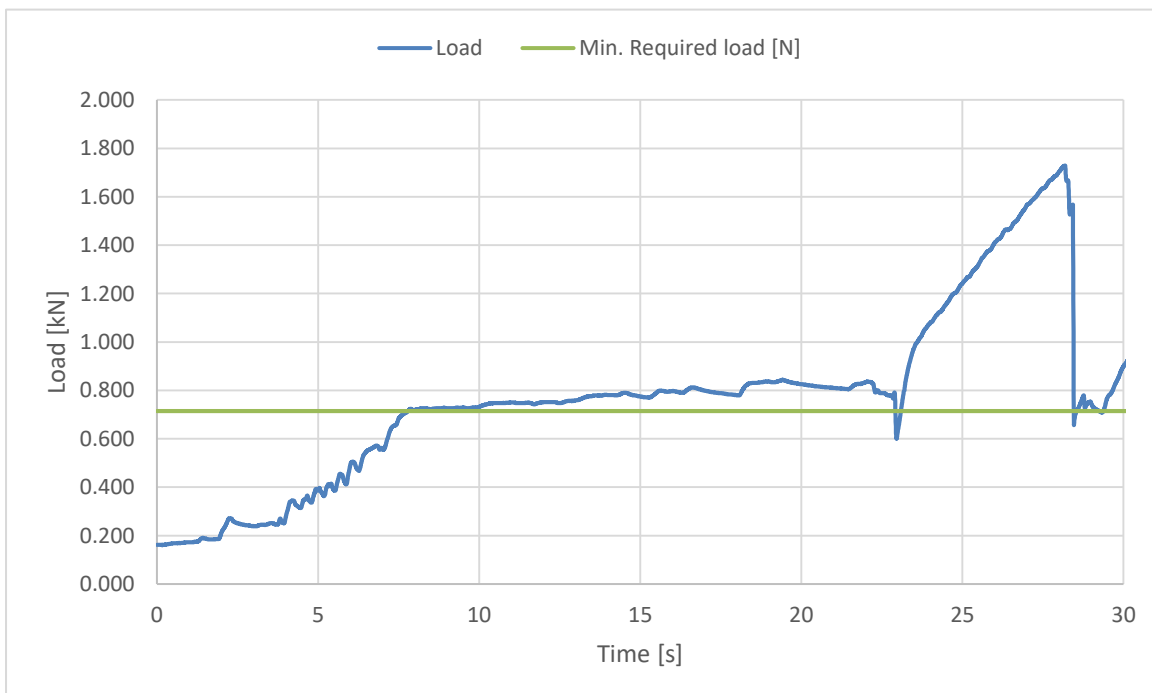
Test ID RRST

Standard	EN12491:2015
Reference in standard	5.3.2
Test setup	Two end points of handle
Attachment points	Sensor connect to end of handle, pull on the other side
	The handle must support min 700 N for 10 s, after measure breaking strength
Min. Required load [N]	700
Minimum test duration [s]	10
Result	
Test duration [s]:	15.1
Breaking strength [N]	1714.01
Test results	POSITIVE
