Harness Structural test Report - LTF

Inspection certificate number: **PH_298.2020**

Name: **Access2**
 Type: **ABS**
 Size: **M**
 Serial number: **2170MM121ROAA2**
 Impact pad type: ⁽¹⁾ **Airbag**
 Clip-in weight [kg]: **120**

Date of test: **10.02.2020**

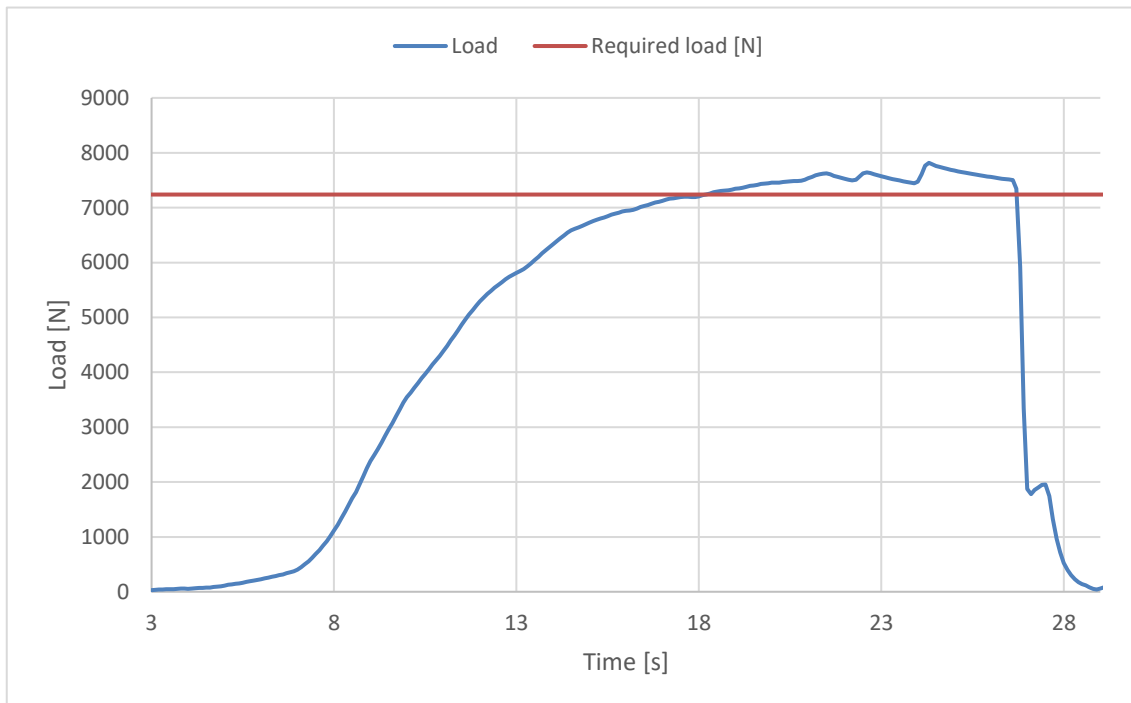
Test ID 02

Standard	EN 1651:1999
Reference in standard	5.3.2.1
Test setup	Default flying position
Attachment points	Both main riser attachment (3,4)
Anchor points	Dummy (B1, B2)
Required load [g]	6
Required load [N]	7200
Minimum test duration [s]	10
Result	
Test duration [s]	8.6
Any signs of structural failure	No
Test results	POSITIVE

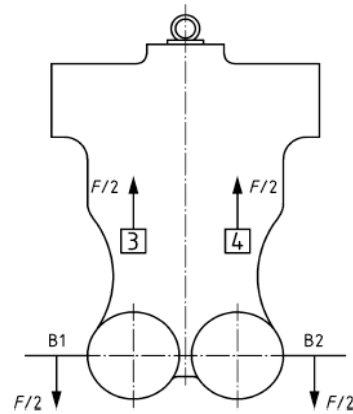
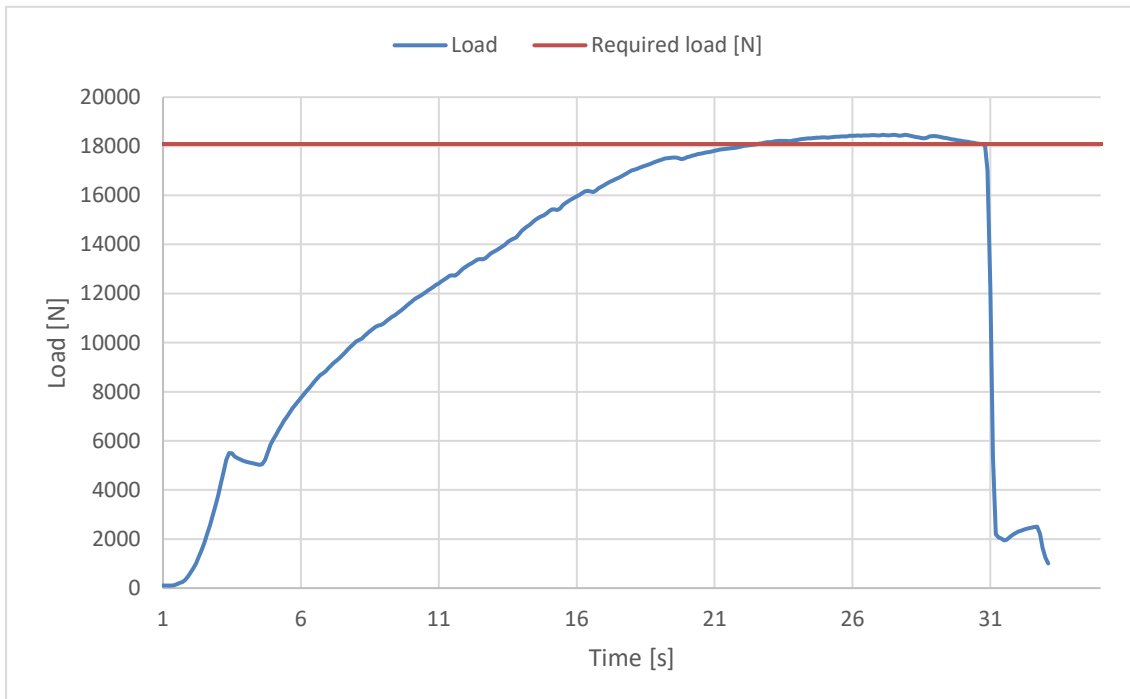
Test ID 03

Standard **EN 1651:1999**
 Reference in standard **5.3.2.2**
 Test setup **Default flying position**
 Attachment points **Both main riser attachment (3,4)**
 Anchor points **Dummy (B1, B2)**

Required load [g] **15**
 Required load [N] **18000**
 Minimum test duration [s] **5**

Test duration [s] **8.1**
 Any signs of structural failure **No**
 Test results **POSITIVE**

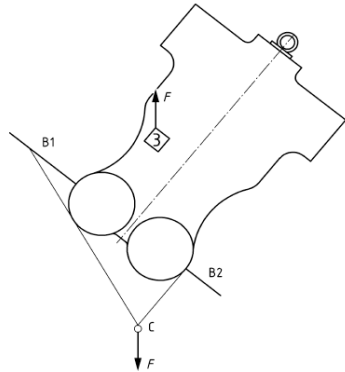
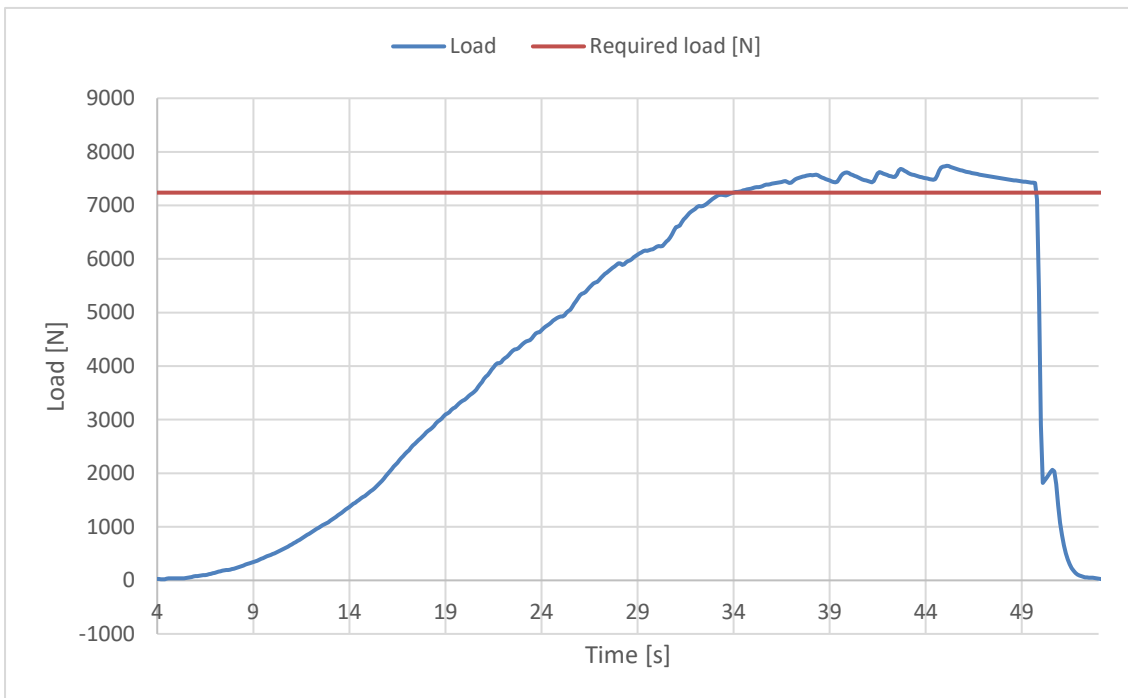
Test ID 04

Standard	EN 1651:1999
Reference in standard	5.3.2.3
Test setup	Asymmetric, one riser
Attachment points	One main riser attachment (3)
Anchor points	Dummy (B1,B2)
Required load [g]	6
Required load [N]	7200
Minimum test duration [s]	10
Result	
Test duration [s]	15.8
Any signs of structural failure	No
Test results	POSITIVE

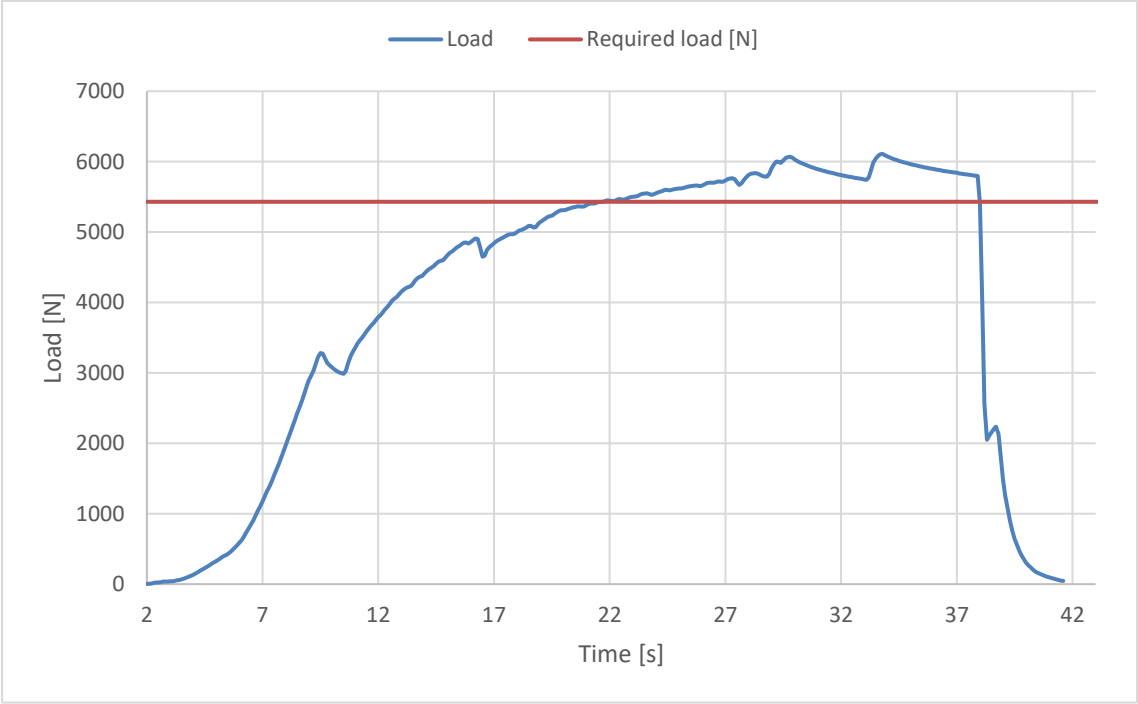
Test ID 07

Reference in standard	5.3.2.6	
Test setup	Asymmetric, negative	
Attachment points	One main riser attachment (3 or 4) downwards	
Anchor points	Dummy (9)	
Required load [g]	4.5	
Required load [N]	5400	
Minimum test duration [s]	10	
Result		
Test duration [s]	16.2	
Any signs of structural failure	No	
Test results	POSITIVE

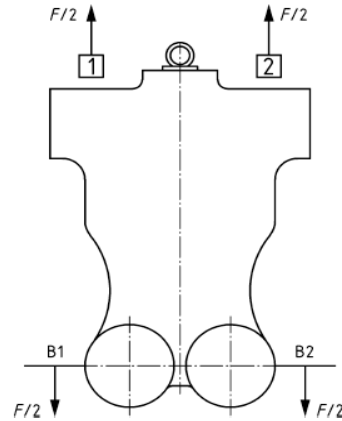
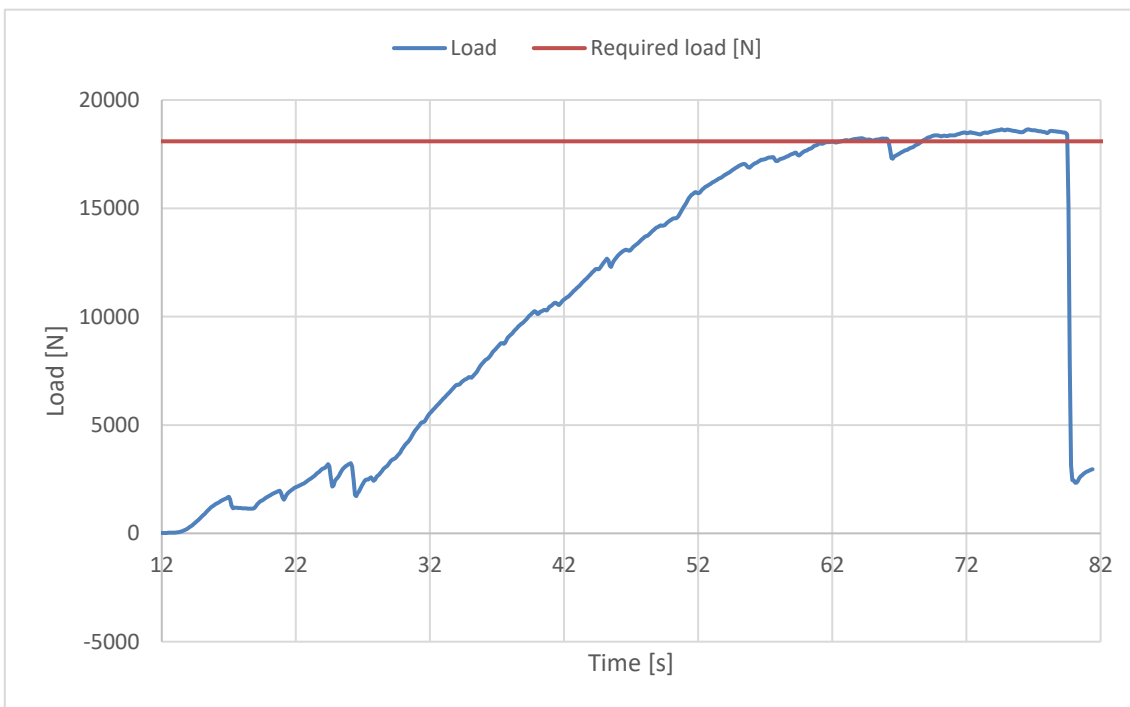
Test ID 09

Standard **EN 1651:1999**
 Reference in standard **5.3.2.4**
 Test setup **Rescue attachments**
 Attachment points **Rescue riser attachment (1,2)**
 Anchor points **Dummy (B1,B2)**

Required load [g] **15**
 Required load [N] **18000**
 Minimum test duration [s] **5**

Test duration [s] **10.9**
 Any signs of structural failure **No**
 Test results **POSITIVE**

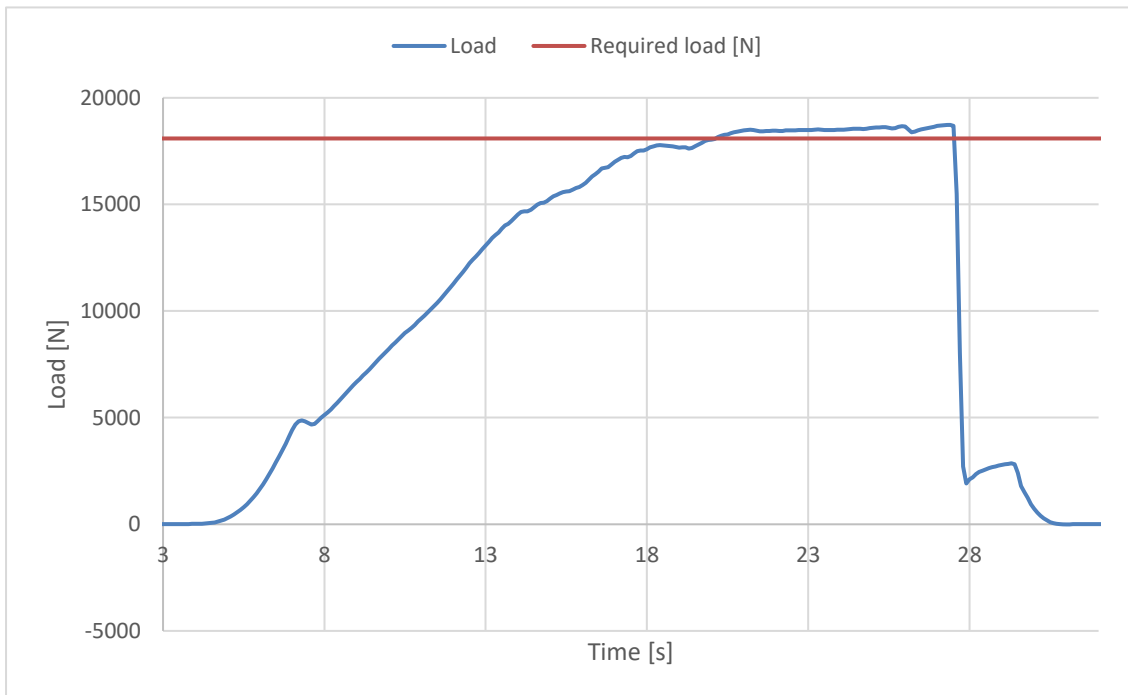
Test ID 13

Standard	EN 1651:1999
Reference in standard	5.3.2.7
Test setup	Flying position before landing
Attachment points	Both main riser attachment (3,4)
Anchor points	Dummy (7,8)
Required load [g]	15
Required load [N]	18000
Minimum test duration [s]	5
Result	
Test duration [s]	7.4
Any signs of structural failure	No
Test results	POSITIVE

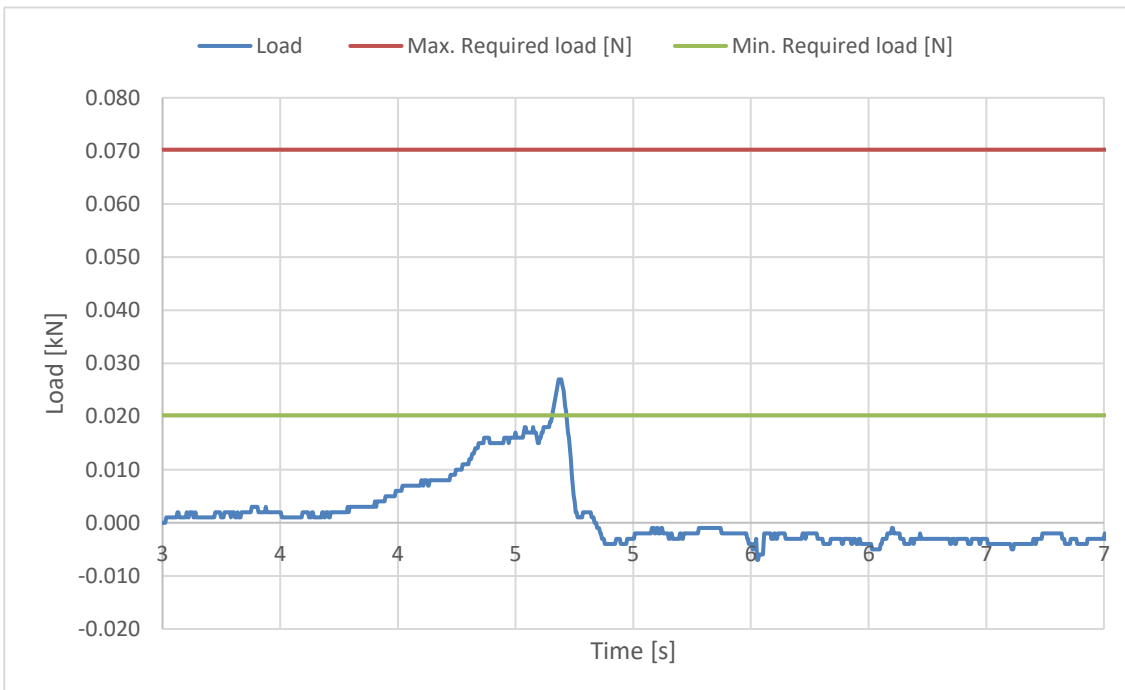
Test ID RRDT

Standard	LTF NfL II 91/09
Reference in standard	6.1.5
Test setup	Default flying position
Attachment points	Sensor connect to handle, and pull in opening direction
	The test is to simulate the load required to open the emergency parachute(1st action).
Min. Required load [N]	20
Max. Required load [N]	70
Result	
Load for first action [N]	26.77
Test results	POSITIVE

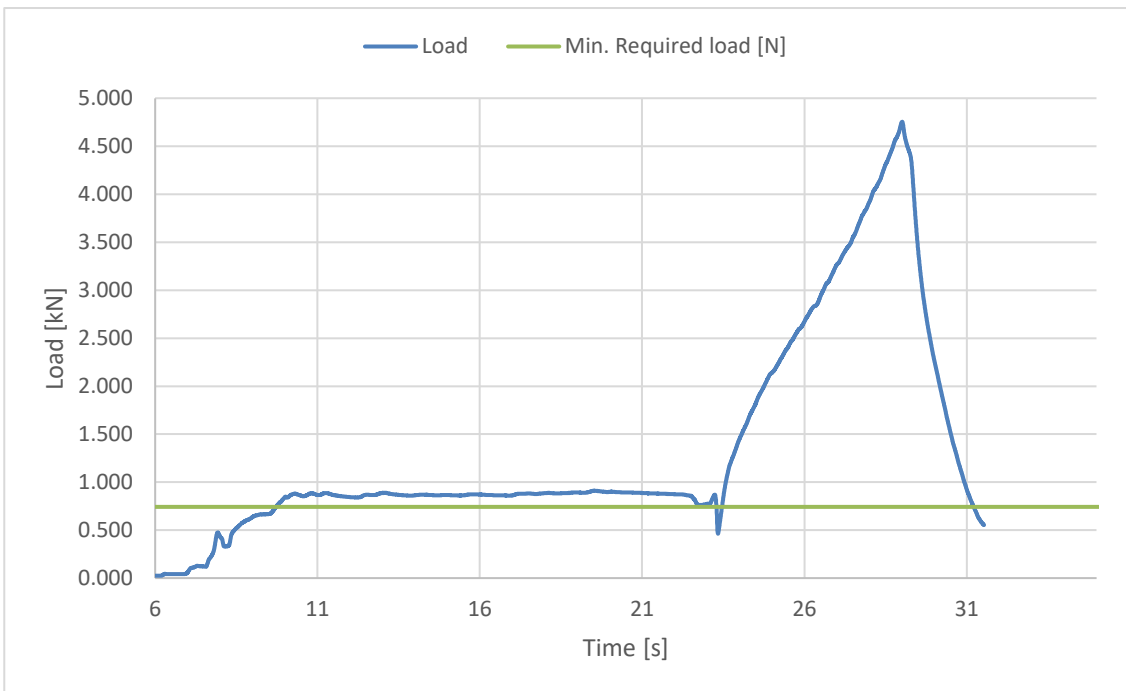
Test ID RRST

Standard	EN12491:2015
Reference in standard	5.3.2
Test setup	Two end points of handle
Attachment points	Sensor connect to end of handle, pull on the other side
	The handle must support min 700 N for 10 s, after measure breaking strength
Min. Required load [N]	700
Minimum test duration [s]	10
Result	
Test duration [s]:	13.5
Breaking strength [N]	4715.75
Test results	POSITIVE
