Harness Structural test Report - EN

Inspection certificate number: **PH_297.2020**

Name: **Access 2**
 Type: **ABS**
 Size: **M**
 Serial number: **2170MMO121ROAB2**
 Impact pad type: ⁽¹⁾ **Foam**
 Clip-in weight [kg]: **120**
 Date of test: **10.02.2020**

model: **Access 2**

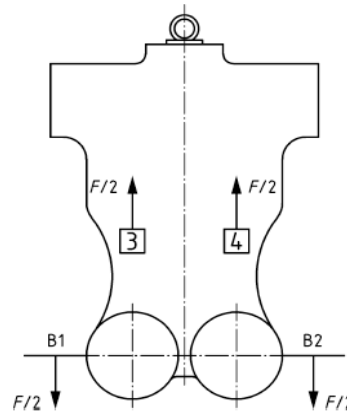
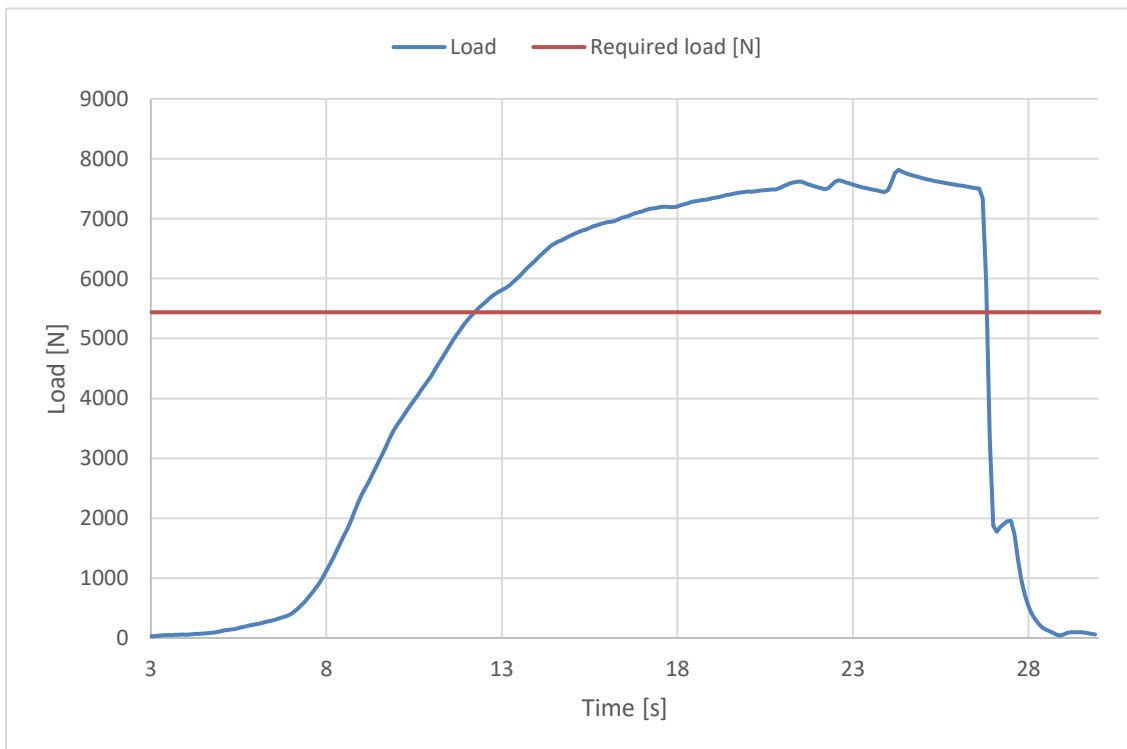
Test ID 01

Standard **EN 1651**
 Reference in standard **5.5.1.1**
 Test setup **Positive symmetric load (Slippage)**
 Attachment points **Both main riser attachment (3,4)**
 Anchor points **Dummy (B1, B2)**

Test duration [s] **14.6**
 Any signs of structural failure **No**
 Slippery test OK **No**
 Test results **POSITIVE**

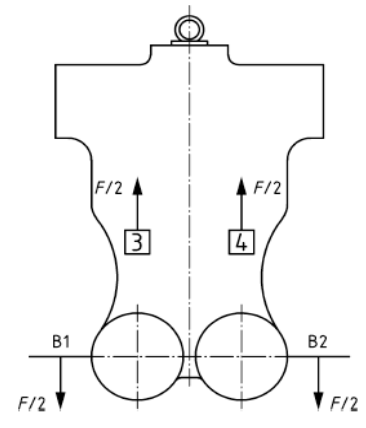
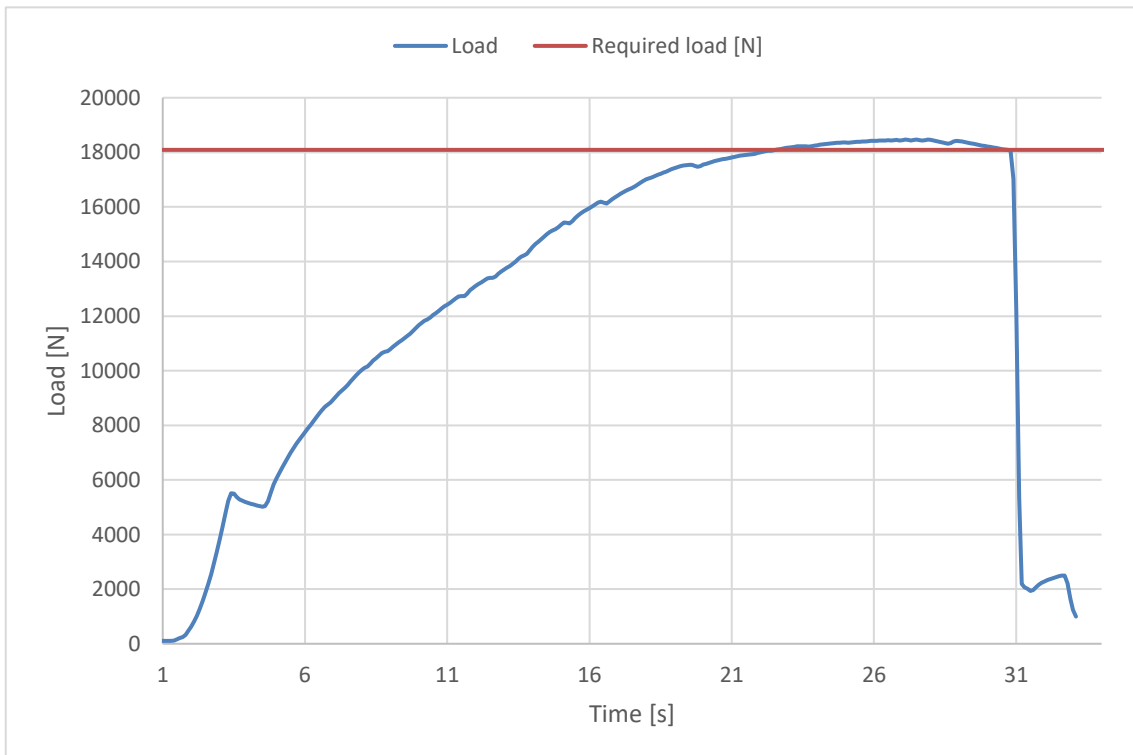
Test ID 03

Standard	EN 1651
Reference in standard	5.5.1.1b
Test setup	Positive symmetric load
Attachment points	Both main riser attachment (3,4)
Anchor points	Dummy (B1, B2)
Required load [g]	15
Required load [N]	18000
Minimum test duration [s]	5
Result	
Test duration [s]	8.1
Any signs of structural failure	No
Slippery test OK	No
Test results	POSITIVE

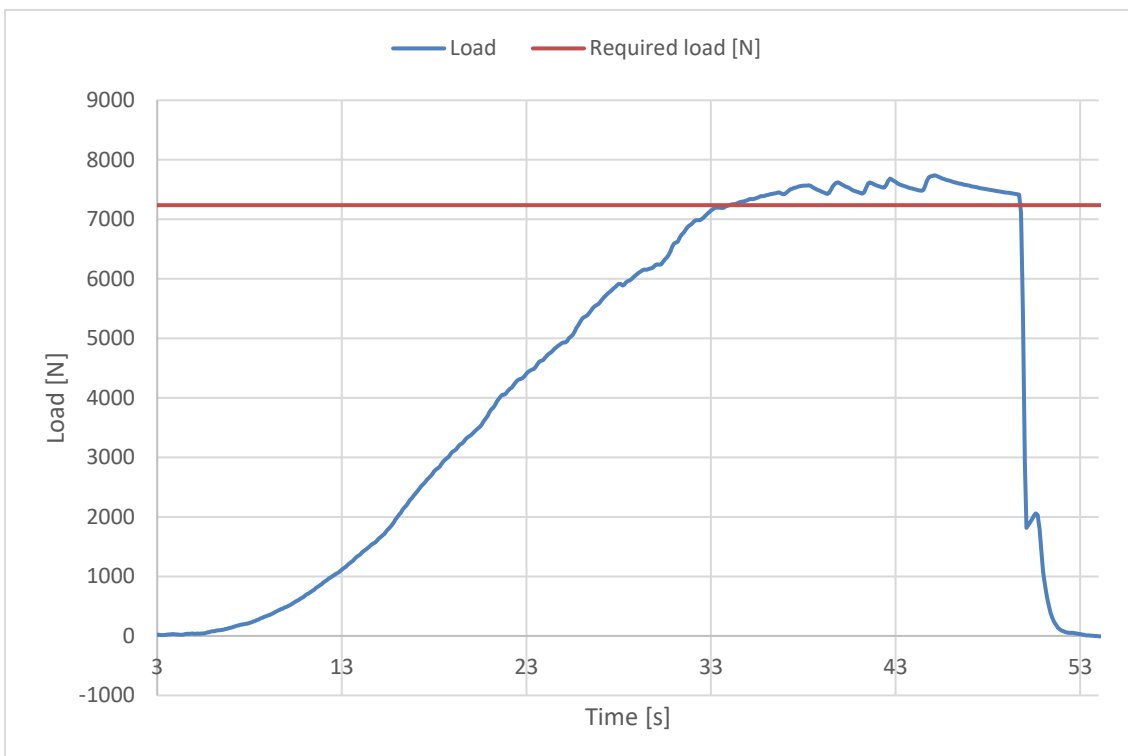
Test ID 05

Standard	EN 1651
Reference in standard	5.5.1.2
Test setup	Positive asymmetric load
Attachment points	One riser attachment (3 or 4)
Anchor points	Dummy (C)
Required load [g]	6
Required load [N]	7200
Minimum test duration [s]	5
Result	
Test duration [s]	15.8
Any signs of structural failure	No
Test results	POSITIVE

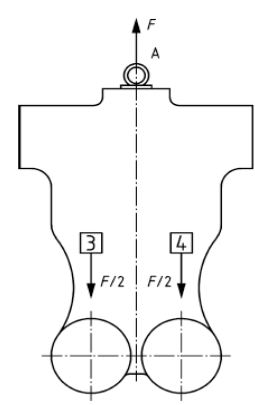
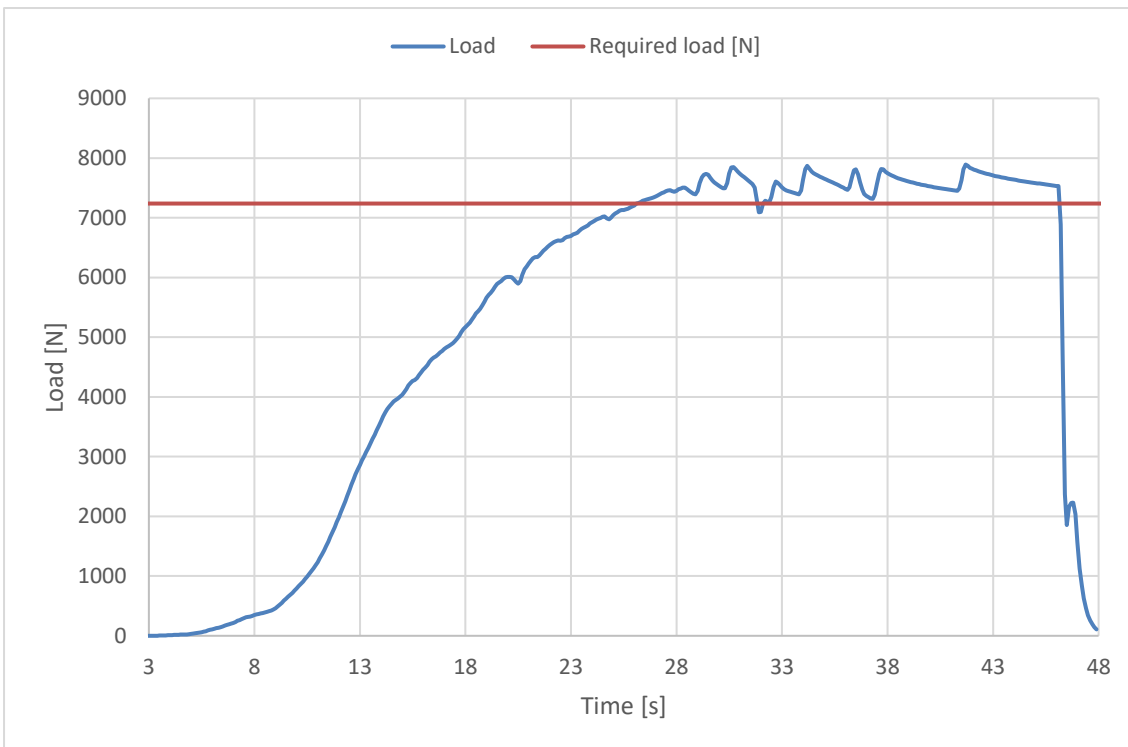
Test ID 06

Standard	EN 1651
Reference in standard	5.5.1.6
Test setup	Negative symmetric load
Attachment points	Both main riser attachment (3,4)
Anchor points	Dummy (A)
Required load [g]	6
Required load [N]	7200
Minimum test duration [s]	5
Result	
Test duration [s]	14
Any signs of structural failure	No
Test results	POSITIVE

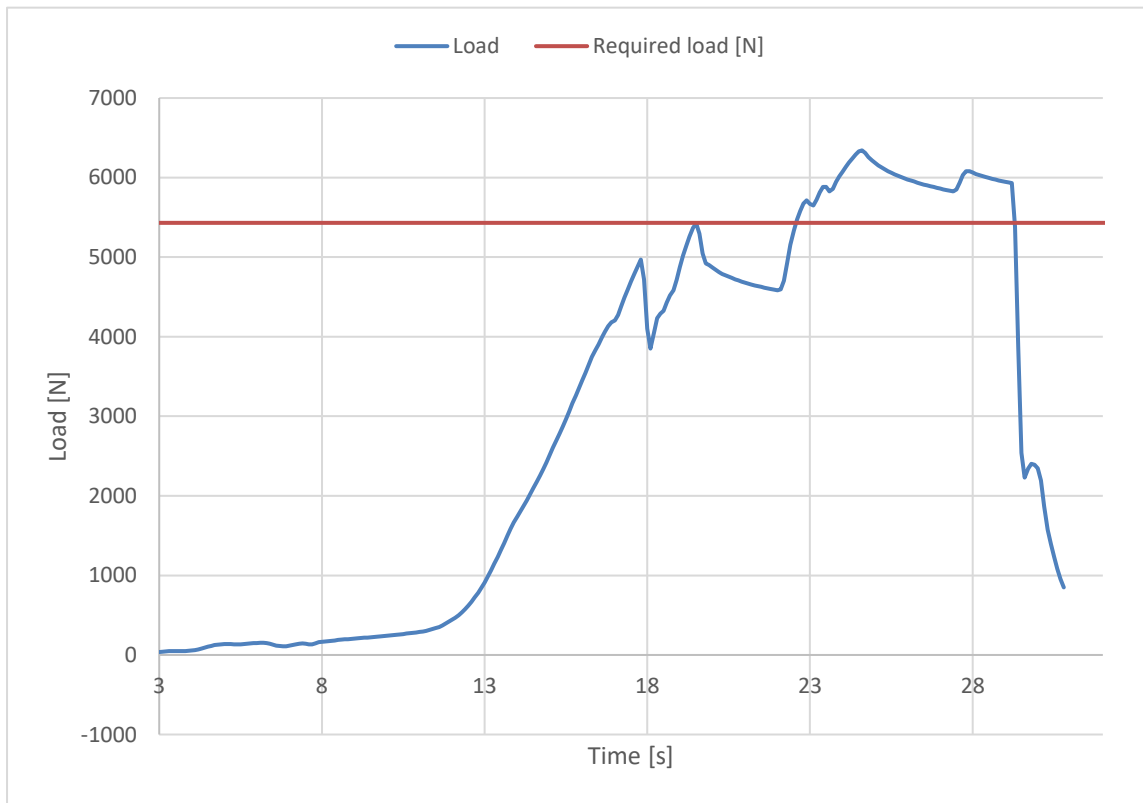
Test ID 08

Standard	EN 1651
Reference in standard	5.5.1.9
Test setup	Anti falling-out system
Attachment points	Around anti falling-out system
Anchor points	Both main riser attachment (no dummy)
Required load [g]	4.5
Required load [N]	5400
Minimum test duration [s]	5
Result	
Test duration [s]	6.7
Any signs of structural failure	No
Test results	POSITIVE

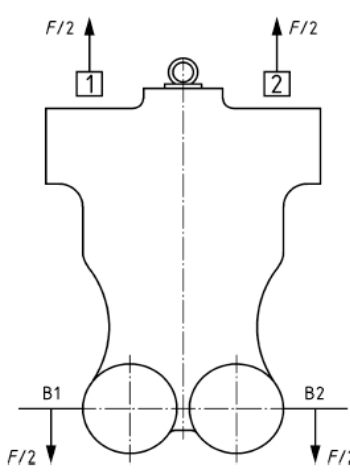
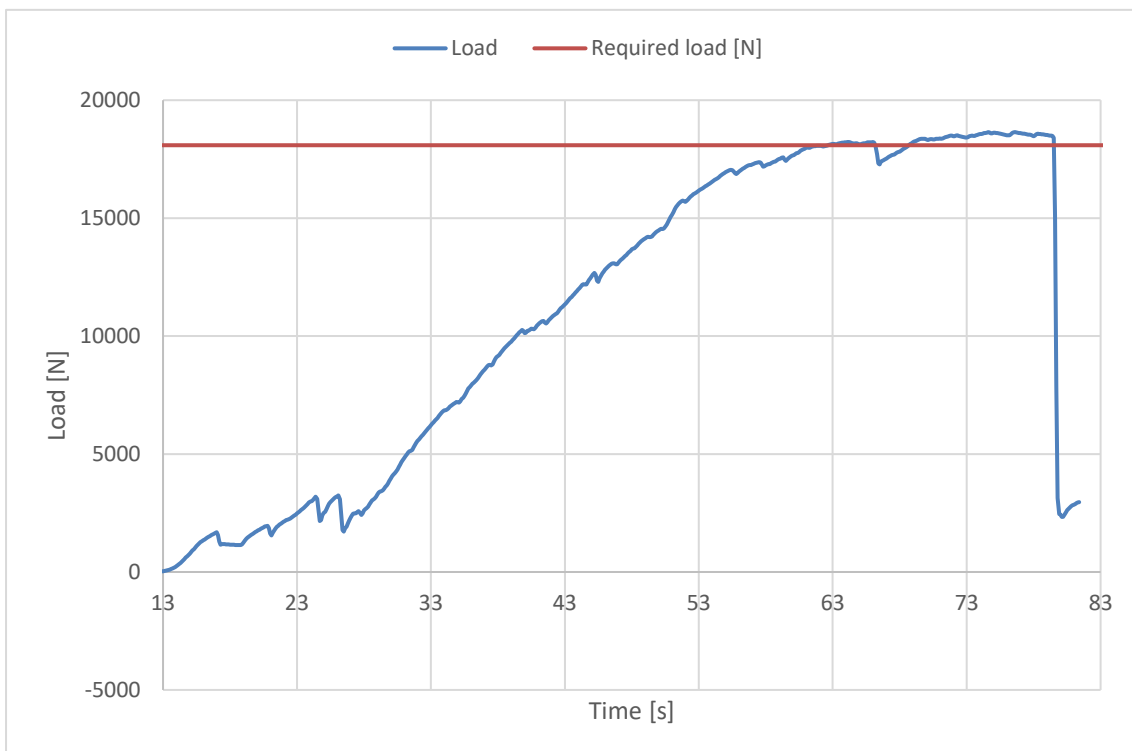
Test ID 09

Standard	EN 1651
Reference in standard	5.5.1.3
Test setup	Positive symmetric load rescue points
Attachment points	Both main riser attachment (1,2)
Anchor points	Dummy (B1,B2)
Required load [g]	15
Required load [N]	18000
Minimum test duration [s]	5
Result	
Test duration [s]	10.9
Any signs of structural failure	No
Slippery test OK	No
Test results	POSITIVE

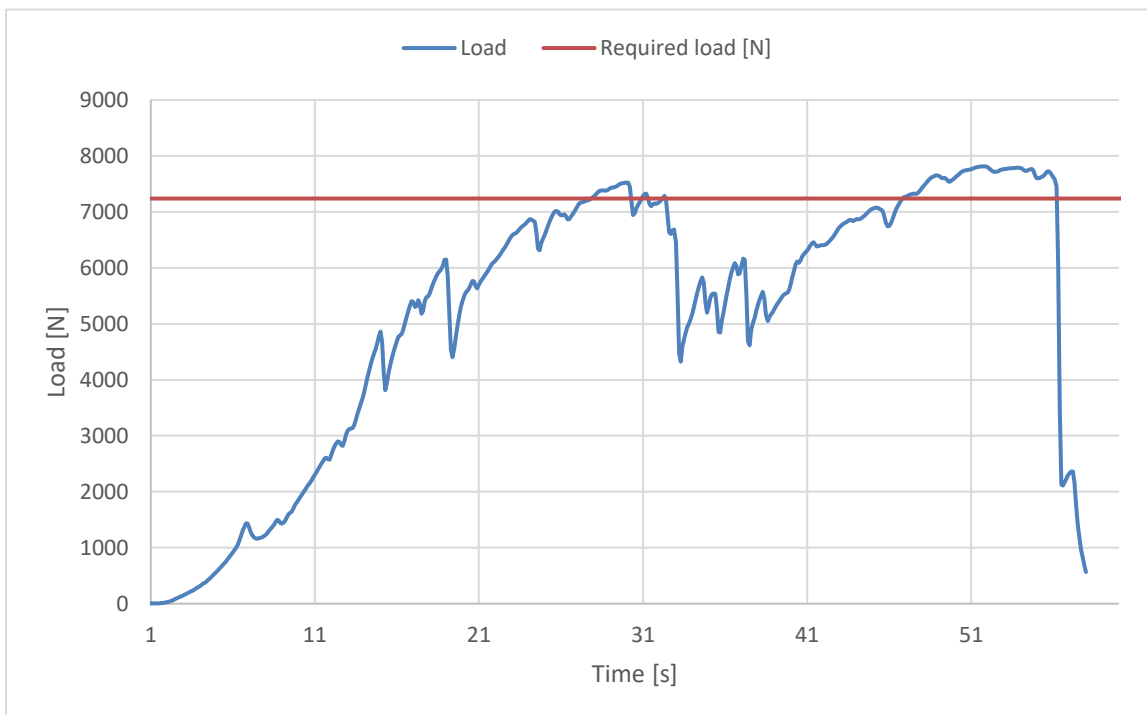
Test ID 12

Standard	EN 1651
Reference in standard	5.5.1.7
Test setup	Upright (landing) position load
Attachment points	Both main riser attachment (3, 4)
Anchor points	Both legstrap of harness (no dummy)
Required load [g]	6
Required load [N]	7200
Minimum test duration [s]	5
Harness type	type a
Result	
Test duration [s]	10.2
Any signs of structural failure	No
Slippery test OK	No
Test results	POSITIVE

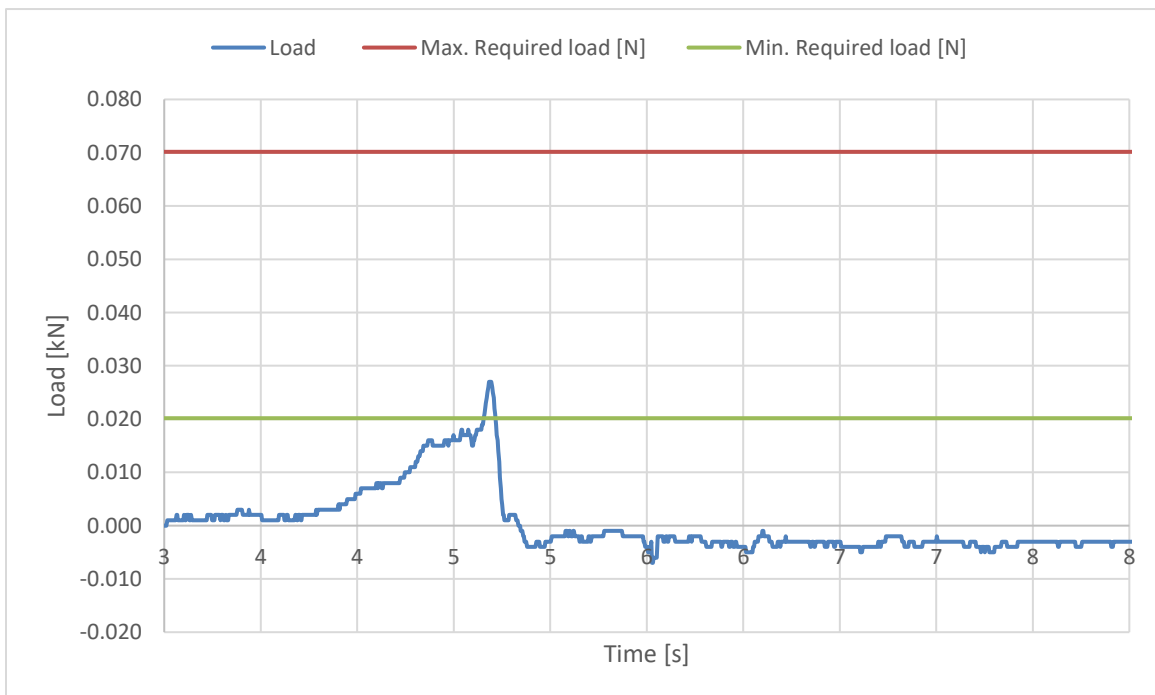
Test ID RRDT

Standard	LTF NfL II 91/09
Reference in standard	6.1.5
Test setup	Default flying position
Attachment points	Sensor connect to handle, and pull in opening direction
	The test is to simulate the load required to open the emergency parachute(1st action).
Min. Required load [N]	20
Max. Required load [N]	70
Result	
Load for first action [N]	26.84
Test results	POSITIVE

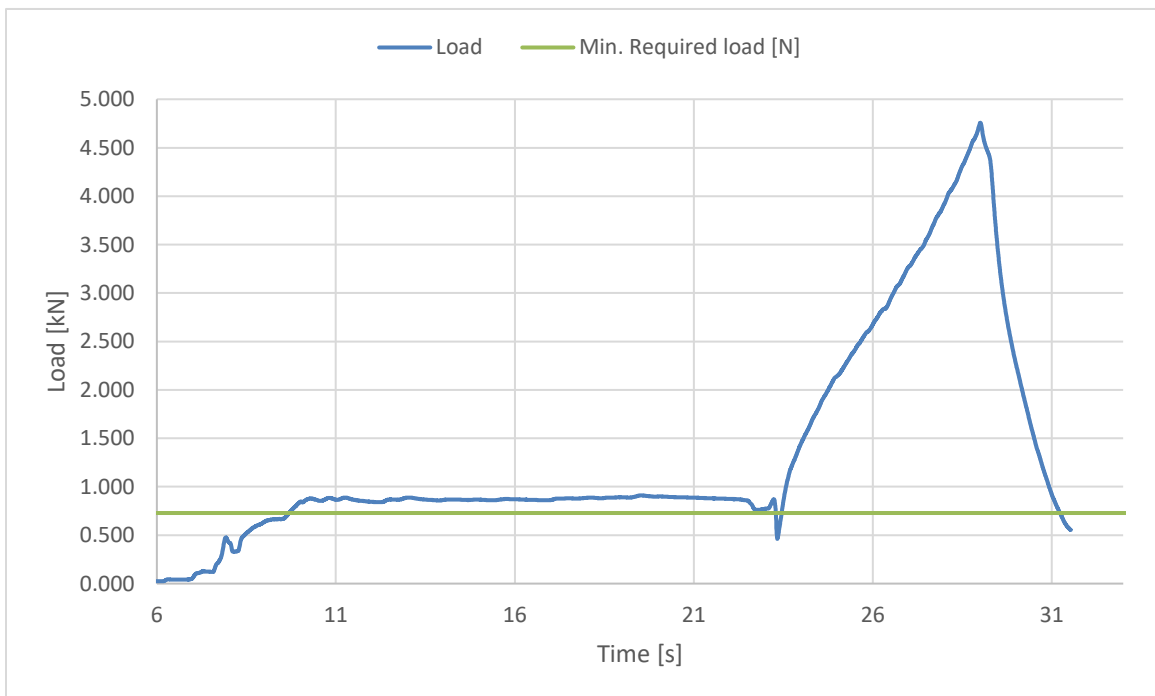
Test ID RRST

Standard	EN12491:2015
Reference in standard	5.3.2
Test setup	Two end points of handle
Attachment points	Sensor connect to end of handle, pull on the other side
	The handle must support min 700 N for 10 s, after measure breaking strength
Min. Required load [N]	700
Minimum test duration [s]	10
Result	
Test duration [s]:	13.6
Breaking strength [N]	4728.42
Test results	POSITIVE
