Harness Structural test Report - LTF

Inspection certificate number: **PH_301.2020**

Name: **Kitto**
 Type: **ABS**
 Size: **M**
 Serial number: **17479**
 Impact pad type: ⁽¹⁾ **Foam**
 Clip-in weight [kg]: **120**

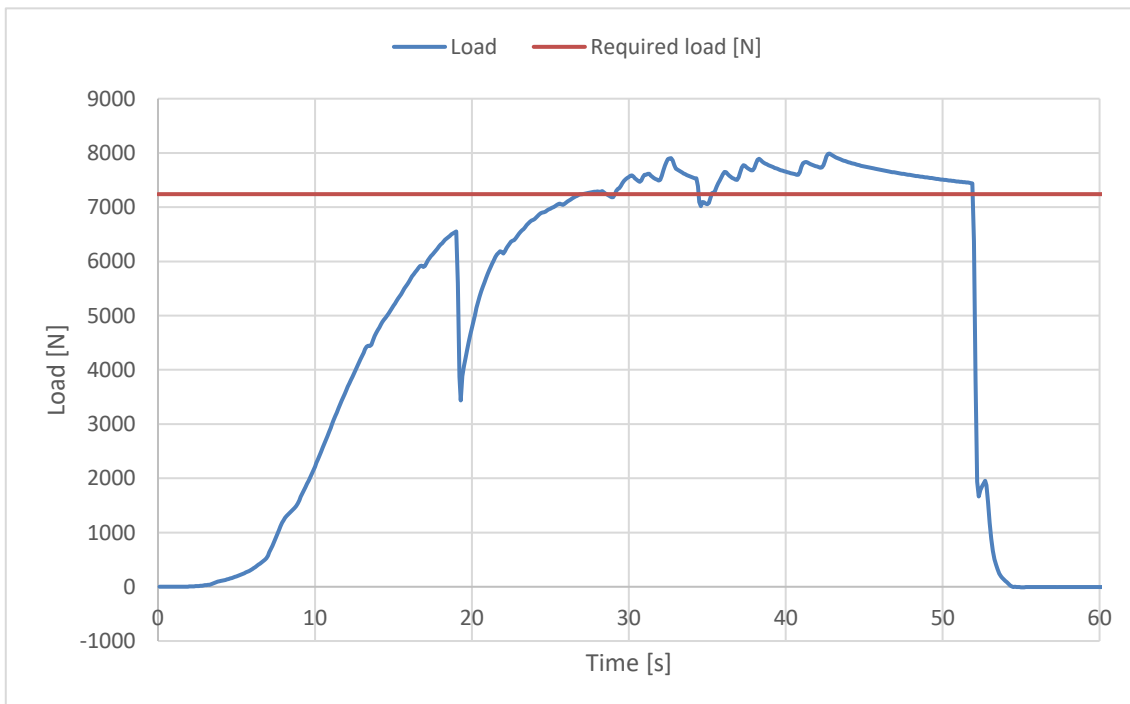
Test ID 02

Standard	LTF NfL II 91/09
Reference	5.3.2.1
Test setup	Default flying position
Attachment points	Both main riser attachment (3,4)
Anchor points	Dummy (B1, B2)
Required load [g]	6
Required load [N]	7200
Minimum test duration [s]	10
Result	
Test duration [s]	16.7
Any signs of structural failure	No
Test results	POSITIVE

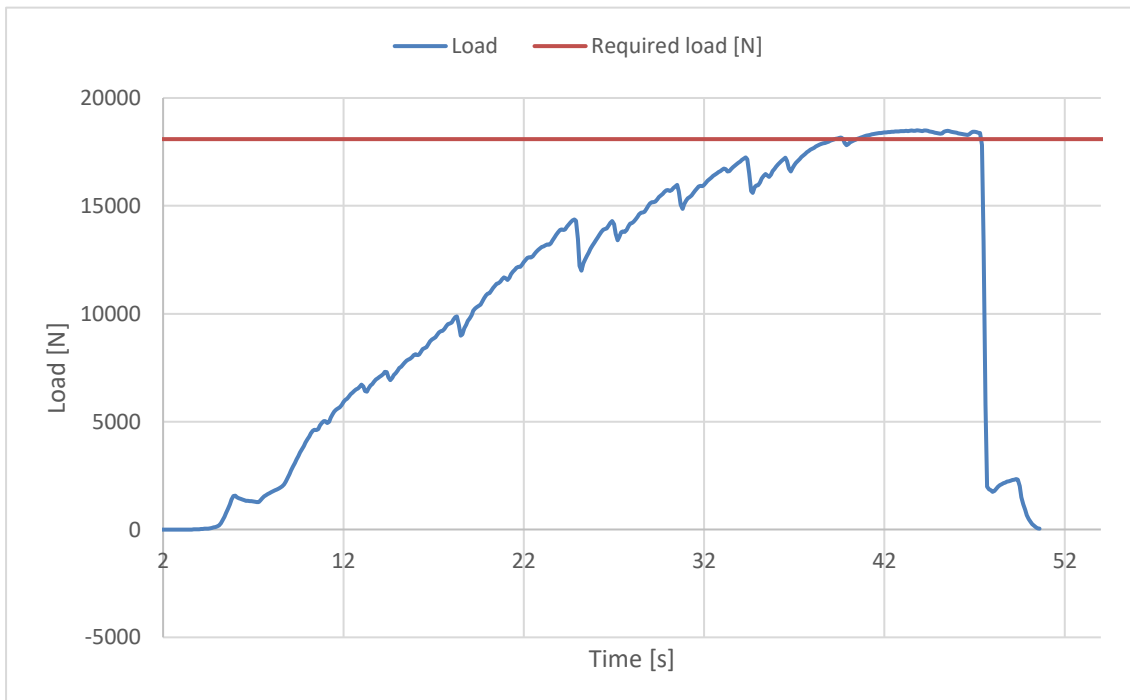
Test ID 03

Test duration [s] **6.9**
 Any signs of structural failure **No**
 Test results **POSITIVE**

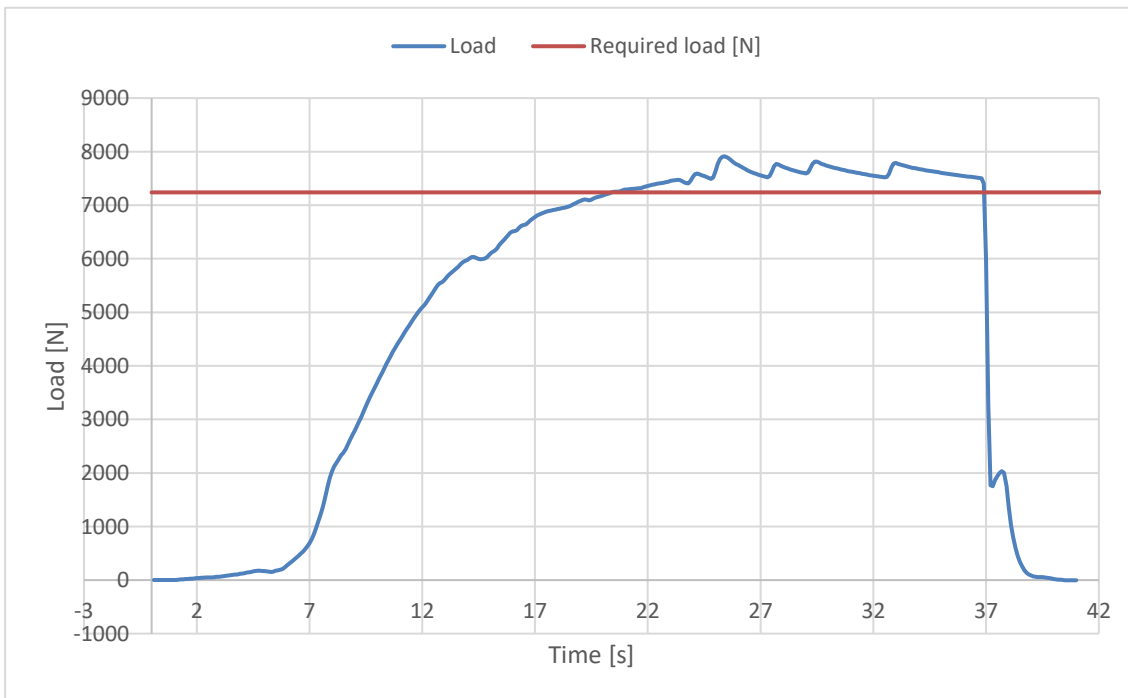
Test ID 04

Standard	LTF NfL II 91/09
Reference	5.3.2.3
Test setup	Asymmetric, one riser
Attachment points	One main riser attachment (3)
Anchor points	Dummy (B1,B2)
Required load [g]	6
Required load [N]	7200
Minimum test duration [s]	10
Result	
Test duration [s]	16.5
Any signs of structural failure	No
Test results	POSITIVE

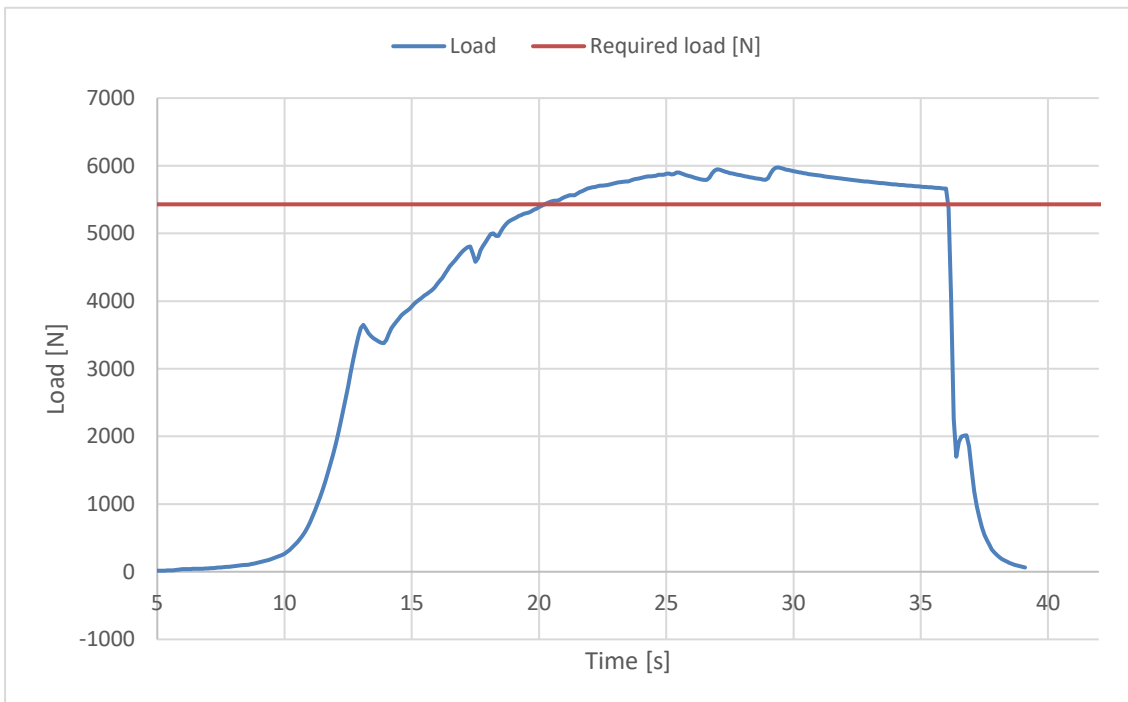
Test ID 07

Standard	LTF NfL II 91/09
Reference	5.3.2.6
Test setup	Asymmetric, negative
Attachment points	One main riser attachment (3 or 4) downwards
Anchor points	Dummy (9)
Required load [g]	4.5
Required load [N]	5400
Minimum test duration [s]	10
Result	
Test duration [s]	15.8
Any signs of structural failure	No
Test results	POSITIVE

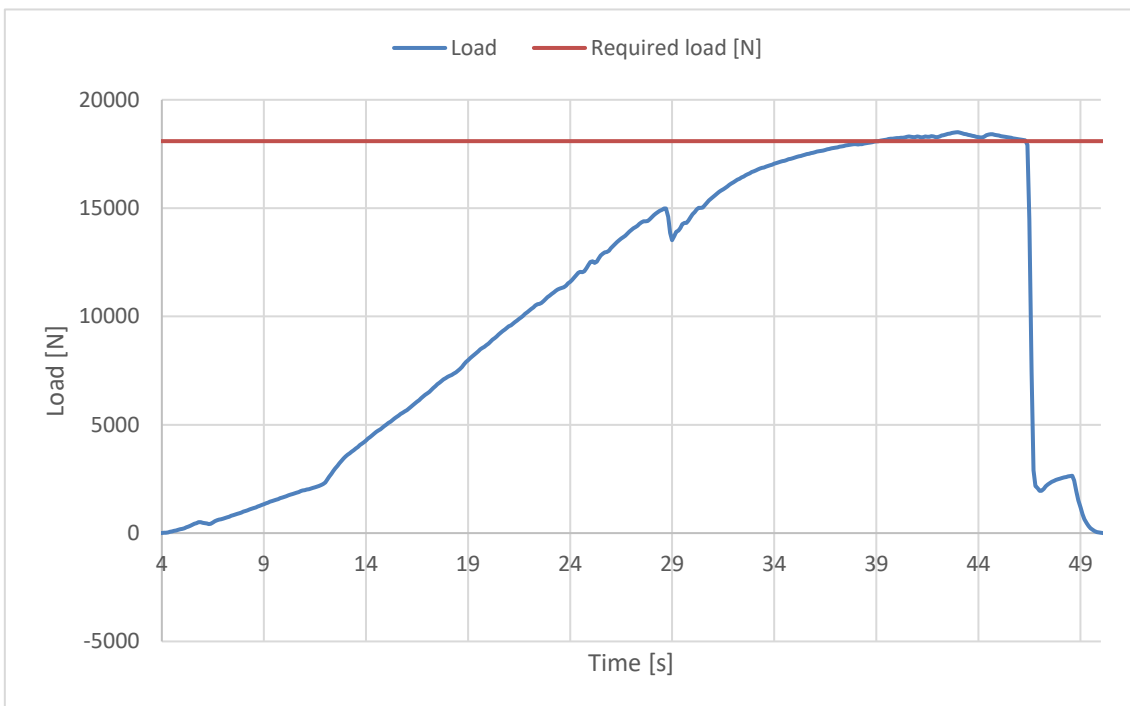
Test ID 09

Test duration [s] **7.3**
 Any signs of structural failure **No**
 Test results **POSITIVE**

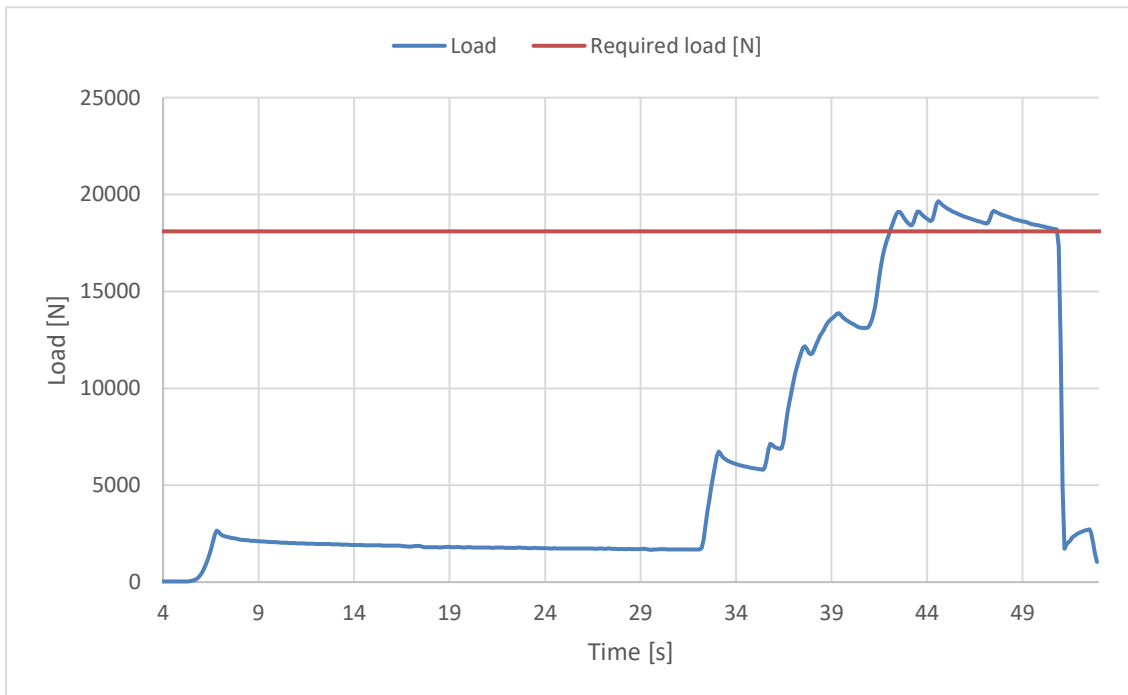
Test ID 13

Standard	LTF NfL II 91/09
Reference	5.3.2.7
Test setup	Flying position before landing
Attachment points	Both main riser attachment (3,4)
Anchor points	Dummy (7,8)
Required load [g]	15
Required load [N]	18000
Minimum test duration [s]	5
Result	
Test duration [s]	8.8
Any signs of structural failure	No
Test results	POSITIVE

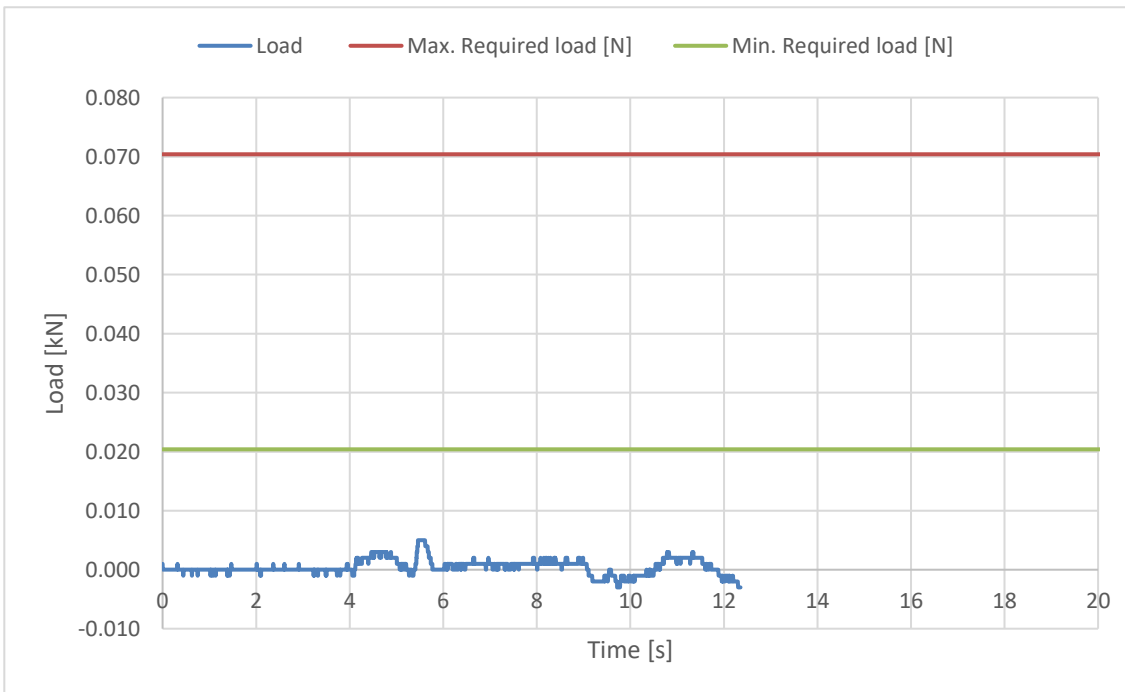
Test ID RRDT

Standard	LTF NfL II 91/09
Reference	6.1.5
Test setup	Default flying position
Attachment points	Sensor connect to handle, and pull in opening direction
	The test is to simulate the load required to open the emergency parachute(1st action).
Min. Required load [N]	20
Max. Required load [N]	70
Result	
Load for first action [N]	45.60
Test results	POSITIVE

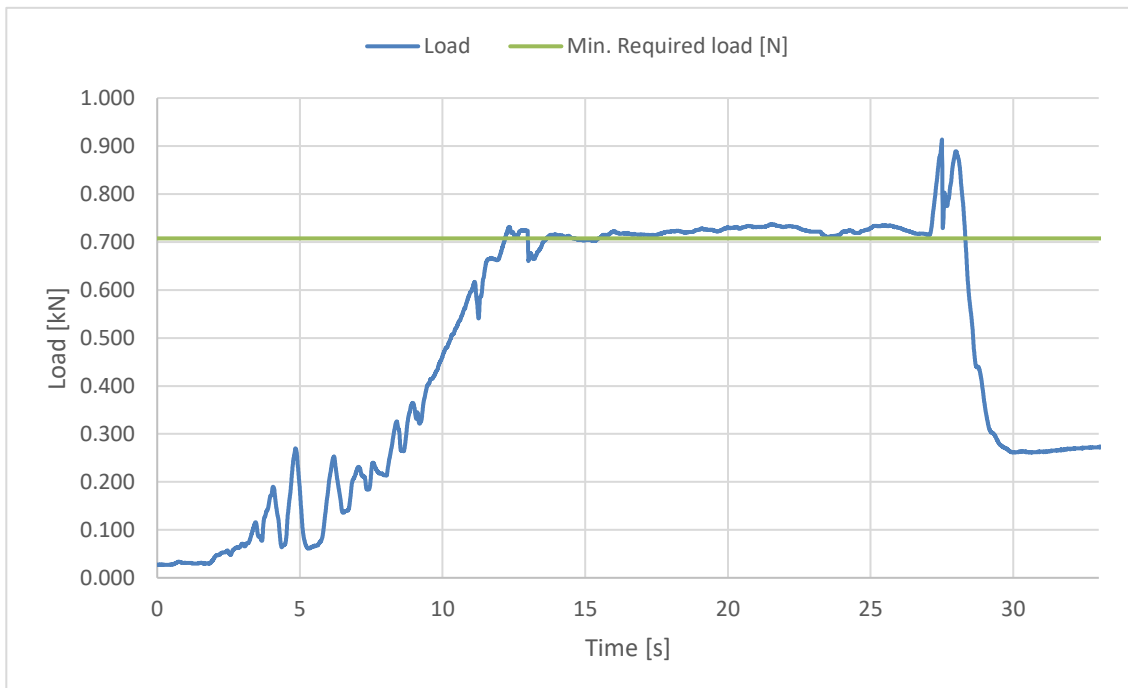
Test ID RRST

Standard	EN12491:2015
Reference in standard	5.3.2
Test setup	Two end points of handle
Attachment points	Sensor connect to end of handle, pull on the other side
	The handle must support min 700 N for 10 s, after measure breaking strength
Min. Required load [N]	700
Minimum test duration [s]	10
Result	
Test duration [s]:	12.8
Breaking strength [N]	906.07
Test results	POSITIVE
