Harness Structural test Report - LTF

Inspection certificate number: **PH_303.2020**

Name: **SLT LOW-MK II**
 Type: **ABS**
 Size: **M**
 Serial number: **17569**
 Impact pad type: ⁽¹⁾ **Airbag**
 Clip-in weight [kg]: **120**

Summary of Structural test

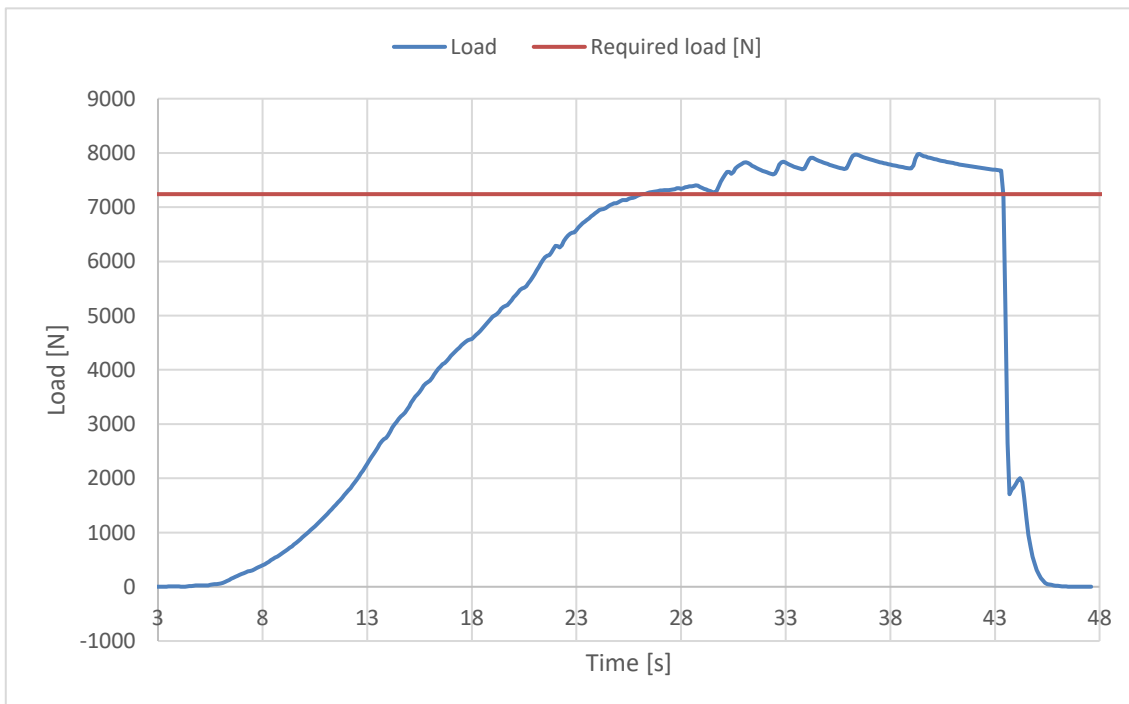
Test ID 02

Standard	LTF NfL II 91/09
Reference	5.3.2.1
Test setup	Default flying position
Attachment points	Both main riser attachment (3,4)
Anchor points	Dummy (B1, B2)
Required load [g]	6
Required load [N]	7200
Minimum test duration [s]	10
Result	
Test duration [s]	17.2
Any signs of structural failure	No
Test results	POSITIVE

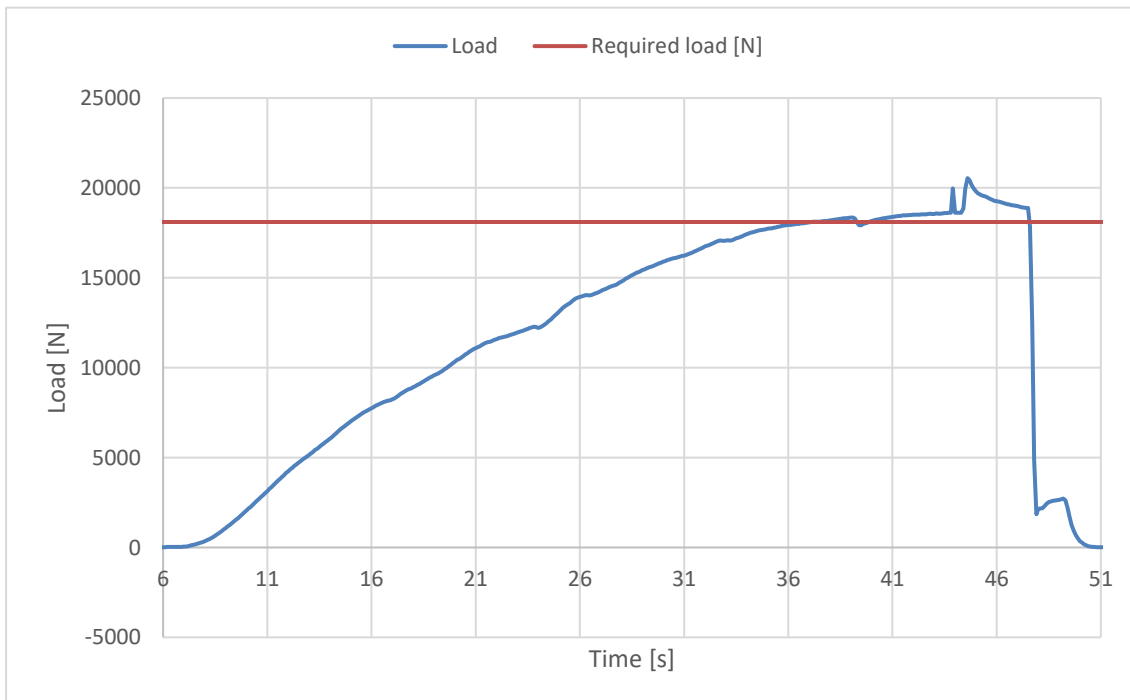
Test ID 03

Standard	LTF NfL II 91/09
Reference	5.3.2.2
Test setup	Default flying position
Attachment points	Both main riser attachment (3,4)
Anchor points	Dummy (B1, B2)
Required load [g]	15
Required load [N]	18000
Minimum test duration [s]	5
Result	
Test duration [s]	7.7
Any signs of structural failure	No
Test results	POSITIVE

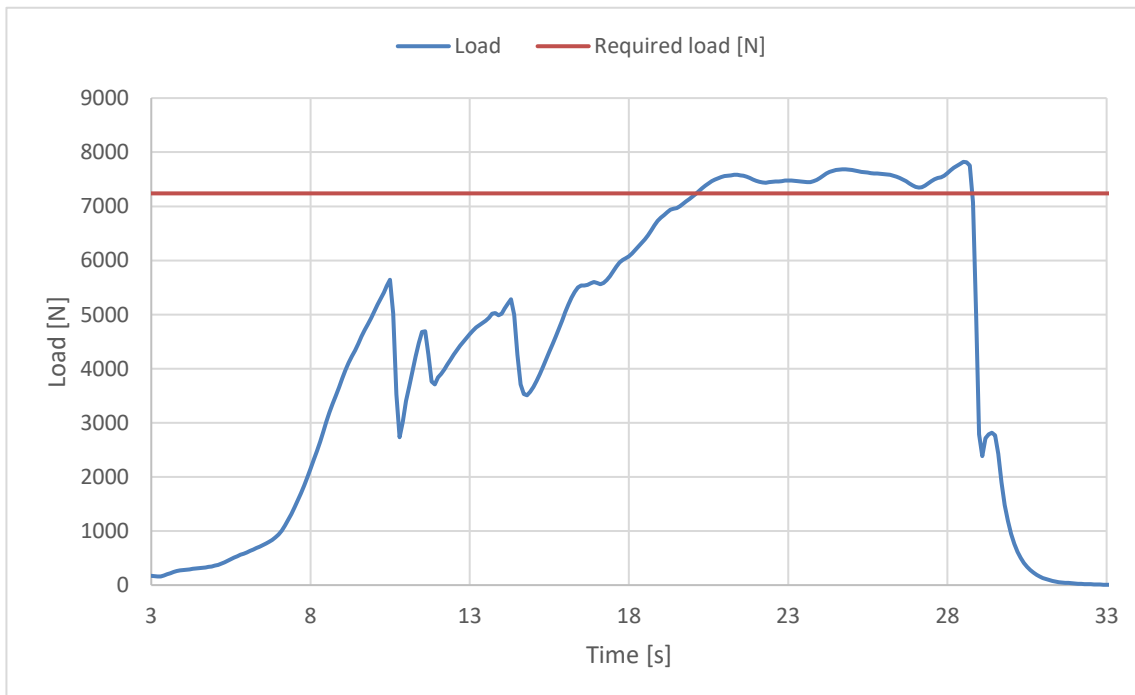
Test ID 04

Standard	LTF NfL II 91/09
Reference	5.3.2.3
Test setup	Asymmetric, one riser
Attachment points	One main riser attachment (3)
Anchor points	Dummy (B1,B2)
Required load [g]	6
Required load [N]	7200
Minimum test duration [s]	10
Result	
Test duration [s]	8.6
Any signs of structural failure	No
Test results	POSITIVE

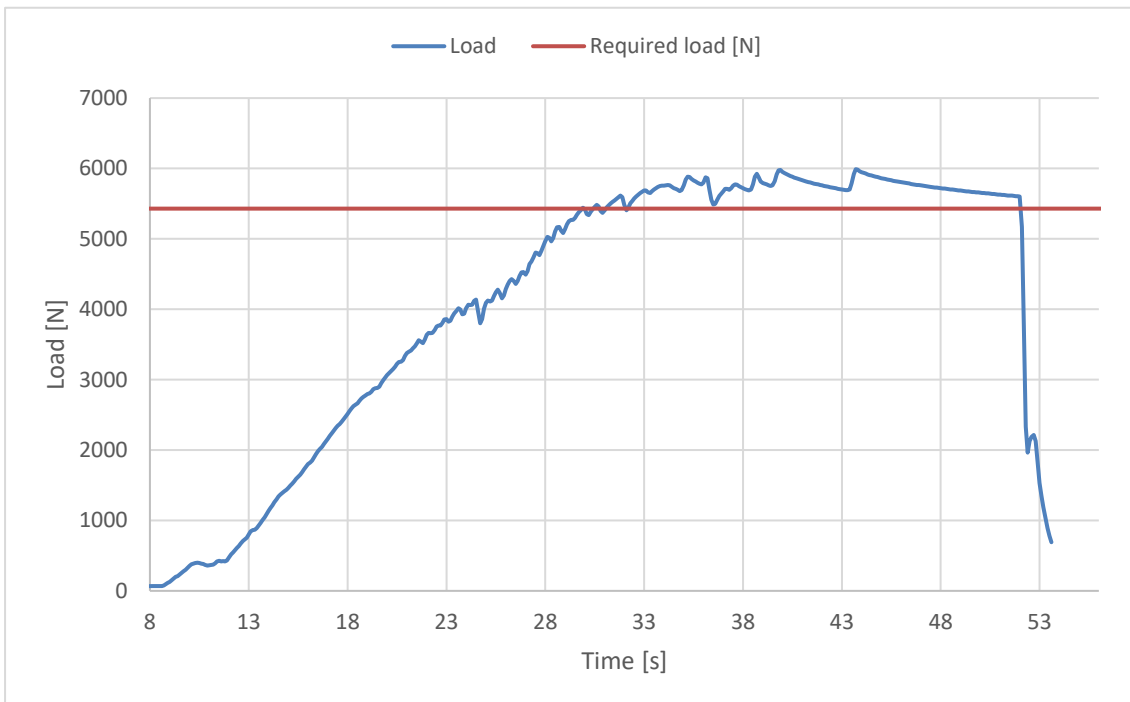
Test ID 07

Reference	5.3.2.6	
Test setup	Asymmetric, negative	
Attachment points	One main riser attachment (3 or 4) downwards	
Anchor points	Dummy (9)	
Required load [g]	4.5	
Required load [N]	5400	
Minimum test duration [s]	10	
Result		
Test duration [s]	19.9	
Any signs of structural failure	No	
Test results	POSITIVE

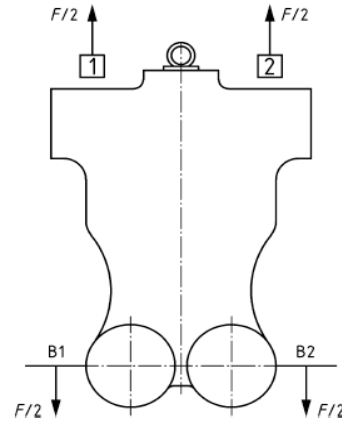
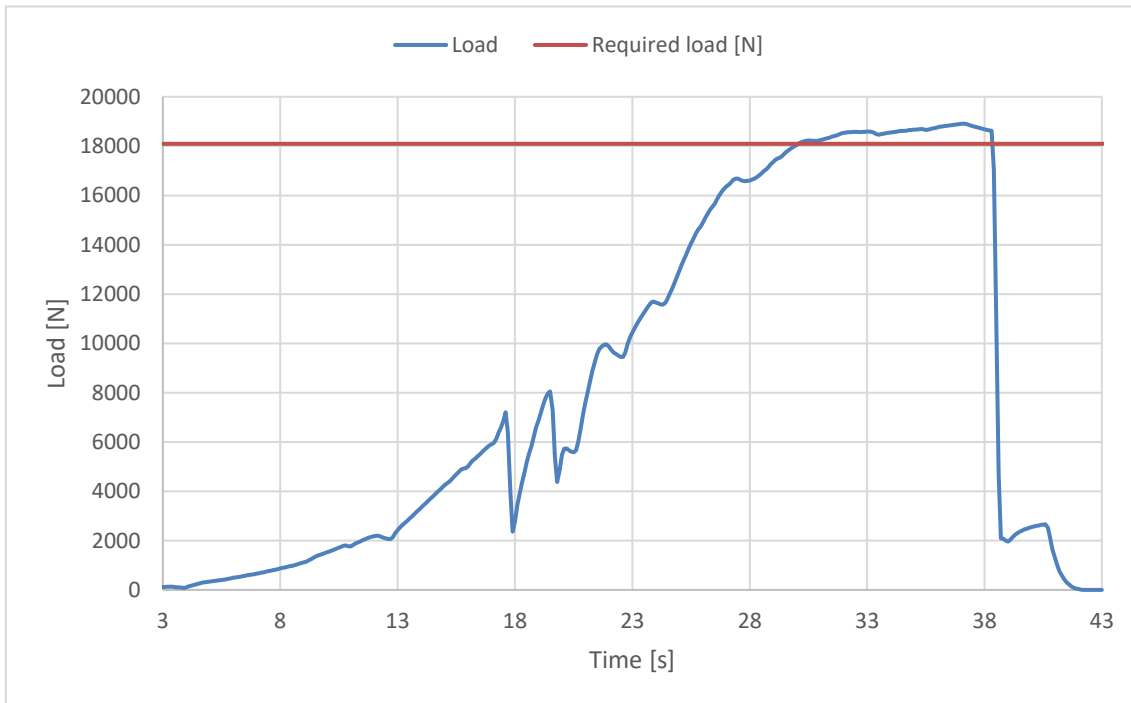
Test ID 09

Standard **LTF NfL II 91/09**
 Reference **5.3.2.4**
 Test setup **Rescue attachments**
 Attachment points **Rescue riser attachment (1,2)**
 Anchor points **Dummy (B1,B2)**

Test duration [s] **8.3**
 Any signs of structural failure **No**
 Test results **POSITIVE**

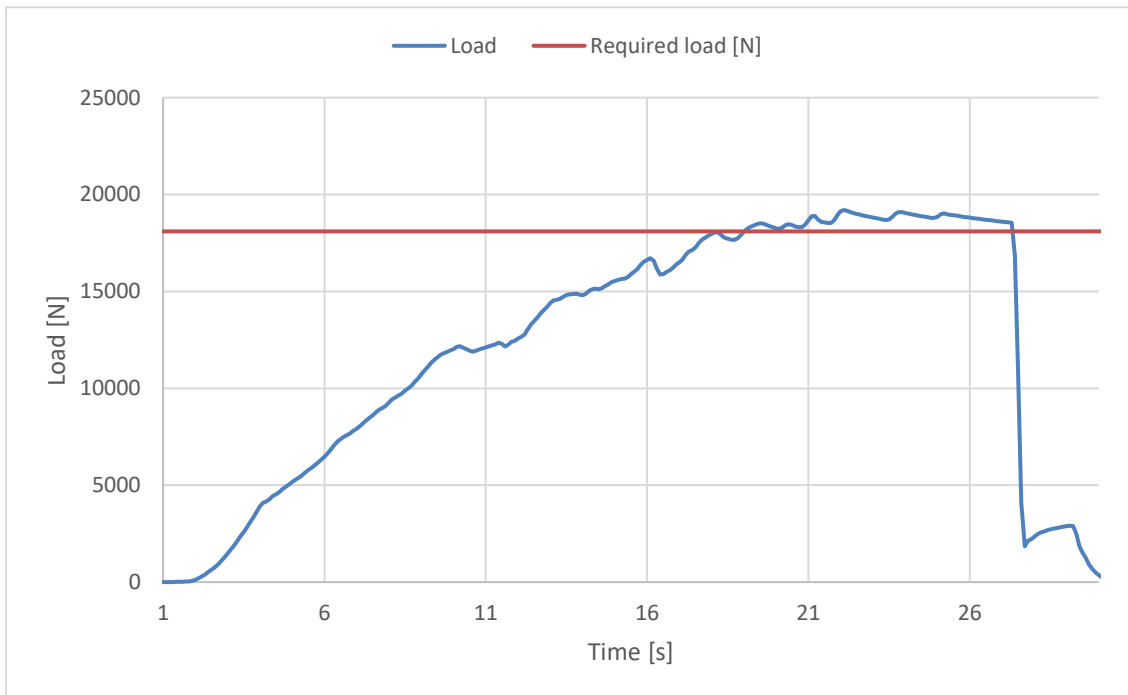
Test ID 13

Standard	LTF NfL II 91/09
Reference	5.3.2.7
Test setup	Flying position before landing
Attachment points	Both main riser attachment (3,4)
Anchor points	Dummy (7,8)
Required load [g]	15
Required load [N]	18000
Minimum test duration [s]	5
Result	
Test duration [s]	8.3
Any signs of structural failure	No
Test results	POSITIVE

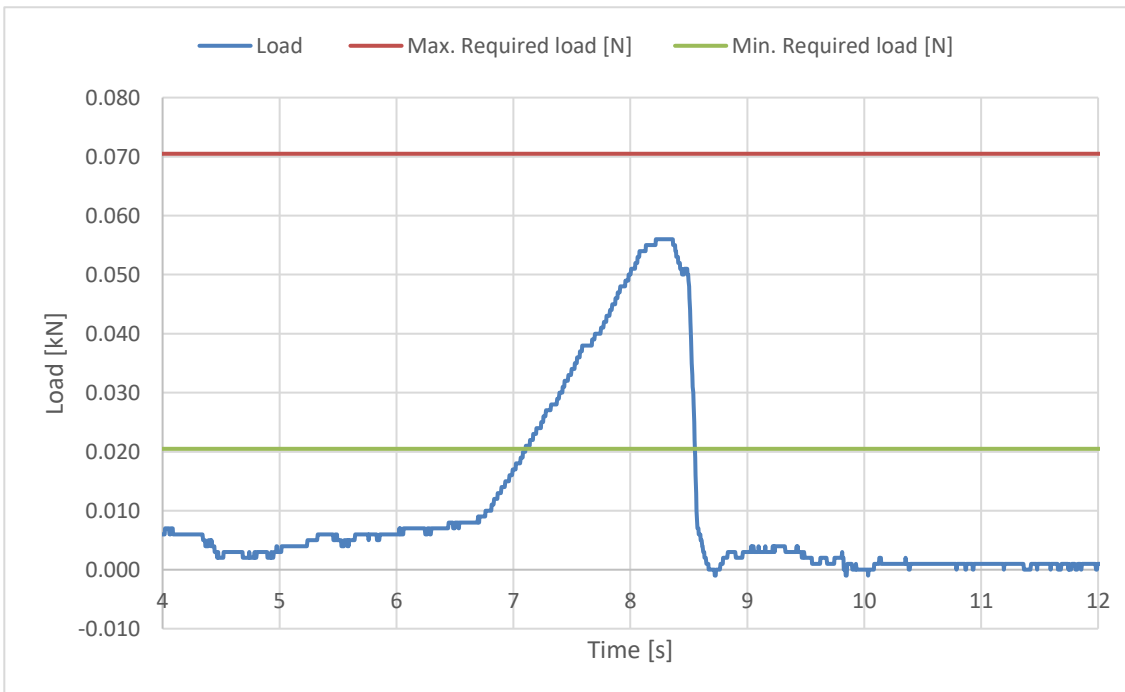
Test ID RRDT

Standard	LTF NfL II 91/09
Reference	6.1.5
Test setup	Default flying position
Attachment points	Sensor connect to handle, and pull in opening direction
	The test is to simulate the load required to open the emergency parachute(1st action).
Min. Required load [N]	20
Max. Required load [N]	70
Result	
Load for first action [N]	55.51
Test results	POSITIVE

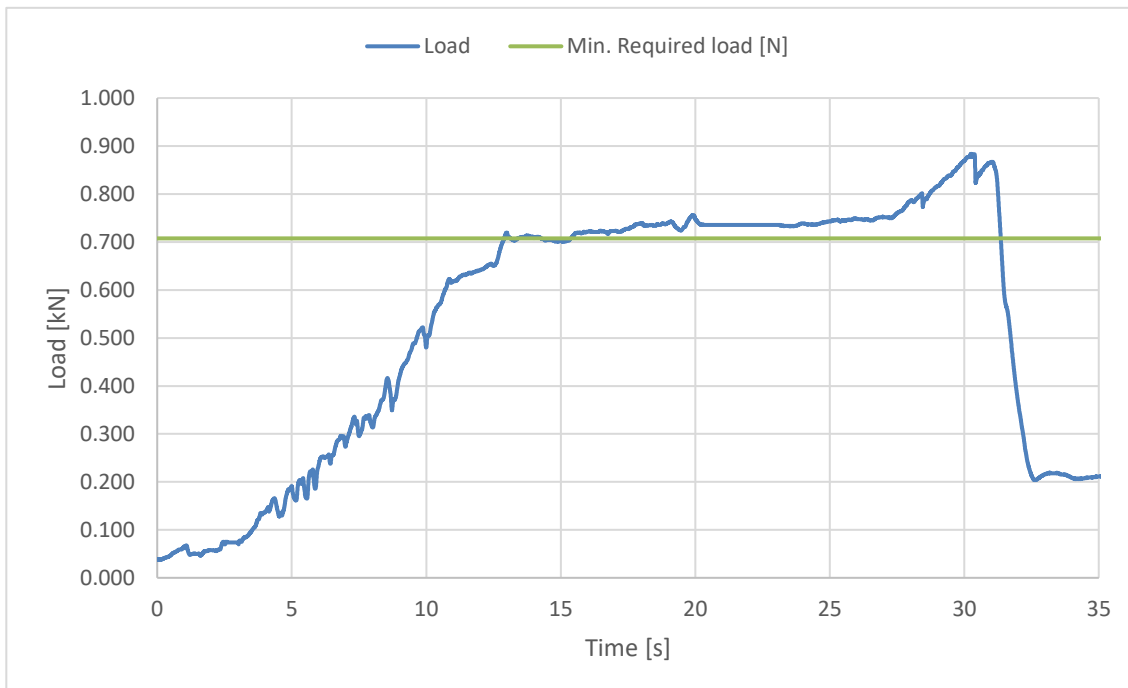
Test ID RRST

Standard	EN12491:2015
Reference in standard	5.3.2
Test setup	Two end points of handle
Attachment points	Sensor connect to end of handle, pull on the other side
	The handle must support min 700 N for 10 s, after measure breaking strength
Min. Required load [N]	700
Minimum test duration [s]	10
Result	
Test duration [s]:	16.0
Breaking strength [N]	876.33
Test results	POSITIVE
