## Harness Structural test Report - LTF

Inspection certificate number: **PH\_295.2020**

Name: **F\*Race**  
 Type: **ABS**  
 Size: **M**  
 Serial number: **001**  
 Impact pad type: <sup>(1)</sup> **Inflatable**  
 Clip-in weight [kg]: **100**

Date of test: **23.01.2020**

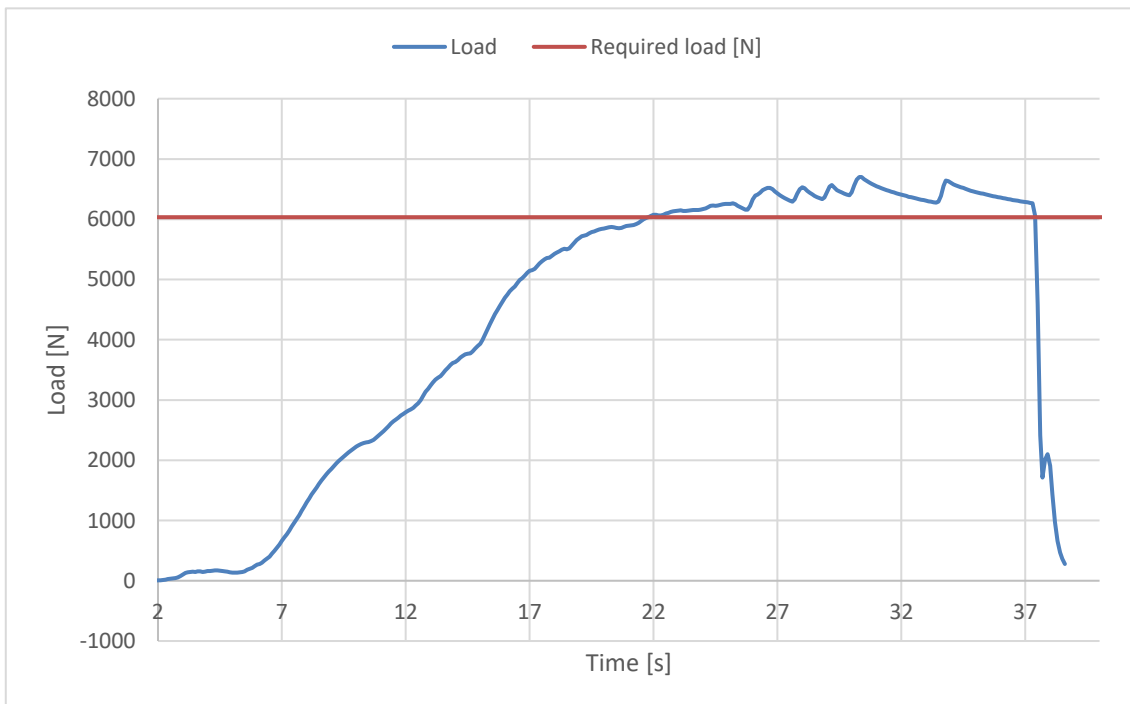
**Test ID 02**

Standard	<b>LTF NfL II 91/09</b>
Reference	<b>5.3.2.1</b>
Test setup	<b>Default flying position</b>
Attachment points	<b>Both main riser attachment (3,4)</b>
Anchor points	<b>Dummy (B1, B2)</b>
Required load [g]	<b>6</b>
Required load [N]	<b>6000</b>
Minimum test duration [s]	<b>10</b>
<b>Result</b>	
Test duration [s]	<b>15.7</b>
Any signs of structural failure	<b>No</b>
Test results	<b>POSITIVE</b>

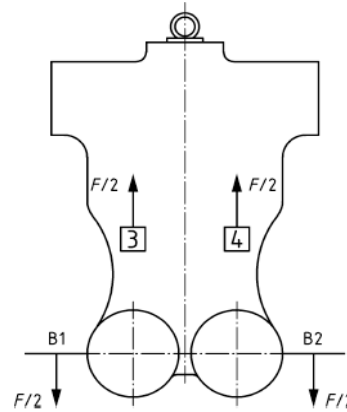
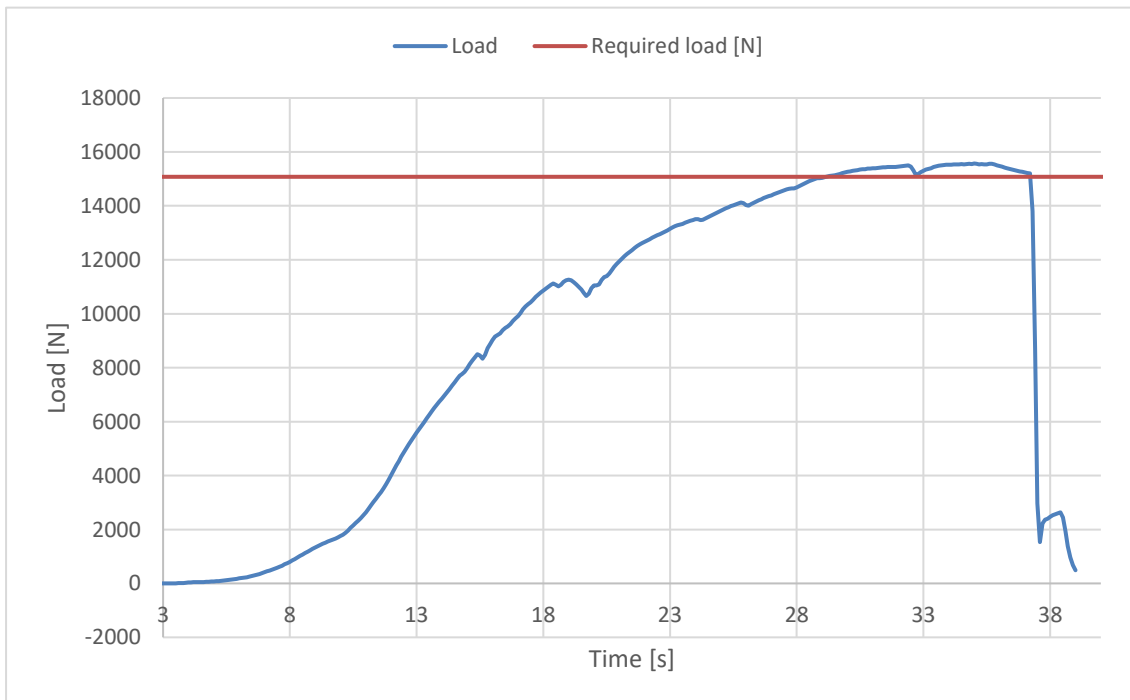
**Test ID 03**

Test duration [s] **8.1**  
 Any signs of structural failure **No**  
 Test results **POSITIVE**

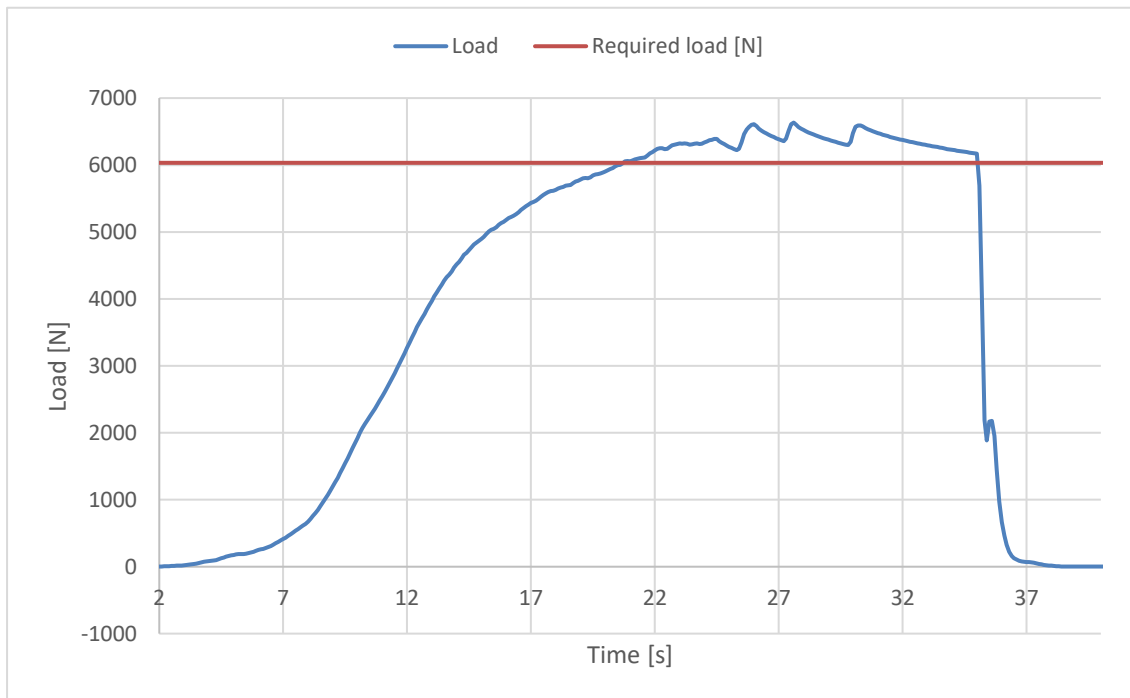
**Test ID 04**

Test duration [s] **14.3**  
 Any signs of structural failure **No**  
 Test results **POSITIVE**

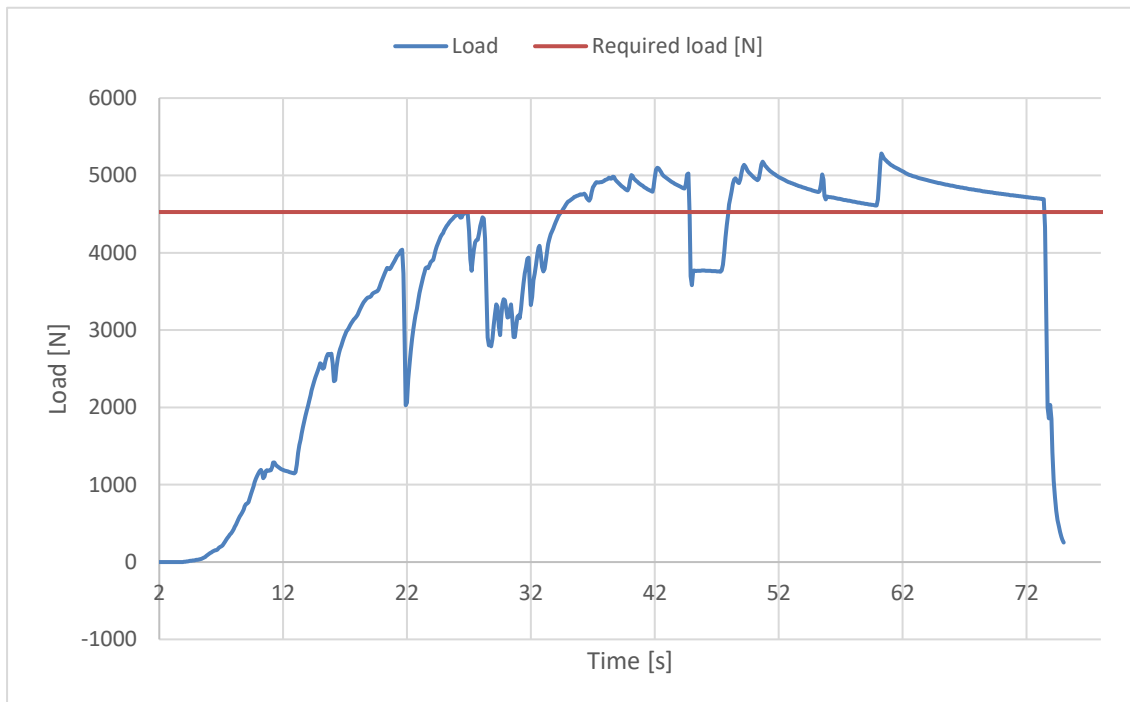
**Test ID 07**

Reference	<b>5.3.2.6</b>	
Test setup	<b>Asymmetric, negative</b>	
Attachment points	<b>One main riser attachment (3 or 4) downwards</b>	
Anchor points	<b>Dummy (9)</b>	
Required load [g]	<b>4.5</b>	
Required load [N]	<b>4500</b>	
Minimum test duration [s]	<b>10</b>	
<b>Result</b>		
Test duration [s]	<b>25.5</b>	
Any signs of structural failure	<b>No</b>	
Test results	<b>POSITIVE</b>

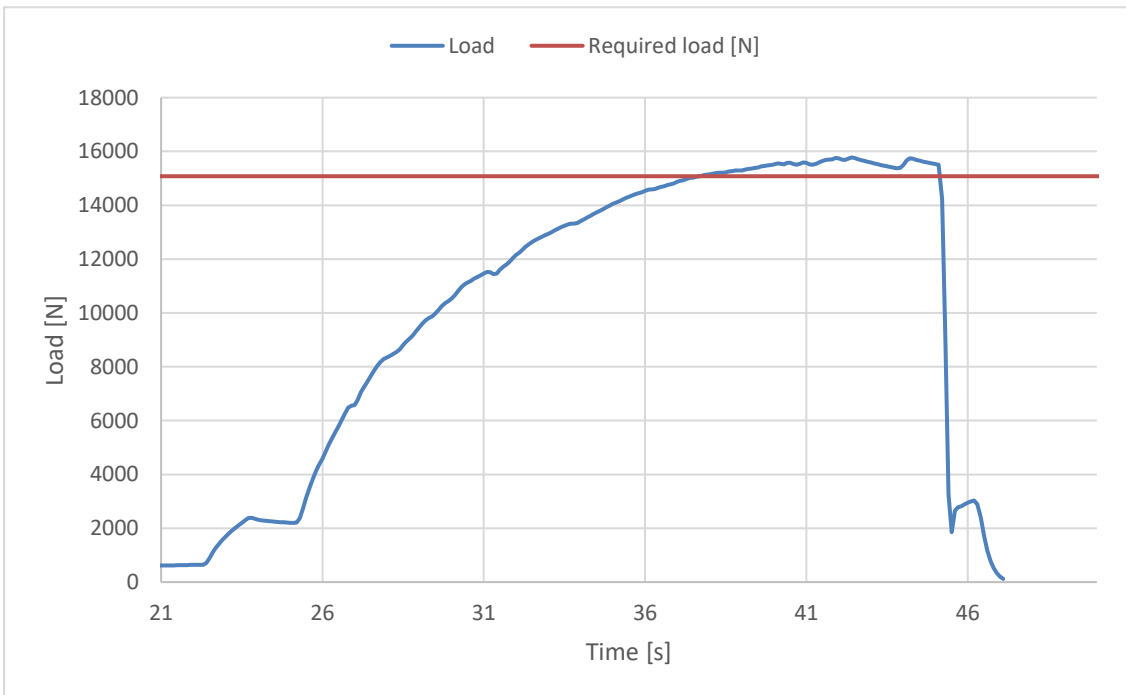
**Test ID 13**

Test duration [s] **7.5**  
 Any signs of structural failure **No**  
 Test results **POSITIVE**

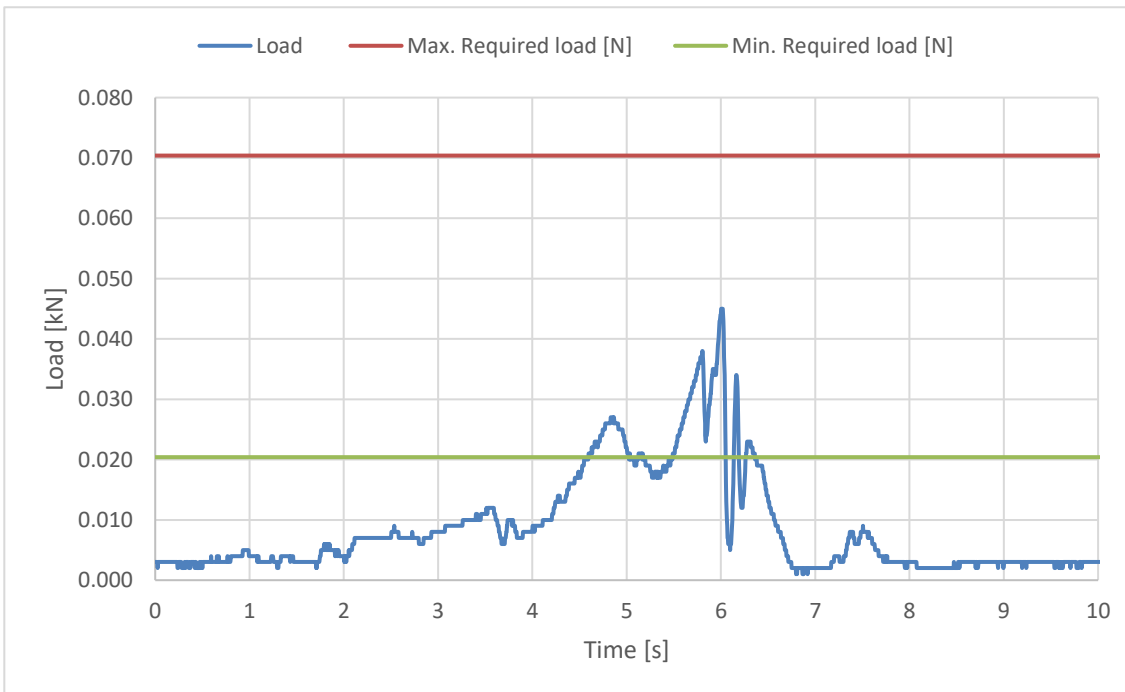
**Test ID RRDT**

Standard	<b>LTF NfL II 91/09</b>
Reference	<b>6.1.5</b>
Test setup	<b>Default flying position</b>
Attachment points	<b>Sensor connect to handle, and pull in opening direction</b>
	The test is to simulate the load required to open the emergency parachute(1st action).
Min. Required load [N]	<b>20</b>
Max. Required load [N]	<b>70</b>
<b>Result</b>	
Load for first action [N]	<b>44.61</b>
Test results	<b>POSITIVE</b>

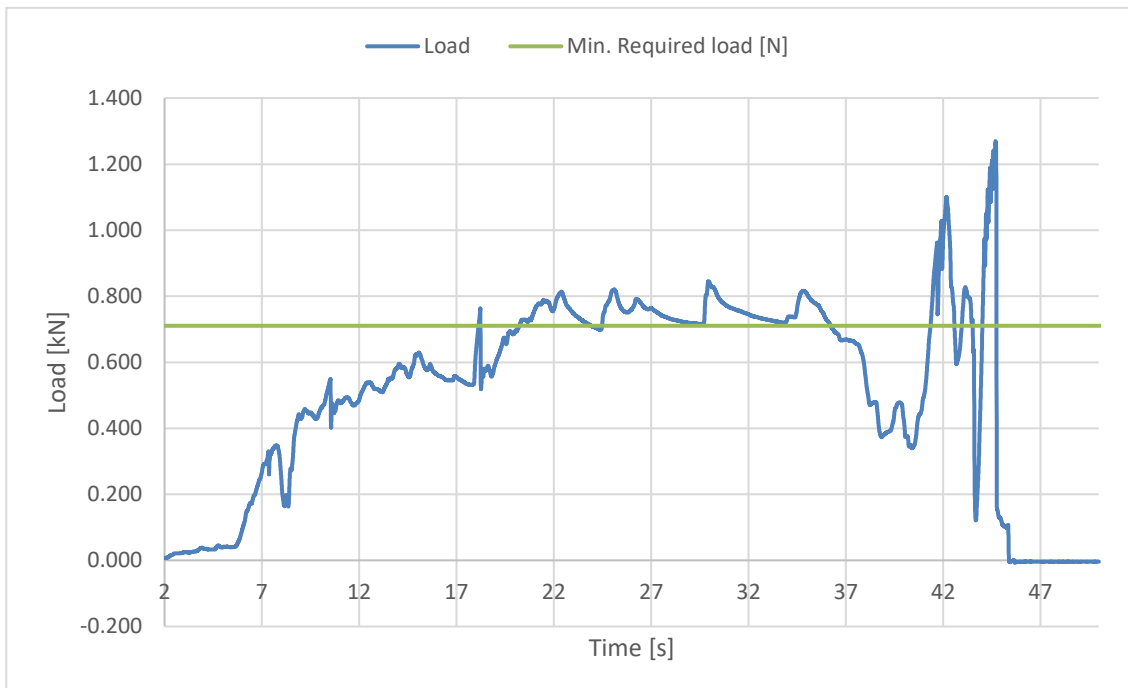
**Test ID RRST**

Standard	<b>EN12491:2015</b>
Reference in standard	<b>5.3.2</b>
Test setup	<b>Two end points of handle</b>
Attachment points	<b>Sensor connect to end of handle, pull on the other side</b>
	The handle must support min 700 N for 10 s, after measure breaking strength
Min. Required load [N]	<b>700</b>
Minimum test duration [s]	<b>10</b>
<b>Result</b>	
Test duration [s]:	<b>11.7</b>
Breaking strength [N]	<b>1258.99</b>
Test results	<b>POSITIVE</b>
