Harness Structural test Report - EN

Inspection certificate number: **PH_310.2020**
Manufacturer data:

Name: **Tanga**
 Type: **ABS**
 Size:
 Serial number: **Tang001**
 Impact pad type: ⁽¹⁾ **Airbag**
 Clip-in weight [kg]: **120**

Harness Structural test

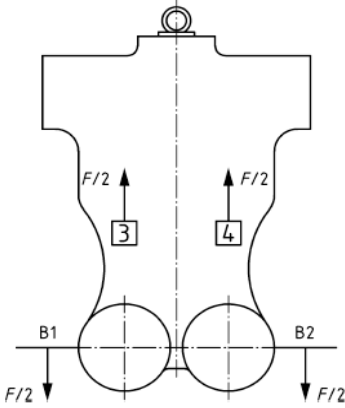
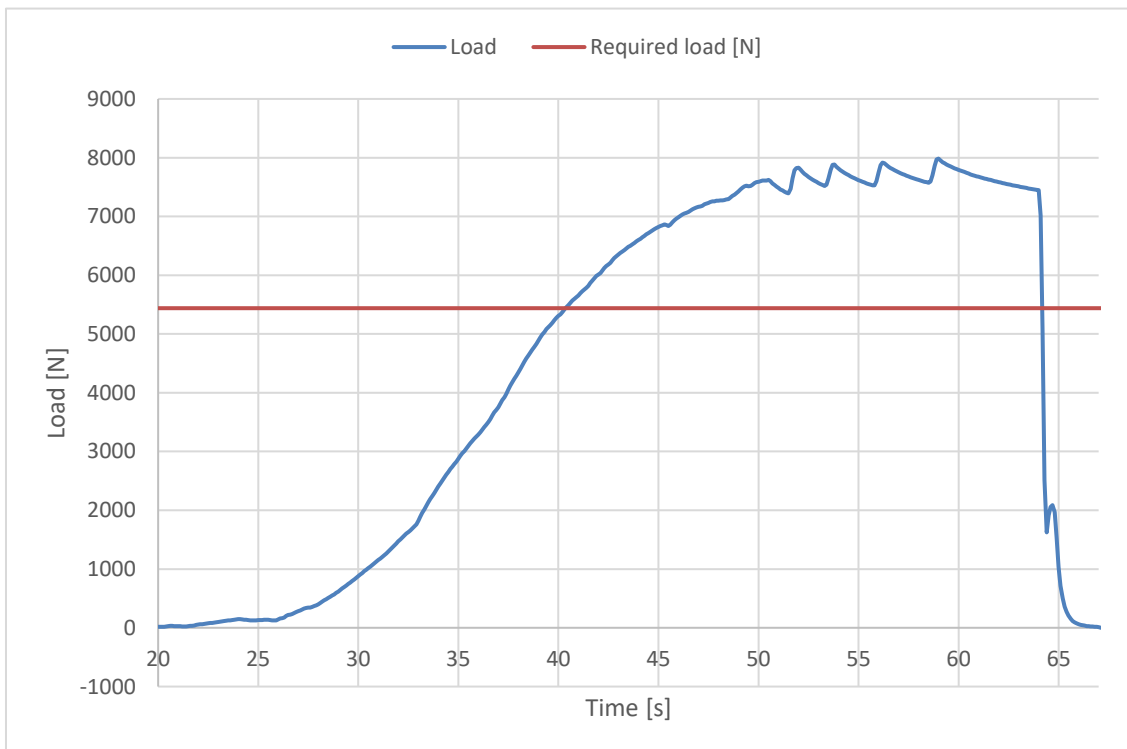
Test ID 01

Reference in standard	5.5.1.1	
Test setup	Positive symmetric load (Slippage)	
Attachment points	Both main riser attachment (3,4)	
Anchor points	Dummy (B1, B2)	
Required load [g]	4.5	
Required load [N]	5400	
Minimum test duration [s]	5	
Result		
Test duration [s]	23.8	
Any signs of structural failure	No	
Slippery test OK	Yes	
Test results	POSITIVE

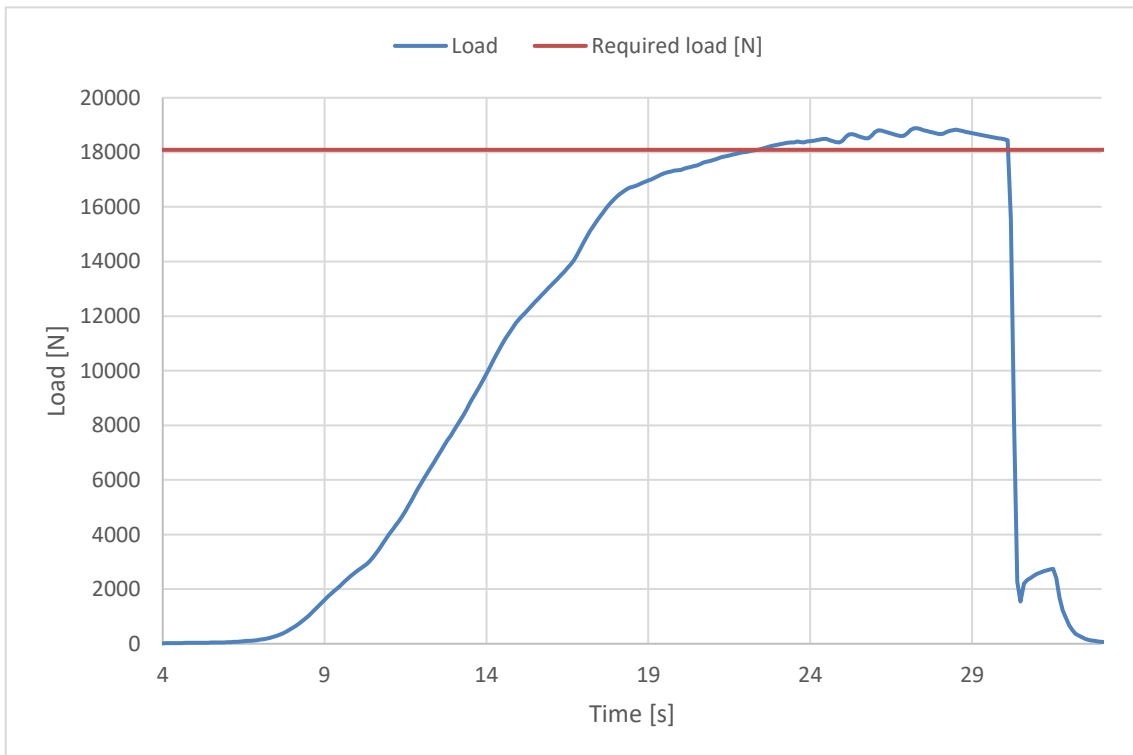
Test ID 03

Standard	EN 1651
Reference in standard	5.5.1.1b
Test setup	Positive symmetric load
Attachment points	Both main riser attachment (3,4)
Anchor points	Dummy (B1, B2)
Required load [g]	15
Required load [N]	18000
Minimum test duration [s]	5
Result	
Test duration [s]	7.8
Any signs of structural failure	No
Slippery test OK	Yes
Test results	POSITIVE

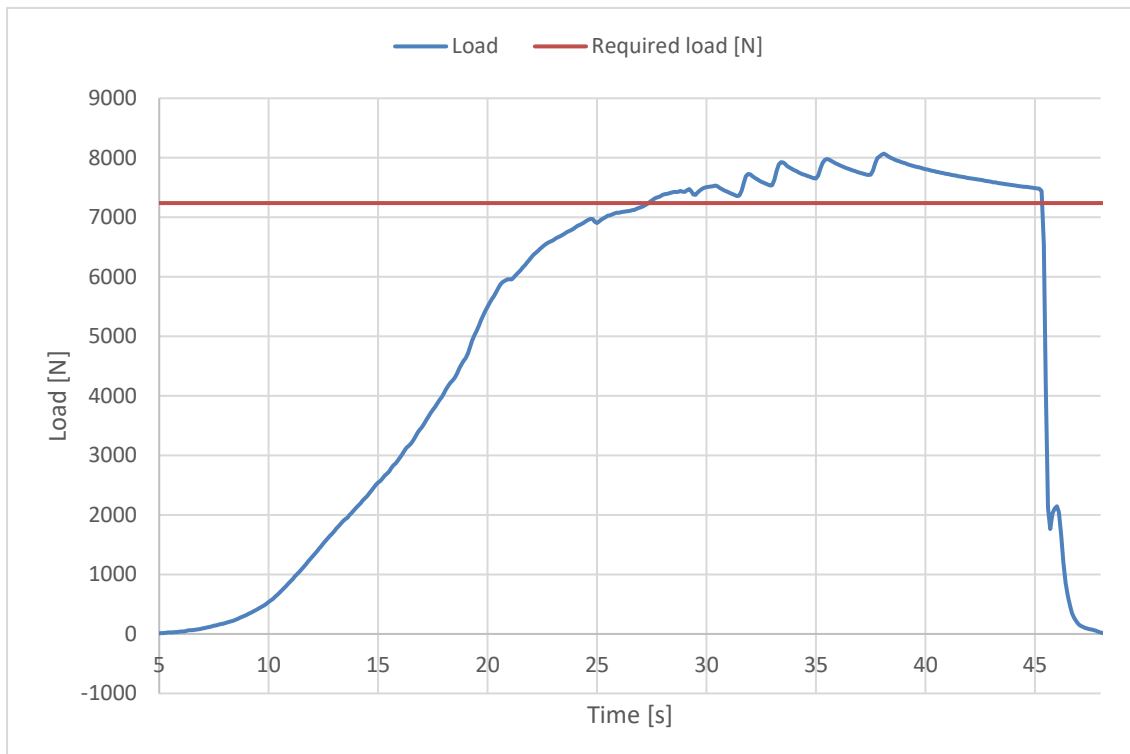
Test ID 05

Standard	EN 1651
Reference in standard	5.5.1.2
Test setup	Positive asymmetric load
Attachment points	One riser attachment (3 or 4)
Anchor points	Dummy (C)
Required load [g]	6
Required load [N]	7200
Minimum test duration [s]	5
Result	
Test duration [s]	18
Any signs of structural failure	No
Test results	POSITIVE

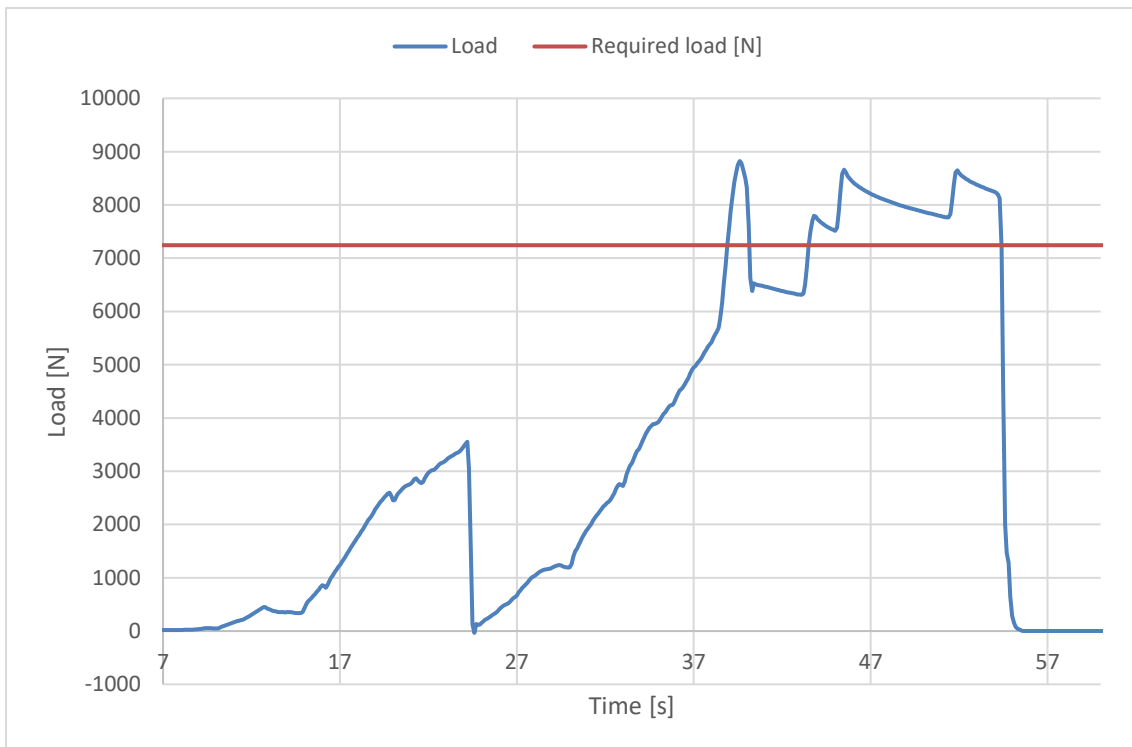
Test ID 06

Standard	EN 1651
Reference in standard	5.5.1.6
Test setup	Negative symmetric load
Attachment points	Both main riser attachment (3,4)
Anchor points	Dummy (A)
Required load [g]	6
Required load [N]	7200
Minimum test duration [s]	5
Result	
Test duration [s]	10.8
Any signs of structural failure	No
Test results	POSITIVE

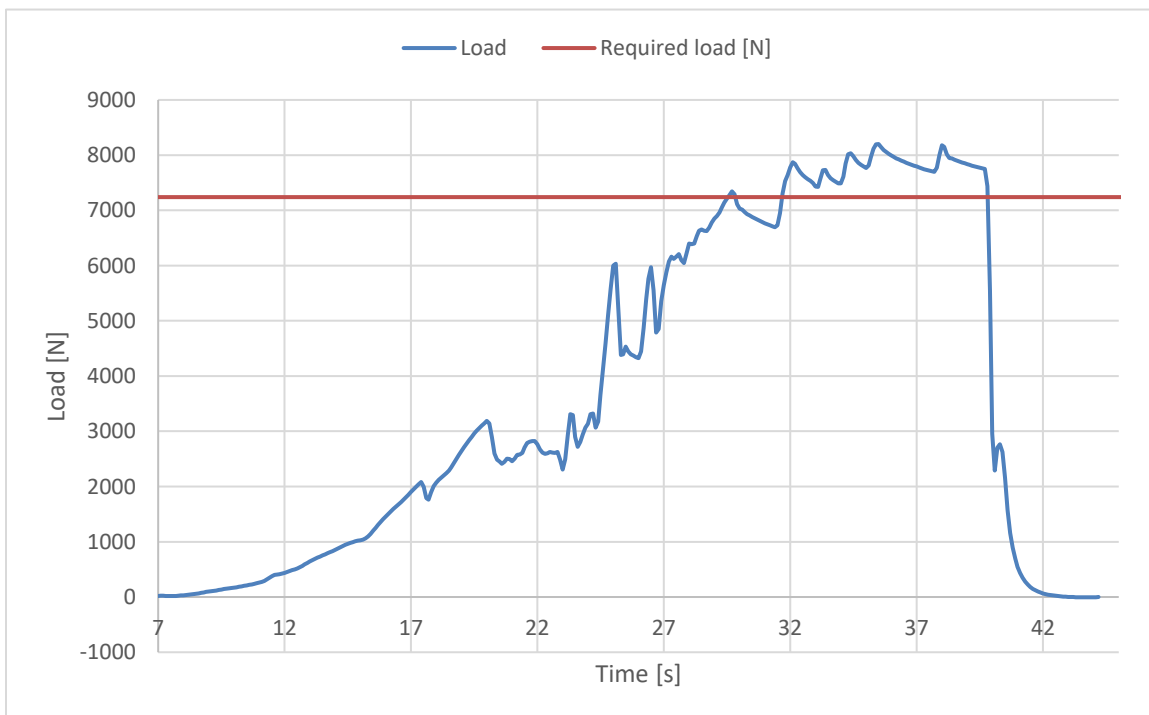
Test ID 12

Standard	EN 1651
Reference in standard	5.5.1.7
Test setup	Upright (landing) position load
Attachment points	Both main riser attachment (3, 4)
Anchor points	Both legstrap of harness (no dummy)
Required load [g]	6
Required load [N]	7200
Minimum test duration [s]	5
Harness type	type c
Result	
Test duration [s]	8.2
Any signs of structural failure	No
Slippery test OK	Yes
Test results	POSITIVE
