Harness Structural test Report - LTF

Inspection certificate number: **PH_310.2020**

Name: **Tanga**
 Type: **ABS**
 Size:
 Serial number: **Tang001**
 Impact pad type: ⁽¹⁾ **Airbag**
 Clip-in weight [kg]: **120**
 Date of test: **24.08.2020**

Summary of Structural test

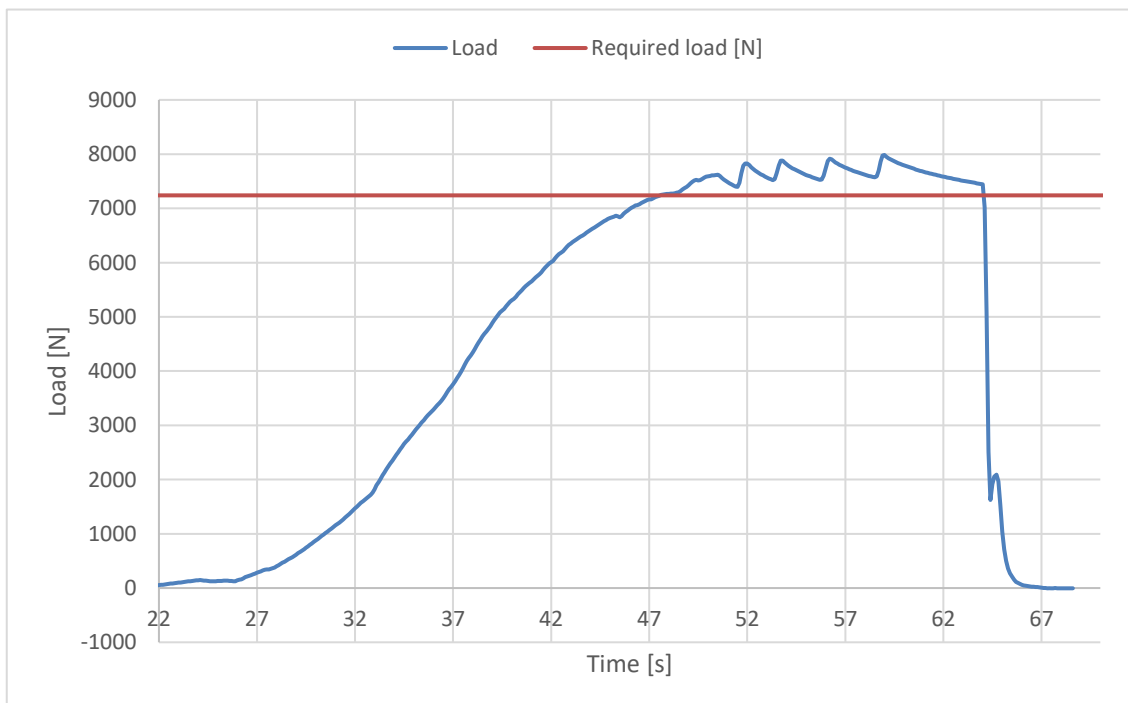
Test ID 02

Standard	LTF NfL II 91/09
Reference	5.3.2.1
Test setup	Default flying position
Attachment points	Both main riser attachment (3,4)
Anchor points	Dummy (B1, B2)
Required load [g]	6
Required load [N]	7200
Minimum test duration [s]	10
Result	
Test duration [s]	16.5
Any signs of structural failure	No
Test results	POSITIVE

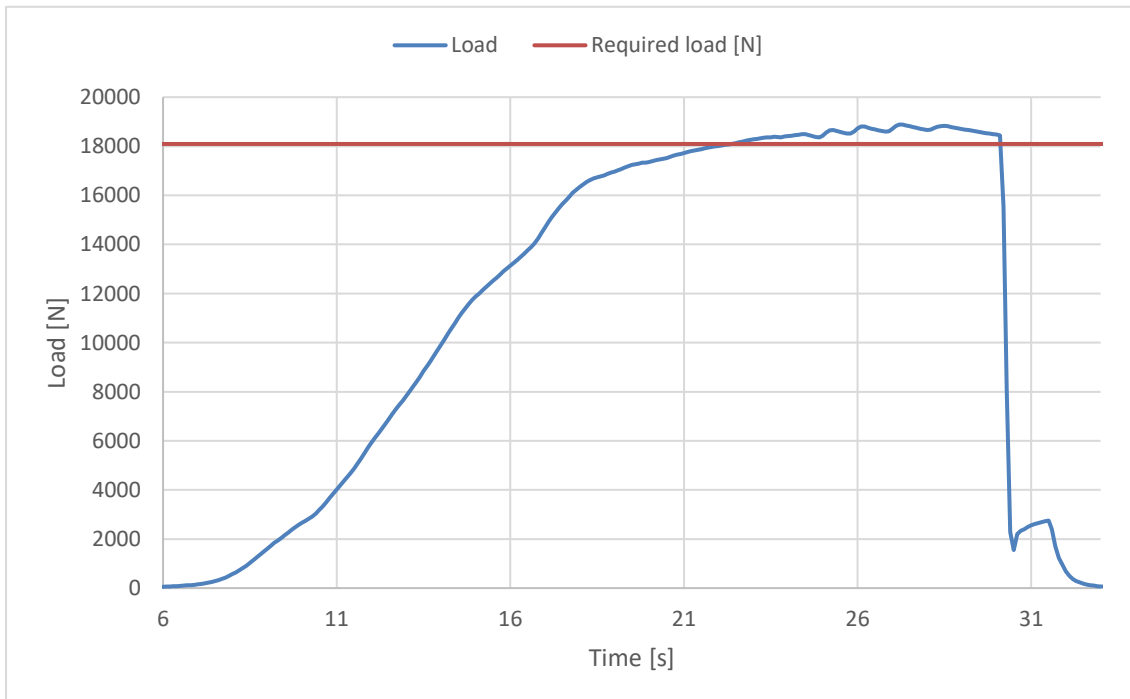
Test ID 03

Standard **LTF NfL II 91/09**
 Reference **5.3.2.2**
 Test setup **Default flying position**
 Attachment points **Both main riser attachment (3,4)**
 Anchor points **Dummy (B1, B2)**

Required load [g] **15**
 Required load [N] **18000**
 Minimum test duration [s] **5**

Test duration [s] **7.8**
 Any signs of structural failure **No**
 Test results **POSITIVE**

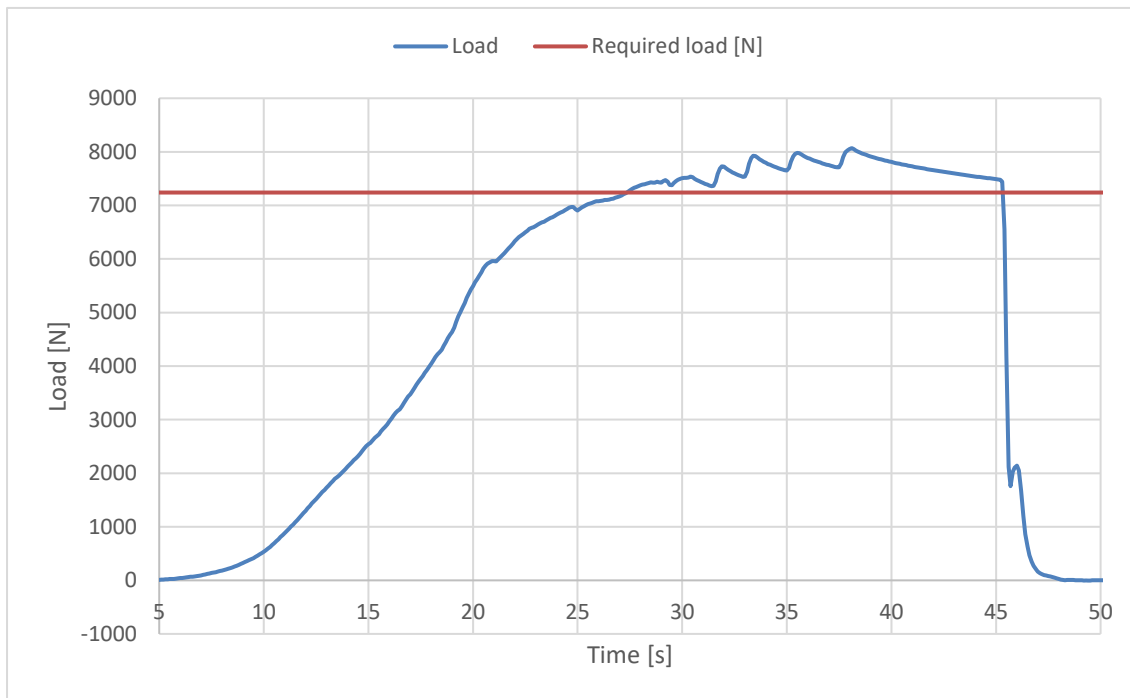
Test ID 04

Standard	LTF NfL II 91/09
Reference	5.3.2.3
Test setup	Asymmetric, one riser
Attachment points	One main riser attachment (3)
Anchor points	Dummy (B1,B2)
Required load [g]	6
Required load [N]	7200
Minimum test duration [s]	10
Result	
Test duration [s]	18
Any signs of structural failure	No
Test results	POSITIVE

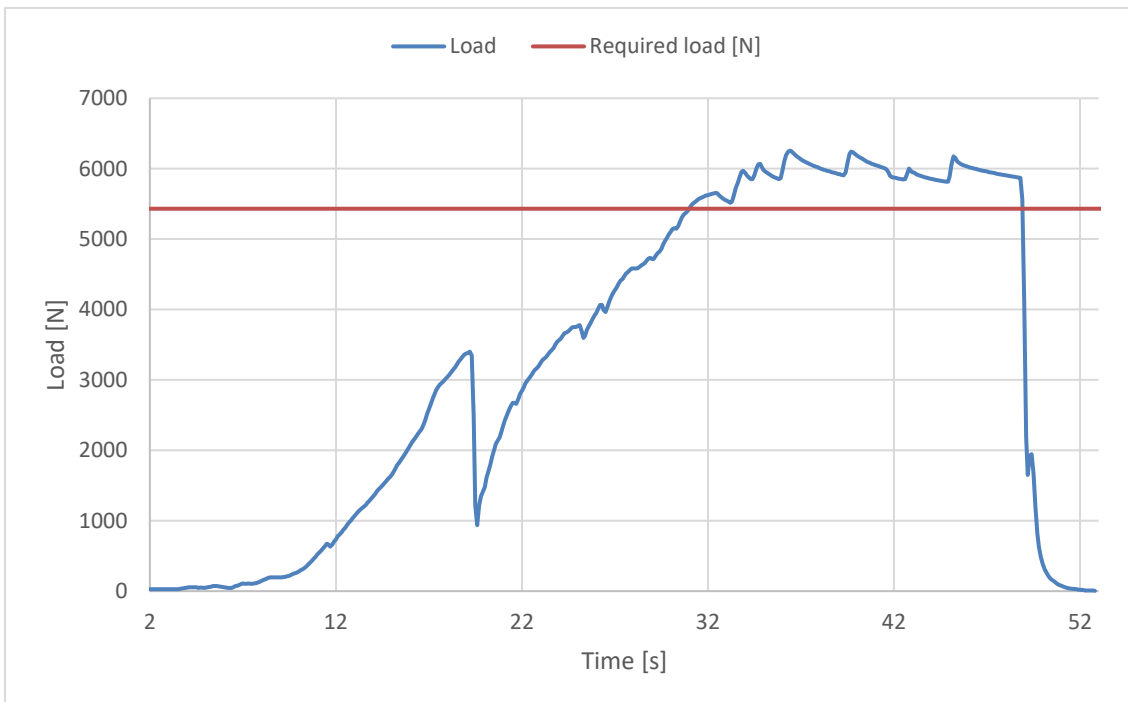
Test ID 07

Standard	LTF NfL II 91/09

Reference	5.3.2.6	
Test setup	Asymmetric, negative	
Attachment points	One main riser attachment (3 or 4) downwards	
Anchor points	Dummy (9)	
Required load [g]	4.5	
Required load [N]	5400	
Minimum test duration [s]	10	
Result		
Test duration [s]	18	
Any signs of structural failure	No	
Test results	POSITIVE

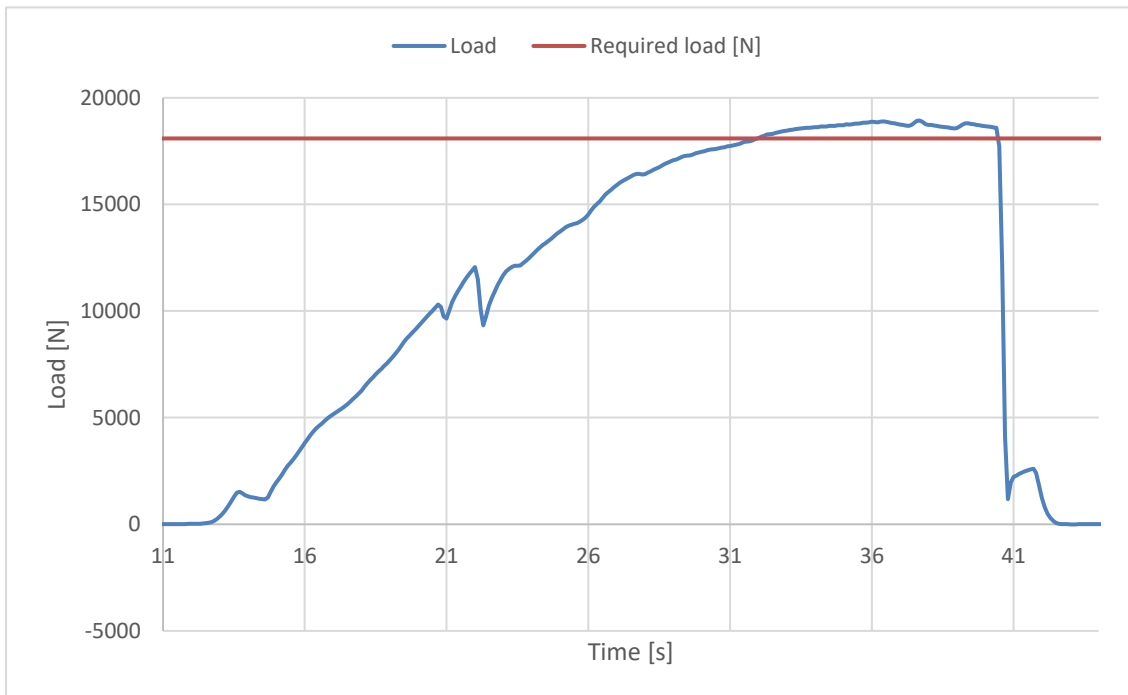
Test ID 13

Standard	LTF NfL II 91/09
Reference	5.3.2.7
Test setup	Flying position before landing
Attachment points	Both main riser attachment (3,4)
Anchor points	Dummy (7,8)
Required load [g]	15
Required load [N]	18000
Minimum test duration [s]	5
Result	
Test duration [s]	8.5
Any signs of structural failure	No
Test results	POSITIVE
