Harness Structural test Report - LTF

Inspection certificate number: **PH_330.2021**

Name: **Kinder 2**
 Type: **ABS**
 Size: **Unique**
 Serial number: **KD2_TU_V4_1**
 Impact pad type: ⁽¹⁾ **Foam**
 Clip-in weight [kg]: **100**

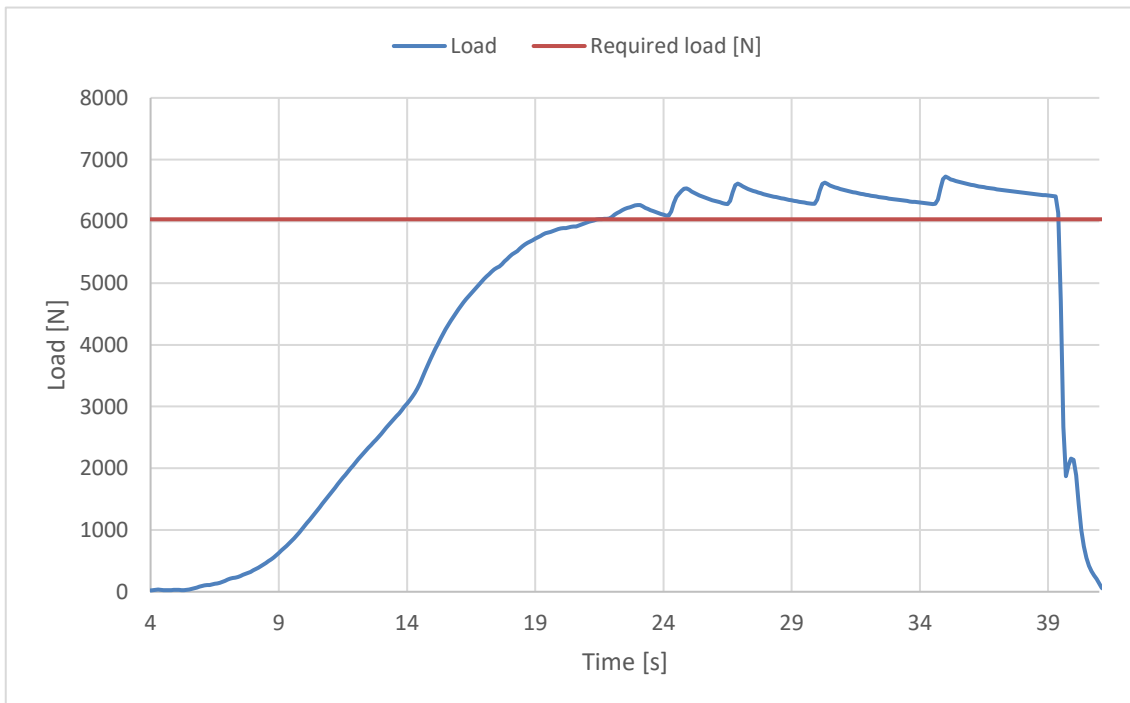
Test ID 02

Standard	LTF NfL II 91/09
Reference	5.3.2.1
Test setup	Default flying position
Attachment points	Both main riser attachment (3,4)
Anchor points	Dummy (B1, B2)
Required load [g]	6
Required load [N]	6000
Minimum test duration [s]	10
Result	
Test duration [s]	18
Any signs of structural failure	No
Test results	POSITIVE

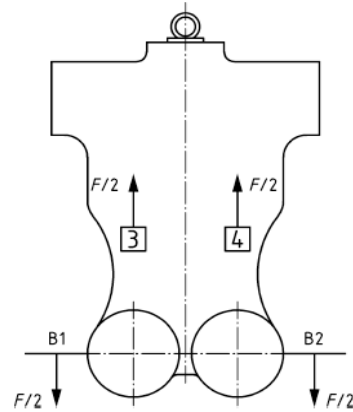
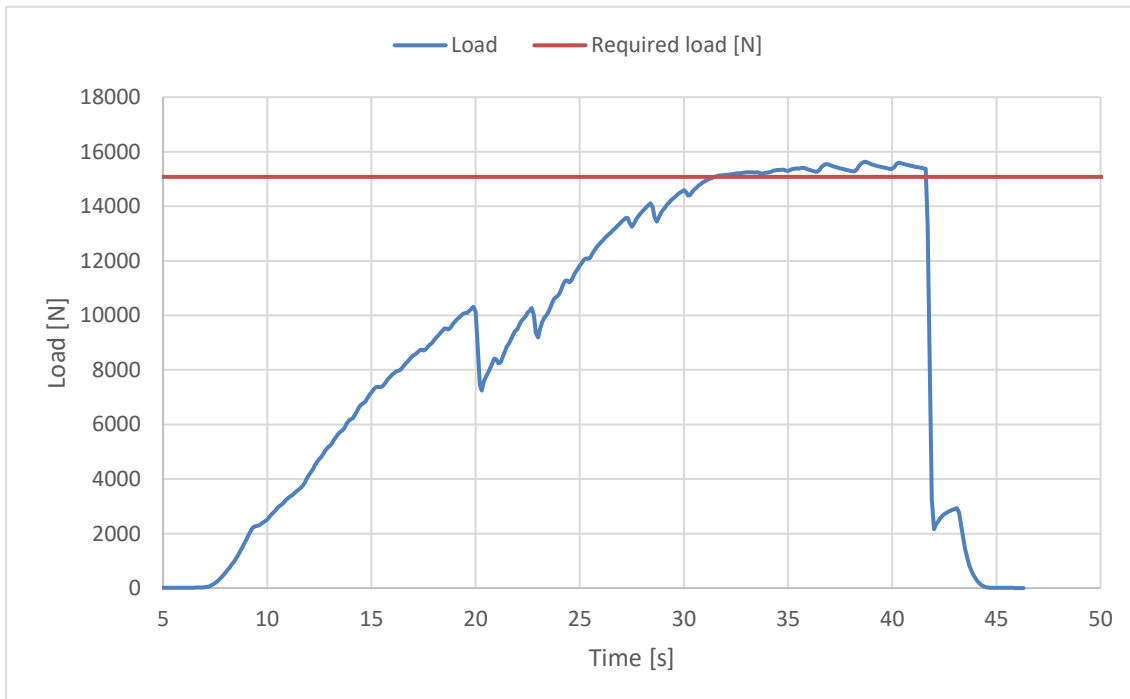
Test ID 03

Test duration [s] **10.2**
 Any signs of structural failure **No**
 Test results **POSITIVE**

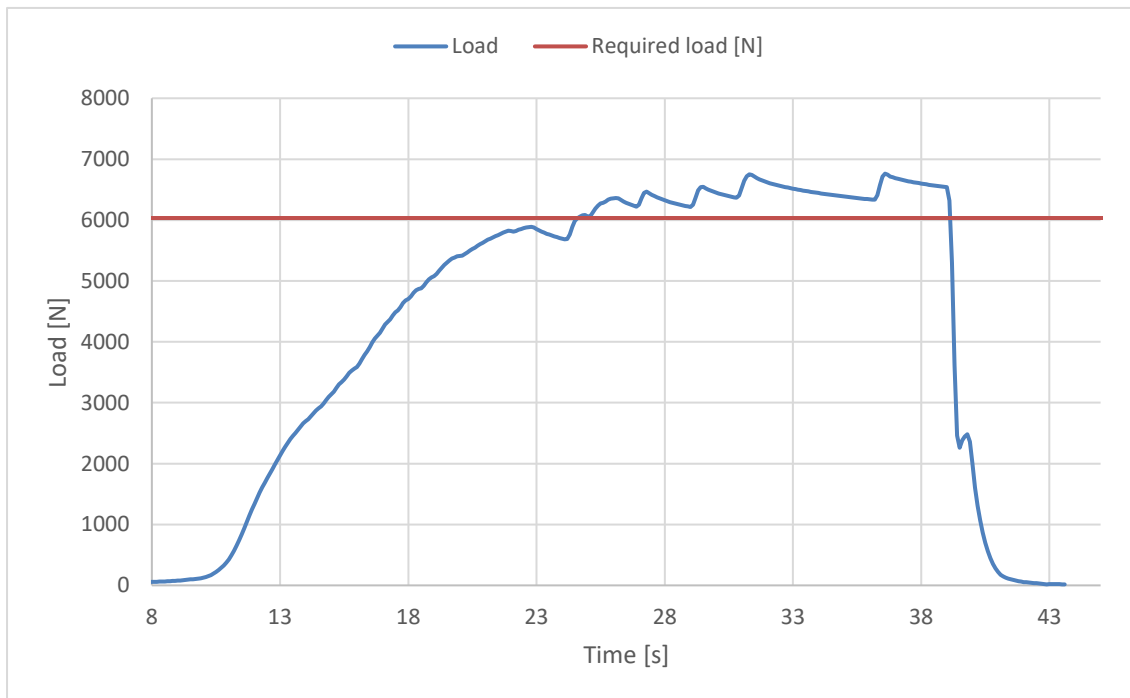
Test ID 04

Test duration [s] **14.5**
 Any signs of structural failure **No**
 Test results **POSITIVE**

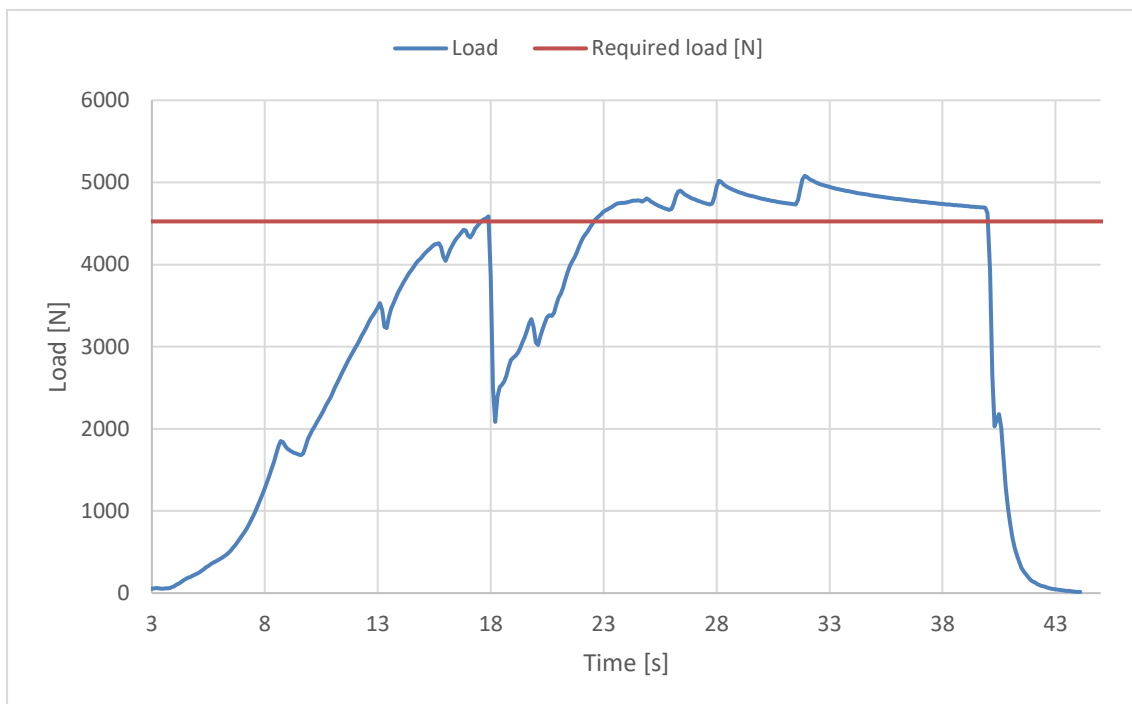
Test ID 07

Reference	5.3.2.6	
Test setup	Asymmetric, negative	
Attachment points	One main riser attachment (3 or 4) downwards	
Anchor points	Dummy (9)	
Required load [g]	4.5	
Required load [N]	4500	
Minimum test duration [s]	10	
Result		
Test duration [s]	17.5	
Any signs of structural failure	No	
Test results	POSITIVE

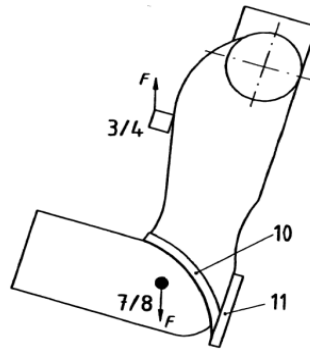
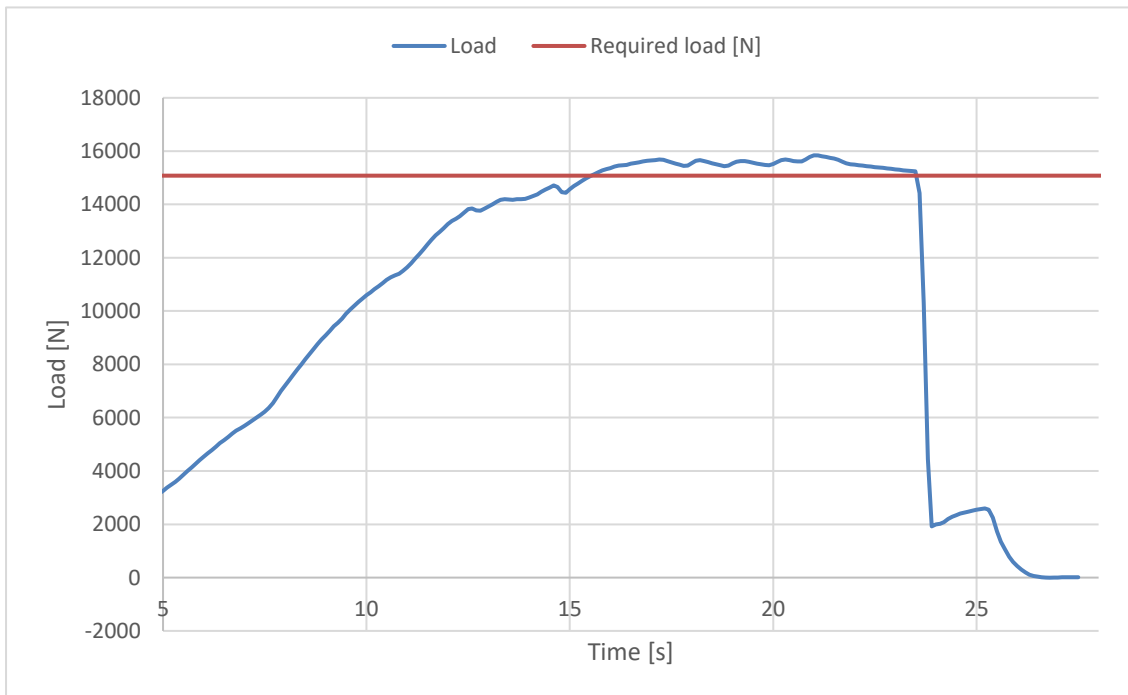
Test ID 13

Test duration [s] **8**
 Any signs of structural failure **No**
 Test results **POSITIVE**
