## Harness Structural test Report - LTF

Inspection certificate number: **PH\_325.2021**

Name: **Pogo 4**  
 Type: **ABS**  
 Size: **M**  
 Serial number: **H-12116**  
 Impact pad type: <sup>(1)</sup> **Foam**  
 Clip-in weight [kg]: **100**

**Harness Structural test**

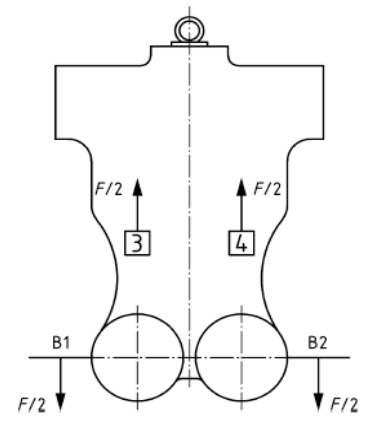
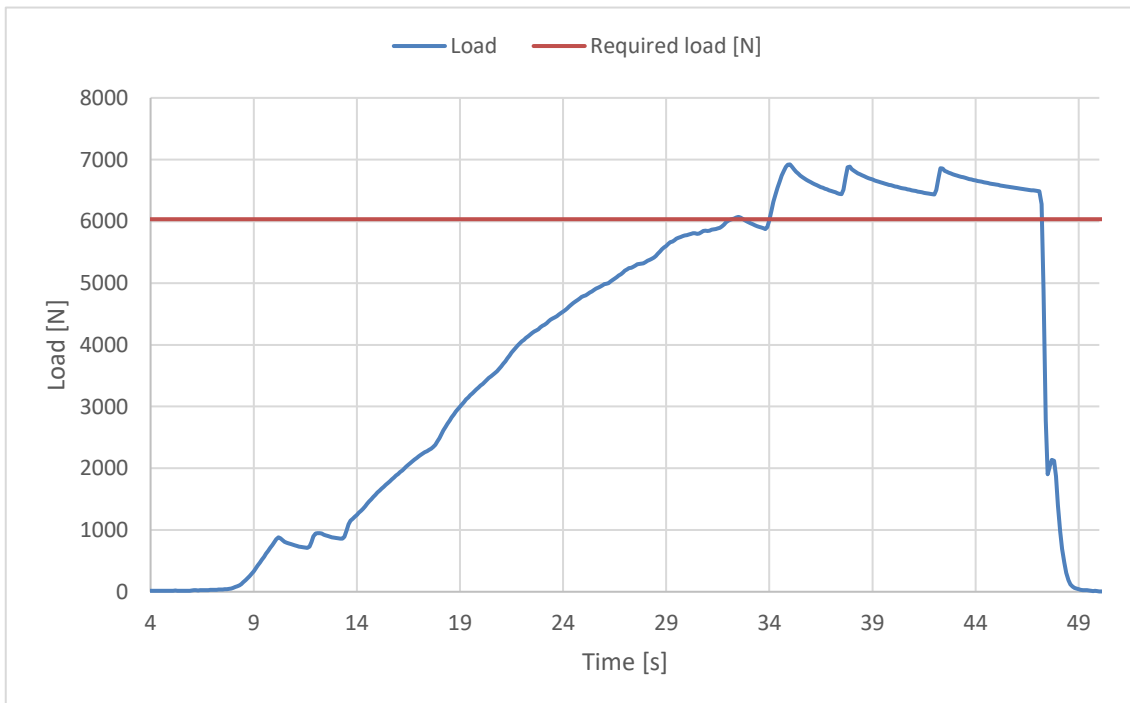
**Test ID 02**

Standard	<b>LTF NfL II 91/09</b>
Reference	<b>5.3.2.1</b>
Test setup	<b>Default flying position</b>
Attachment points	<b>Both main riser attachment (3,4)</b>
Anchor points	<b>Dummy (B1, B2)</b>
Required load [g]	<b>6</b>
Required load [N]	<b>6000</b>
Minimum test duration [s]	<b>10</b>
<b>Result</b>	
Test duration [s]	<b>13.2</b>
Any signs of structural failure	<b>No</b>
Test results	<b>POSITIVE</b>

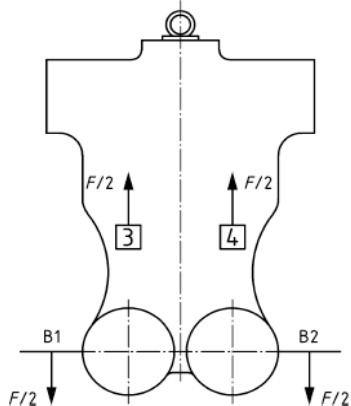
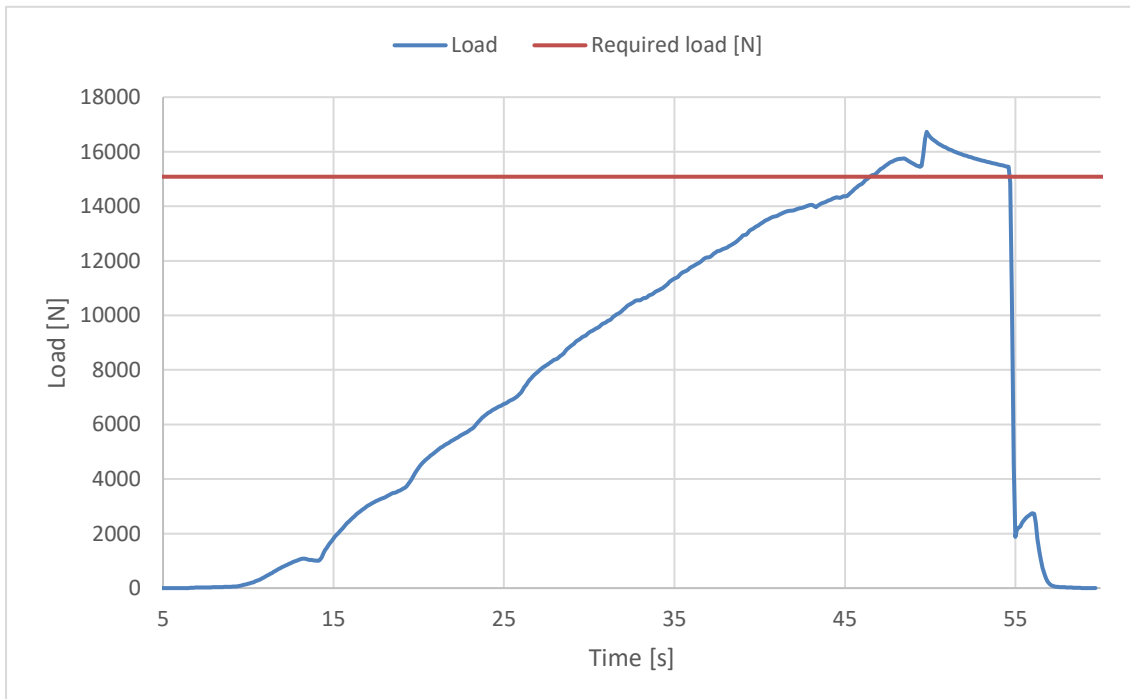
**Test ID 03**

Standard	<b>LTF NfL II 91/09</b>
Reference	<b>5.3.2.2</b>
Test setup	<b>Default flying position</b>
Attachment points	<b>Both main riser attachment (3,4)</b>
Anchor points	<b>Dummy (B1, B2)</b>
Required load [g]	<b>15</b>
Required load [N]	<b>15000</b>
Minimum test duration [s]	<b>5</b>
<b>Result</b>	
Test duration [s]	<b>8.2</b>
Any signs of structural failure	<b>No</b>
Test results	<b>POSITIVE</b>

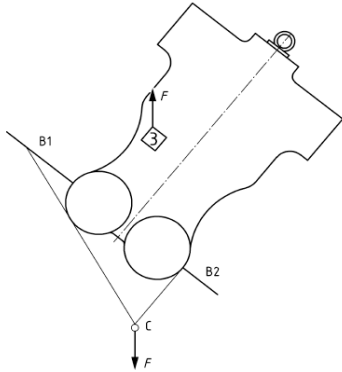
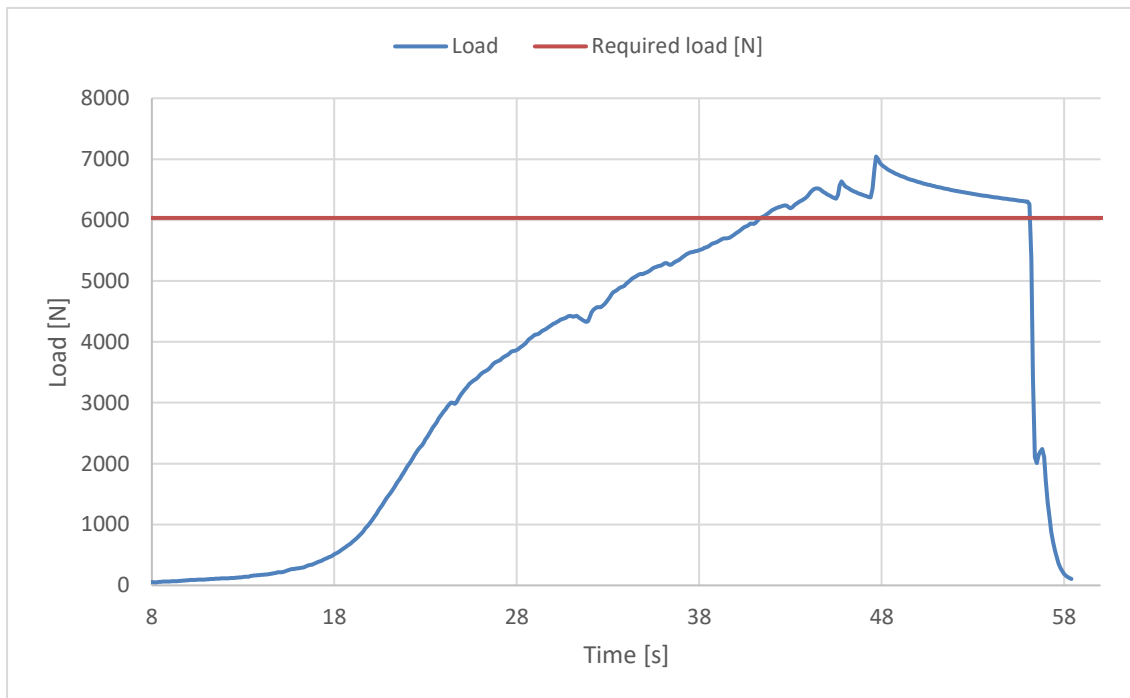
**Test ID 04**

Standard	<b>LTF NfL II 91/09</b>
Reference	<b>5.3.2.3</b>
Test setup	<b>Asymmetric, one riser</b>
Attachment points	<b>One main riser attachment (3)</b>
Anchor points	<b>Dummy (B1,B2)</b>
Required load [g]	<b>6</b>
Required load [N]	<b>6000</b>
Minimum test duration [s]	<b>10</b>
<b>Result</b>	
Test duration [s]	<b>14.8</b>
Any signs of structural failure	<b>No</b>
Test results	<b>POSITIVE</b>

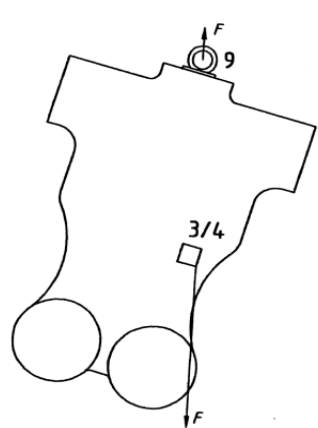
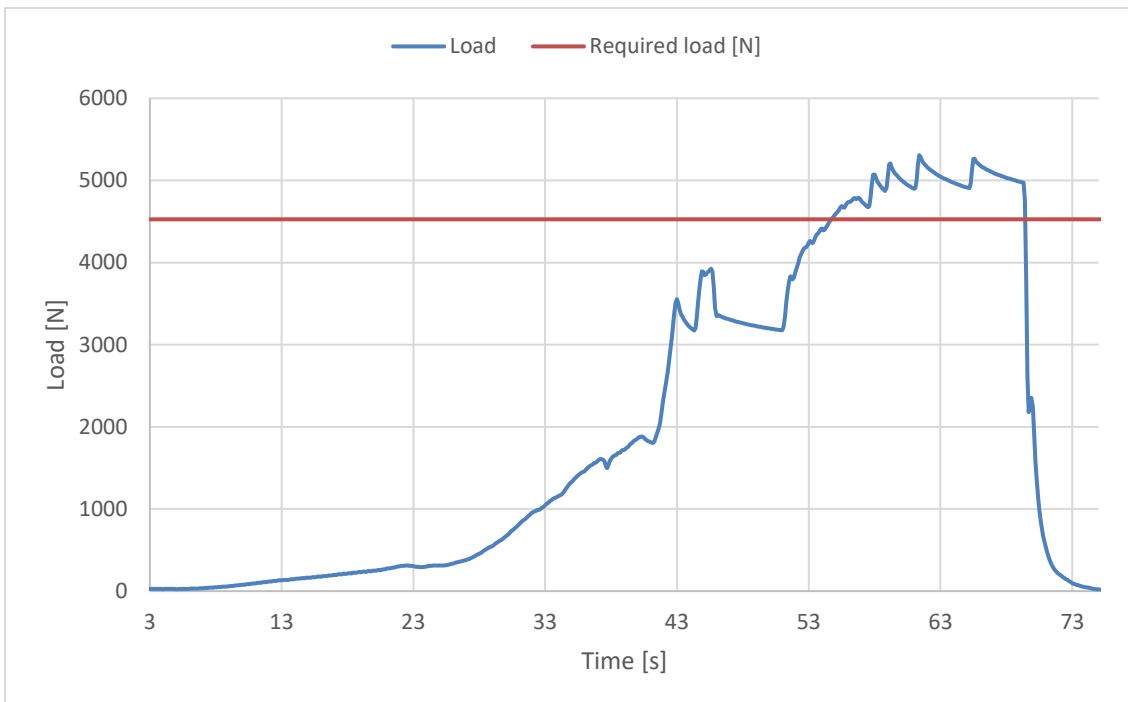
**Test ID 07**

Reference	<b>5.3.2.6</b>	
Test setup	<b>Asymmetric, negative</b>	
Attachment points	<b>One main riser attachment (3 or 4) downwards</b>	
Anchor points	<b>Dummy (9)</b>	
Required load [g]	<b>4.5</b>	
Required load [N]	<b>4500</b>	
Minimum test duration [s]	<b>10</b>	
<b>Result</b>		
Test duration [s]	<b>14.7</b>	
Any signs of structural failure	<b>No</b>	
Test results	<b>POSITIVE</b>

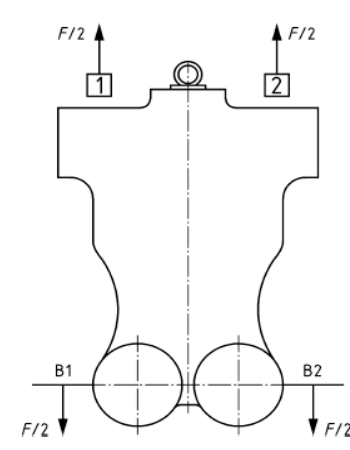
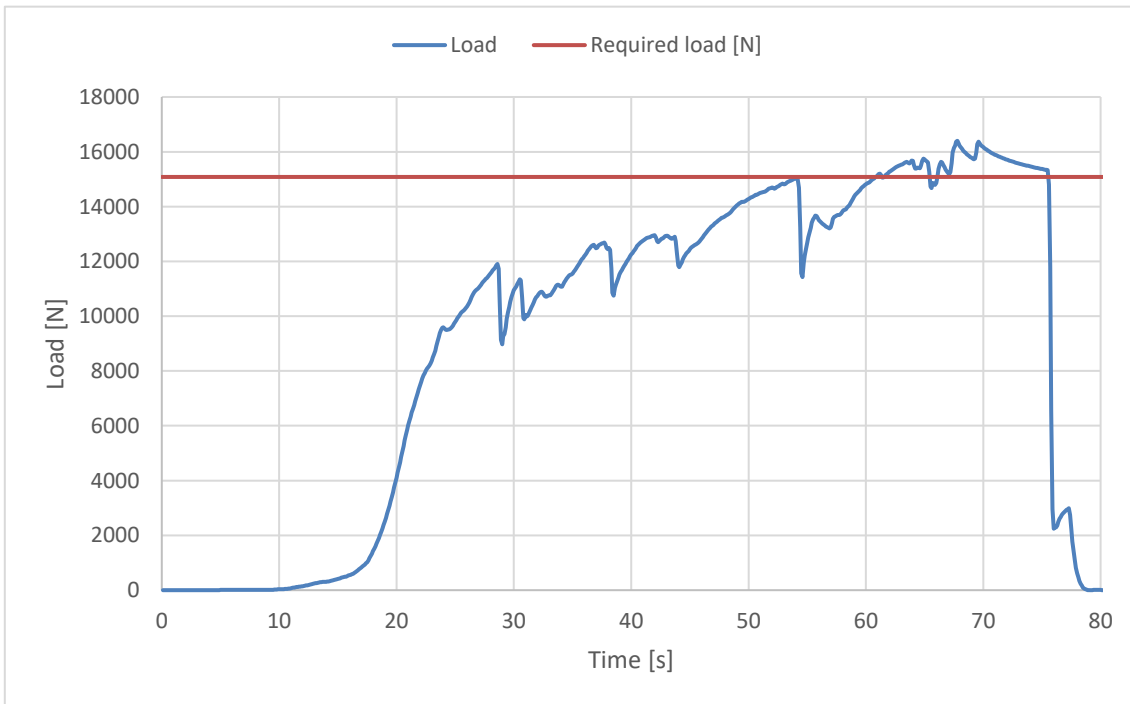
**Test ID 09**

Standard	<b>LTF NfL II 91/09</b>
Reference	<b>5.3.2.4</b>
Test setup	<b>Rescue attachments</b>
Attachment points	<b>Rescue riser attachment (1,2)</b>
Anchor points	<b>Dummy (B1,B2)</b>
Required load [g]	<b>15</b>
Required load [N]	<b>15000</b>
Minimum test duration [s]	<b>5</b>
<b>Result</b>	
Test duration [s]	<b>9.5</b>
Any signs of structural failure	<b>No</b>
Test results	<b>POSITIVE</b>

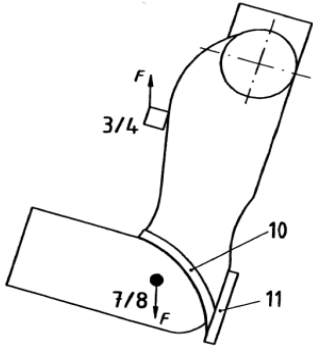
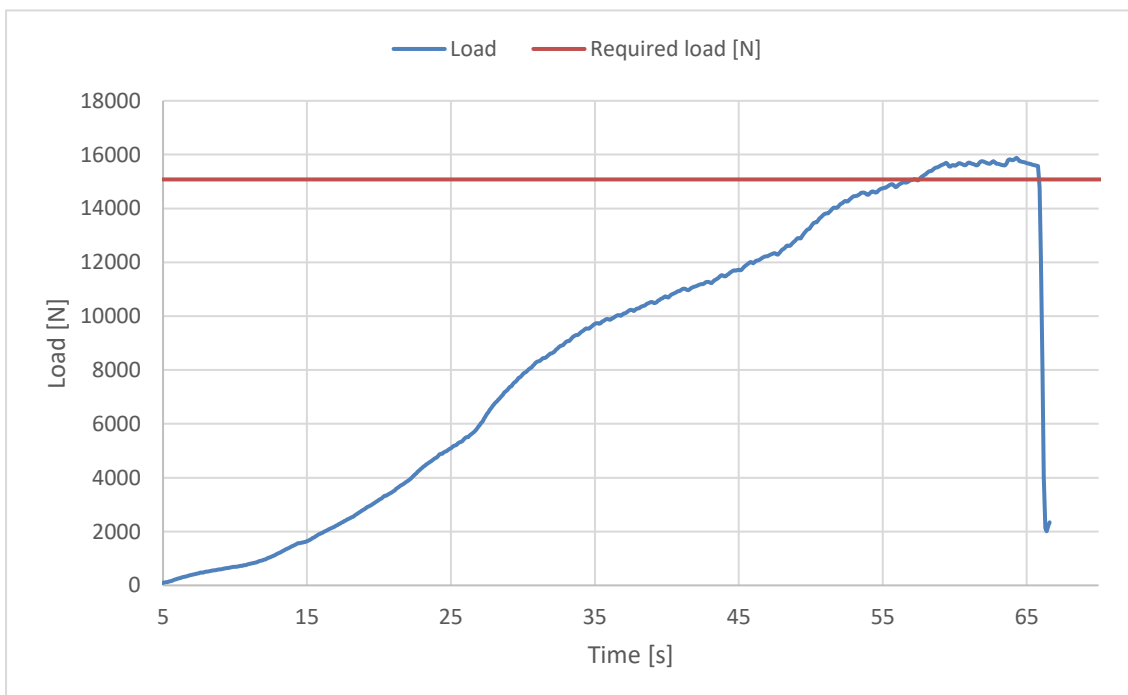
**Test ID 13**

Standard	<b>LTF NfL II 91/09</b>
Reference	<b>5.3.2.7</b>
Test setup	<b>Flying position before landing</b>
Attachment points	<b>Both main riser attachment (3,4)</b>
Anchor points	<b>Dummy (7,8)</b>
Required load [g]	<b>15</b>
Required load [N]	<b>15000</b>
Minimum test duration [s]	<b>5</b>
<b>Result</b>	
Test duration [s]	<b>8.3</b>
Any signs of structural failure	<b>No</b>
Test results	<b>POSITIVE</b>

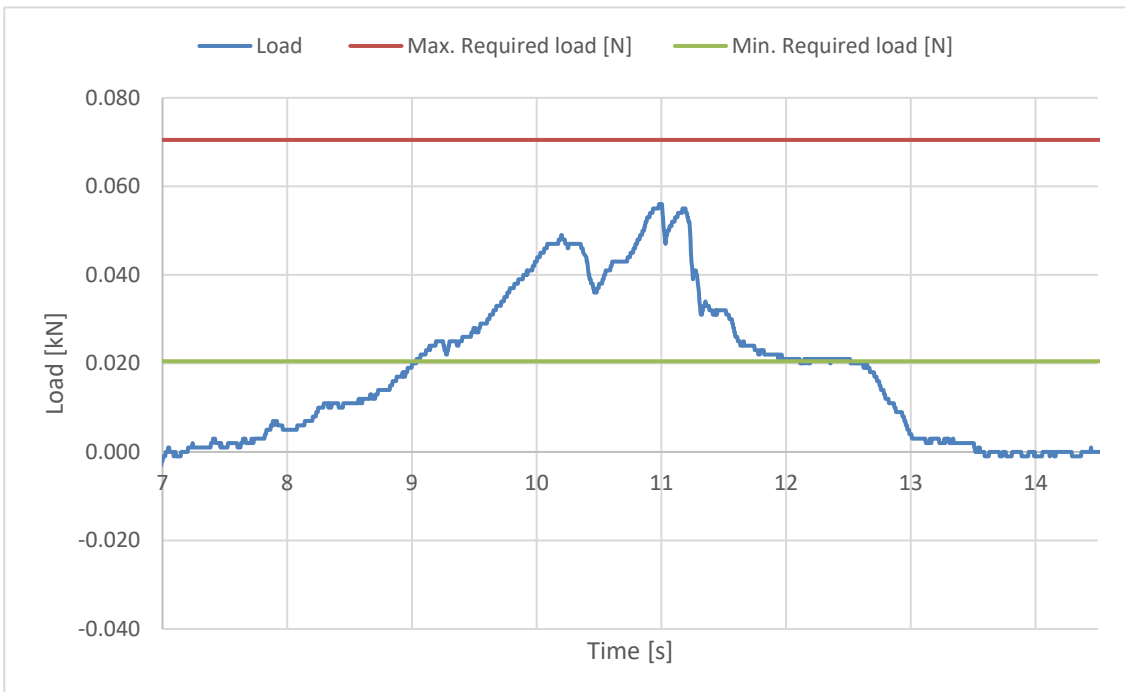
**Test ID RRDT**

Standard	<b>LTF NfL II 91/09</b>
Reference	<b>6.1.5</b>
Test setup	<b>Default flying position</b>
Attachment points	<b>Sensor connect to handle, and pull in opening direction</b>
	The test is to simulate the load required to open the emergency parachute(1st action).
Min. Required load [N]	<b>20</b>
Max. Required load [N]	<b>70</b>
<b>Result</b>	
Load for first action [N]	<b>55.51</b>
Test results	<b>POSITIVE</b>

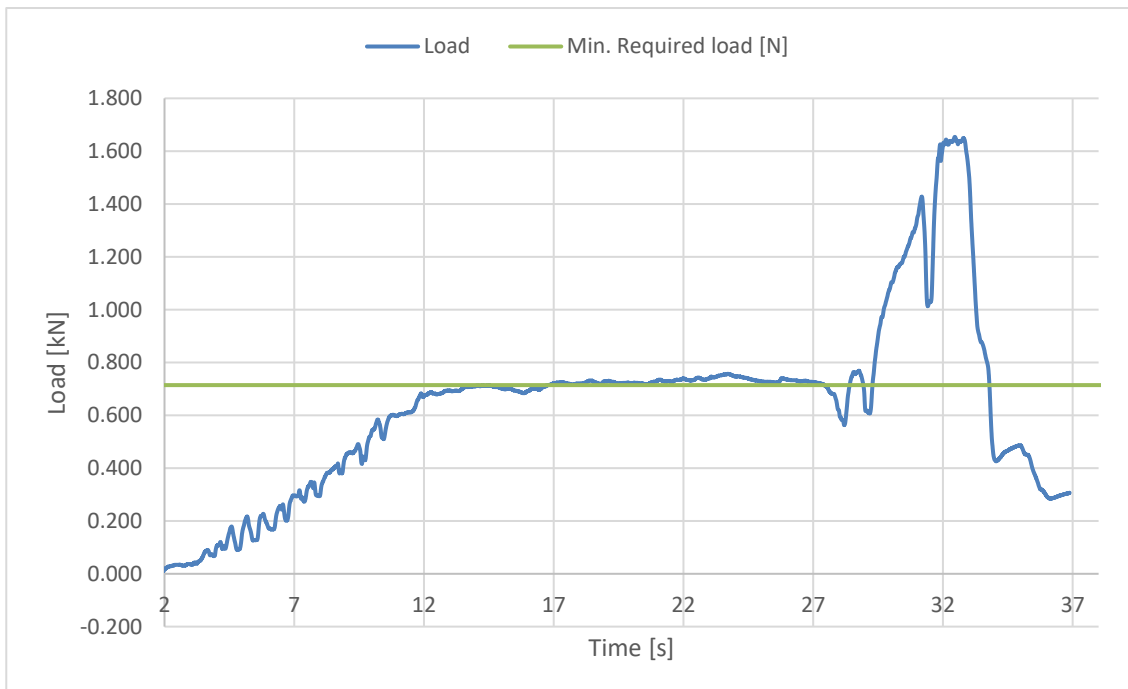
**Test ID RRST**

Standard	<b>EN12491:2015</b>
Reference in standard	<b>5.3.2</b>
Test setup	<b>Two end points of handle</b>
Attachment points	<b>Sensor connect to end of handle, pull on the other side</b>
	The handle must support min 700 N for 10 s, after measure breaking strength
Min. Required load [N]	<b>700</b>
Minimum test duration [s]	<b>10</b>
<b>Result</b>	
Test duration [s]:	<b>10.6</b>
Breaking strength [N]	<b>1639.66</b>
Test results	<b>POSITIVE</b>
