## Harness Structural test Report - LTF

Inspection certificate number: **PH\_326.2021**

Name: **Soul 2021**  
 Type: **ABS**  
 Size: **M**  
 Serial number: **H-12115**  
 Impact pad type: <sup>(1)</sup> **Foam**  
 Clip-in weight [kg]: **100**  
 Date of test: **15.01.2021**

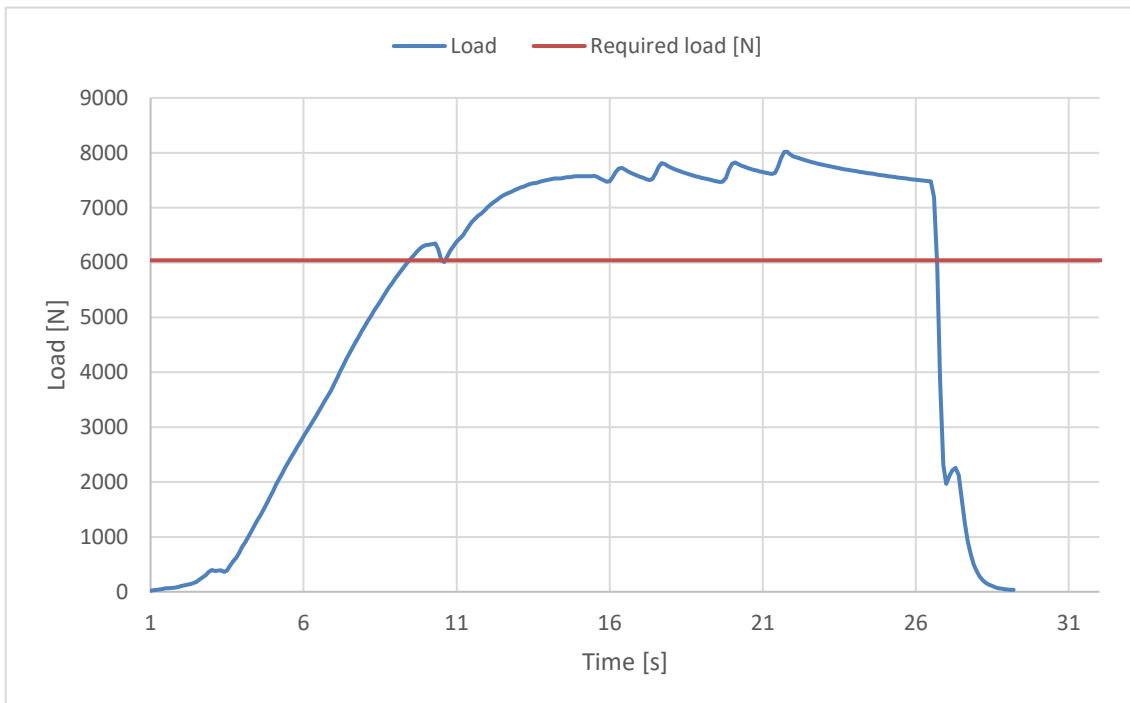
**Test ID 02**

Test duration [s] **16**  
 Any signs of structural failure **No**  
 Test results **POSITIVE**

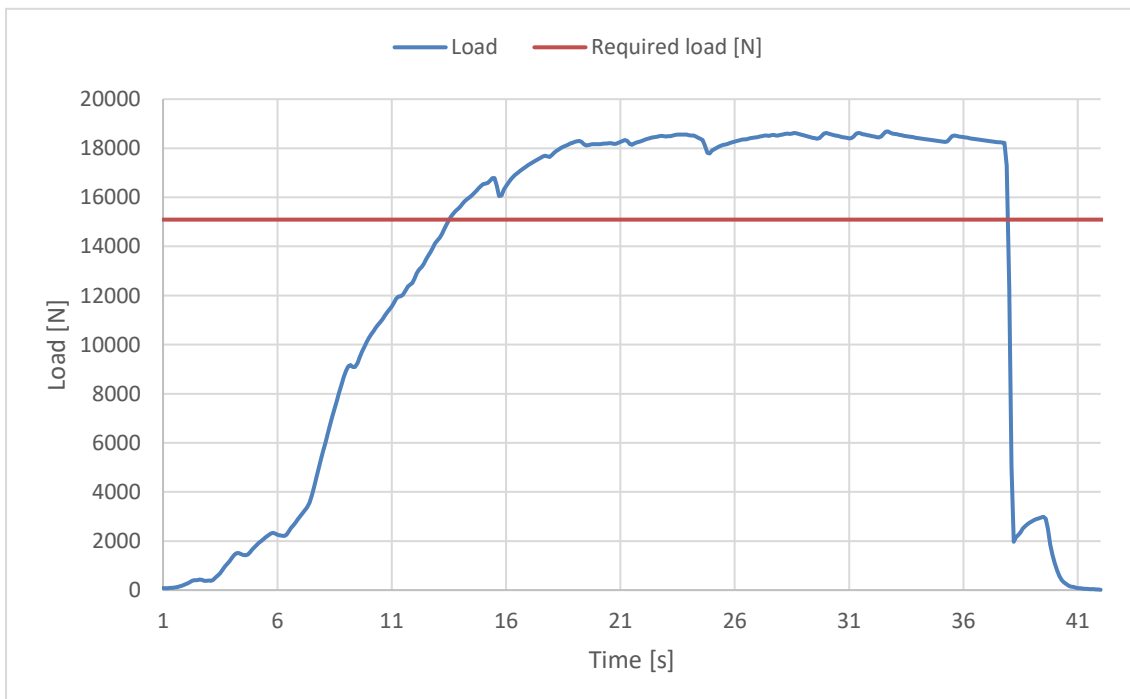
**Test ID 03**

Test duration [s] **24.4**  
 Any signs of structural failure **No**  
 Test results **POSITIVE**

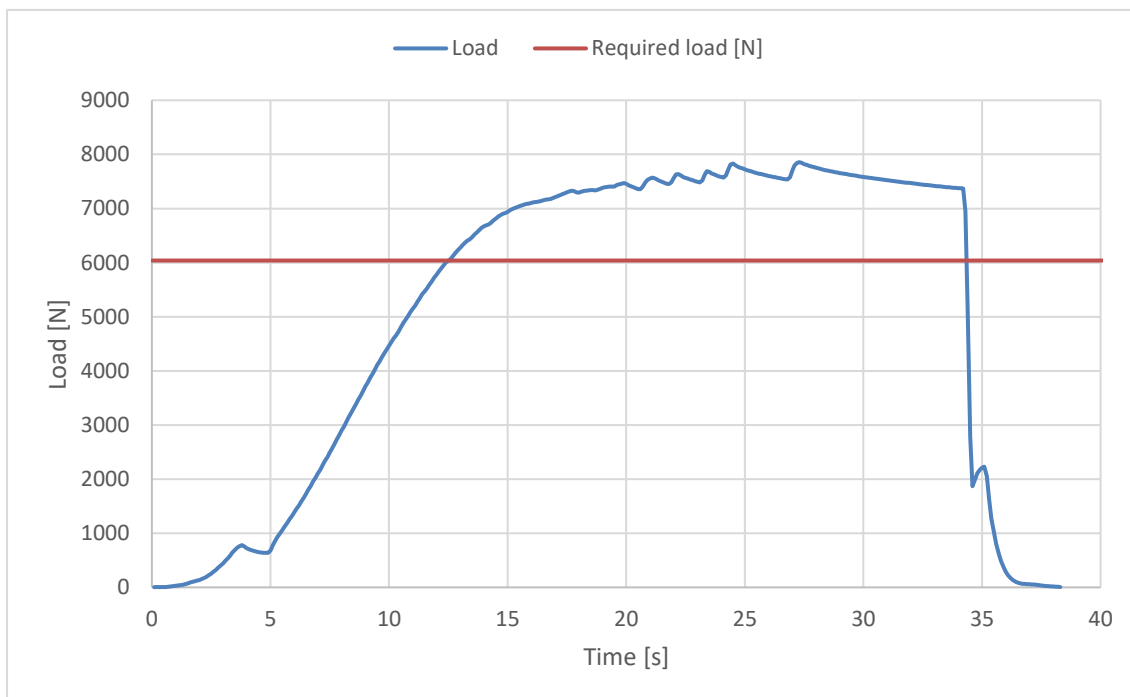
**Test ID 04**

Standard	<b>LTF NfL II 91/09</b>
Reference	<b>5.3.2.3</b>
Test setup	<b>Asymmetric, one riser</b>
Attachment points	<b>One main riser attachment (3)</b>
Anchor points	<b>Dummy (B1,B2)</b>
Required load [g]	<b>6</b>
Required load [N]	<b>6000</b>
Minimum test duration [s]	<b>10</b>
<b>Result</b>	
Test duration [s]	<b>21.8</b>
Any signs of structural failure	<b>No</b>
Test results	<b>POSITIVE</b>

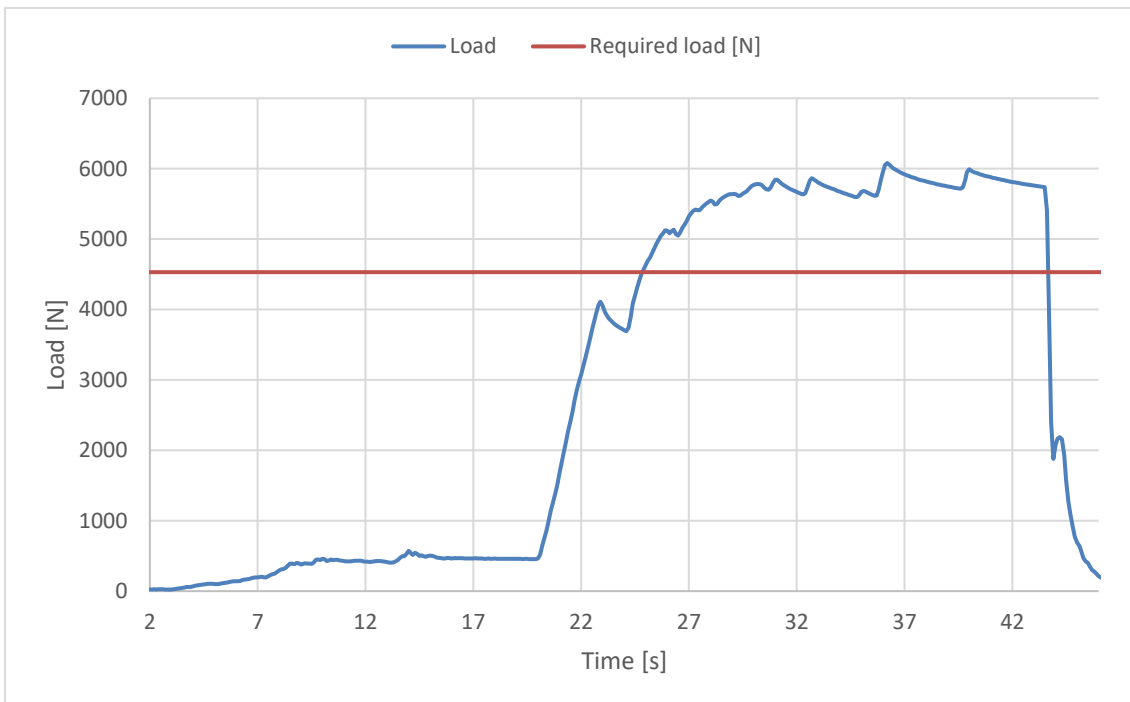
**Test ID 07**

Reference	<b>5.3.2.6</b>	
Test setup	<b>Asymmetric, negative</b>	
Attachment points	<b>One main riser attachment (3 or 4) downwards</b>	
Anchor points	<b>Dummy (9)</b>	
Required load [g]	<b>4.5</b>	
Required load [N]	<b>4500</b>	
Minimum test duration [s]	<b>10</b>	
<b>Result</b>		
Test duration [s]	<b>18.8</b>	
Any signs of structural failure	<b>No</b>	
Test results	<b>POSITIVE</b>

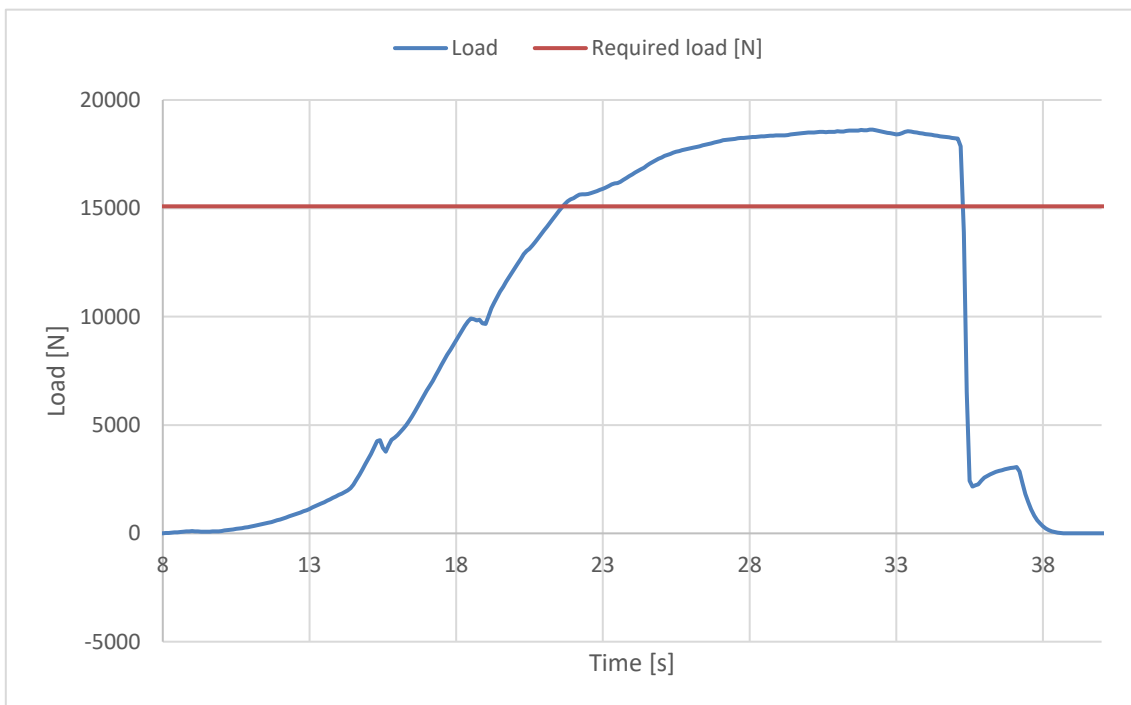
**Test ID 09**

Test duration [s] **13.6**  
 Any signs of structural failure **No**  
 Test results **POSITIVE**

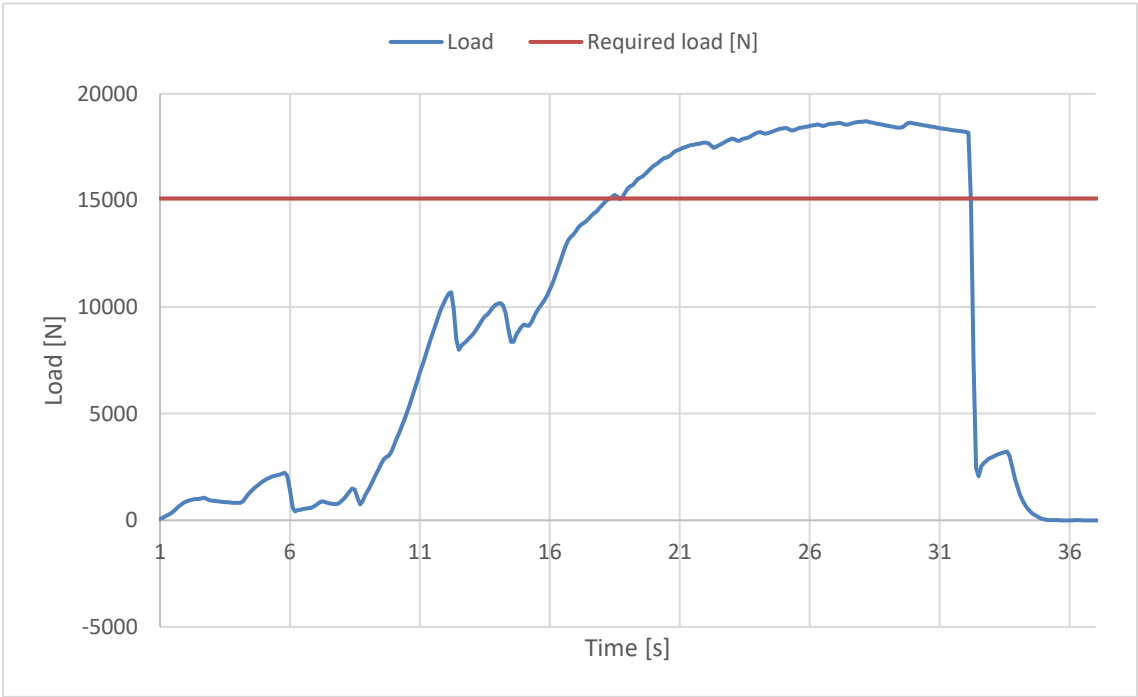
**Test ID 13**

Standard	<b>LTF NfL II 91/09</b>
Reference	<b>5.3.2.7</b>
Test setup	<b>Flying position before landing</b>
Attachment points	<b>Both main riser attachment (3,4)</b>
Anchor points	<b>Dummy (7,8)</b>
Required load [g]	<b>15</b>
Required load [N]	<b>15000</b>
Minimum test duration [s]	<b>5</b>
<b>Result</b>	
Test duration [s]	<b>13.4</b>
Any signs of structural failure	<b>No</b>
Test results	<b>POSITIVE</b>

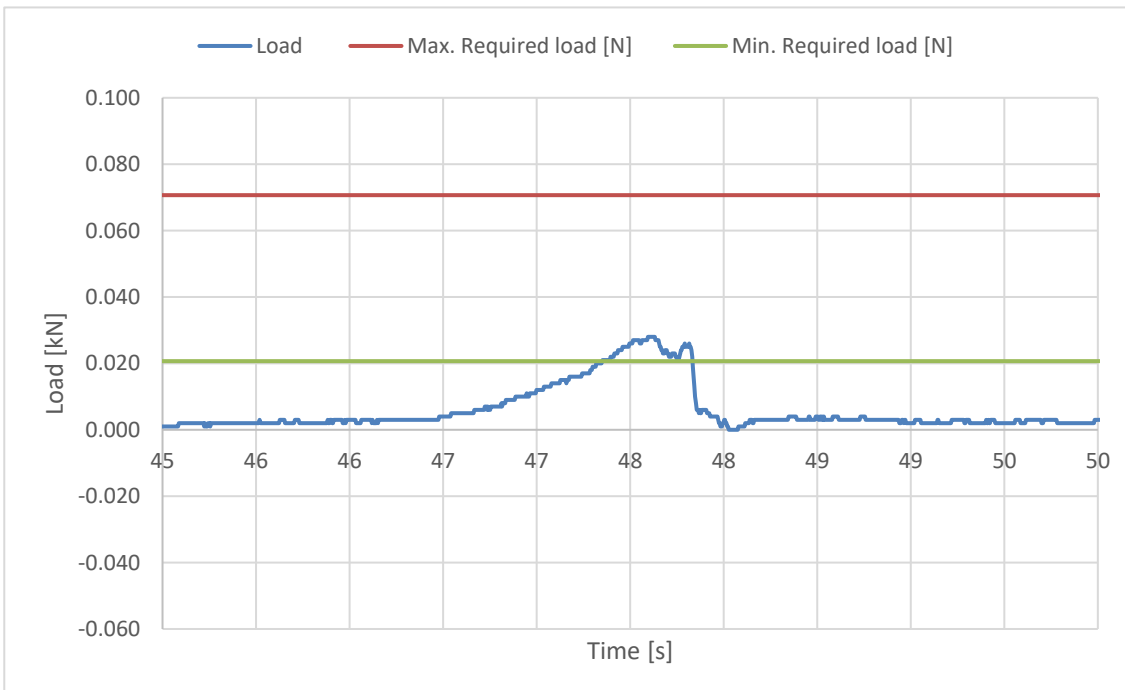
**Test ID RRDT**

Standard	<b>LTF NfL II 91/09</b>
Reference	<b>6.1.5</b>
Test setup	<b>Default flying position</b>
Attachment points	<b>Sensor connect to handle, and pull in opening direction</b>
	The test is to simulate the load required to open the emergency parachute(1st action).
Min. Required load [N]	<b>20</b>
Max. Required load [N]	<b>70</b>
<b>Result</b>	
Load for first action [N]	<b>28.56</b>
Test results	<b>POSITIVE</b>

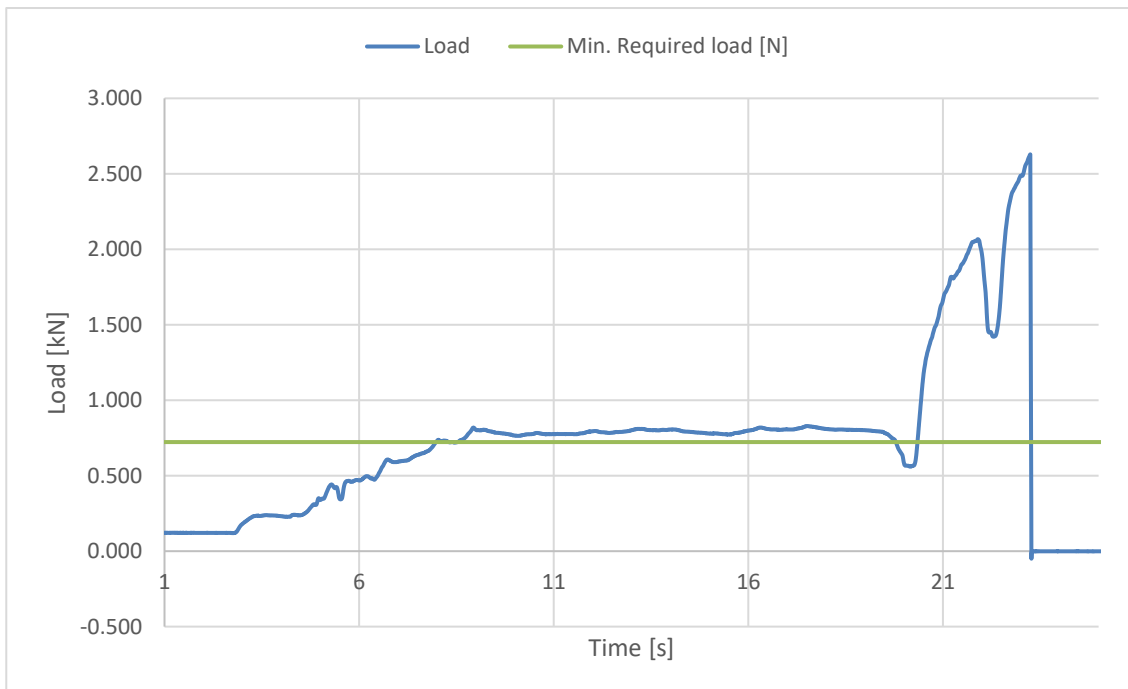
**Test ID RRST**

Standard	<b>EN12491:2015</b>
Reference in standard	<b>5.3.2</b>
Test setup	<b>Two end points of handle</b>
Attachment points	<b>Sensor connect to end of handle, pull on the other side</b>
	The handle must support min 700 N for 10 s, after measure breaking strength
Min. Required load [N]	<b>700</b>
Minimum test duration [s]	<b>10</b>
<b>Result</b>	
Test duration [s]:	<b>11.2</b>
Breaking strength [N]	<b>2606.20</b>
Test results	<b>POSITIVE</b>
