Harness Structural test Report - LTF

Inspection certificate number: **PH_331.2021**

Name: **Strike 2**
 Type: **ABS**
 Size: **M**
 Serial number: **STK2PSM_V2**
 Impact pad type: ⁽¹⁾ **Foam**
 Clip-in weight [kg]: **120**

model: **Strike 2**

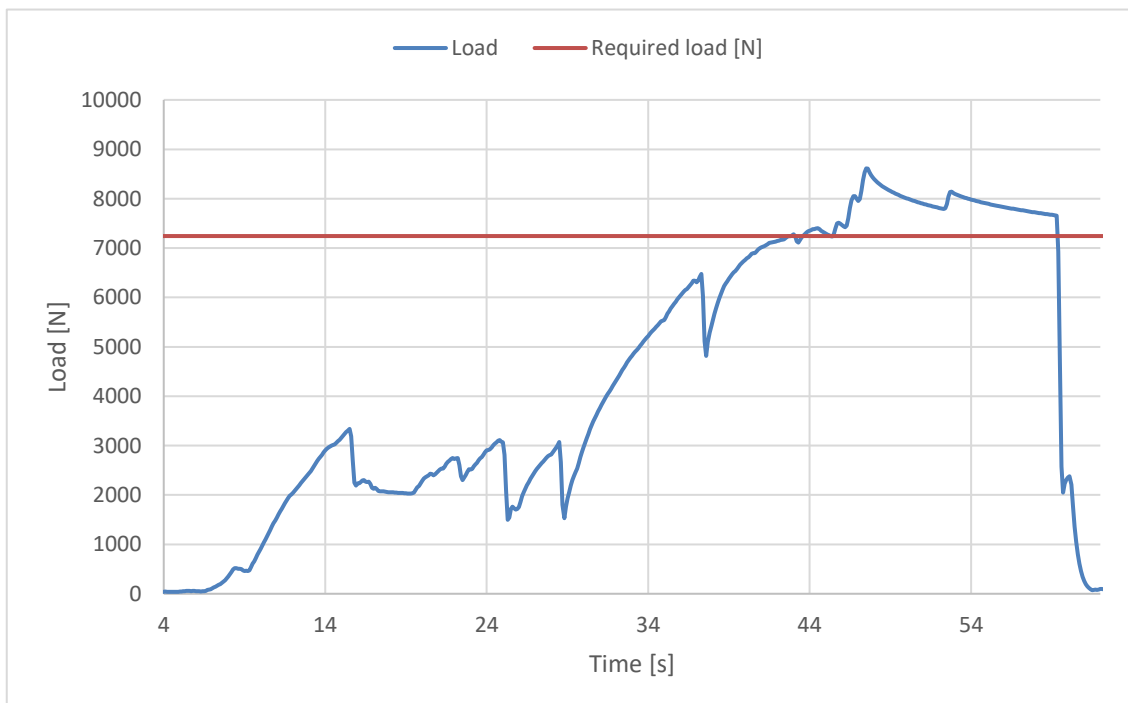
Test ID 02

Standard	LTF NfL II 91/09
Reference	5.3.2.1
Test setup	Default flying position
Attachment points	Both main riser attachment (3,4)
Anchor points	Dummy (B1, B2)
Required load [g]	6
Required load [N]	7200
Minimum test duration [s]	10
Result	
Test duration [s]	13.9
Any signs of structural failure	No
Test results	POSITIVE

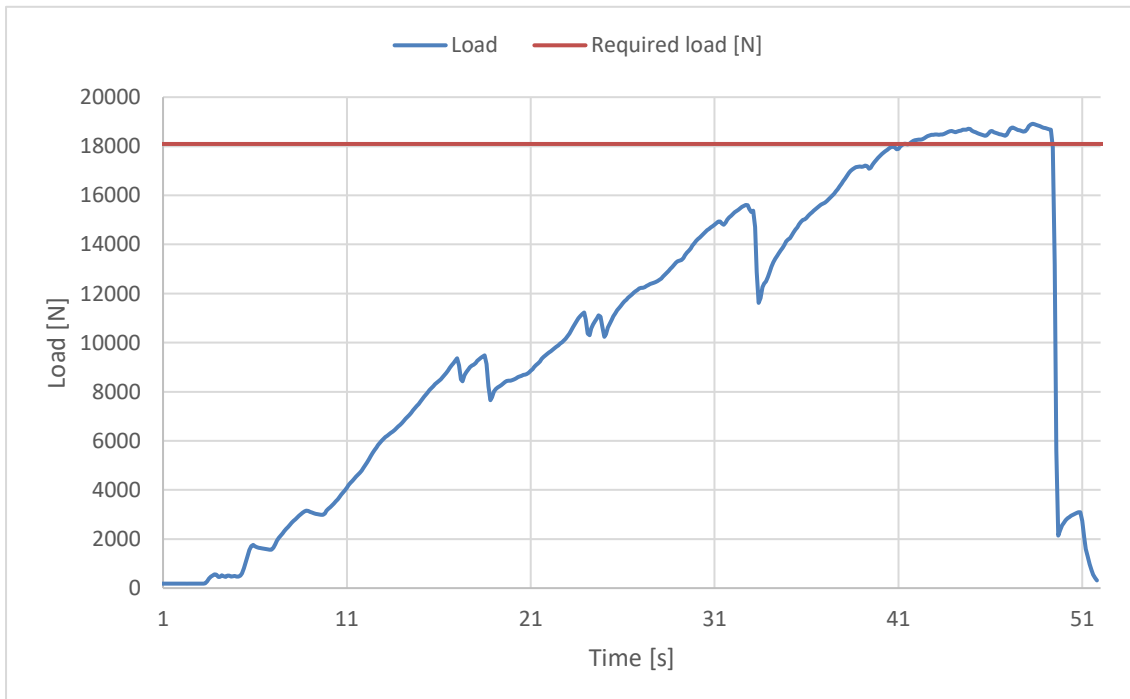
Test ID 03

Standard	LTF NfL II 91/09
Reference	5.3.2.2
Test setup	Default flying position
Attachment points	Both main riser attachment (3,4)
Anchor points	Dummy (B1, B2)
Required load [g]	15
Required load [N]	18000
Minimum test duration [s]	5
Result	
Test duration [s]	7.8
Any signs of structural failure	No
Test results	POSITIVE

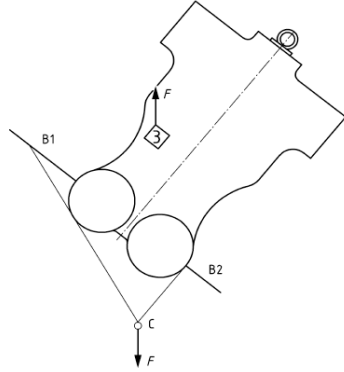
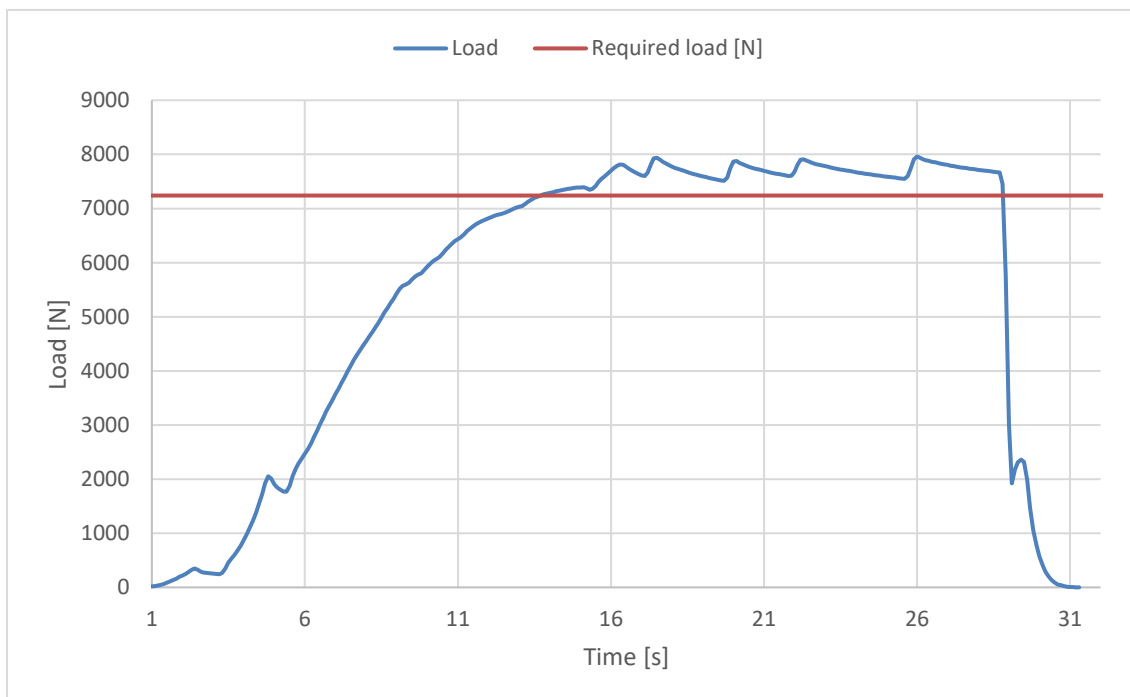
Test ID 04

Standard	LTF NfL II 91/09
Reference	5.3.2.3
Test setup	Asymmetric, one riser
Attachment points	One main riser attachment (3)
Anchor points	Dummy (B1,B2)
Required load [g]	6
Required load [N]	7200
Minimum test duration [s]	10
Result	
Test duration [s]	15.2
Any signs of structural failure	No
Test results	POSITIVE

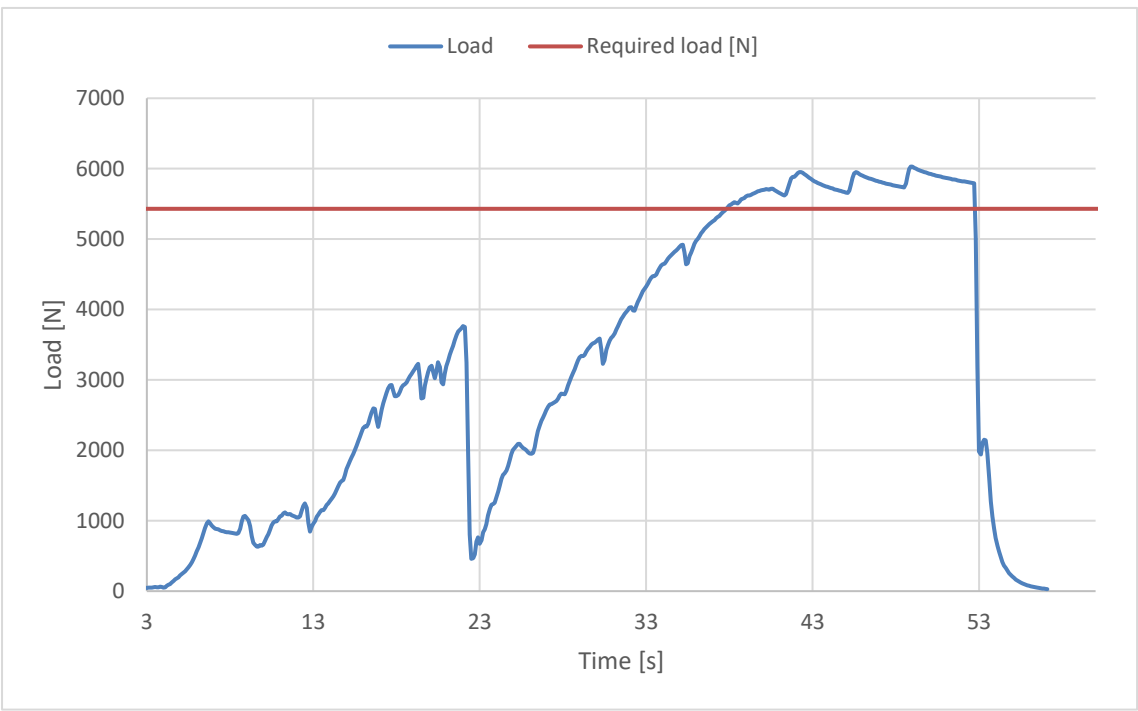
Test ID 07

Reference	5.3.2.6	
Test setup	Asymmetric, negative	
Attachment points	One main riser attachment (3 or 4) downwards	
Anchor points	Dummy (9)	
Required load [g]	4.5	
Required load [N]	5400	
Minimum test duration [s]	10	
Result		
Test duration [s]	14.9	
Any signs of structural failure	No	
Test results	POSITIVE

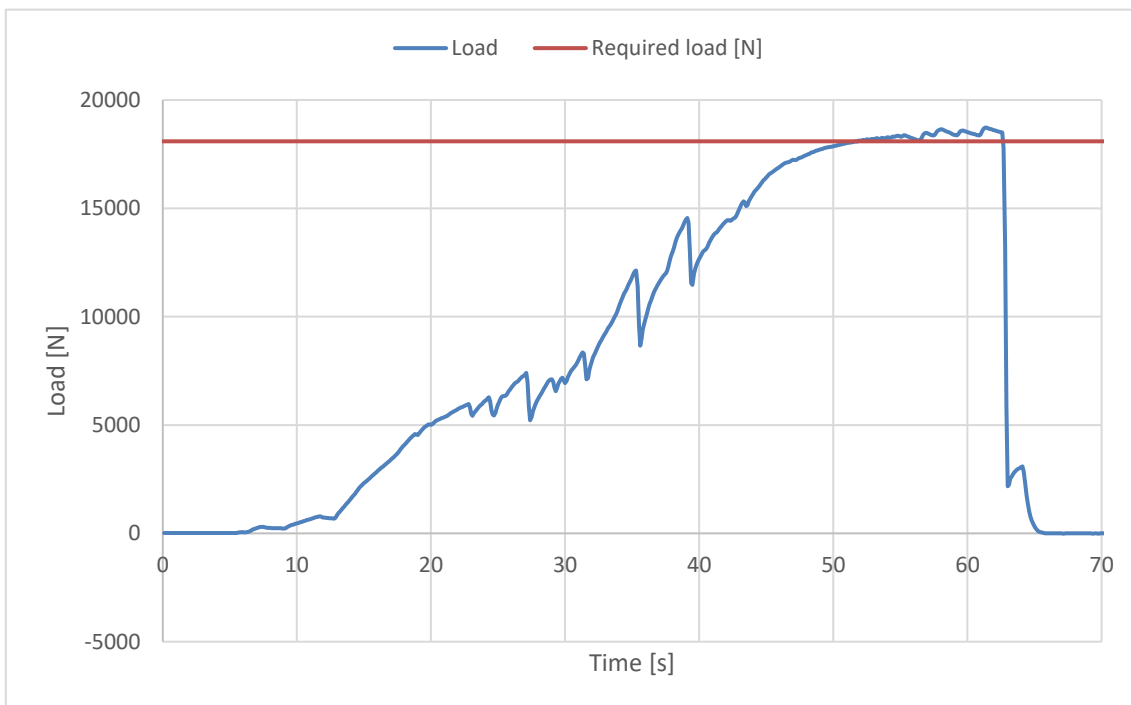
Test ID 09

Standard	LTF NfL II 91/09
Reference	5.3.2.4
Test setup	Rescue attachments
Attachment points	Rescue riser attachment (1,2)
Anchor points	Dummy (B1,B2)
Required load [g]	15
Required load [N]	18000
Minimum test duration [s]	5
Result	
Test duration [s]	10.8
Any signs of structural failure	No
Test results	POSITIVE

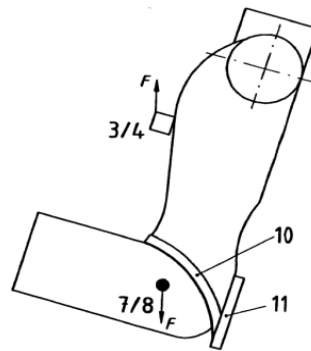
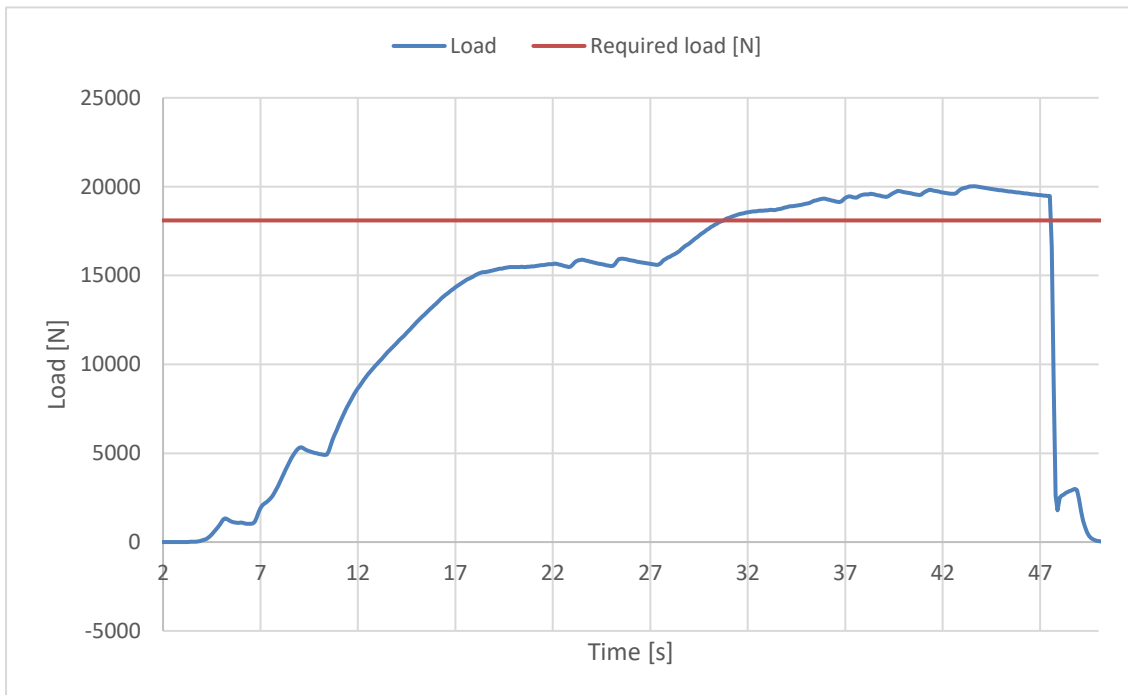
Test ID 13

Standard **LTF NfL II 91/09**
 Reference **5.3.2.7**
 Test setup **Flying position before landing**
 Attachment points **Both main riser attachment (3,4)**
 Anchor points **Dummy (7,8)**

Test duration [s] **16.8**
 Any signs of structural failure **No**
 Test results **POSITIVE**

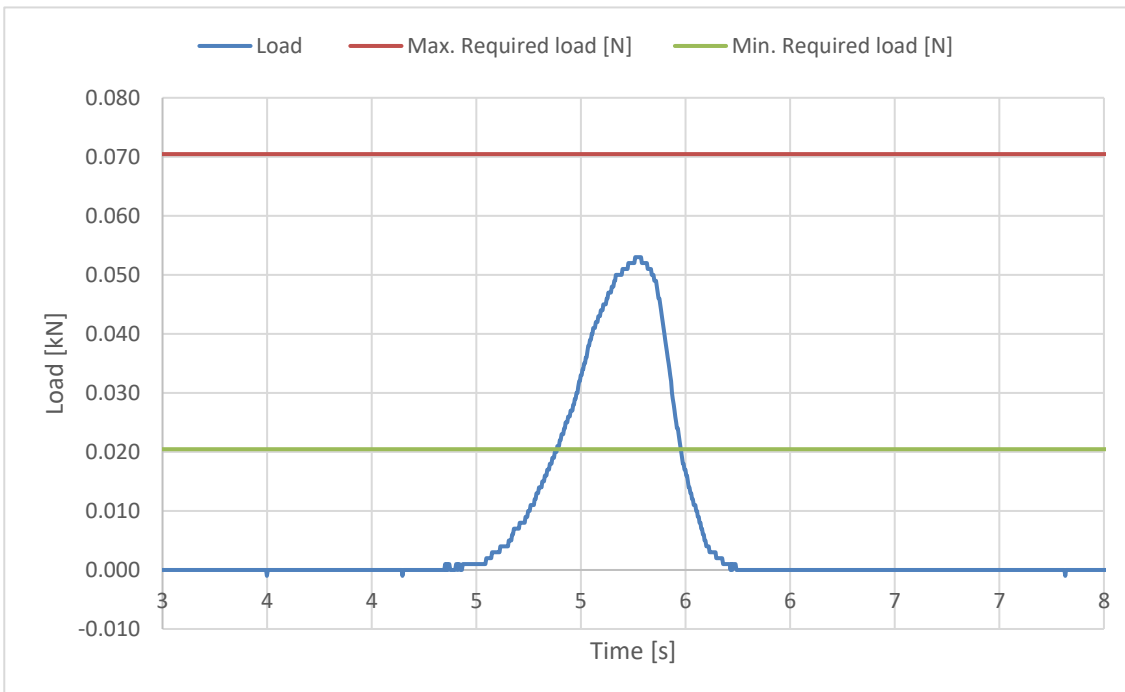
Test ID RRDT

Standard	LTF NfL II 91/09
Reference	6.1.5
Test setup	Default flying position
Attachment points	Sensor connect to handle, and pull in opening direction The test is to simulate the load required to open the emergency parachute(1st action).
Min. Required load [N]	20
Max. Required load [N]	70
Result	
Load for first action [N]	52.54
Test results	POSITIVE

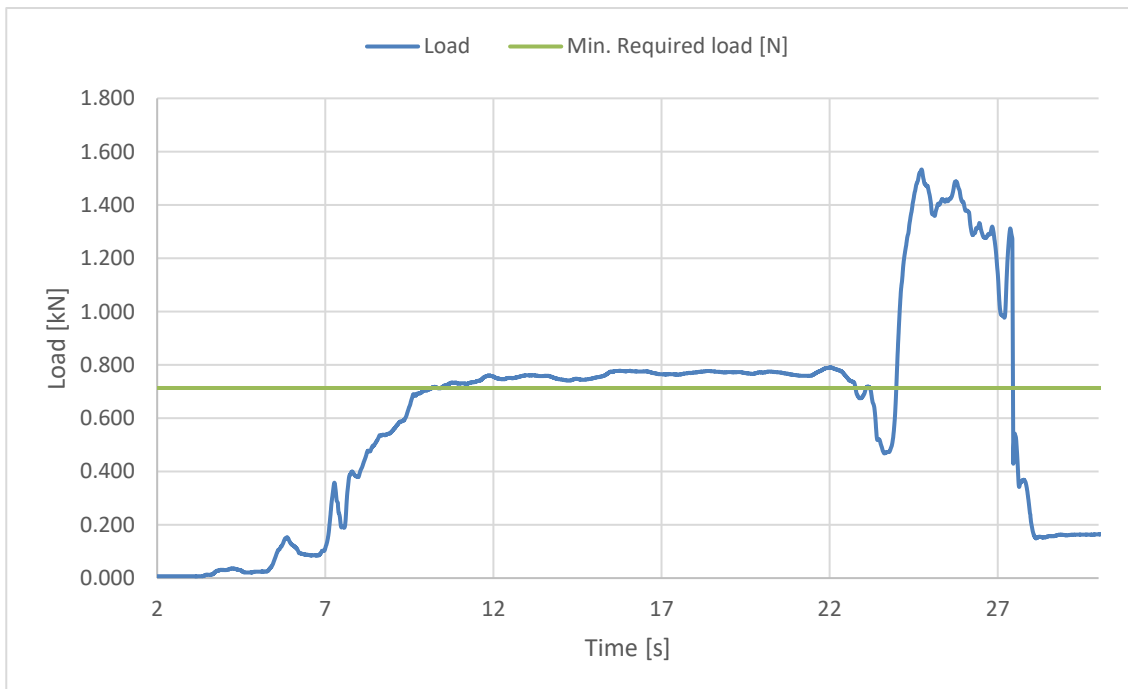
Test ID RRST

Standard	EN12491:2015
Reference in standard	5.3.2
Test setup	Two end points of handle
Attachment points	Sensor connect to end of handle, pull on the other side
	The handle must support min 700 N for 10 s, after measure breaking strength
Min. Required load [N]	700
Minimum test duration [s]	10
Result	
Test duration [s]:	12.3
Breaking strength [N]	1519.71
Test results	POSITIVE
