Harness Structural test Report - EN

Inspection certificate number: **PH_336.2021**

Name: **TAG**
 Type: **Zip Harness**
 Size: **L**
 Serial number: **23031202/08**
 Impact pad type: ⁽¹⁾ **n/a**
 Clip-in weight [kg]: **120**

Summary of Structural test

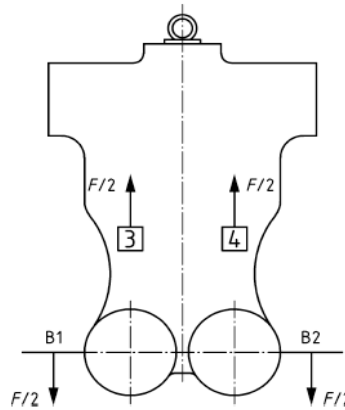
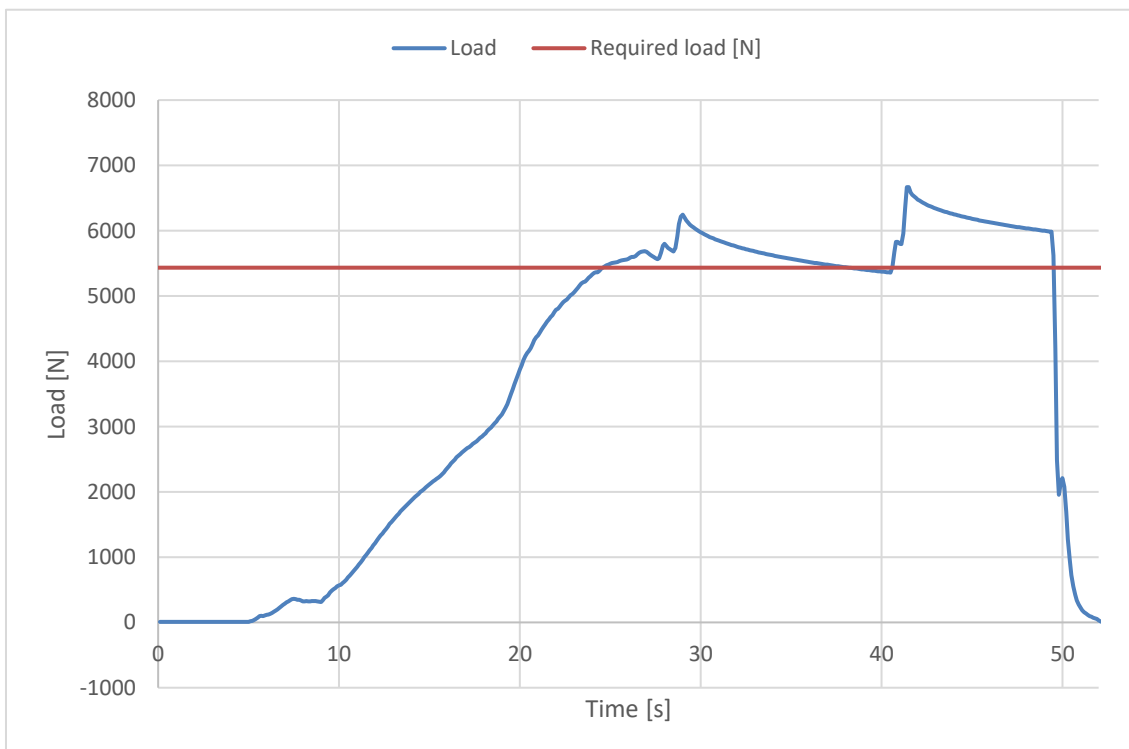
Test ID 01

Test duration [s]	13.6
Any signs of structural failure	No
Slippery test OK	Yes
Test results	POSITIVE

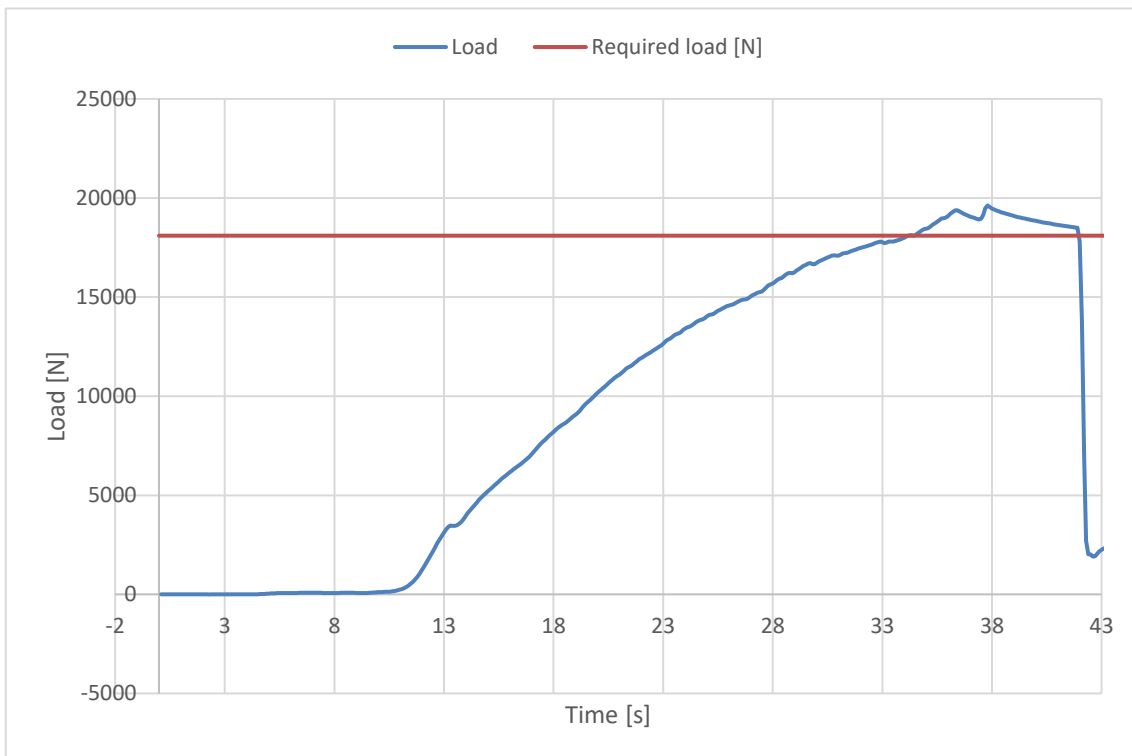
Test ID 03

Test duration [s] **7.5**
 Any signs of structural failure **No**
 Slippery test OK **Yes**
 Test results **POSITIVE**

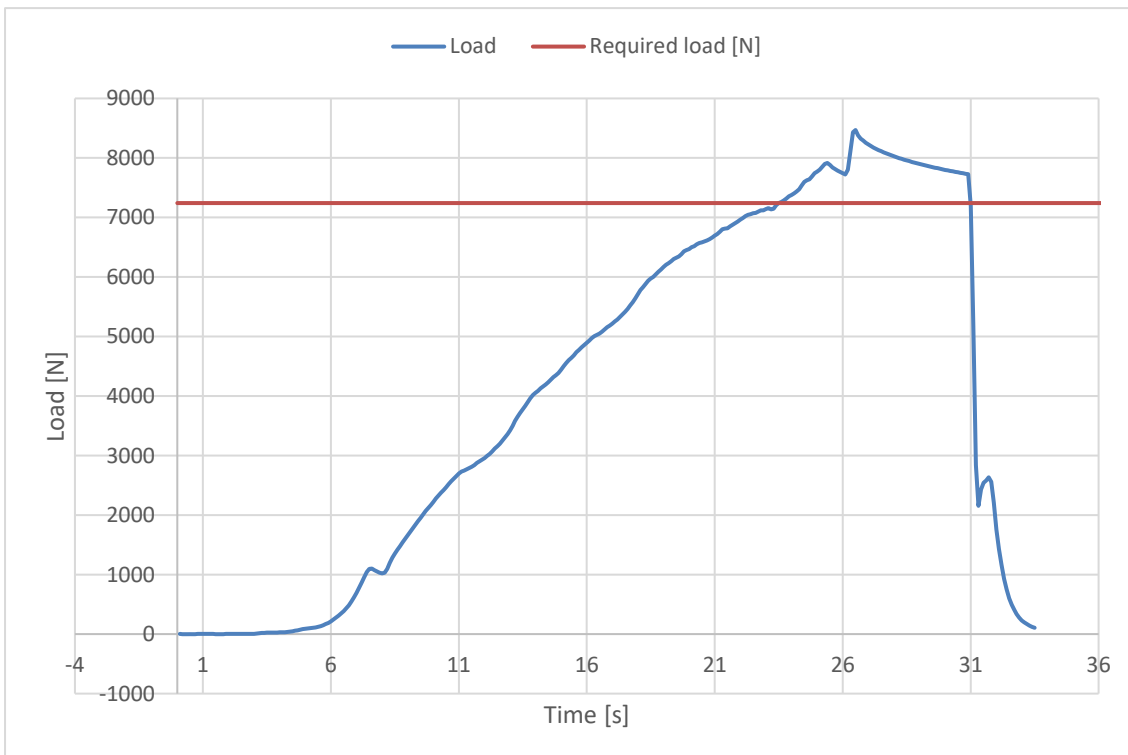
Test ID 05

Standard	EN 1651
Reference in standard	5.5.1.2
Test setup	Positive asymmetric load
Attachment points	One riser attachment (3 or 4)
Anchor points	Dummy (C)
Required load [g]	6
Required load [N]	7200
This harness is not made for paragliding. Only for Zipline.	
Result	
Test duration [s]	7.5
Any signs of structural failure	No
Test results	POSITIVE

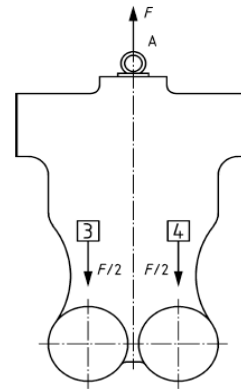
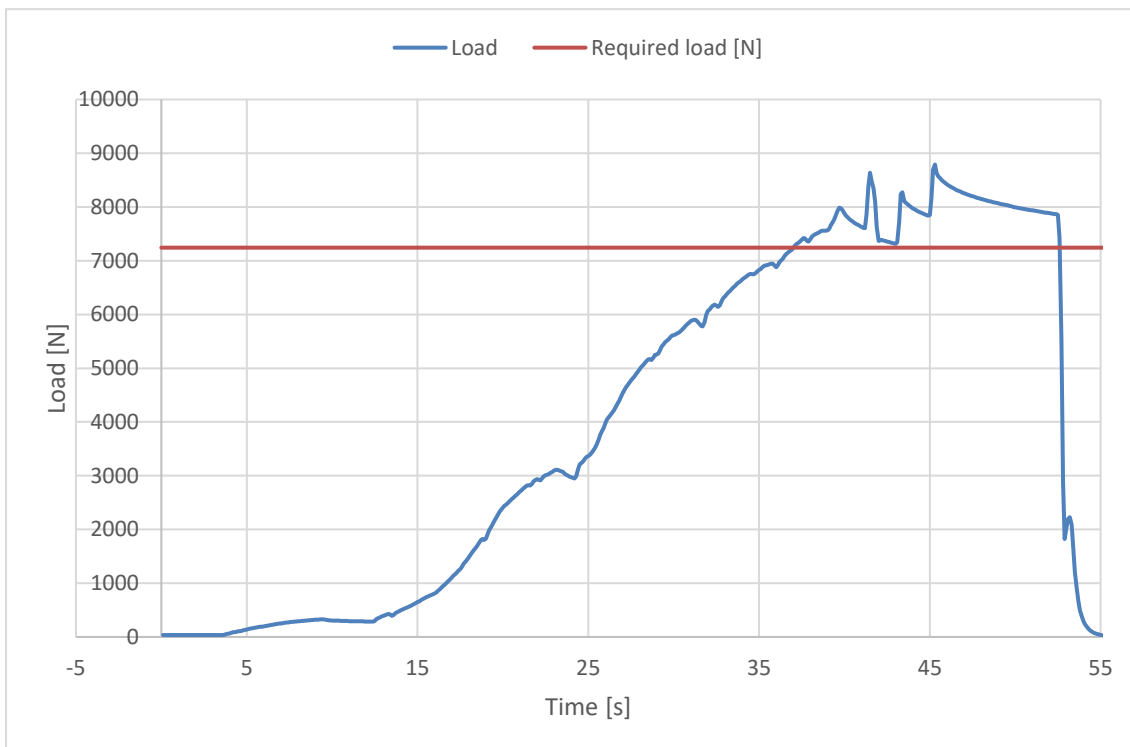
Test ID 06

Test duration [s]	15.6
Any signs of structural failure	No
Test results	POSITIVE

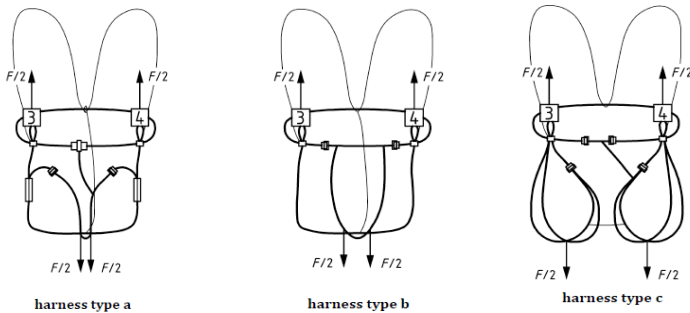
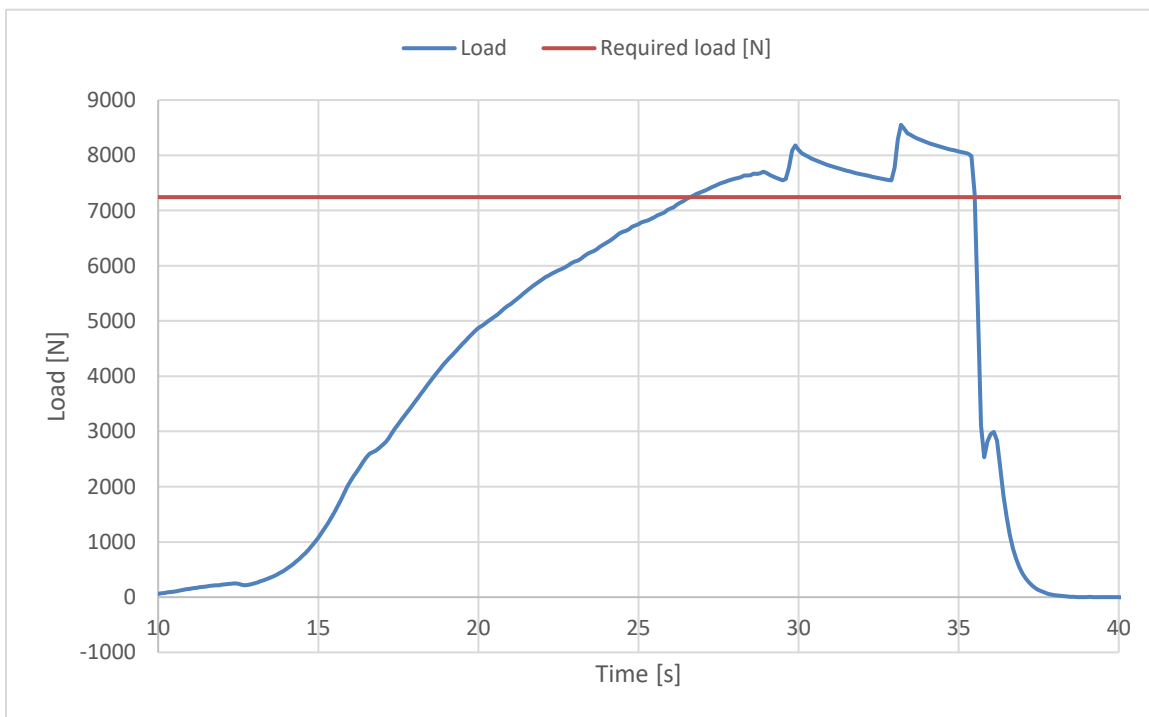
Test ID 12

Test duration [s]	8.9
Any signs of structural failure	No
Slippery test OK	Yes
Test results	POSITIVE
