Harness Structural test Report

Inspection certificate number: **PH_336.2021**

Name: **TAG**
 Type: **Zip Harness**
 Size: **L**
 Serial number: **23031202/08**

Date of test: **25.05.2021**

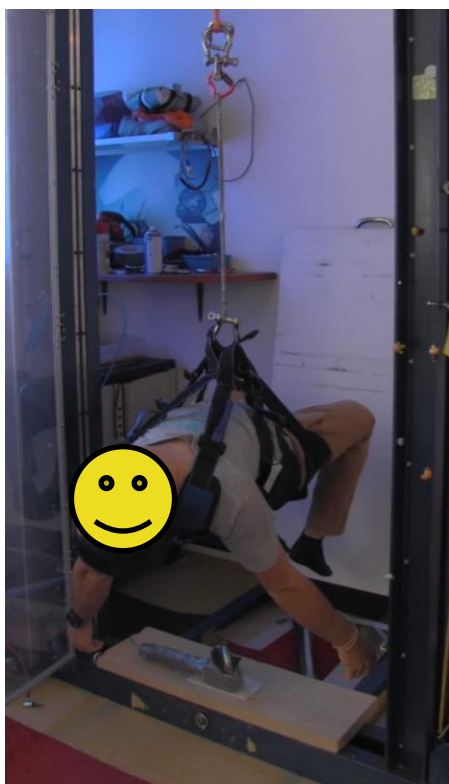
Test ID 1

Standard	EN 12277
Reference in standard	5.2.3.1
Test setup	Default sitting position
Attachment points	Both main attachment point

This test shows that an unconscious person doesn't turn upside down

Any signs of structural failure **No**

Test results **POSITIVE**

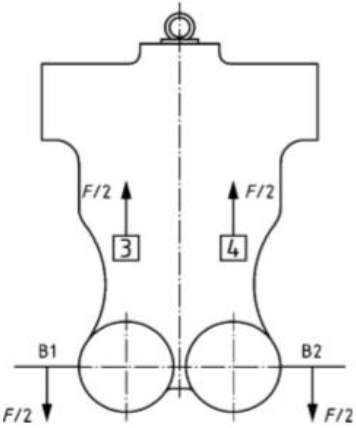
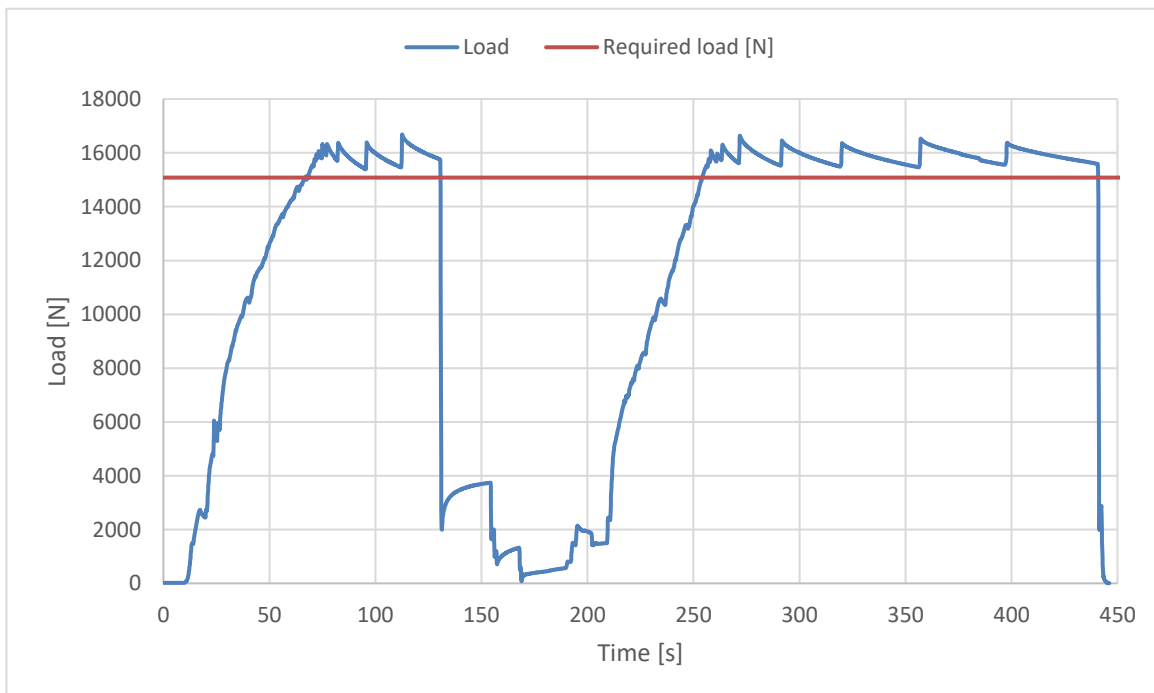
Test ID 2

Standard	EN 12277	
Reference in standard	5.2.3.2	
Test setup	n/a	
Attachment points	Both main attachment point (3,4)	
Anchor points	Dummy (B1, B2)	
	1st loading	2nd loading
Required load [N]	15000	15000
Minimum test duration [s]	60	180
Result	No	
Any signs of structural failure	POSITIVE	
Test results

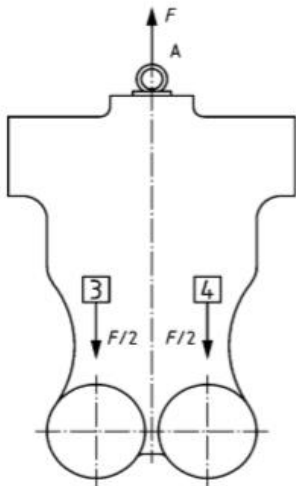
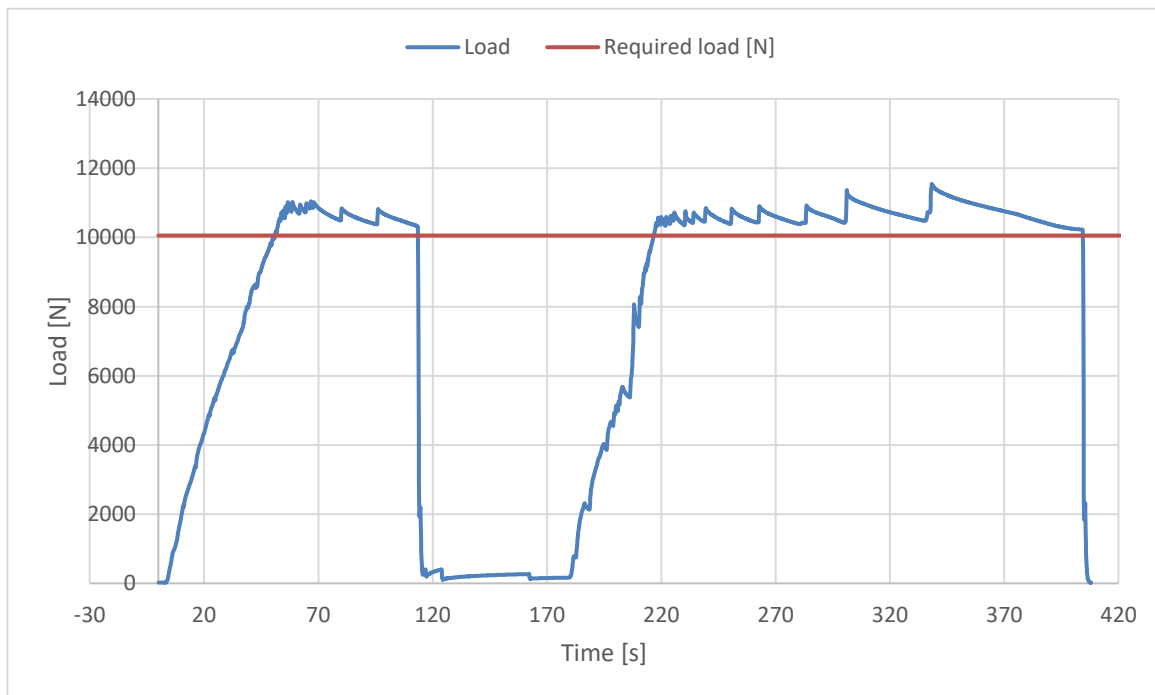
Test ID 4

Reference in standard	5.2.3.3		
Test setup	n/a		
Attachment points	Both main attachment point (3,4)		
Anchor points	Dummy (A)		
	1st loading	2nd loading	
Required load [N]	10000	10000	
Minimum test duration [s]	60	180	
Result			
Any signs of structural failure	No		
Test results	POSITIVE
