# Harness Structural test Report

Inspection certificate number: **PH\_290.2019**
**Manufacturer data:**

Manufacturer name: **Davinci Products Inc.**  
 Representative: **Jihun Lee**  
 Street: **63 sinchon-gil, Okcheon-myeon, Yangpy**  
 Post code place: **Gyeonggi-do 12505**  
 Country: **Republic of Korea**

Name: **Soul**  
 Type: **ABS**  
 Size: **M**  
 Serial number: **HS-KF-111002**  
 Impact pad type: <sup>(1)</sup> **Foam**  
 Clip-in weight [kg]: **120**

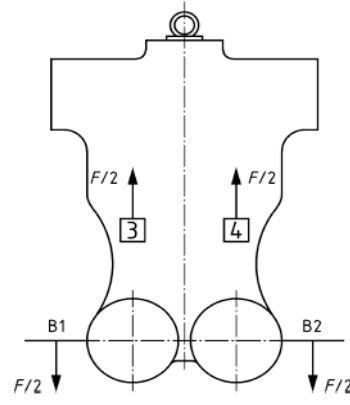
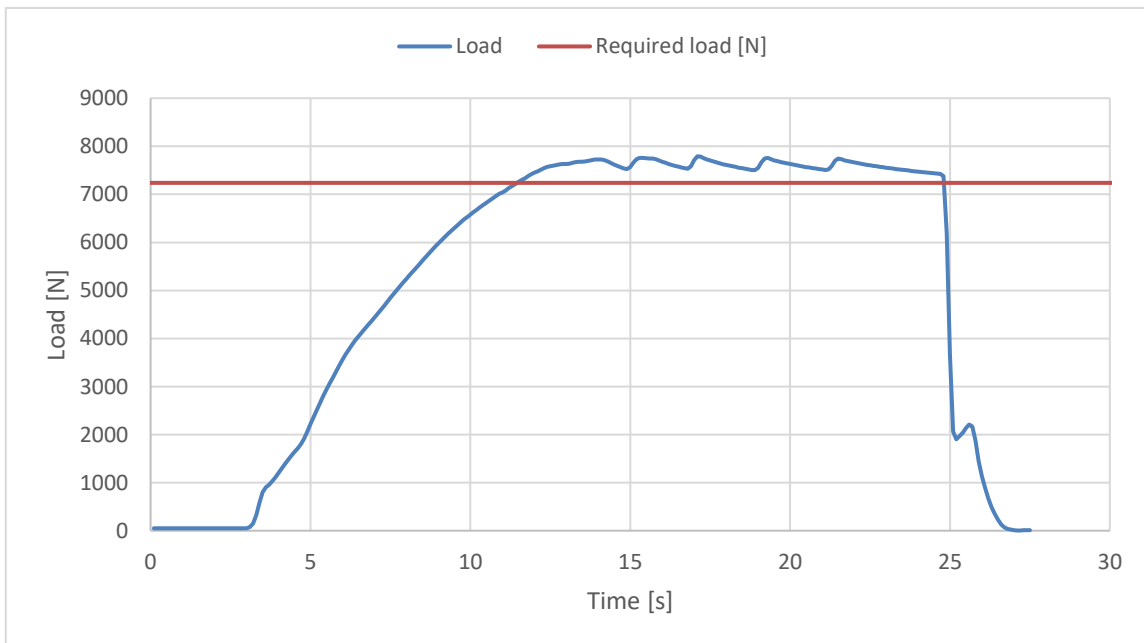
**Test ID 02**

Standard	<b>EN 1651:1999</b>
Reference in standard	<b>5.3.2.1</b>
Test setup	<b>Default flying position</b>
Attachment points	<b>Both main riser attachment (3,4)</b>
Anchor points	<b>Dummy (B1, B2)</b>
Required load [g]	<b>6</b>
Required load [N]	<b>7200</b>
Minimum test duration [s]	<b>10</b>
<b>Result</b>	
Test duration [s]	<b>13.4</b>
Any signs of structural failure	<b>No</b>
Test results	<b>POSITIVE</b>

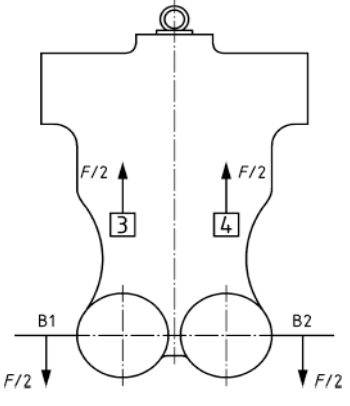
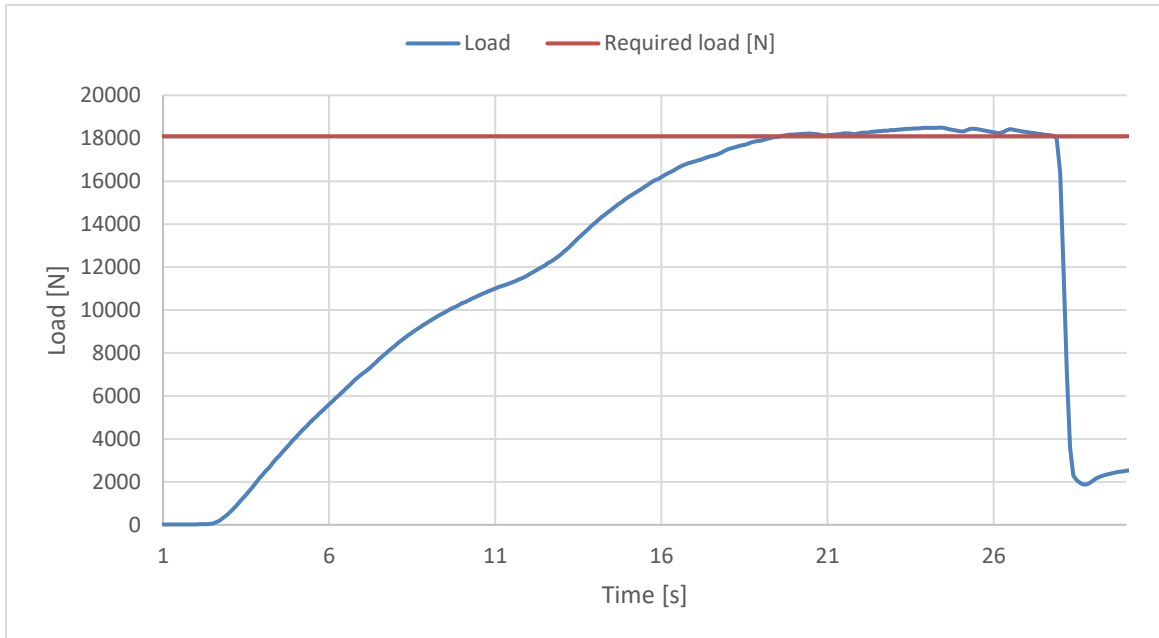
**Test ID 03**

Reference in standard	<b>5.3.2.2</b>	
Test setup	<b>Default flying position</b>	
Attachment points	<b>Both main riser attachment (3,4)</b>	
Anchor points	<b>Dummy (B1, B2)</b>	
Required load [g]	<b>15</b>	
Required load [N]	<b>18000</b>	
Minimum test duration [s]	<b>5</b>	
<b>Result</b>		
Test duration [s]	<b>8.3</b>	
Any signs of structural failure	<b>No</b>	
Test results	<b>POSITIVE</b>

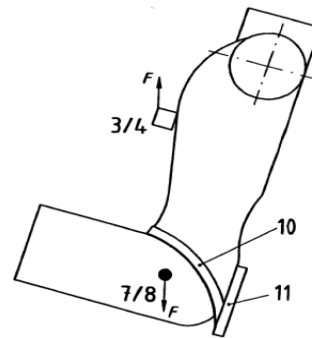
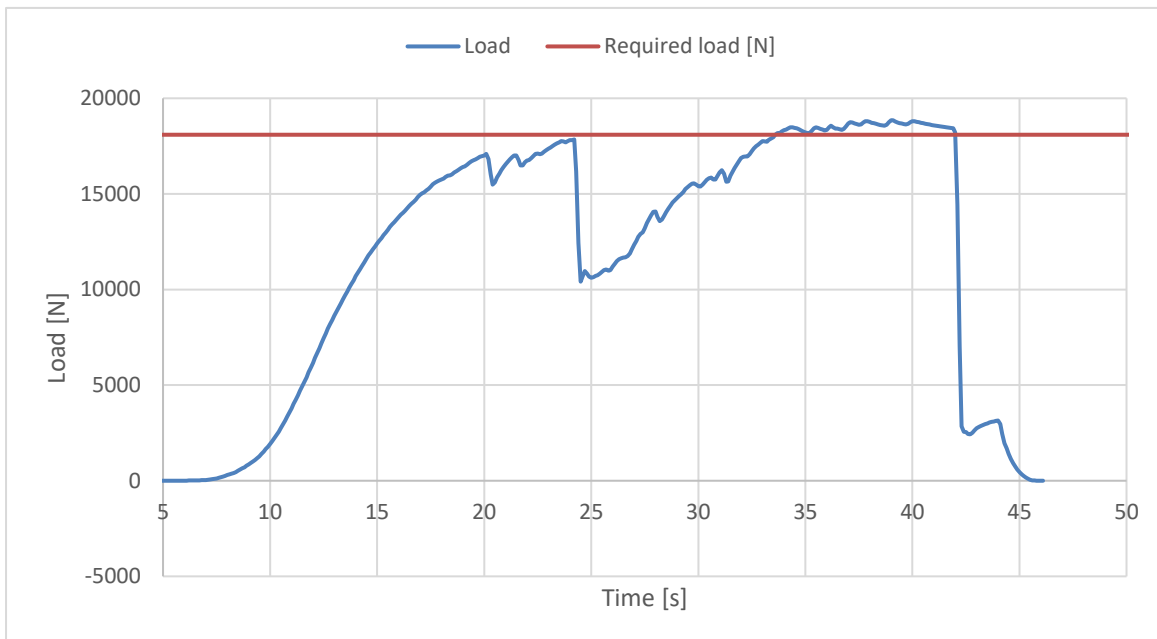
**Test ID 13**

Standard	<b>EN 1651:1999</b>
Reference in standard	<b>5.3.2.7</b>
Test setup	<b>Flying position before landing</b>
Attachment points	<b>Both main riser attachment (3,4)</b>
Anchor points	<b>Dummy (7,8)</b>
Required load [g]	<b>15</b>
Required load [N]	<b>18000</b>
Minimum test duration [s]	<b>5</b>

Test duration [s]	<b>8.5</b>
Any signs of structural failure	<b>No</b>
Test results	<b>POSITIVE</b>

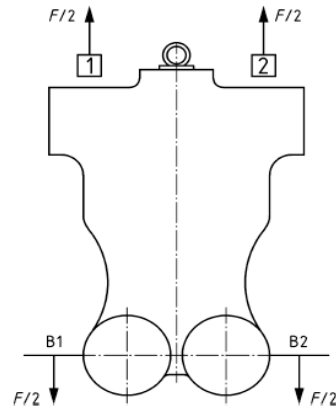
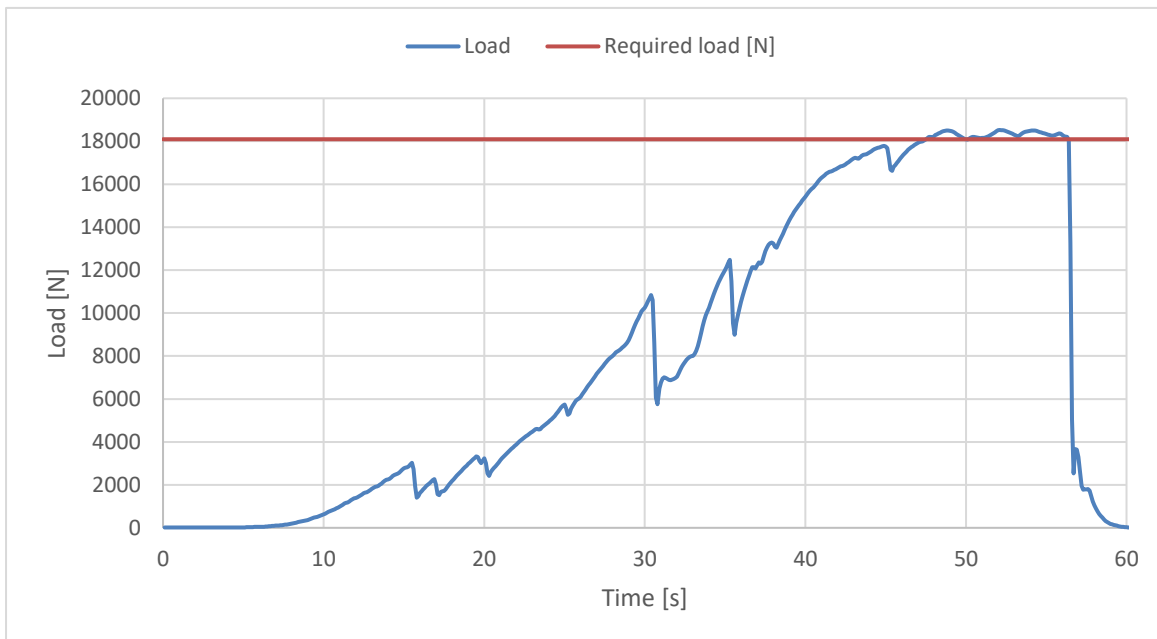
**Test ID 09**

Standard **EN 1651:1999**  
 Reference in standard **5.3.2.4**  
 Test setup **Rescue attachments**  
 Attachment points **Rescue riser attachment (1,2)**  
 Anchor points **Dummy (B1,B2)**

Test duration [s] **6.2**  
 Any signs of structural failure **No**  
 Test results **POSITIVE**

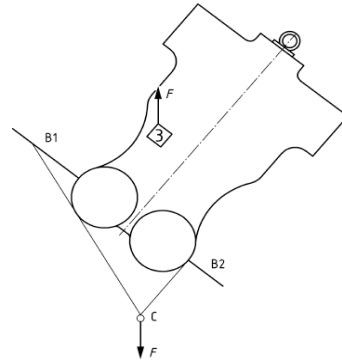
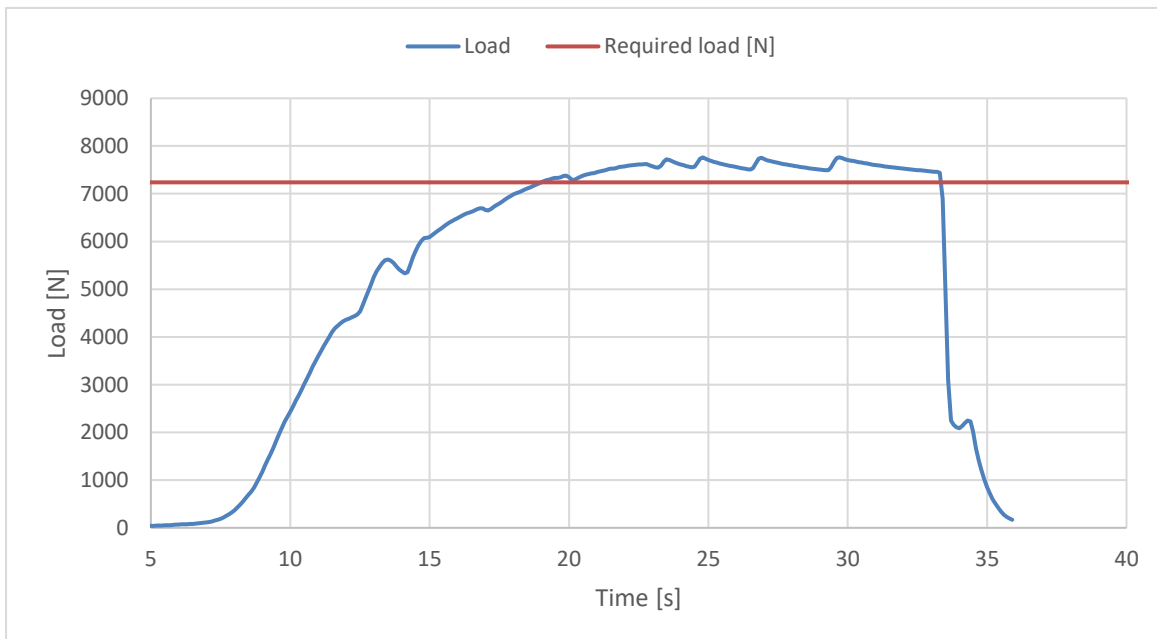
**Test ID 04**

Standard **EN 1651:1999**  
 Reference in standard **5.3.2.3**  
 Test setup **Asymmetric, one riser**  
 Attachment points **One main riser attachment (3)**  
 Anchor points **Dummy (B1,B2)**

Test duration [s] **14.4**  
 Any signs of structural failure **No**  
 Test results **POSITIVE**

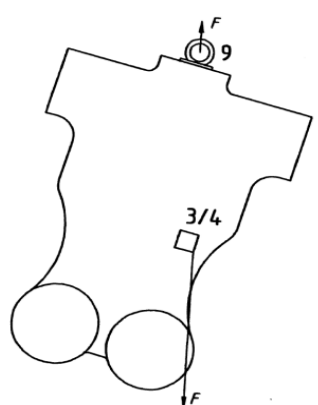
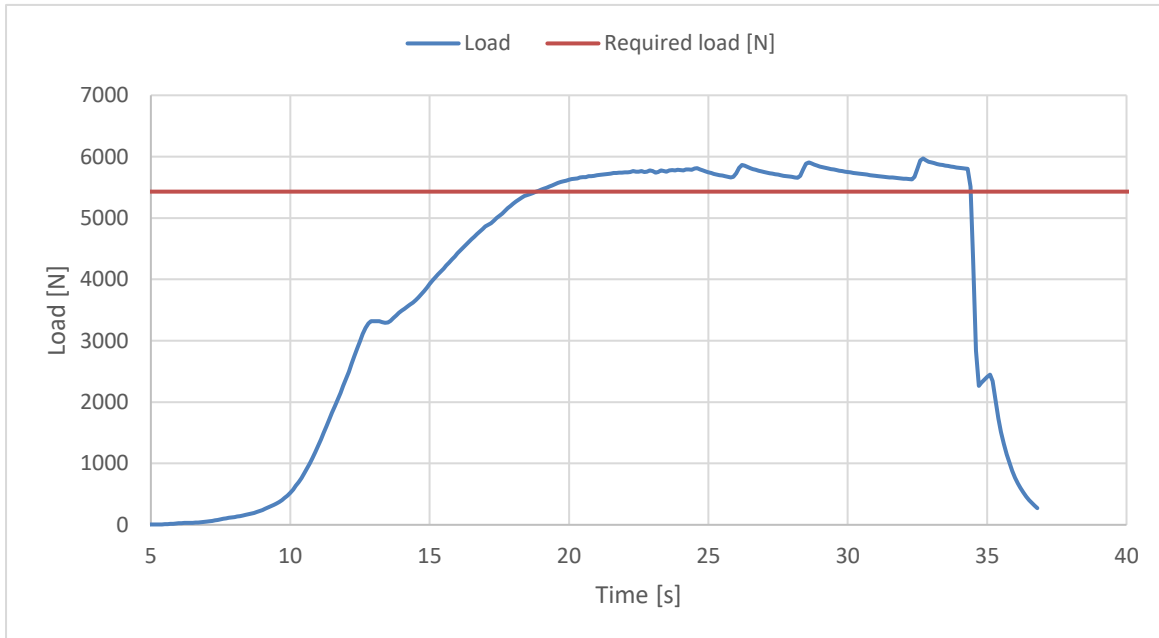
**Test ID 07**

Reference in standard	<b>5.3.2.6</b>	
Test setup	<b>Asymmetric, negative</b>	
Attachment points	<b>One main riser attachment (3 or 4) downwards</b>	
Anchor points	<b>Dummy (9)</b>	
Required load [g]	<b>4.5</b>	
Required load [N]	<b>5400</b>	
Minimum test duration [s]	<b>10</b>	
<b>Result</b>		
Test duration [s]	<b>15.6</b>	
Any signs of structural failure	<b>No</b>	
Test results	<b>POSITIVE</b>

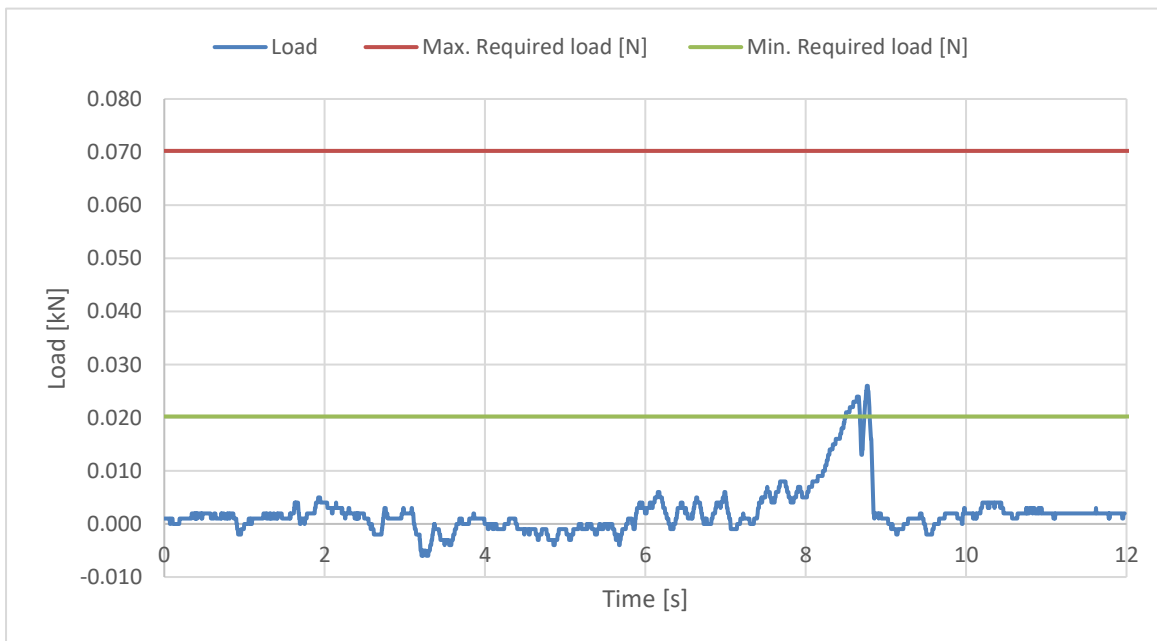
**Test ID RRDT**

Standard **LTF NfL II 91/09**  
 Reference in standard **6.1.5**  
 Test setup **Default flying position**  
 Attachment points **Sensor connect to handle, and pull in opening direction**  
 The test is to simulate the load required to open the emergency parachute(1st action).

Load for first action [N] **25.77**  
 Test results **POSITIVE**

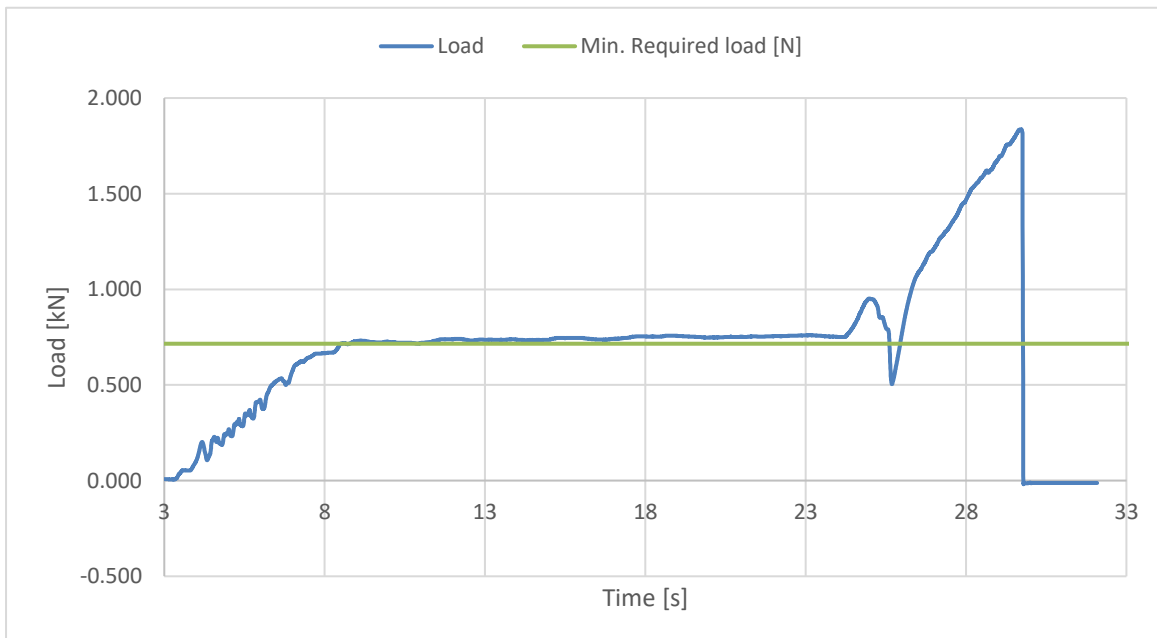
**Test ID RRST**

Standard	<b>EN12491:2015</b>
Reference in standard	<b>5.3.2</b>
Test setup	<b>Two end points of handle</b>
Attachment points	<b>Sensor connect to end of handle, pull on the other side</b>
	The handle must support min 700 N for 10 s, after measure breaking strength
Min. Required load [N]	<b>700</b>
Minimum test duration [s]	<b>10</b>
<b>Result</b>	
Test duration [s]:	<b>16.8</b>
Breaking strength [N]	<b>1821.07</b>
Test results	<b>POSITIVE</b>
