# Harness Structural test Report - EN

Inspection certificate number: **PH\_337.2021**

Name: **Runa**  
 Type: **ABS**  
 Size: **L**  
 Serial number: **55.L.4-0621-144**  
 Impact pad type: <sup>(1)</sup> **Inflatable**  
 Clip-in weight [kg]: **120**  
 Date of test: **21.06.2021**

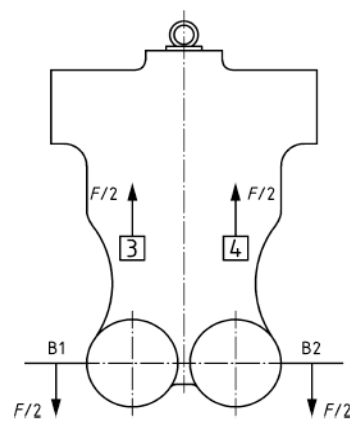
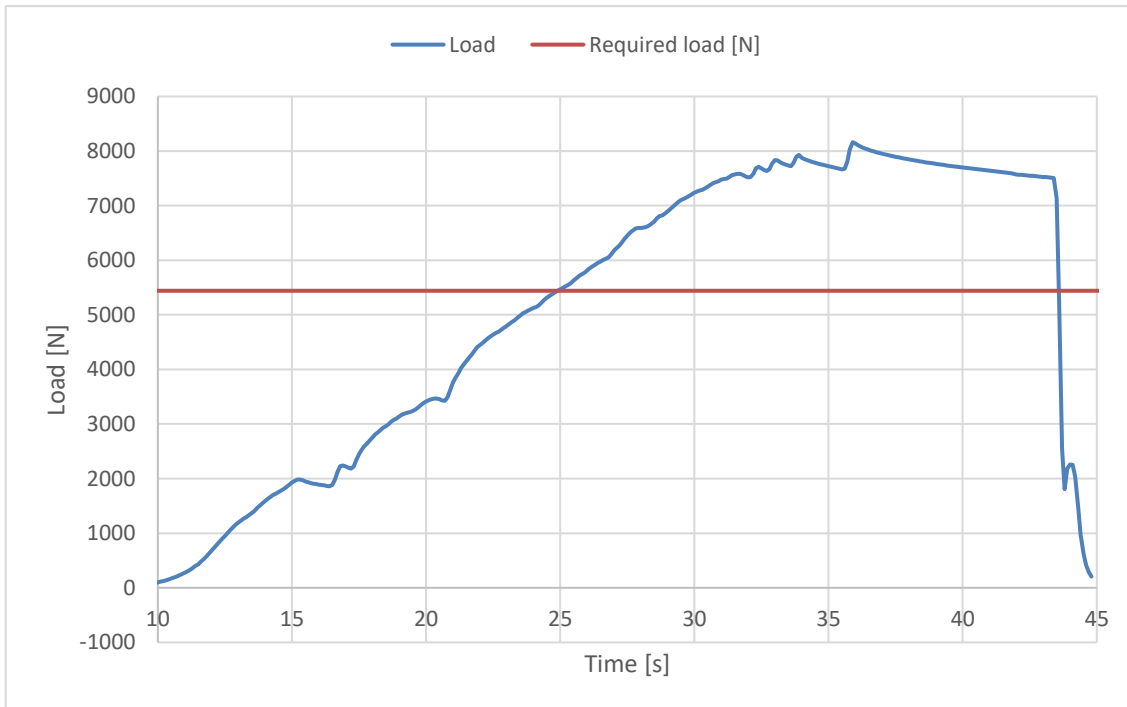
**Test ID 01**

Standard	<b>EN 1651</b>
Reference in standard	<b>5.5.1.1</b>
Test setup	<b>Positive symmetric load (Slippage)</b>
Attachment points	<b>Both main riser attachment (3,4)</b>
Anchor points	<b>Dummy (B1, B2)</b>
Required load [g]	<b>4.5</b>
Required load [N]	<b>5400</b>
Minimum test duration [s]	<b>5</b>
<b>Result</b>	
Test duration [s]	<b>18.7</b>
Any signs of structural failure	<b>No</b>
Slippery test OK	<b>Yes</b>
Test results	<b>POSITIVE</b>

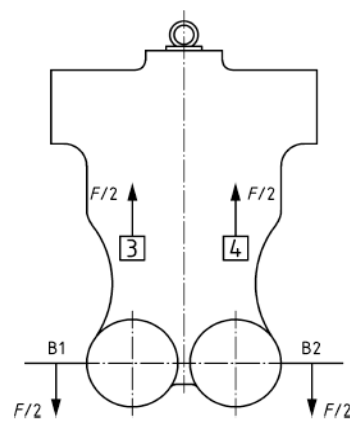
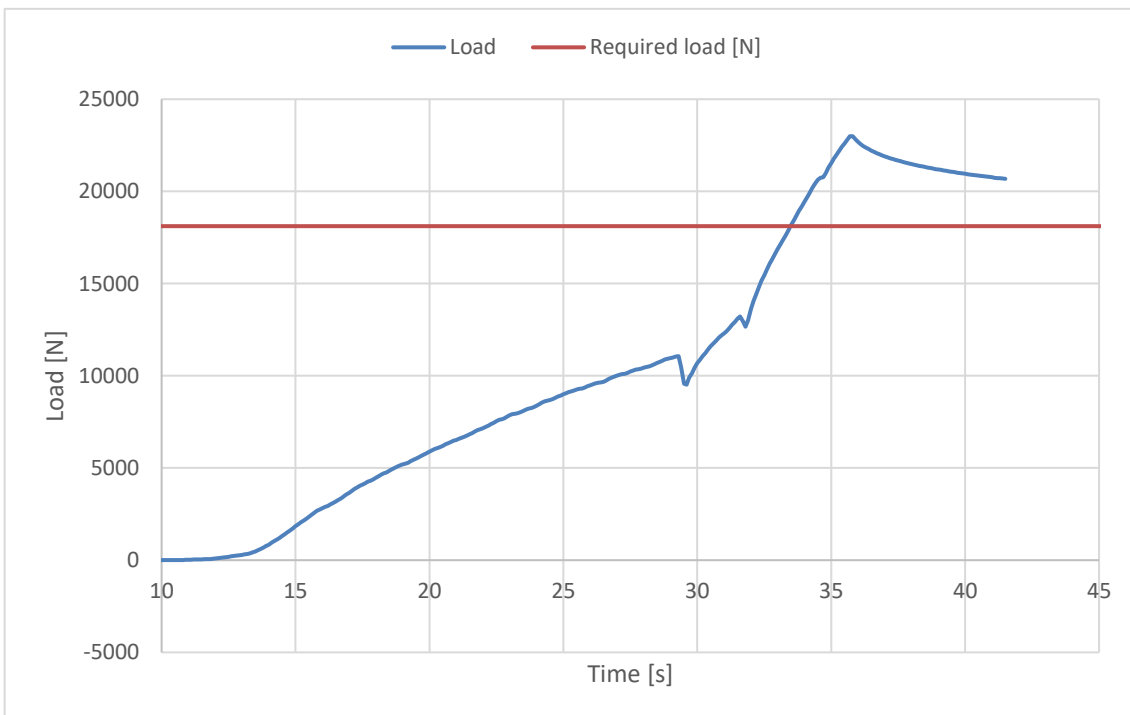
**Test ID 03**

Standard	<b>EN 1651</b>
Reference in standard	<b>5.5.1.1b</b>
Test setup	<b>Positive symmetric load</b>
Attachment points	<b>Both main riser attachment (3,4)</b>
Anchor points	<b>Dummy (B1, B2)</b>
Required load [g]	<b>15</b>
Required load [N]	<b>18000</b>
Minimum test duration [s]	<b>5</b>
<b>Result</b>	
Test duration [s]	<b>8.1</b>
Any signs of structural failure	<b>No</b>
Slippery test OK	<b>Yes</b>
Test results	<b>POSITIVE</b>

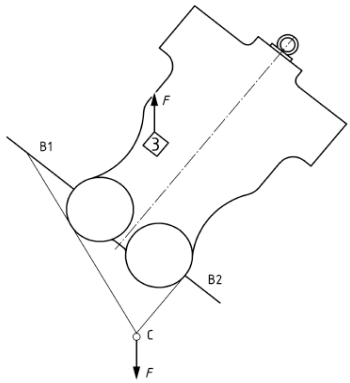
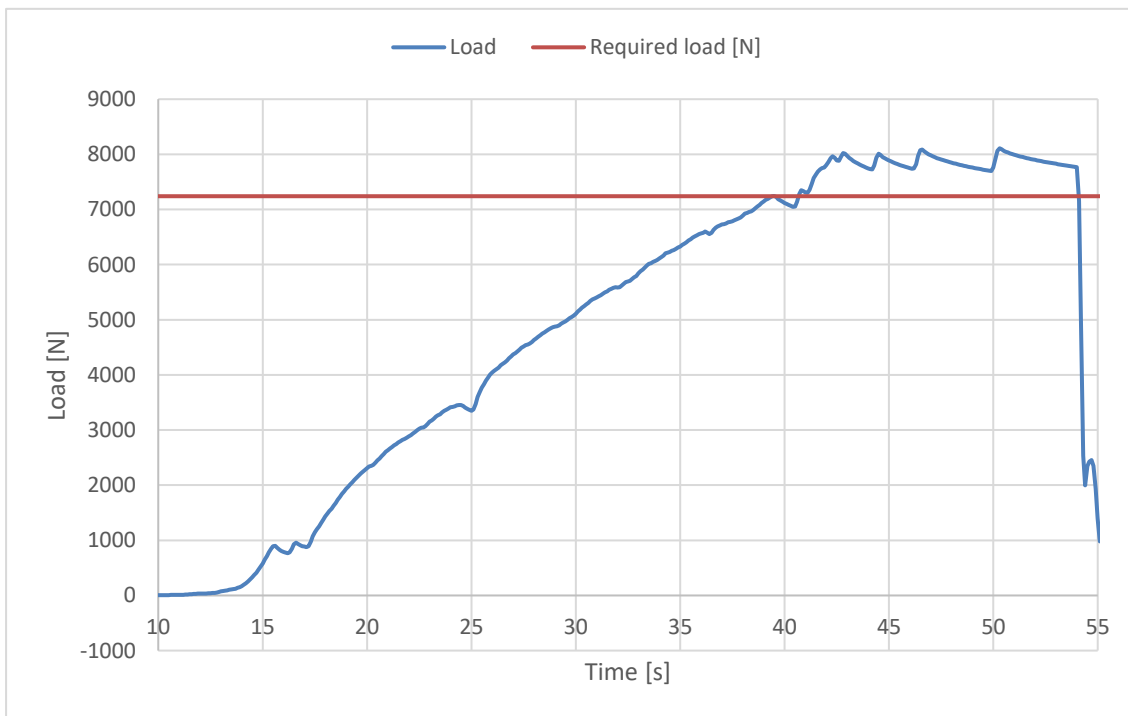
**Test ID 05**

Standard	<b>EN 1651</b>
Reference in standard	<b>5.5.1.2</b>
Test setup	<b>Positive asymmetric load</b>
Attachment points	<b>One riser attachment (3 or 4)</b>
Anchor points	<b>Dummy (C)</b>
Required load [g]	<b>6</b>
Required load [N]	<b>7200</b>
Minimum test duration [s]	<b>5</b>
<b>Result</b>	
Test duration [s]	<b>13.4</b>
Any signs of structural failure	<b>No</b>
Test results	<b>POSITIVE</b>

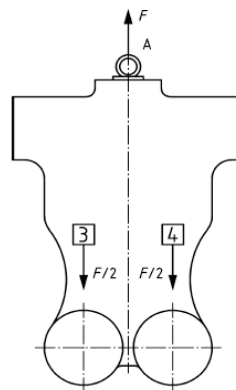
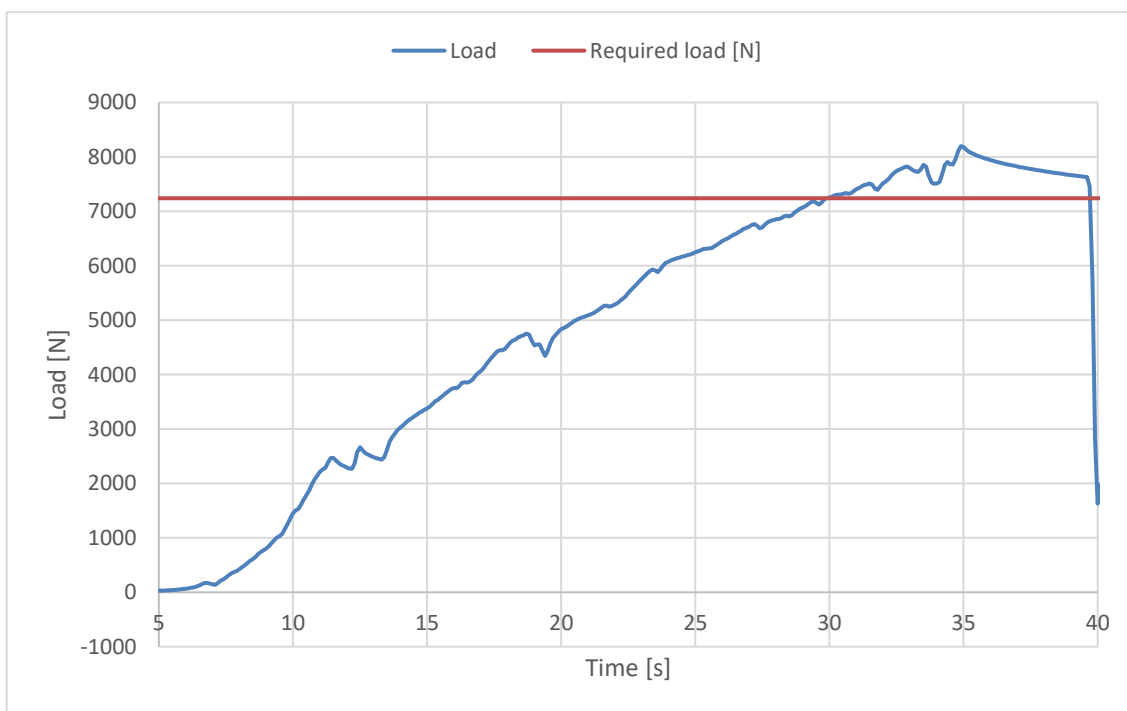
**Test ID 06**

Standard **EN 1651**  
 Reference in standard **5.5.1.6**  
 Test setup **Negative symmetric load**  
 Attachment points **Both main riser attachment (3,4)**  
 Anchor points **Dummy (A)**

Test duration [s] **9.9**  
 Any signs of structural failure **No**  
 Test results **POSITIVE**

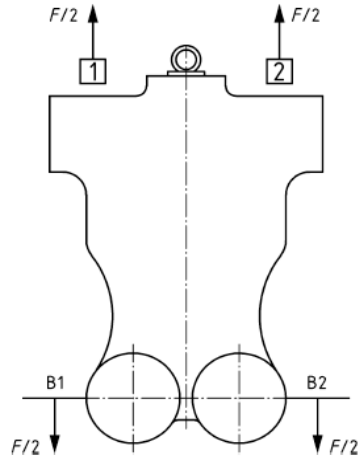
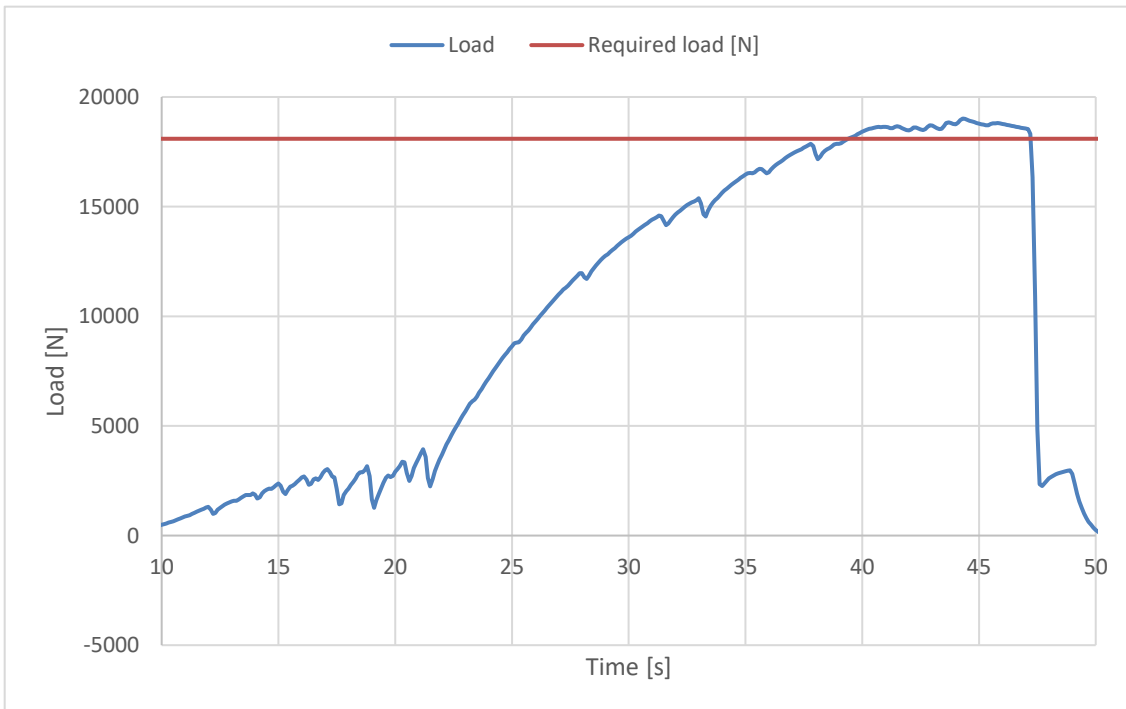
**Test ID 09**

Standard **EN 1651**  
 Reference in standard **5.5.1.3**  
 Test setup **Positive symmetric load rescue points**  
 Attachment points **Both main riser attachment (1,2)**  
 Anchor points **Dummy (B1,B2)**

Test duration [s] **7.9**  
 Any signs of structural failure **No**  
 Slippery test OK **Yes**  
 Test results **POSITIVE**

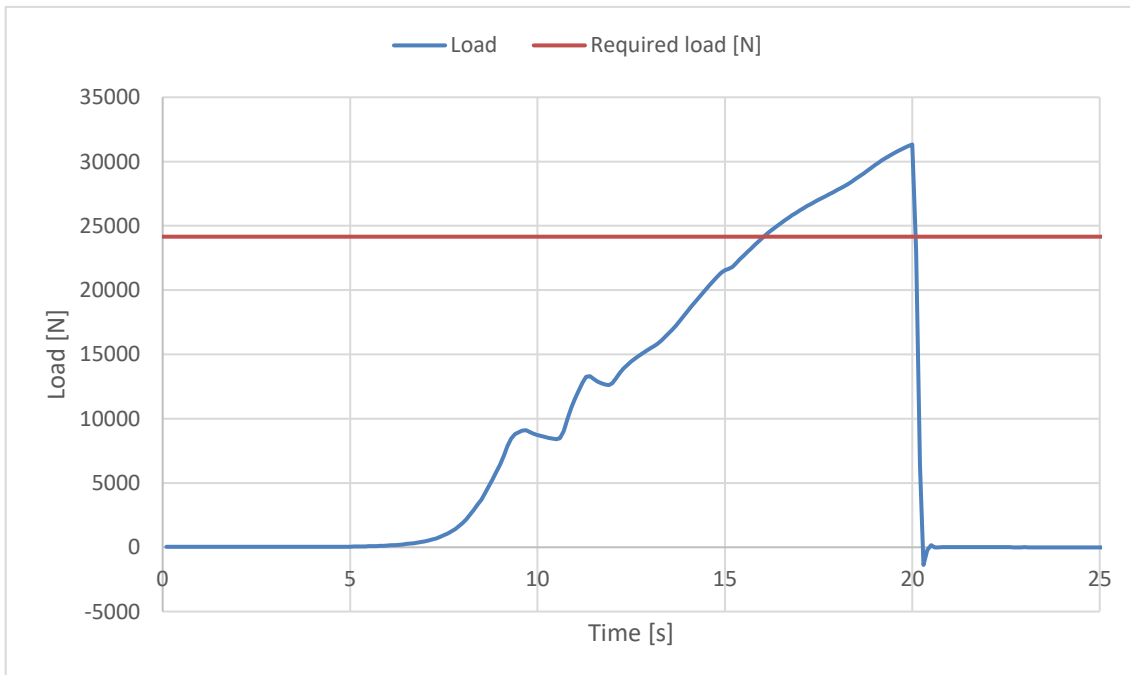
**Test ID 11**

Standard	<b>EN 1651</b>
Reference in standard	<b>5.5.1.8</b>
Test setup	<b>Connecting element for rescue</b>
Attachment points	<b>End point (emergency parachute)</b>
Anchor points	<b>Both attachment to harness</b>
Required load [g]	<b>n/a</b>
Required load [N]	<b>24000</b>
Minimum test duration [s]	<b>0.3</b>
Type of connecting element	<b>b) standard Y-bridle</b>
<b>Result</b>	
Test duration [s]	<b>4</b>
Any signs of structural failure	<b>No</b>
Test results	<b>POSITIVE</b>

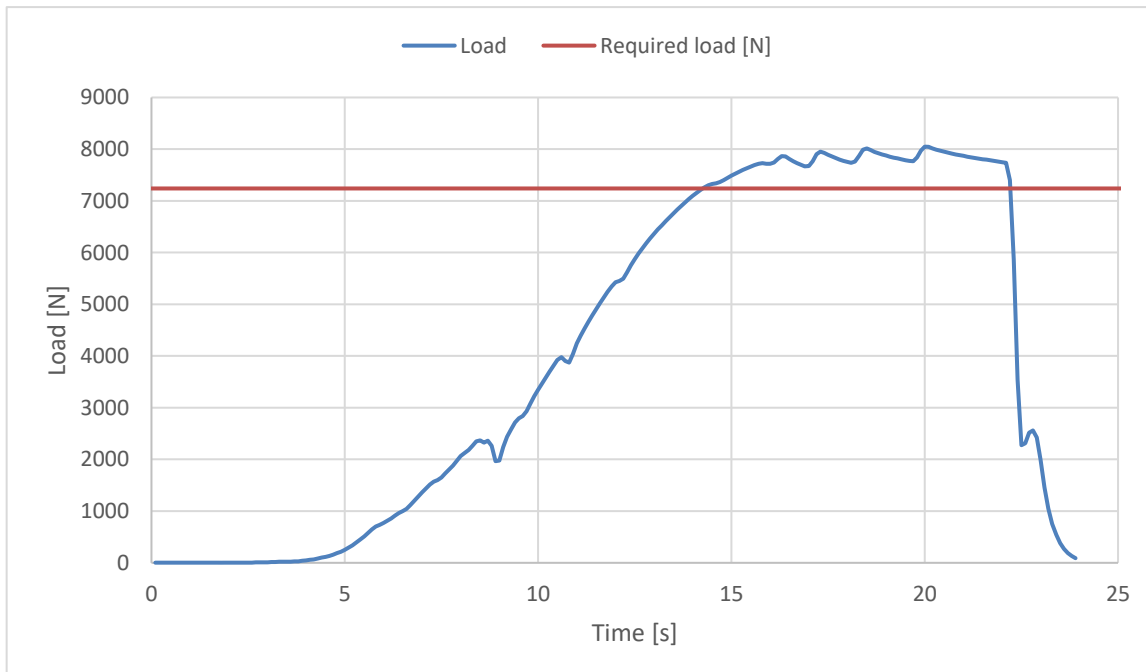
**Test ID 12**

Standard	<b>EN 1651</b>
Reference in standard	<b>5.5.1.7</b>
Test setup	<b>Upright (landing) position load</b>
Attachment points	<b>Both main riser attachment (3, 4)</b>
Anchor points	<b>Both legstrap of harness (no dummy)</b>
Required load [g]	<b>6</b>
Required load [N]	<b>7200</b>
Minimum test duration [s]	<b>5</b>
Harness type	<b>type b</b>
<b>Result</b>	
Test duration [s]	<b>8</b>
Any signs of structural failure	<b>No</b>
Slippery test OK	<b>Yes</b>
Test results	<b>POSITIVE</b>

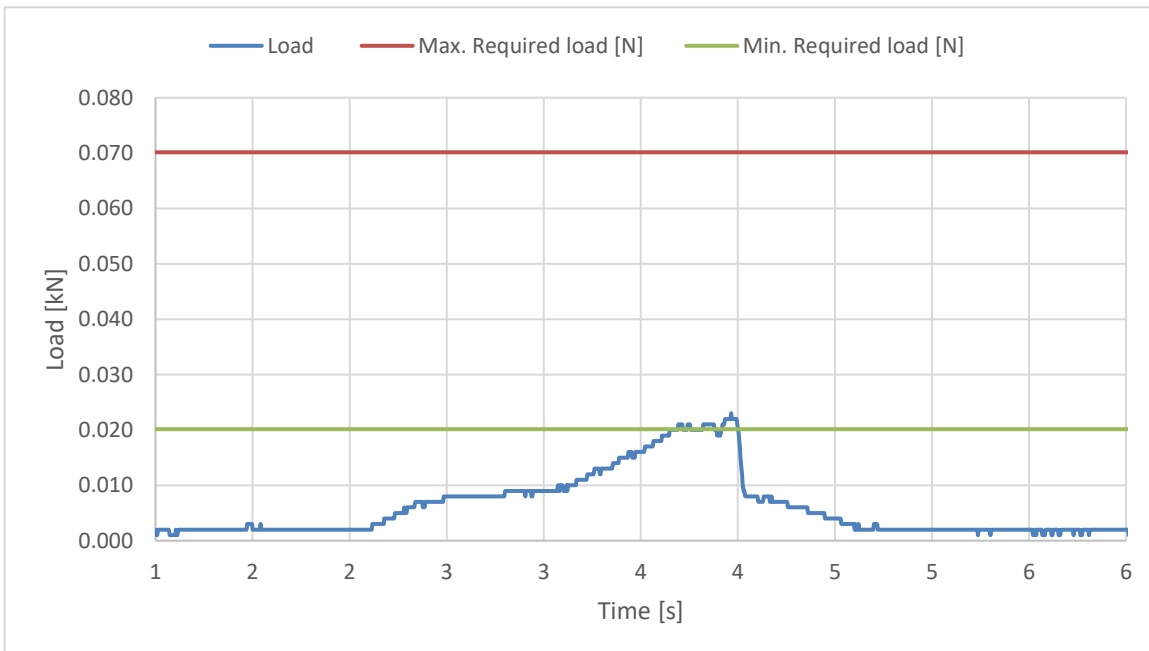
**Test ID RRDT**

Standard	<b>LTF NfL II 91/09</b>
Reference in standard	<b>6.1.5</b>
Test setup	<b>Default flying position</b>
Attachment points	<b>Sensor connect to handle, and pull in opening direction</b> The test is to simulate the load required to open the emergency parachute(1st action).
Min. Required load [N]	<b>20</b>
Max. Required load [N]	<b>70</b>
<b>Result</b>	
Load for first action [N]	<b>22.85</b>
Test results	<b>POSITIVE</b>

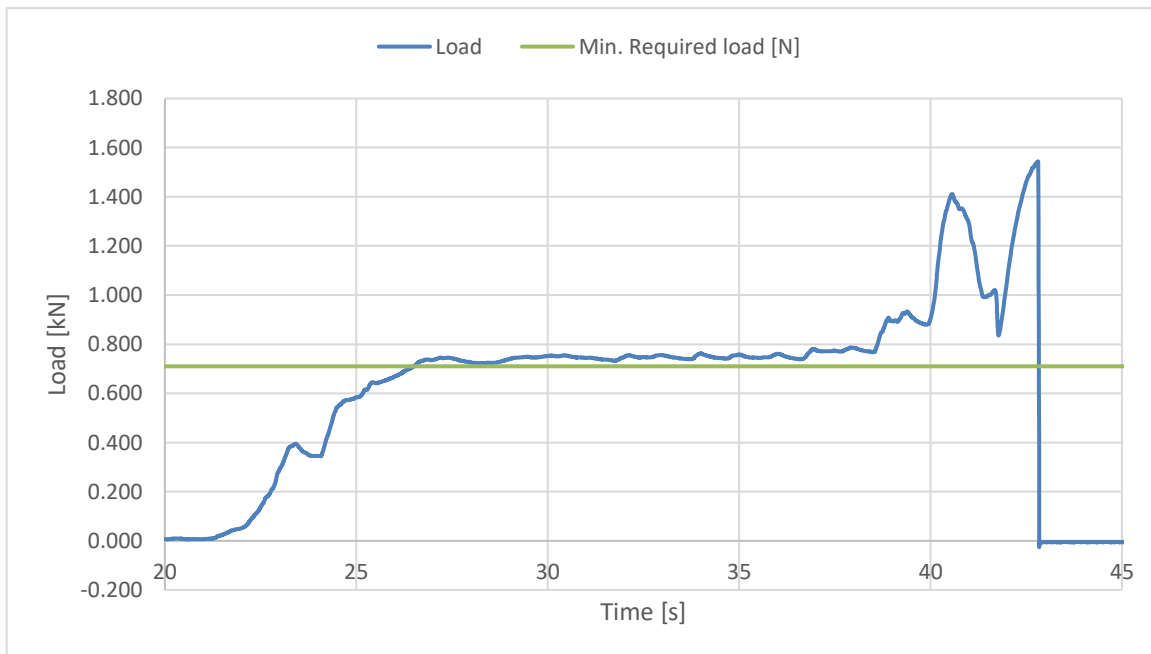
**Test ID RRSST**

Standard	<b>EN12491:2015</b>
Reference in standard	<b>5.3.2</b>
Test setup	<b>Two end points of handle</b>
Attachment points	<b>Sensor connect to end of handle, pull on the other side</b> The handle must support min 700 N for 10 s, after measure breaking strength
Min. Required load [N]	<b>700</b>
Minimum test duration [s]	<b>10</b>
<b>Result</b>	
Test duration [s]:	<b>16.3</b>
Breaking strength [N]	<b>1533.74</b>
Test results	<b>POSITIVE</b>
