Harness Structural test Report - LTF

Inspection certificate number: **PH_339.2021**

Name: **Kuik 3**
 Type: **ABS**
 Size: **M**
 Serial number: **S 06/20.003**
 Impact pad type: ⁽¹⁾ **Airbag**
 Clip-in weight [kg]: **120**

Air Turquoise SA, having thoroughly assessed the sample mentioned above, declare it was found conform with
 Airworthiness Requirements **LTF NfL II 91/09 - EN12491:2015 5.3.2**

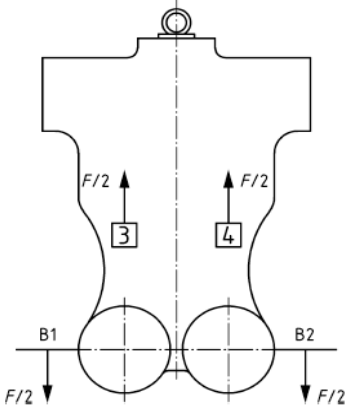
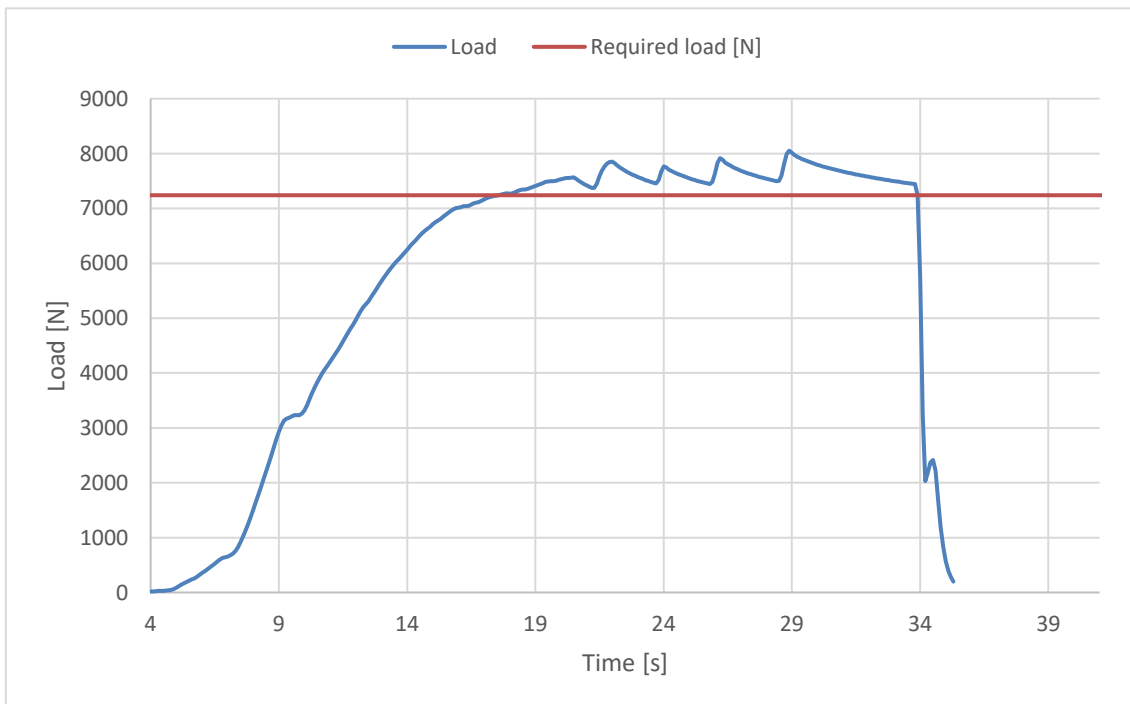
Test ID 02

Standard	LTF NfL II 91/09
Reference	5.3.2.1
Test setup	Default flying position
Attachment points	Both main riser attachment (3,4)
Anchor points	Dummy (B1, B2)
Required load [g]	6
Required load [N]	7200
Minimum test duration [s]	10
Result	
Test duration [s]	16.4
Any signs of structural failure	No
Test results	POSITIVE

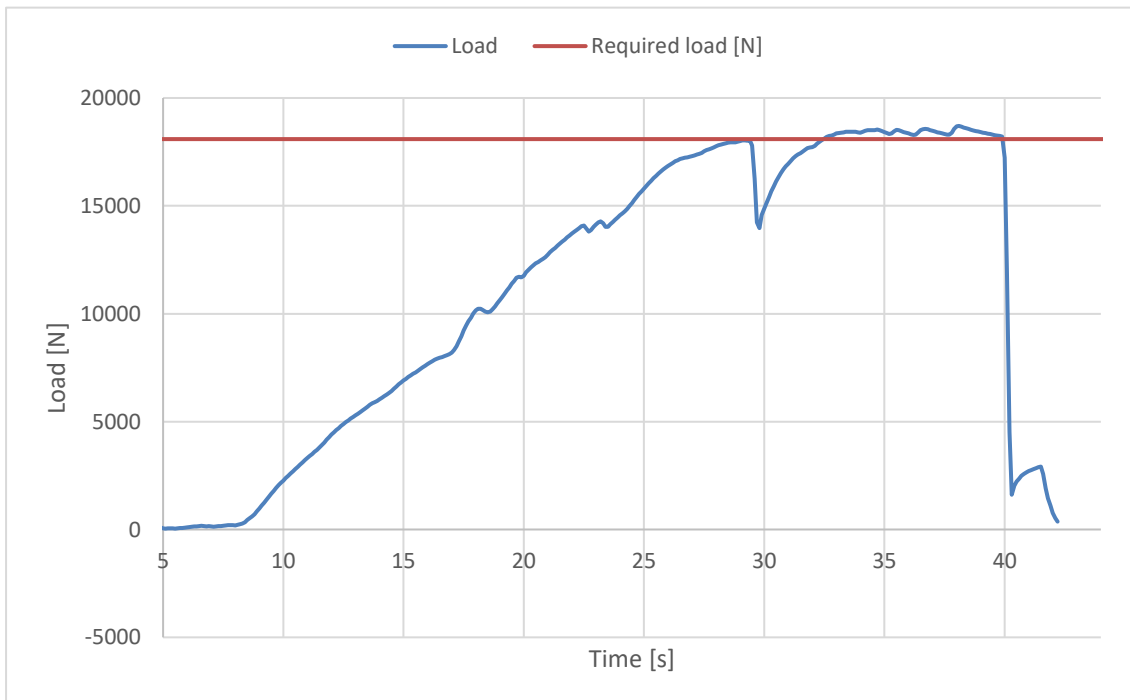
Test ID 03

Standard	LTF NfL II 91/09
Reference	5.3.2.2
Test setup	Default flying position
Attachment points	Both main riser attachment (3,4)
Anchor points	Dummy (B1, B2)
Required load [g]	15
Required load [N]	18000
Minimum test duration [s]	5
Result	
Test duration [s]	7.5
Any signs of structural failure	No
Test results	POSITIVE

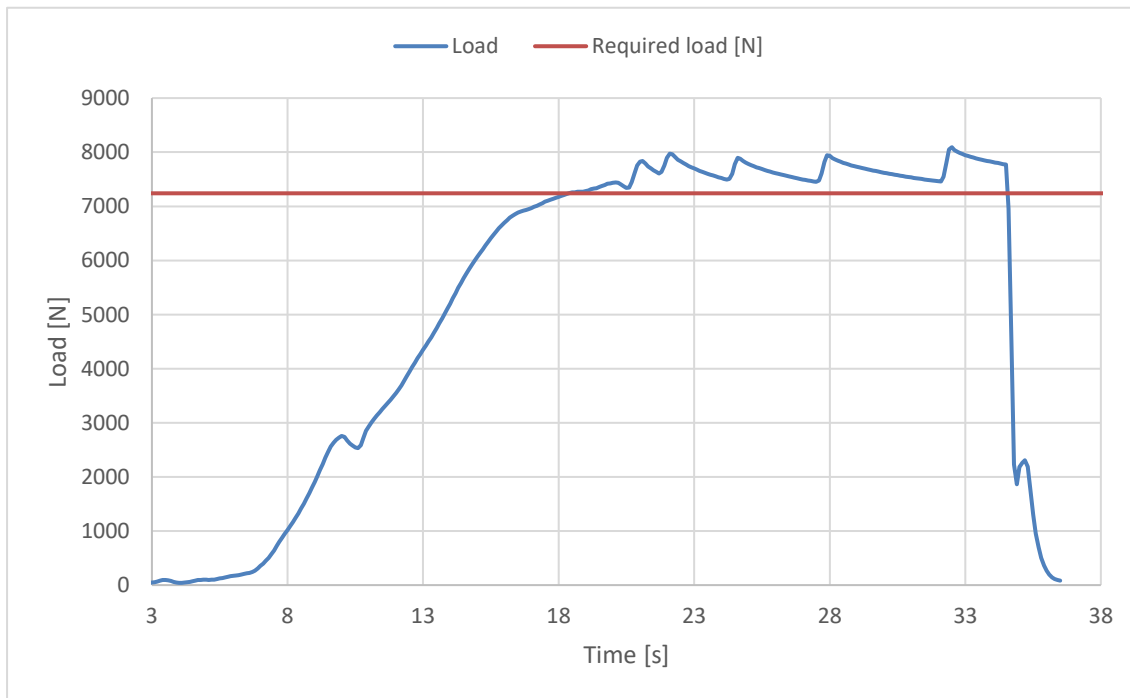
Test ID 04

Standard	LTF NfL II 91/09
Reference	5.3.2.3
Test setup	Asymmetric, one riser
Attachment points	One main riser attachment (3)
Anchor points	Dummy (B1,B2)
Required load [g]	6
Required load [N]	7200
Minimum test duration [s]	10
Result	
Test duration [s]	16.2
Any signs of structural failure	No
Test results	POSITIVE

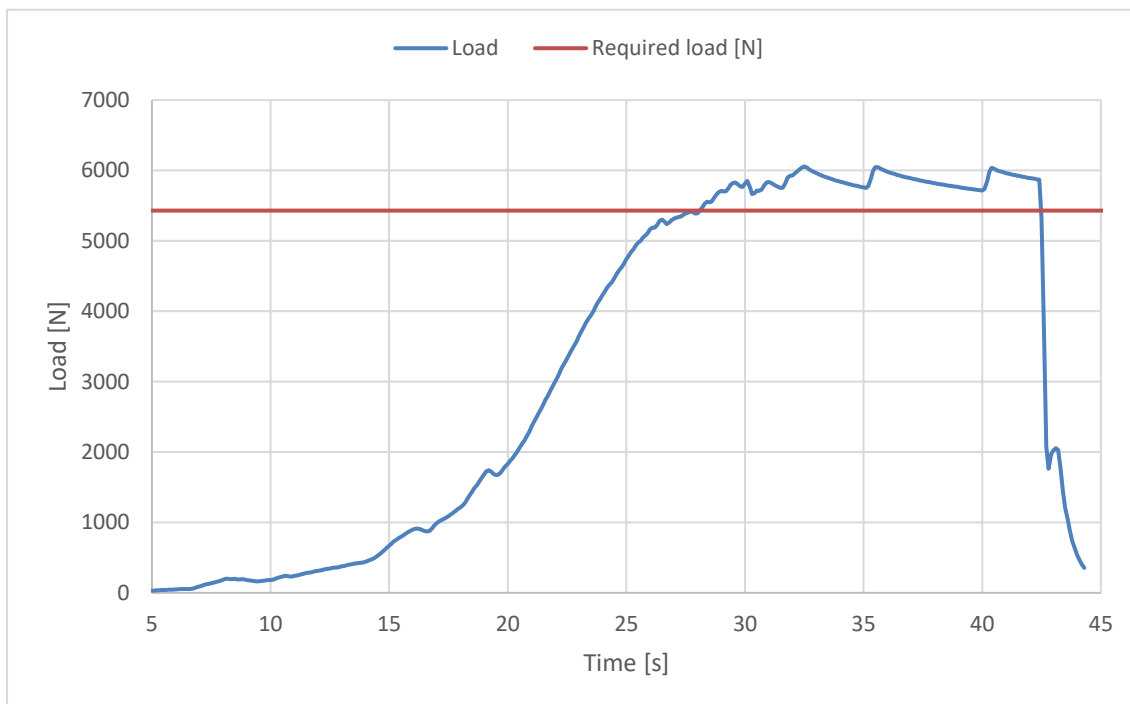
Test ID 07

Reference	5.3.2.6	
Test setup	Asymmetric, negative	
Attachment points	One main riser attachment (3 or 4) downwards	
Anchor points	Dummy (9)	
Required load [g]	4.5	
Required load [N]	5400	
Minimum test duration [s]	10	
Result		
Test duration [s]	14.4	
Any signs of structural failure	No	
Test results	POSITIVE

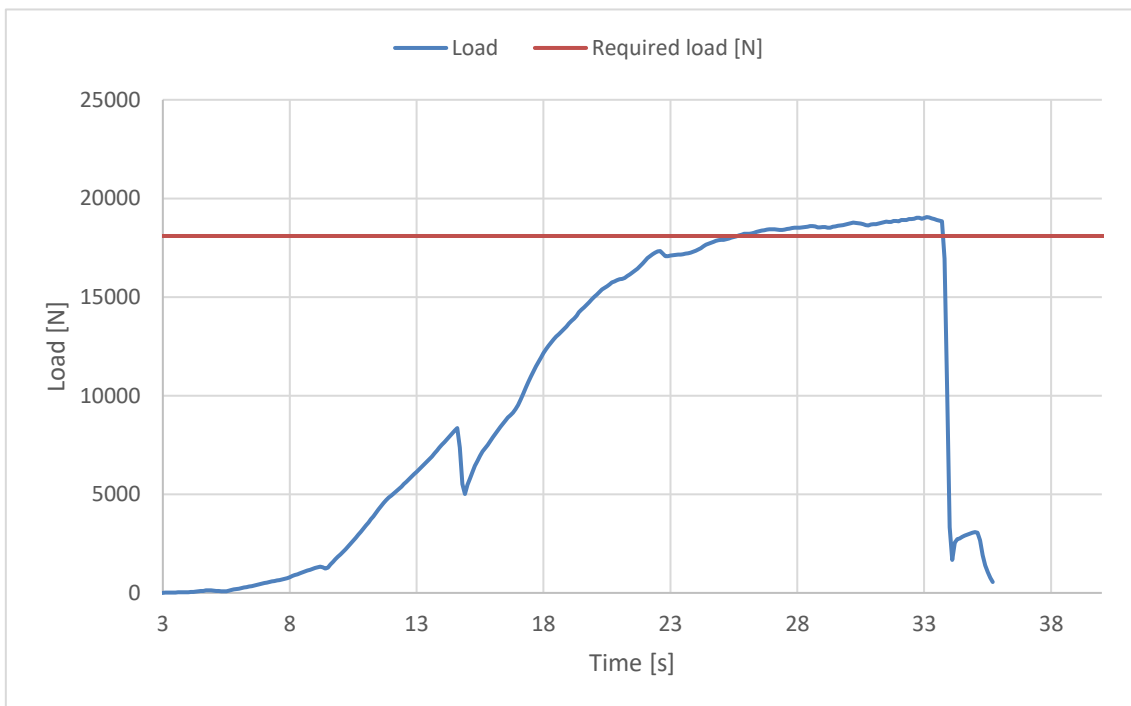
Test ID 09

Standard	LTF NfL II 91/09
Reference	5.3.2.4
Test setup	Rescue attachments
Attachment points	Rescue riser attachment (1,2)
Anchor points	Dummy (B1,B2)
Required load [g]	15
Required load [N]	18000
Minimum test duration [s]	5
Result	
Test duration [s]	8.1
Any signs of structural failure	No
Test results	POSITIVE

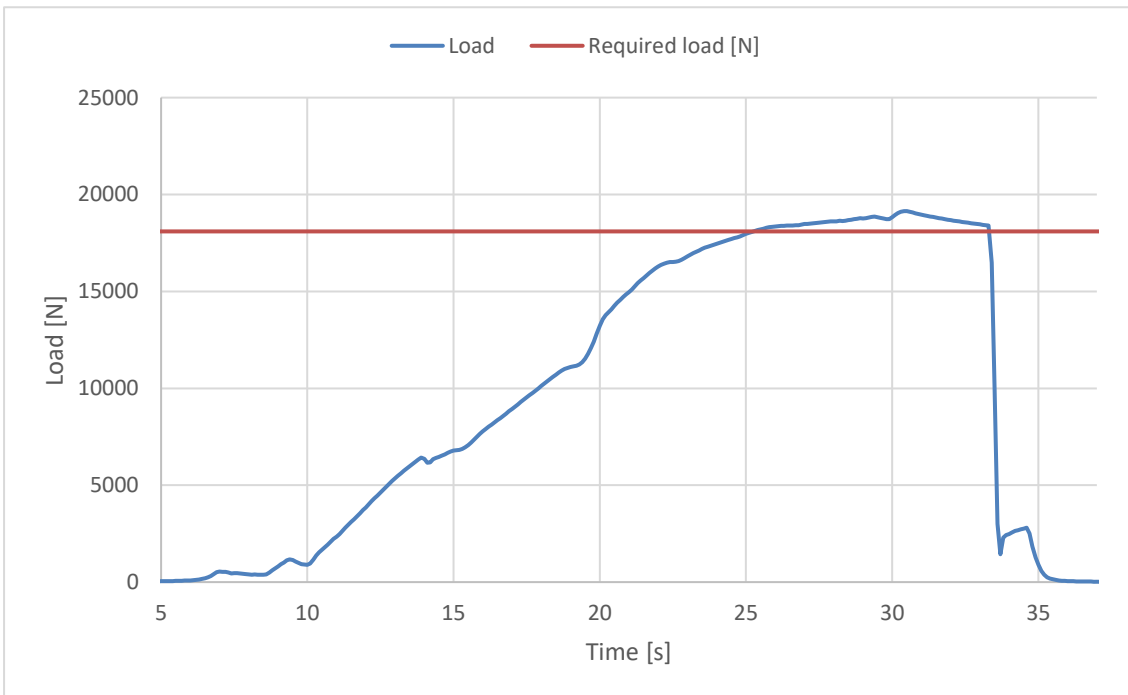
Test ID 13

Standard	LTF NfL II 91/09
Reference	5.3.2.7
Test setup	Flying position before landing
Attachment points	Both main riser attachment (3,4)
Anchor points	Dummy (7,8)
Required load [g]	15
Required load [N]	18000
Minimum test duration [s]	5
Result	
Test duration [s]	8.1
Any signs of structural failure	No
Test results	POSITIVE

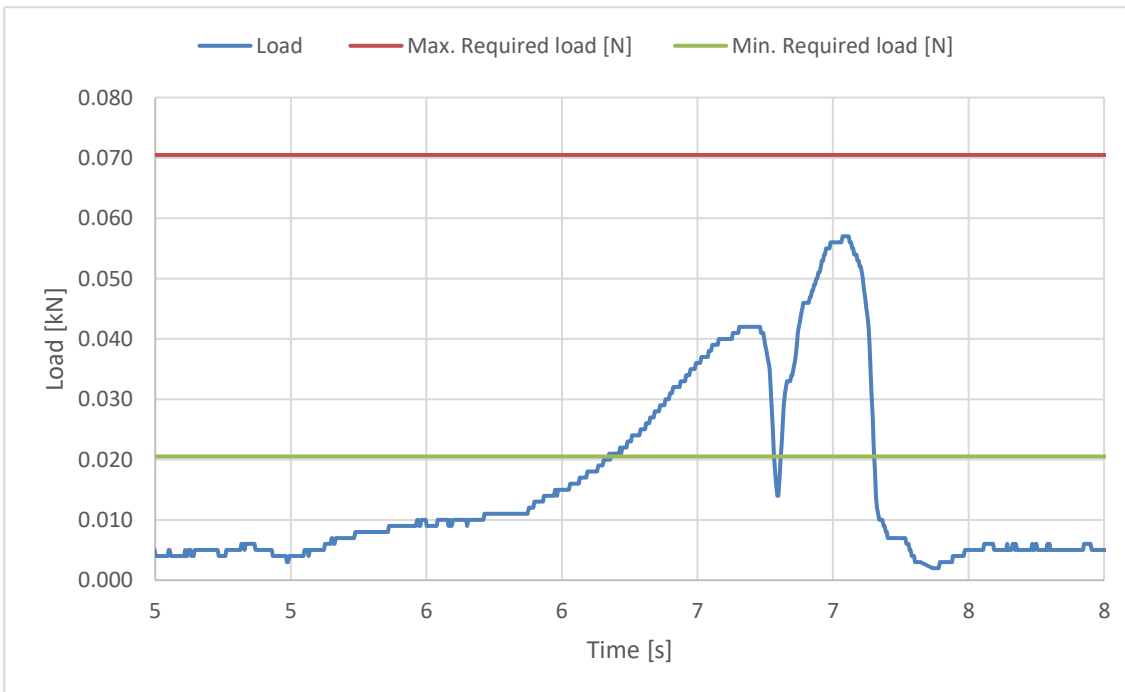
Test ID RRDT

Standard	LTF NfL II 91/09
Reference	6.1.5
Test setup	Default flying position
Attachment points	Sensor connect to handle, and pull in opening direction
	The test is to simulate the load required to open the emergency parachute(1st action).
Min. Required load [N]	20
Max. Required load [N]	70
Result	
Load for first action [N]	56.51
Test results	POSITIVE

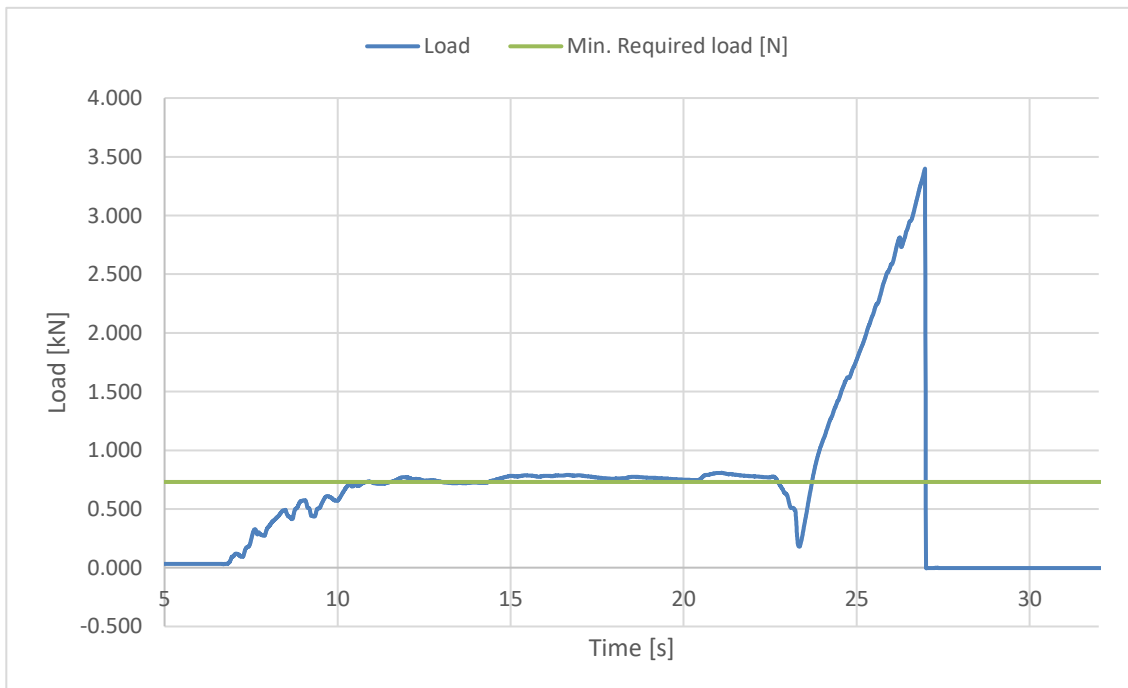
Test ID RRST

Standard	EN12491:2015
Reference in standard	5.3.2
Test setup	Two end points of handle
Attachment points	Sensor connect to end of handle, pull on the other side
	The handle must support min 700 N for 10 s, after measure breaking strength
Min. Required load [N]	700
Minimum test duration [s]	10
Result	
Test duration [s]:	8.3
Breaking strength [N]	3369.53
Test results	POSITIVE
