Harness Structural test Report - LTF

Inspection certificate number: **PH_341.2021**

Name: **Switch2**
 Type: **ABS**
 Size: **Unique**
 Serial number: **0701-KSW20001F_V2**
 Impact pad type: ⁽¹⁾ **Airbag**
 Clip-in weight [kg]: **120**
 Date of test: **02.03.2021**

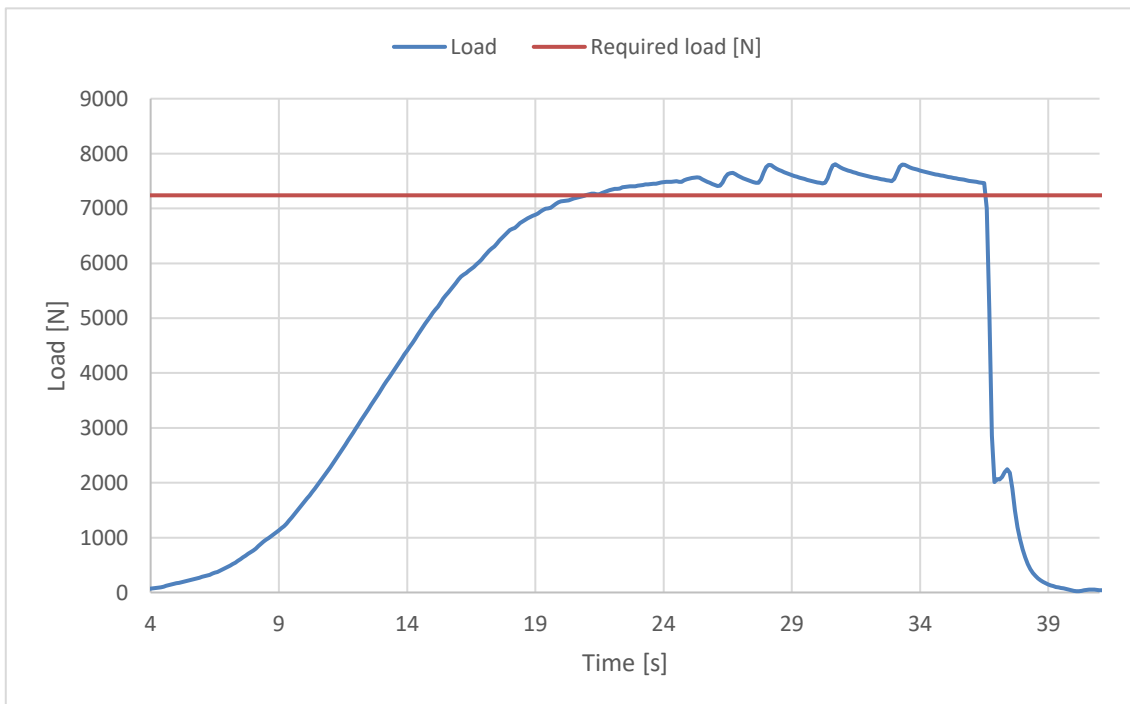
Test ID 02

Standard	LTF NfL II 91/09
Reference	5.3.2.1
Test setup	Default flying position
Attachment points	Both main riser attachment (3,4)
Anchor points	Dummy (B1, B2)
Required load [g]	6
Required load [N]	7200
Minimum test duration [s]	10
Result	
Test duration [s]	15.6
Any signs of structural failure	No
Test results	POSITIVE

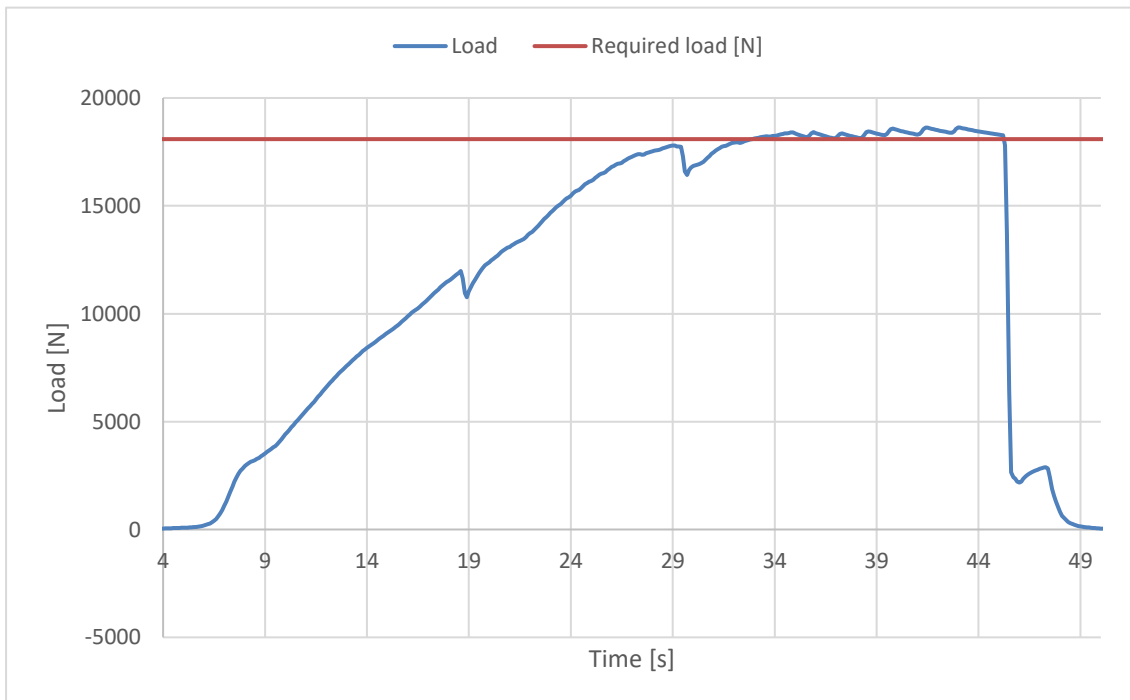
Test ID 03

Standard **LTF NfL II 91/09**
 Reference **5.3.2.2**
 Test setup **Default flying position**
 Attachment points **Both main riser attachment (3,4)**
 Anchor points **Dummy (B1, B2)**

Test duration [s] **12.4**
 Any signs of structural failure **No**
 Test results **POSITIVE**

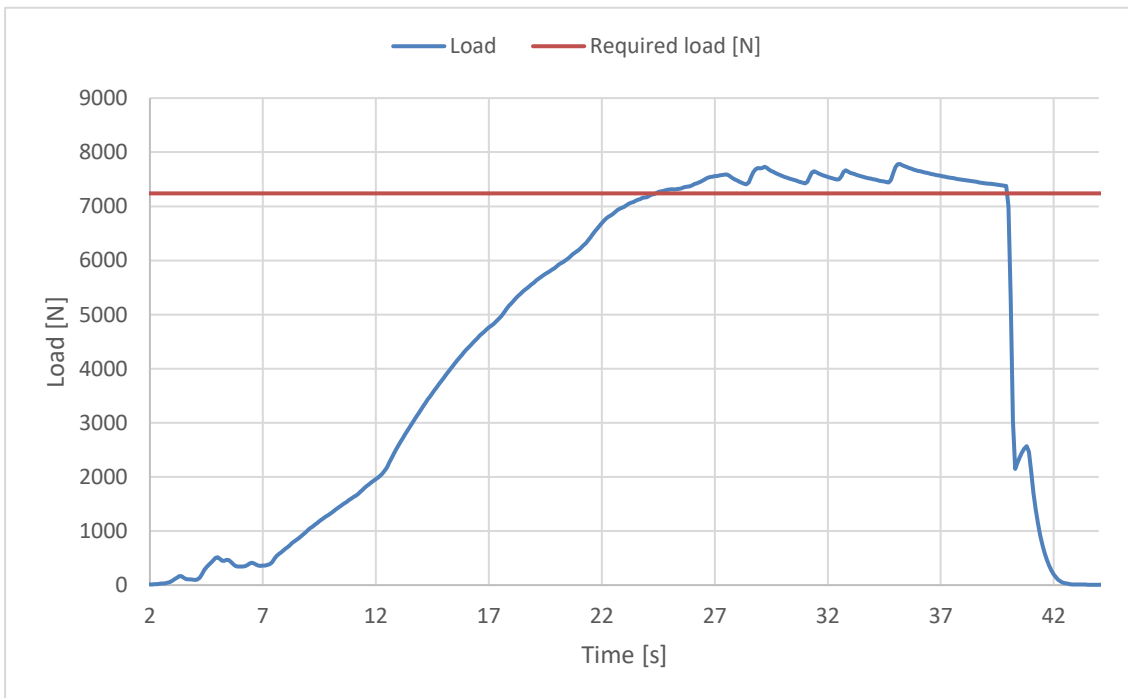
Test ID 04

Standard **LTF NfL II 91/09**
 Reference **5.3.2.3**
 Test setup **Asymmetric, one riser**
 Attachment points **One main riser attachment (3)**
 Anchor points **Dummy (B1,B2)**

Test duration [s] **15.6**
 Any signs of structural failure **No**
 Test results **POSITIVE**

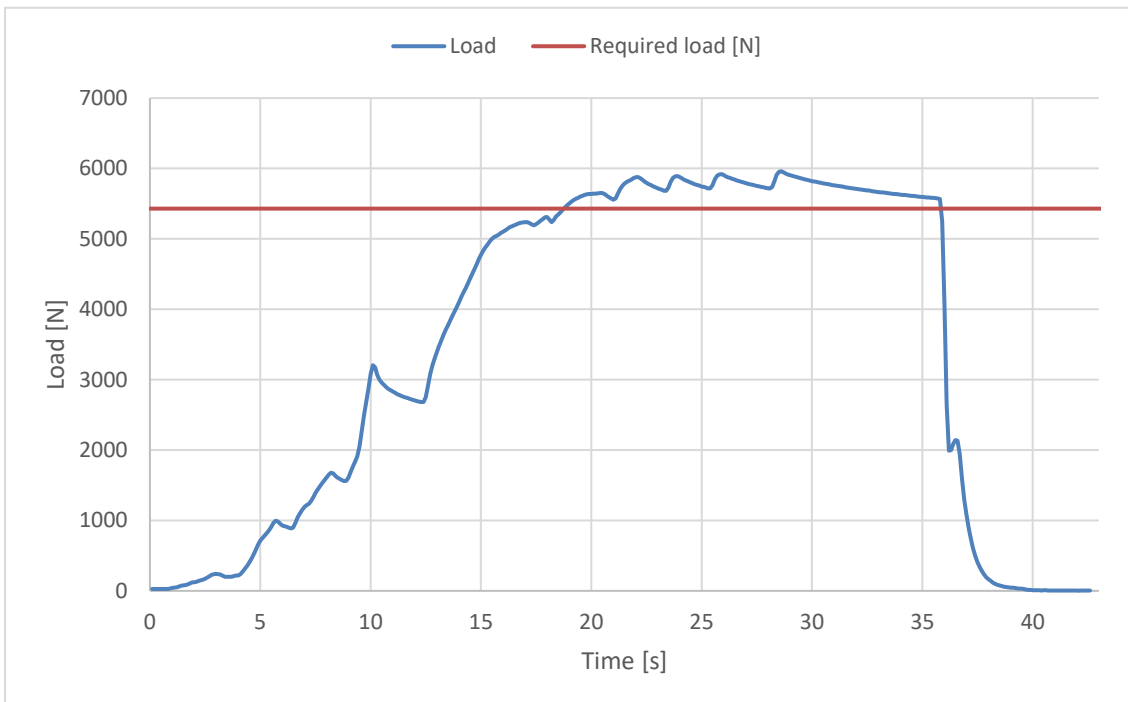
Test ID 07

Reference	5.3.2.6	
Test setup	Asymmetric, negative	
Attachment points	One main riser attachment (3 or 4) downwards	
Anchor points	Dummy (9)	
Required load [g]	4.5	
Required load [N]	5400	
Minimum test duration [s]	10	
Result		
Test duration [s]	17.1	
Any signs of structural failure	No	
Test results	POSITIVE

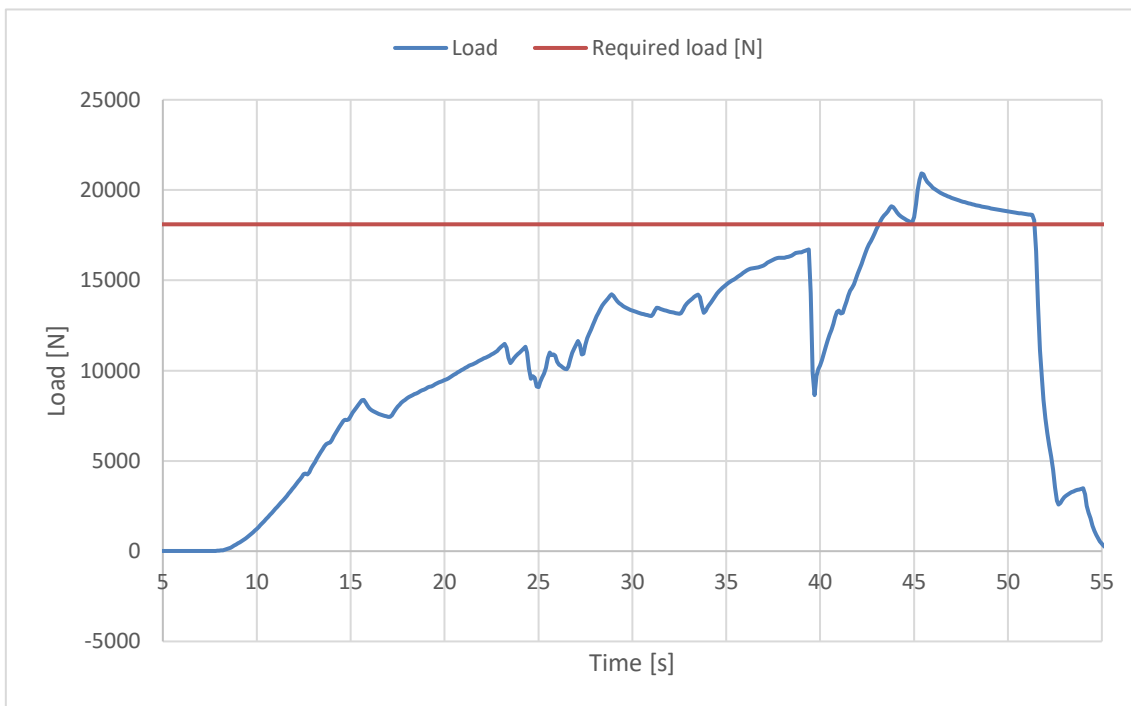
Test ID 09

Standard	LTF NfL II 91/09
Reference	5.3.2.4
Test setup	Rescue attachments
Attachment points	Rescue riser attachment (1,2)
Anchor points	Dummy (B1,B2)
Required load [g]	15
Required load [N]	18000
Minimum test duration [s]	5
Result	
Test duration [s]	8.3
Any signs of structural failure	No
Test results	POSITIVE

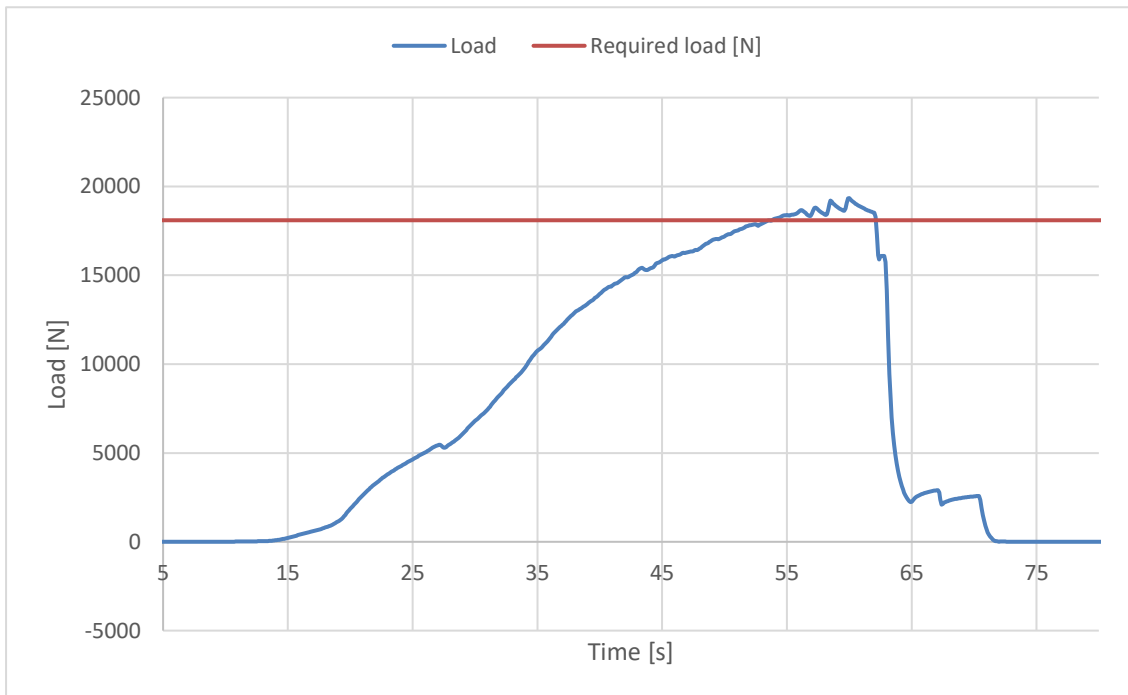
Test ID 13

Standard **LTF NfL II 91/09**
 Reference **5.3.2.7**
 Test setup **Flying position before landing**
 Attachment points **Both main riser attachment (3,4)**
 Anchor points **Dummy (7,8)**

Test duration [s] **8.3**
 Any signs of structural failure **No**
 Test results **POSITIVE**

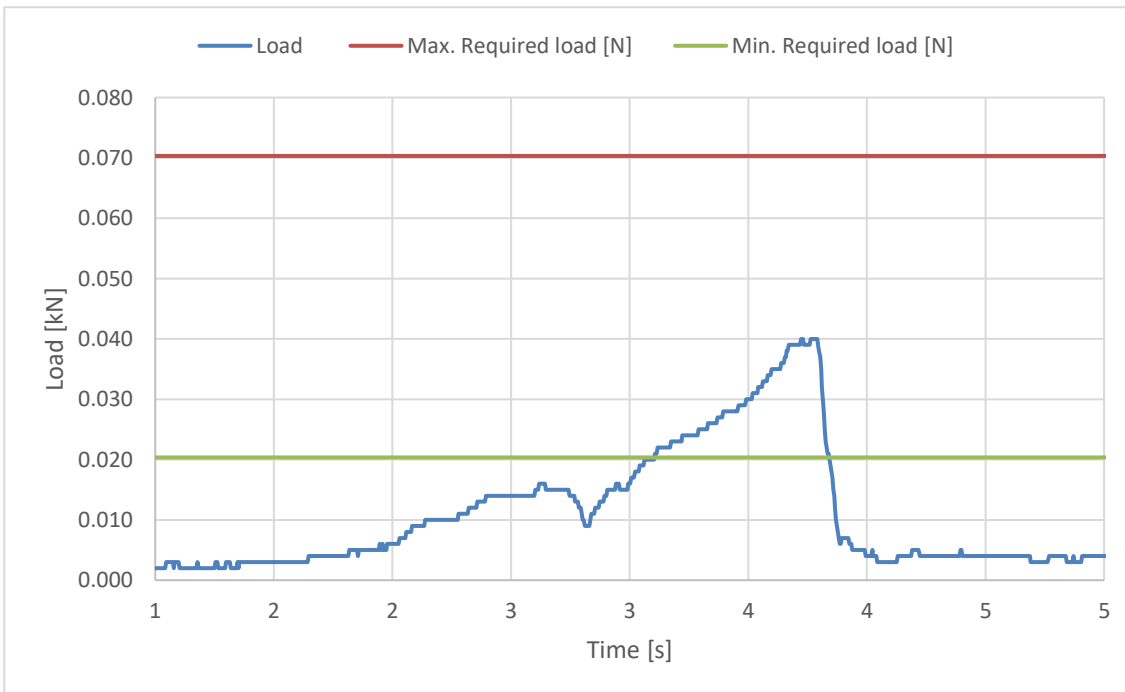
Test ID RRDT

Standard **LTF NfL II 91/09**
 Reference **6.1.5**
 Test setup **Default flying position**
 Attachment points **Sensor connect to handle, and pull in opening direction**
 The test is to simulate the load required to open the emergency parachute(1st action).

Load for first action [N] **39.65**
 Test results **POSITIVE**

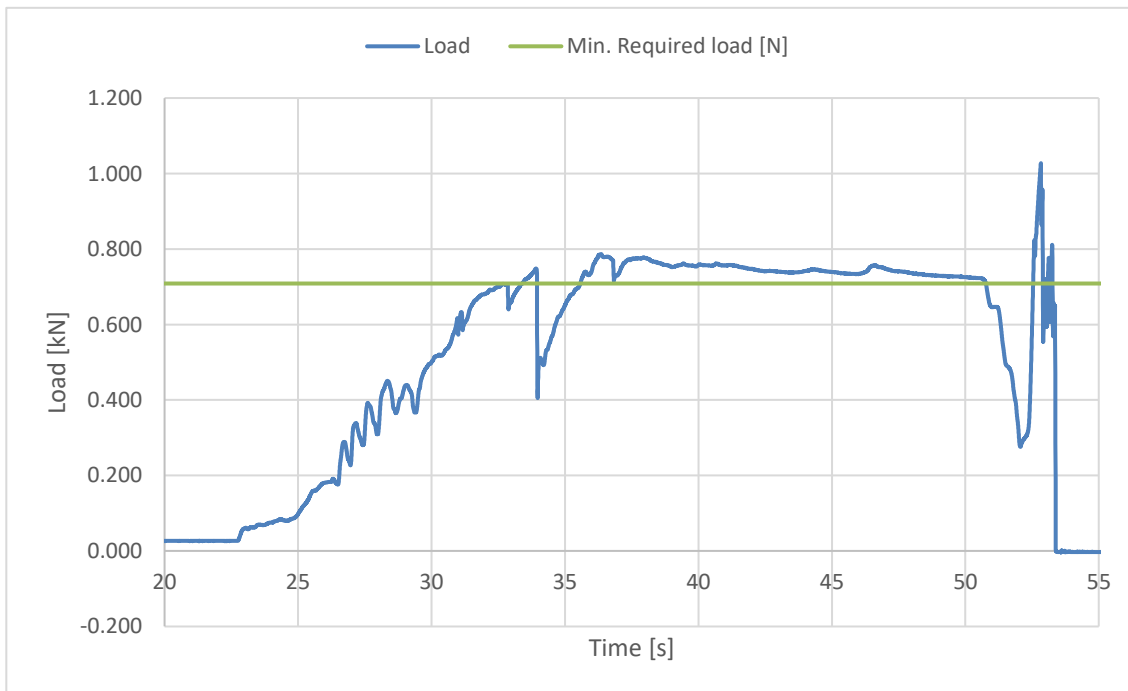
Test ID RRST

Standard	EN12491:2015
Reference in standard	5.3.2
Test setup	Two end points of handle
Attachment points	Sensor connect to end of handle, pull on the other side
	The handle must support min 700 N for 10 s, after measure breaking strength
Min. Required load [N]	700
Minimum test duration [s]	10
Result	
Test duration [s]:	15.2
Breaking strength [N]	1019.09
Test results	POSITIVE
