Harness Structural test Report - LTF

Inspection certificate number: **PH_346.2021**

Name: **Lycia Acro Base**
 Type: **ABS**
 Size: **M**
 Serial number: **M-TM-ACROBASE-1**
 Impact pad type: ⁽¹⁾ **Foam**
 Clip-in weight [kg]: **120**

Air Turquoise SA, having thoroughly assessed the sample mentioned above, declare it was found conform with
 Airworthiness Requirements LTF NfL II 91/09 - EN12491:2015 5.3.2

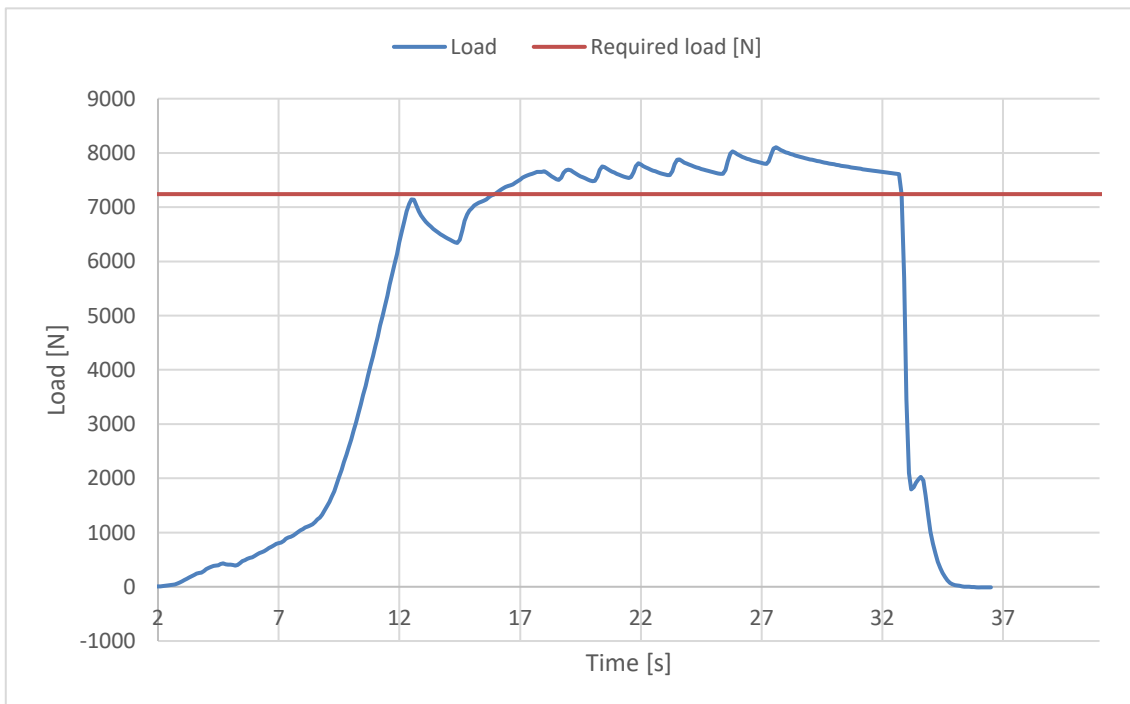
Test ID 02

Test duration [s] **16.8**
 Any signs of structural failure **No**
 Test results **POSITIVE**

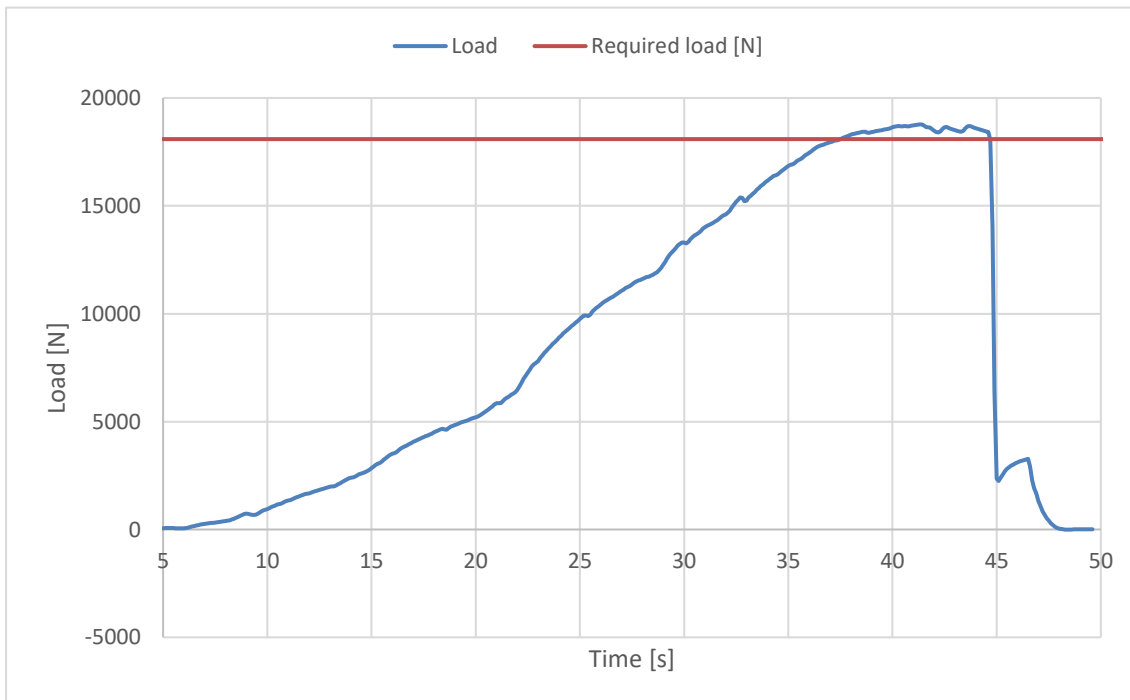
Test ID 03

Standard	LTF NfL II 91/09
Reference	5.3.2.2
Test setup	Default flying position
Attachment points	Both main riser attachment (3,4)
Anchor points	Dummy (B1, B2)
Required load [g]	15
Required load [N]	18000
Minimum test duration [s]	5
Result	
Test duration [s]	7.1
Any signs of structural failure	No
Test results	POSITIVE

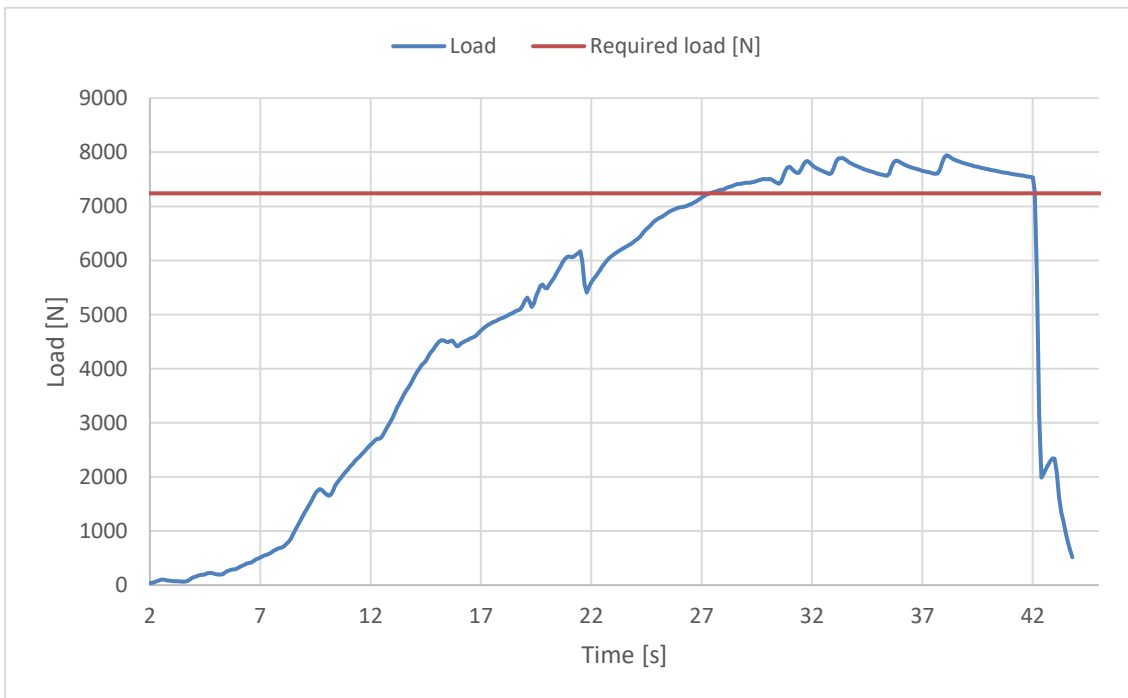
Test ID 04

Test duration [s] **14.8**
 Any signs of structural failure **No**
 Test results **POSITIVE**

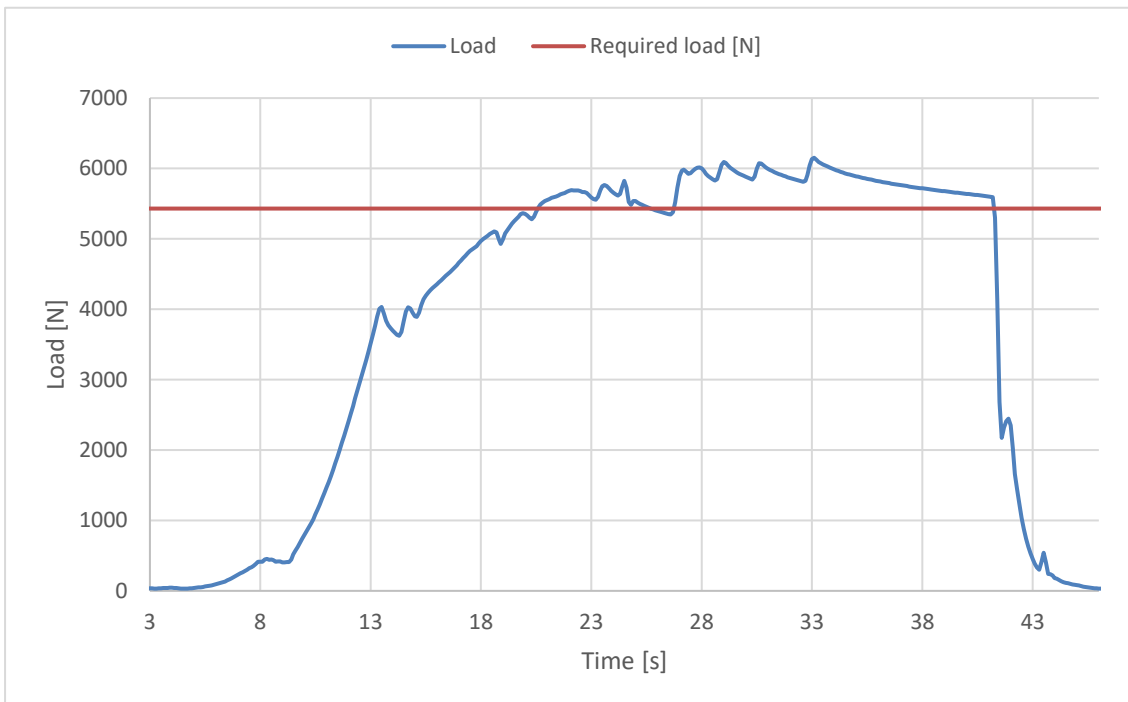
Test ID 07

Standard	LTF NfL II 91/09
Reference	5.3.2.6
Test setup	Asymmetric, negative
Attachment points	One main riser attachment (3 or 4) downwards
Anchor points	Dummy (9)
Required load [g]	4.5
Required load [N]	5400
Minimum test duration [s]	10
Result	
Test duration [s]	14.5
Any signs of structural failure	No
Test results	POSITIVE

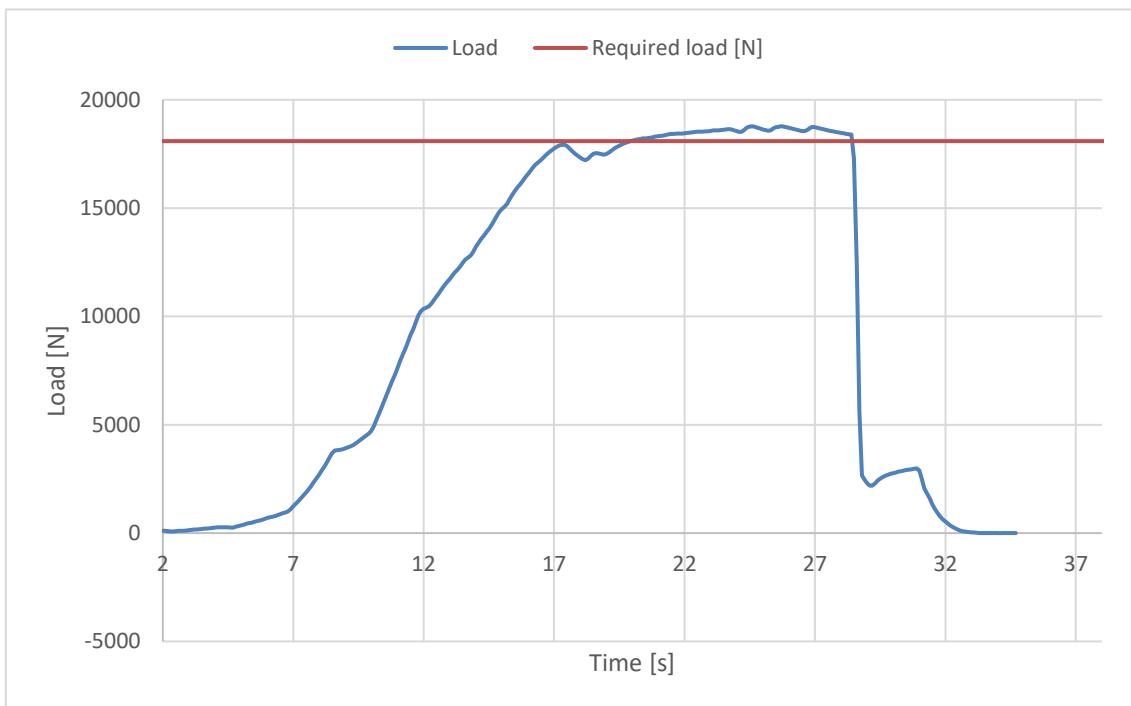
Test ID 09

Reference	5.3.2.4	
Test setup	Rescue attachments	
Attachment points	Rescue riser attachment (1,2)	
Anchor points	Dummy (B1,B2)	
Required load [g]	15	
Required load [N]	18000	
Minimum test duration [s]	5	
Result		
Test duration [s]	8.5	
Any signs of structural failure	No	
Test results	POSITIVE

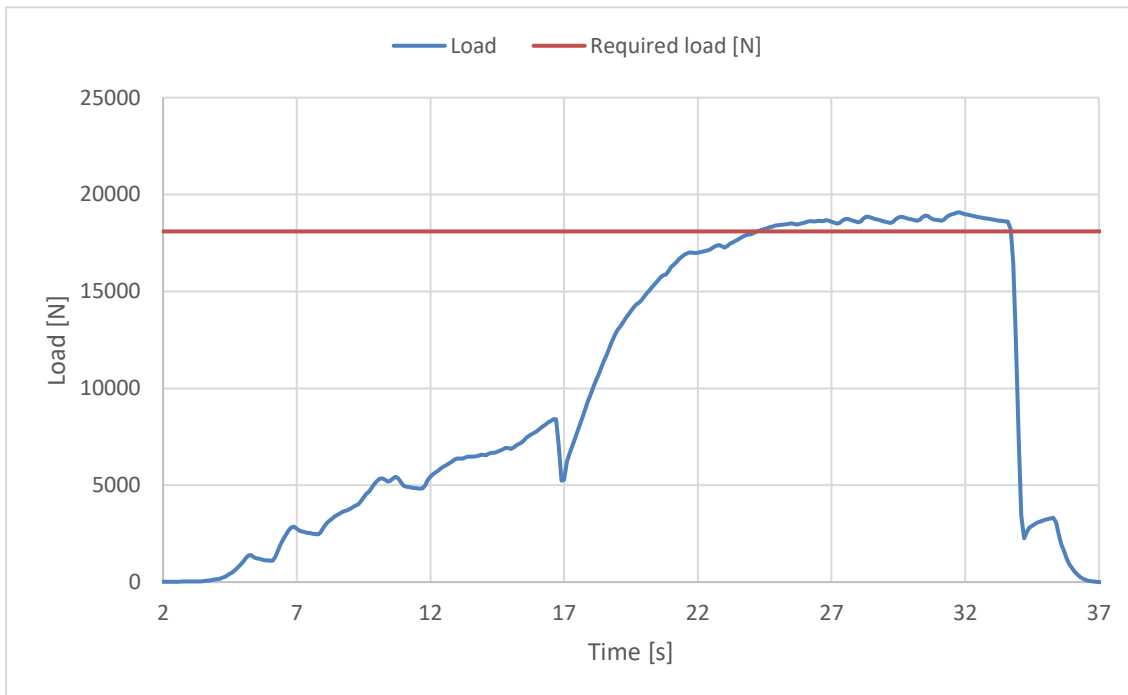
Test ID 13

Standard	LTF NfL II 91/09
Reference	5.3.2.7
Test setup	Flying position before landing
Attachment points	Both main riser attachment (3,4)
Anchor points	Dummy (7,8)
Required load [g]	15
Required load [N]	18000
Minimum test duration [s]	5
Result	
Test duration [s]	9.5
Any signs of structural failure	No
Test results	POSITIVE

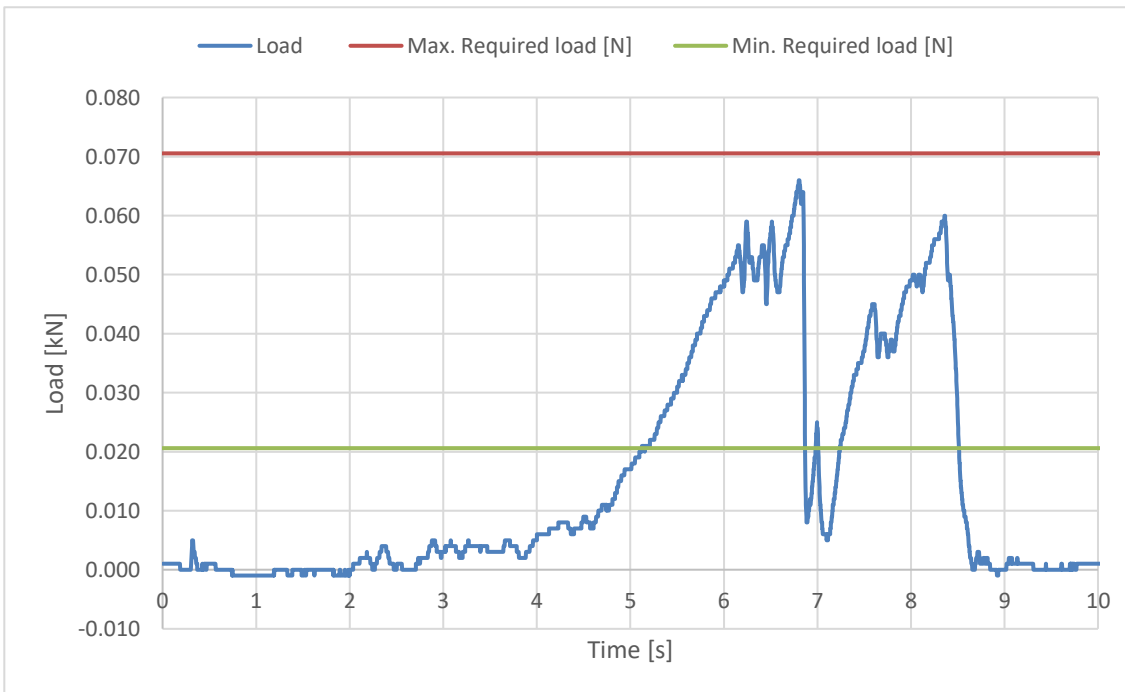
Test ID RRDT

Load for first action [N] **65.43**
 Test results **POSITIVE**

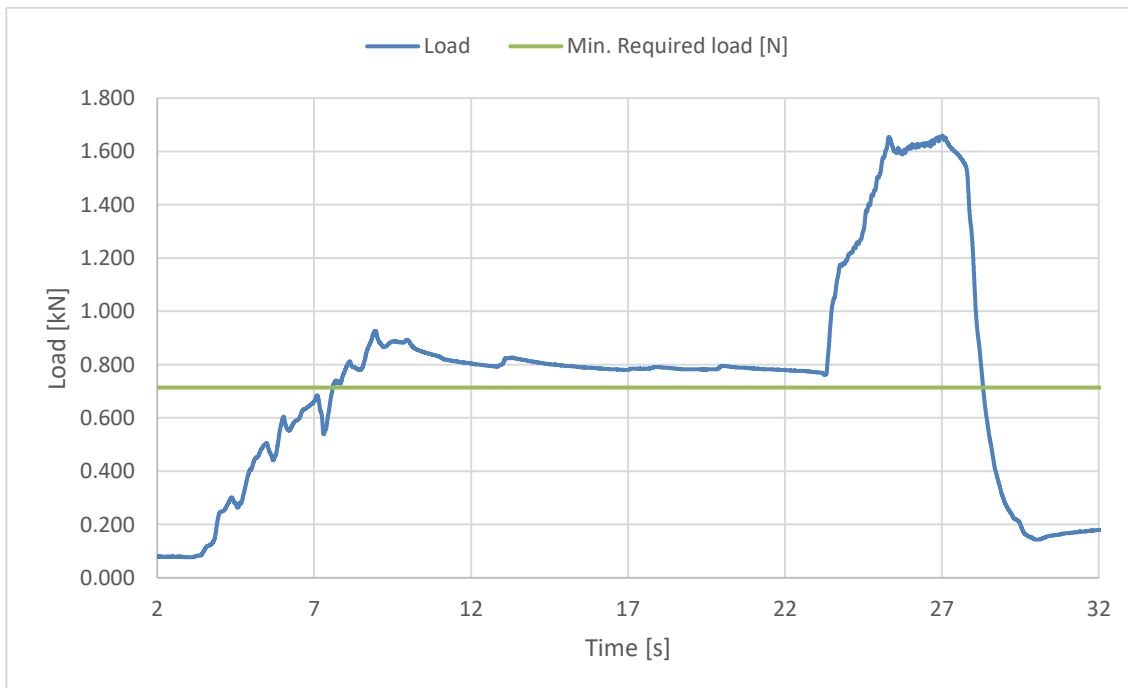
Test ID RRST

Standard	EN12491:2015
Reference in standard	5.3.2
Test setup	Two end points of handle
Attachment points	Sensor connect to end of handle, pull on the other side
	The handle must support min 700 N for 10 s, after measure breaking strength
Min. Required load [N]	700
Minimum test duration [s]	10
Result	
Test duration [s]:	20.7
Breaking strength [N]	1644.61
Test results	POSITIVE
