Harness Structural test Report - EN

Inspection certificate number: **PH_308.2020**
Manufacturer data:

Name: **Logo! Pro +**
 Type: **ABS**
 Size: **M**
 Serial number: **Rf-001-07-20**
 Impact pad type: ⁽¹⁾ **Foam**
 Clip-in weight [kg]: **140**

model: **Logo! Pro +**

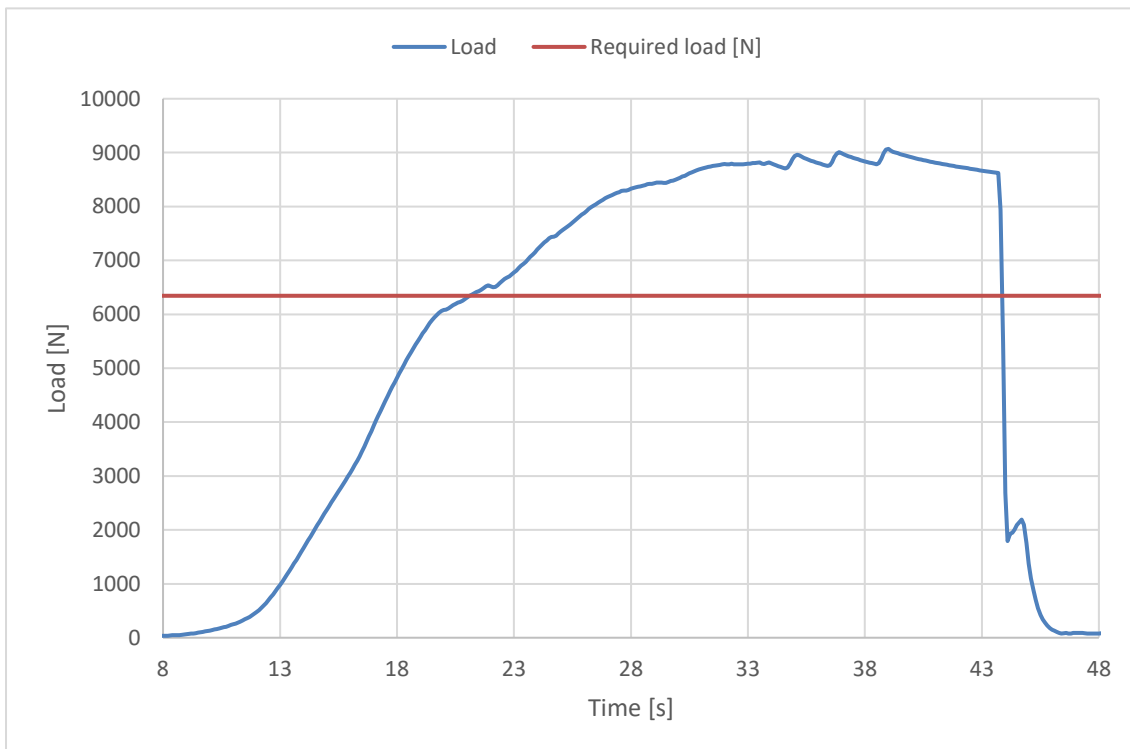
Test ID 01

Test duration [s] **22.7**
 Any signs of structural failure **No**
 Slippery test OK **No**
 Test results **POSITIVE**

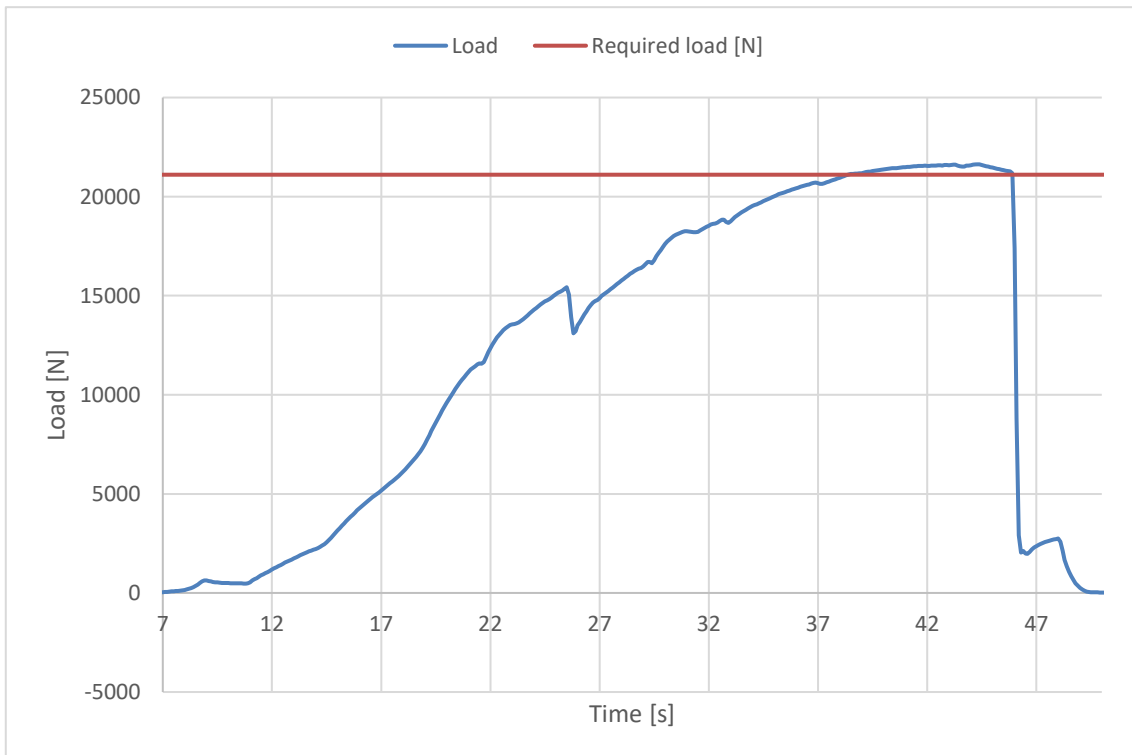
Test ID 03

Test duration [s] **7.6**
 Any signs of structural failure **No**
 Slippery test OK **No**
 Test results **POSITIVE**

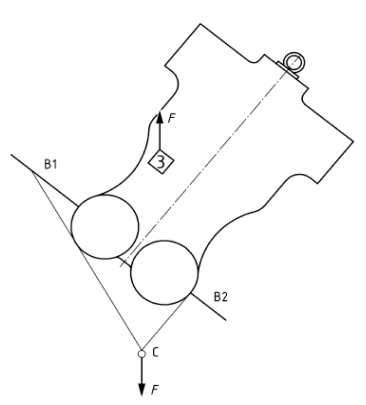
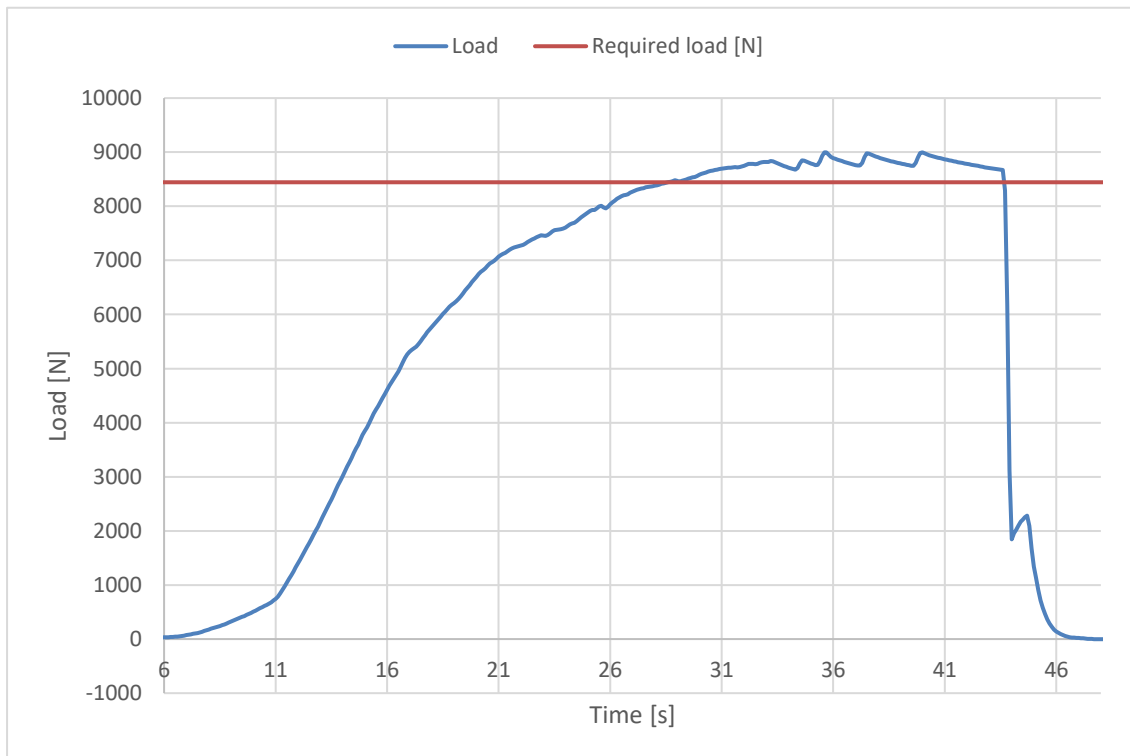
Test ID 05

Standard	EN 1651
Reference in standard	5.5.1.2
Test setup	Positive asymmetric load
Attachment points	One riser attachment (3 or 4)
Anchor points	Dummy (C)
Required load [g]	6
Required load [N]	8400
Minimum test duration [s]	5
Result	
Test duration [s]	15.1
Any signs of structural failure	No
Test results	POSITIVE

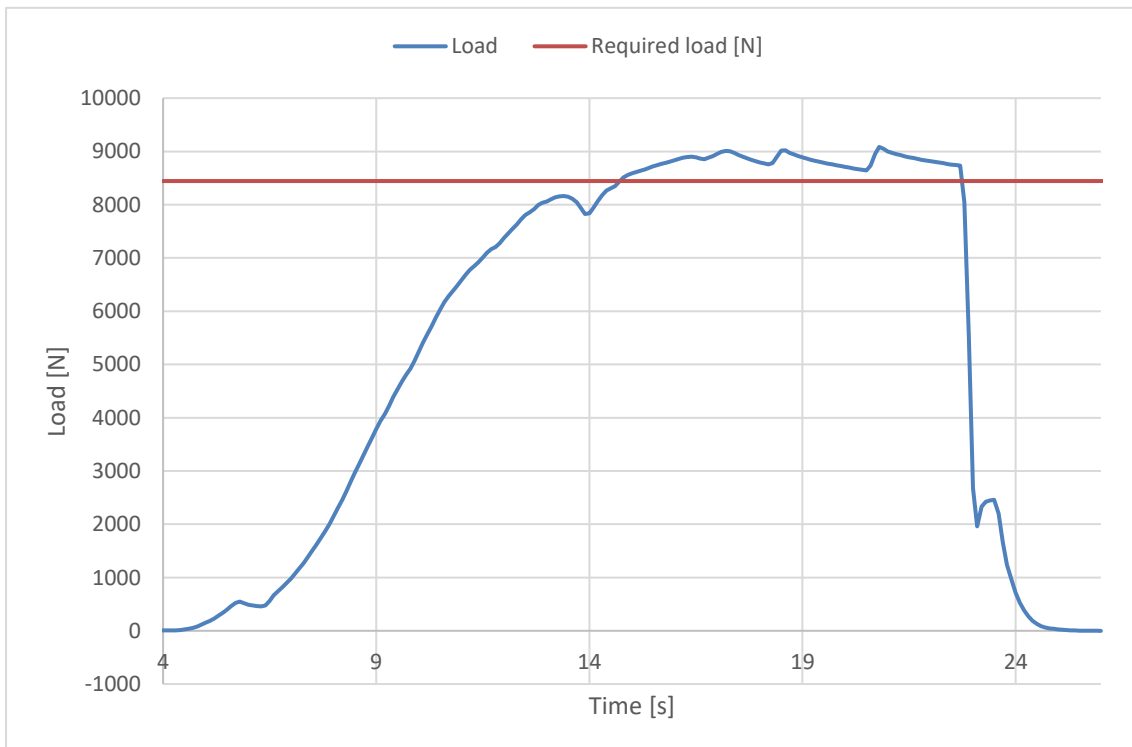
Test ID 06

Standard	EN 1651
Reference in standard	5.5.1.6
Test setup	Negative symmetric load
Attachment points	Both main riser attachment (3,4)
Anchor points	Dummy (A)
Required load [g]	6
Required load [N]	8400
Minimum test duration [s]	5
Result	
Test duration [s]	8
Any signs of structural failure	No
Test results	POSITIVE

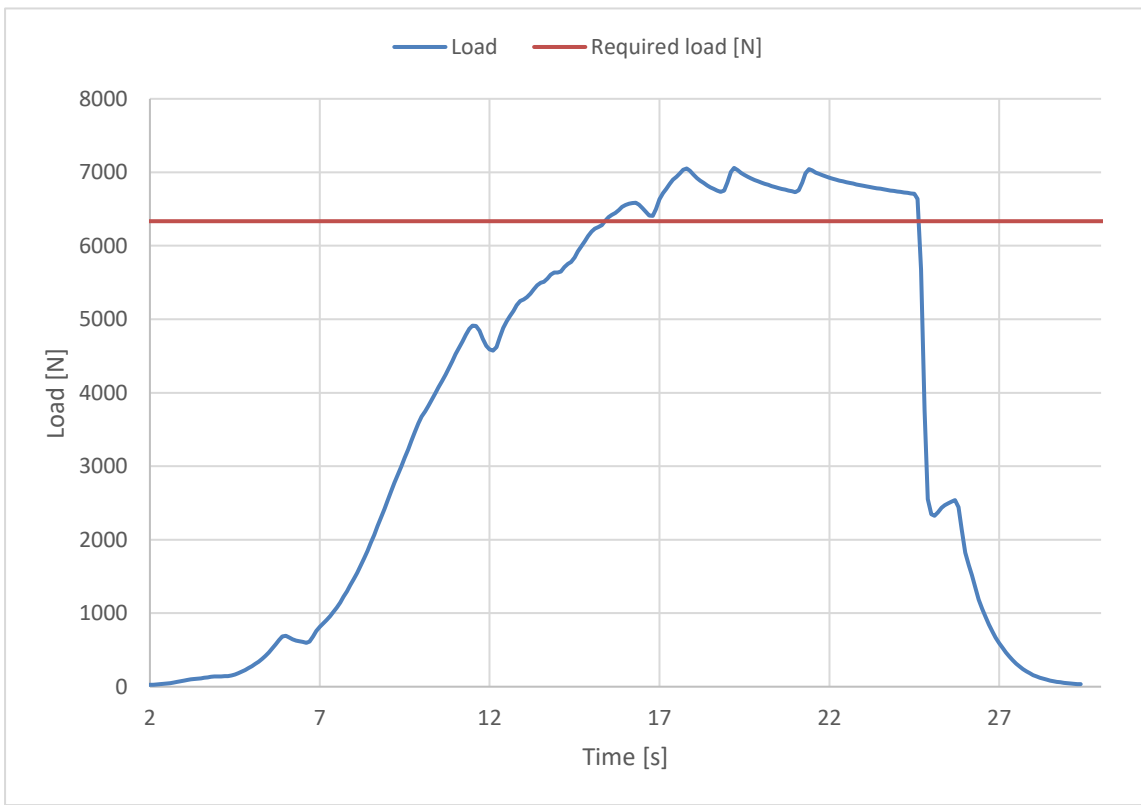
Test ID 08

Standard	EN 1651
Reference in standard	5.5.1.9
Test setup	Anti falling-out system
Attachment points	Around anti falling-out system
Anchor points	Both main riser attachment (no dummy)
Required load [g]	4.5
Required load [N]	6300
Minimum test duration [s]	5
Result	
Test duration [s]	9.3
Any signs of structural failure	No
Test results	POSITIVE

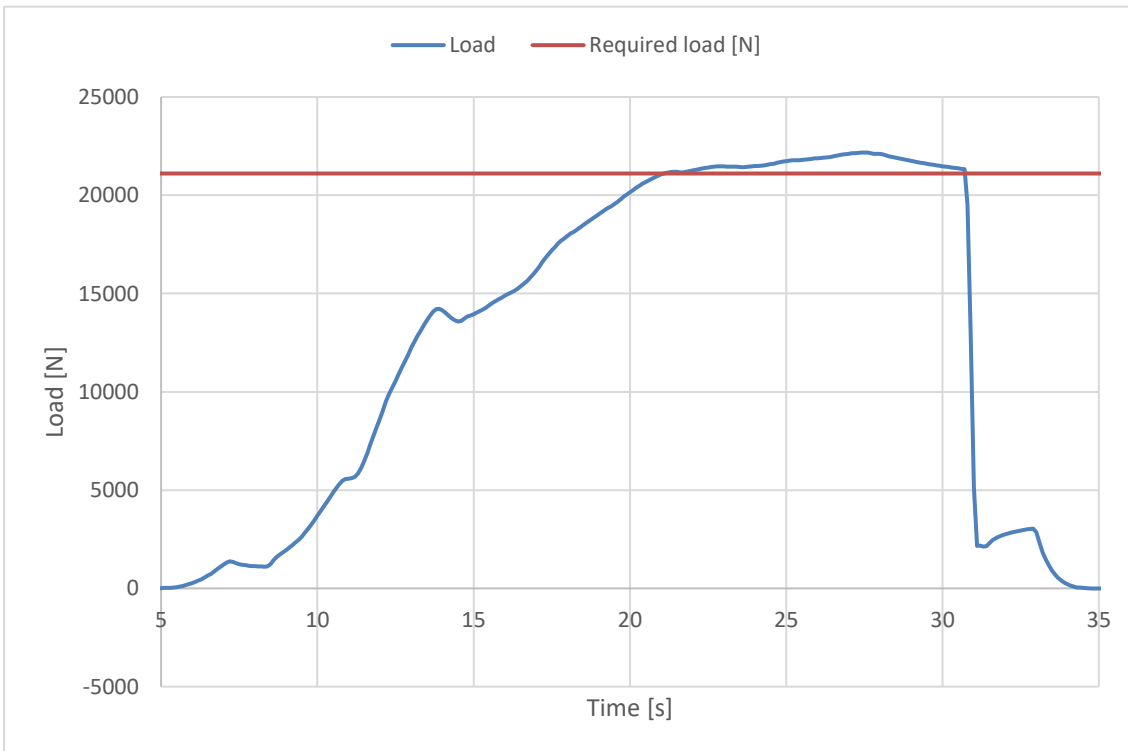
Test ID 09

Reference in standard	5.5.1.3	
Test setup	Positive symmetric load rescue points	
Attachment points	Both main riser attachment (1,2)	
Anchor points	Dummy (B1,B2)	
Required load [g]	15	
Required load [N]	21000	
Minimum test duration [s]	5	
Result		
Test duration [s]	9.6	
Any signs of structural failure	No	
Slippery test OK	No	
Test results	POSITIVE

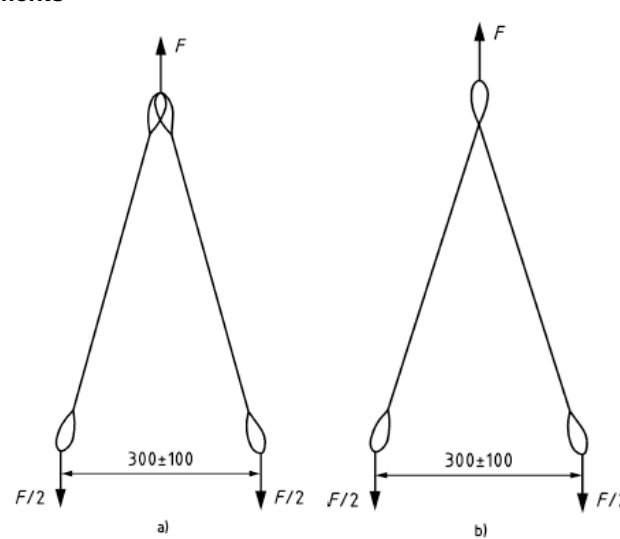
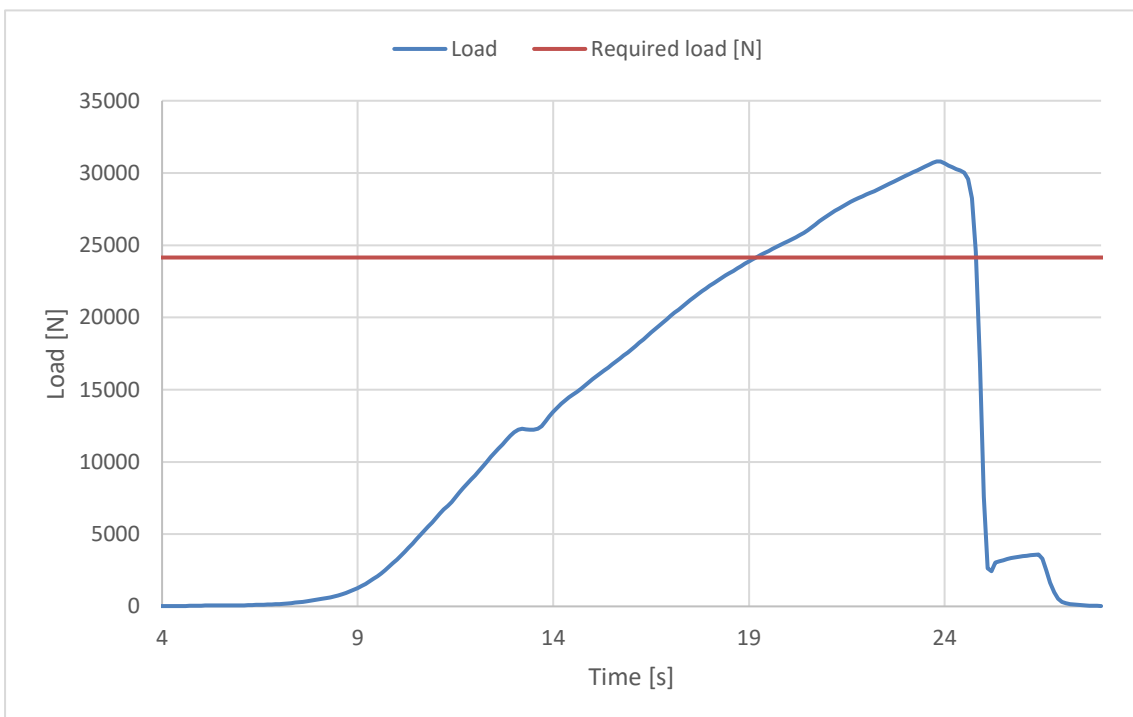
Test ID 11

Standard	EN 1651
Reference in standard	5.5.1.8
Test setup	Connecting element for rescue
Attachment points	End point (emergency parachute)
Anchor points	Both attachment to harness
Required load [g]	n/a
Required load [N]	24000
Minimum test duration [s]	0.3
Type of connecting element	a) two single elements
Result	
Test duration [s]	5.7
Any signs of structural failure	No
Test results	POSITIVE

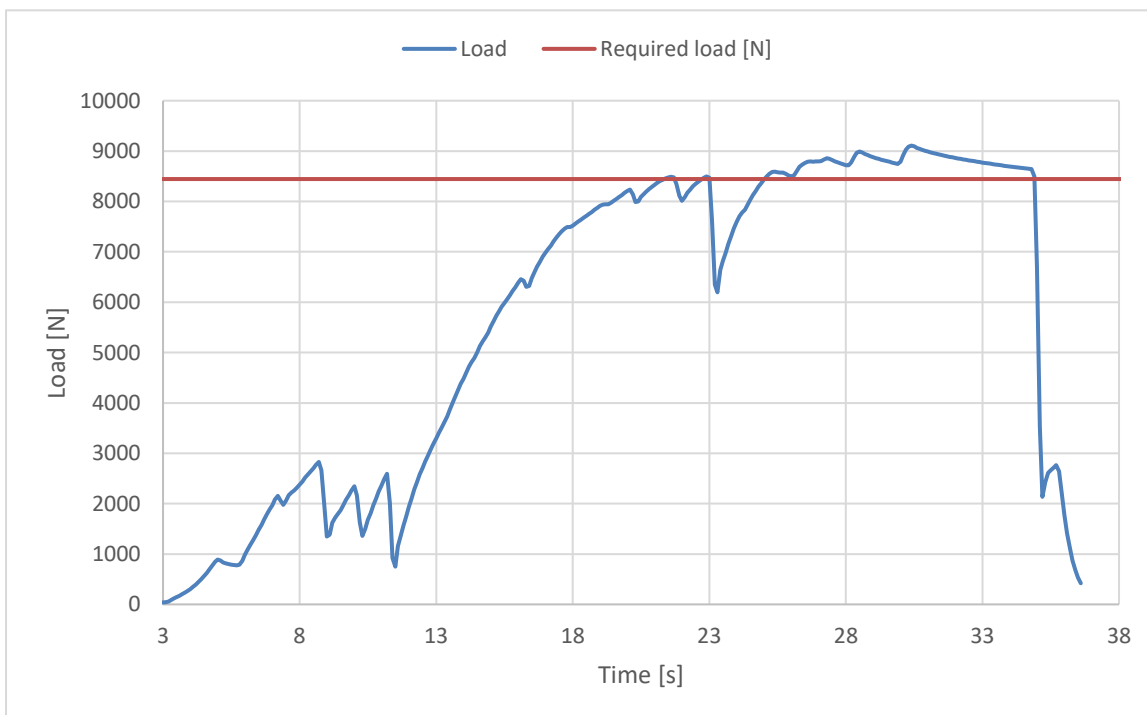
Test ID 12

Standard	EN 1651
Reference in standard	5.5.1.7
Test setup	Upright (landing) position load
Attachment points	Both main riser attachment (3, 4)
Anchor points	Both legstrap of harness (no dummy)
Required load [g]	6
Required load [N]	8400
Minimum test duration [s]	5
Harness type	type a
Result	
Test duration [s]	9.9
Any signs of structural failure	No
Slippery test OK	Yes
Test results	POSITIVE

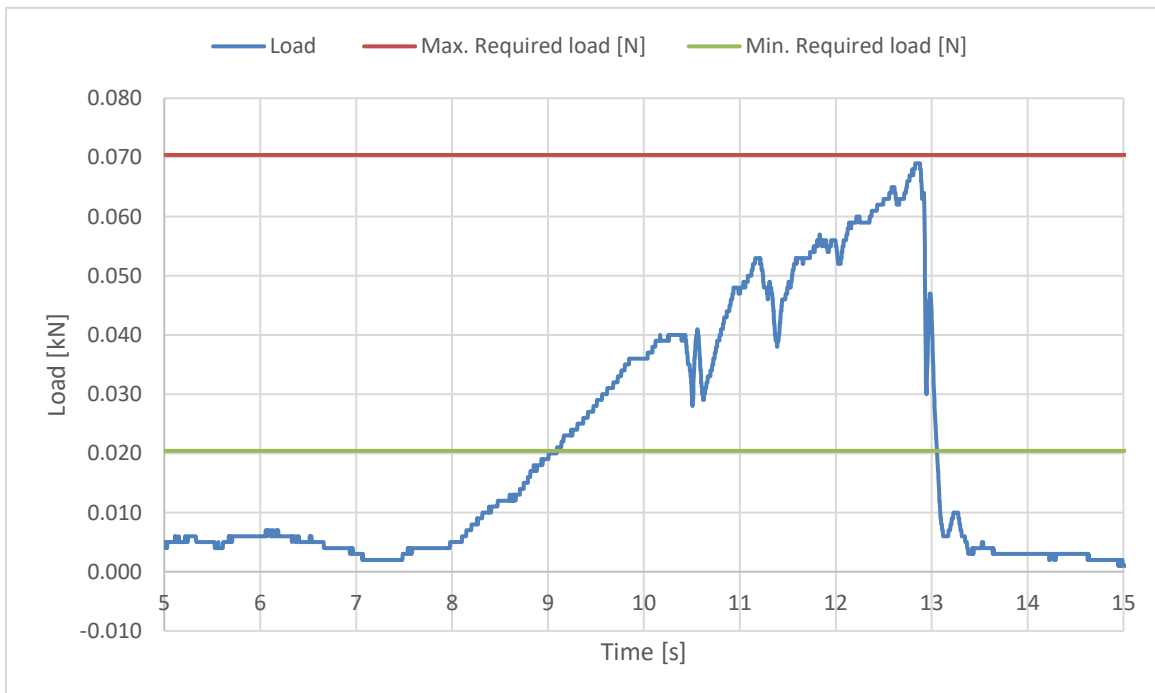
Test ID RRDT

Standard	LTF NfL II 91/09
Reference in standard	6.1.5
Test setup	Default flying position
Attachment points	Sensor connect to handle, and pull in opening direction
	The test is to simulate the load required to open the emergency parachute(1st action).
Min. Required load [N]	20
Max. Required load [N]	70
Result	
Load for first action [N]	68.59
Test results	POSITIVE

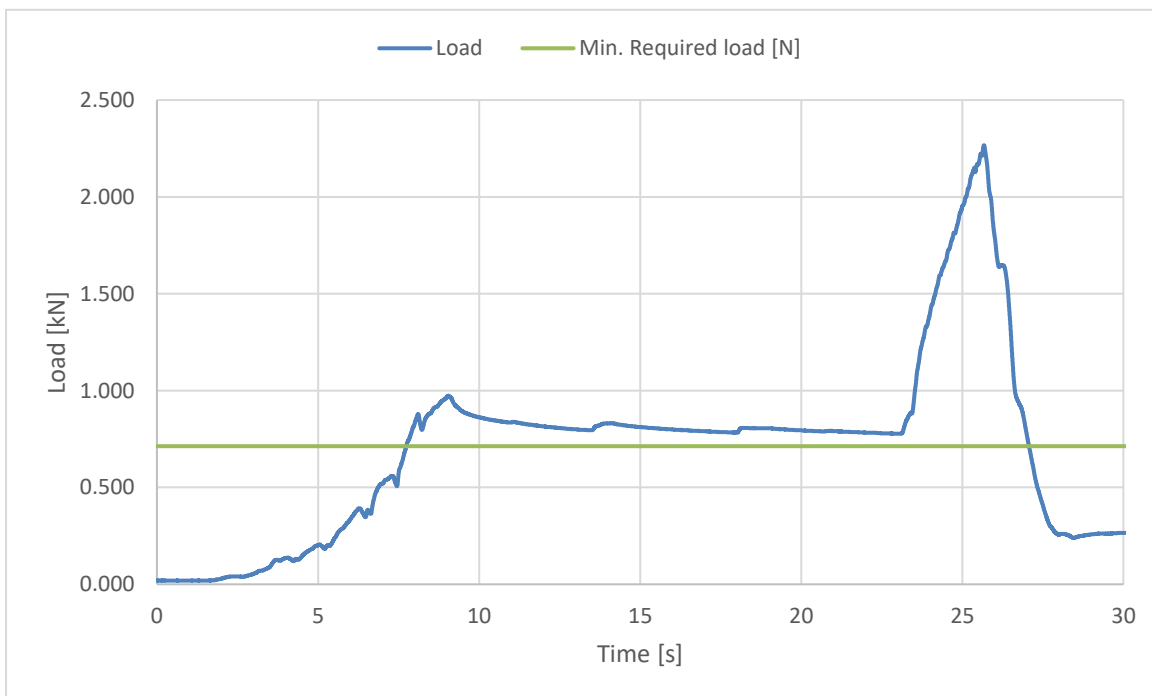
Test ID RRST

Standard	EN12491:2015
Reference in standard	5.3.2
Test setup	Two end points of handle
Attachment points	Sensor connect to end of handle, pull on the other side
	The handle must support min 700 N for 10 s, after measure breaking strength
Min. Required load [N]	700
Minimum test duration [s]	10
Result	
Test duration [s]:	19.3
Breaking strength [N]	2253.38
Test results	POSITIVE
