Harness Structural test Report

Inspection certificate number: **PH_219.2018**
Manufacturer data:

Name: **Watson**
 Type: **ABS**
 Size: **M**
 Serial number: **Eskort OS V6**
 Impact pad type: ⁽¹⁾ **Airbag**
 Clip-in weight [kg]: **120**

model: **Watson M**

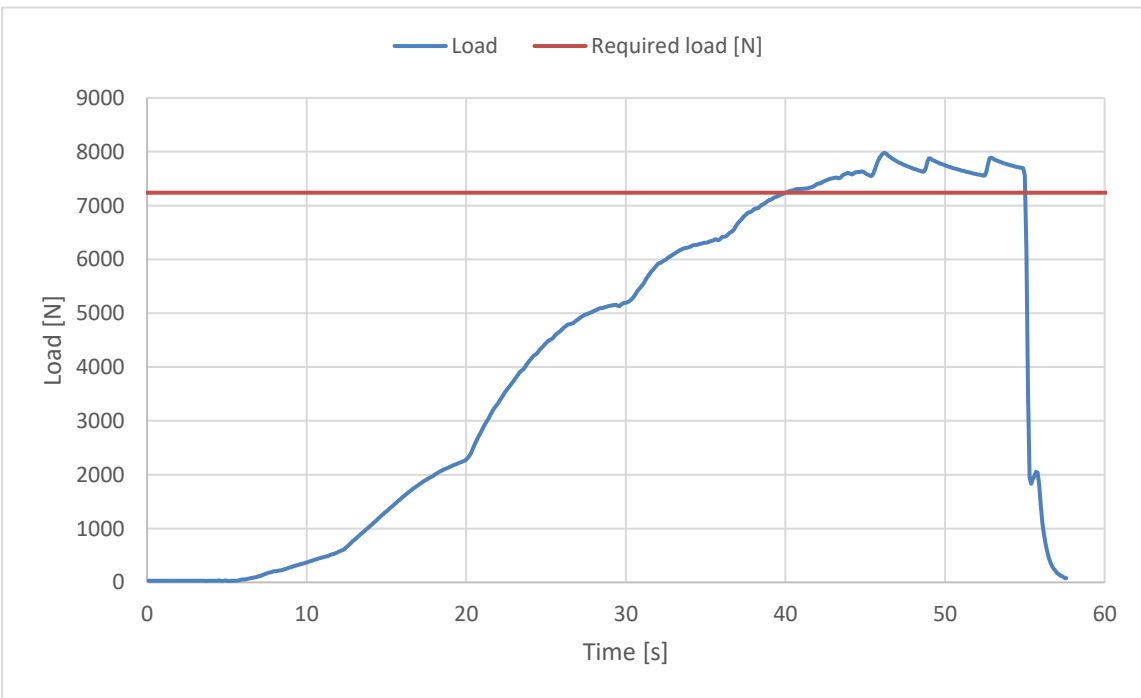
Test ID R0

Reference in standard	5.3.2.1	
Test setup	Default flying position	
Attachment points	Both main riser attachment (3,4)	
Anchor points	Dummy (B1, B2)	
Required load [g]	6	
Required load [N]	7200	
Minimum test duration [s]	10	
Result		
Test duration [s]	15	
Any signs of structural failure	No	
Test results	POSITIVE

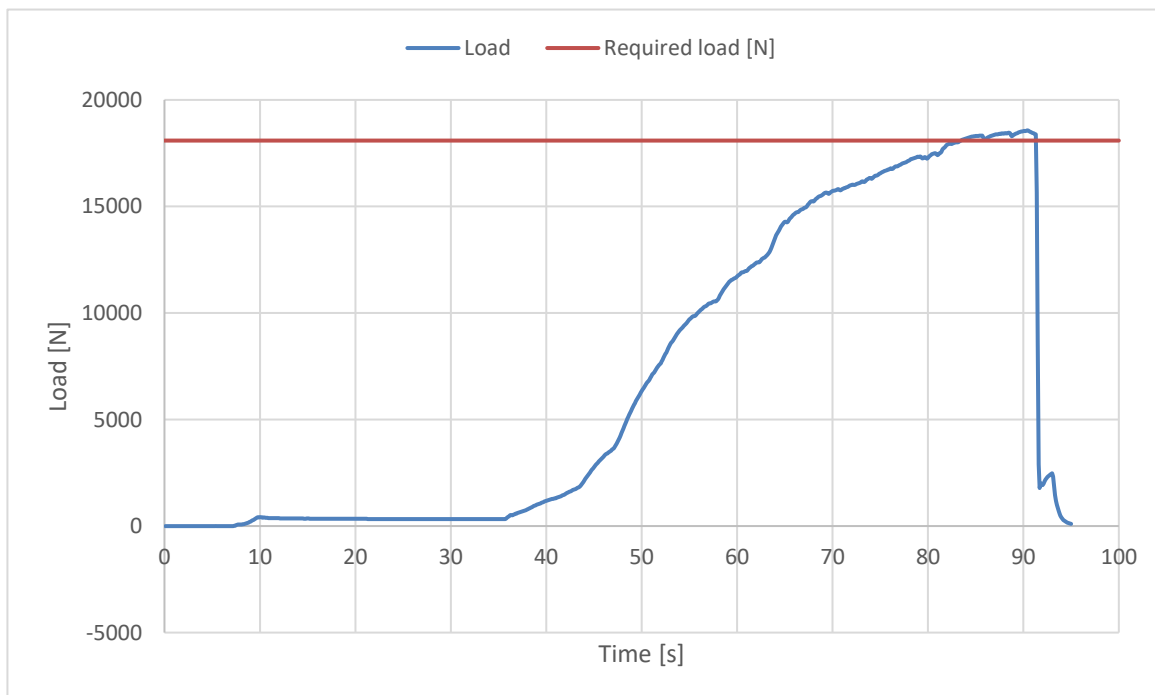
Test ID R2

Reference in standard	5.3.2.2	
Test setup	Default flying position	
Attachment points	Both main riser attachment (3,4)	
Anchor points	Dummy (B1, B2)	
Required load [g]	15	
Required load [N]	18000	
Minimum test duration [s]	5	
Result		
Test duration [s]	7.9	
Any signs of structural failure	No	
Test results	POSITIVE

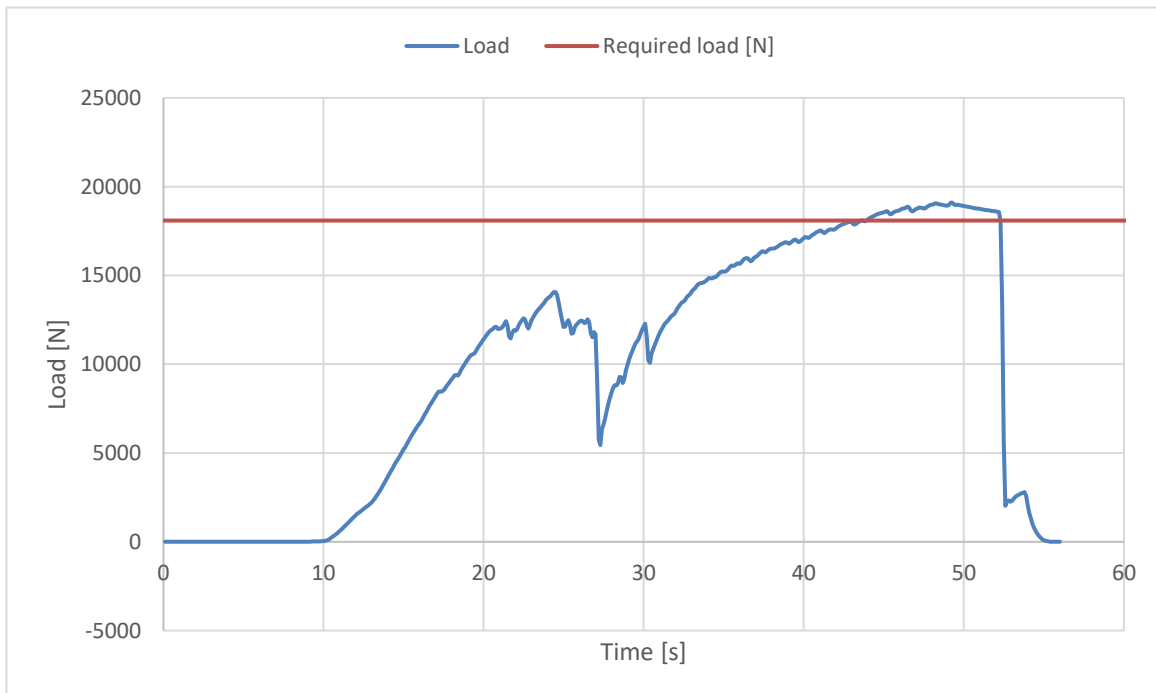
Test ID R4

Standard	EN 1651:1999
Reference in standard	5.3.2.7
Test setup	Flying position before landing
Attachment points	Both main riser attachment (3,4)
Anchor points	Dummy (7,8)
Required load [g]	15
Required load [N]	18000
Minimum test duration [s]	5
Result	
Test duration [s]	8.3
Any signs of structural failure	No
Test results	POSITIVE

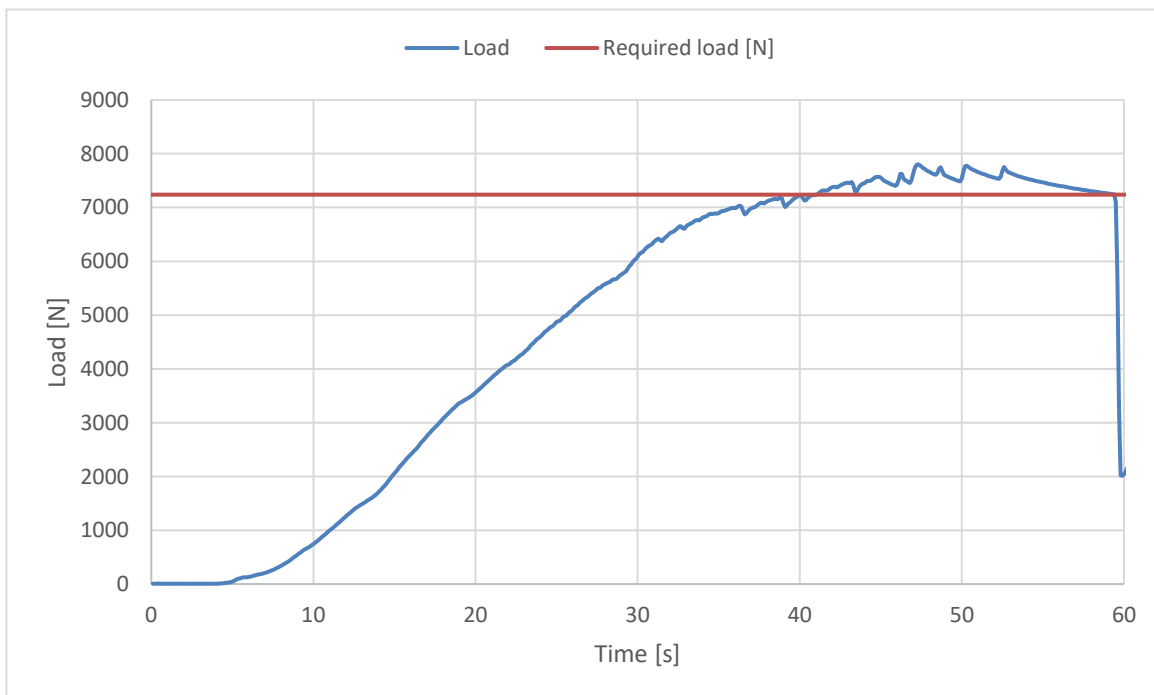
Test ID R8

Standard	EN 1651:1999	
Reference in standard	5.3.2.3	
Test setup	Asymmetric, one riser	
Attachment points	One main riser attachment (3)	
Anchor points	Dummy (B1,B2)	
Required load [g]	6	
Required load [N]	7200	
Minimum test duration [s]	10	
Result		
Test duration [s]	18.4	
Any signs of structural failure	No	
Test results	POSITIVE

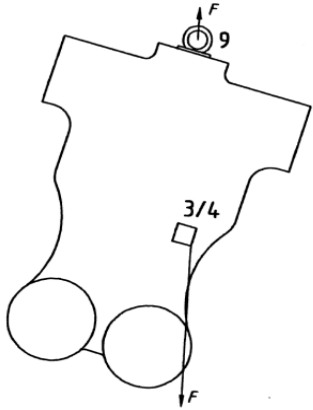
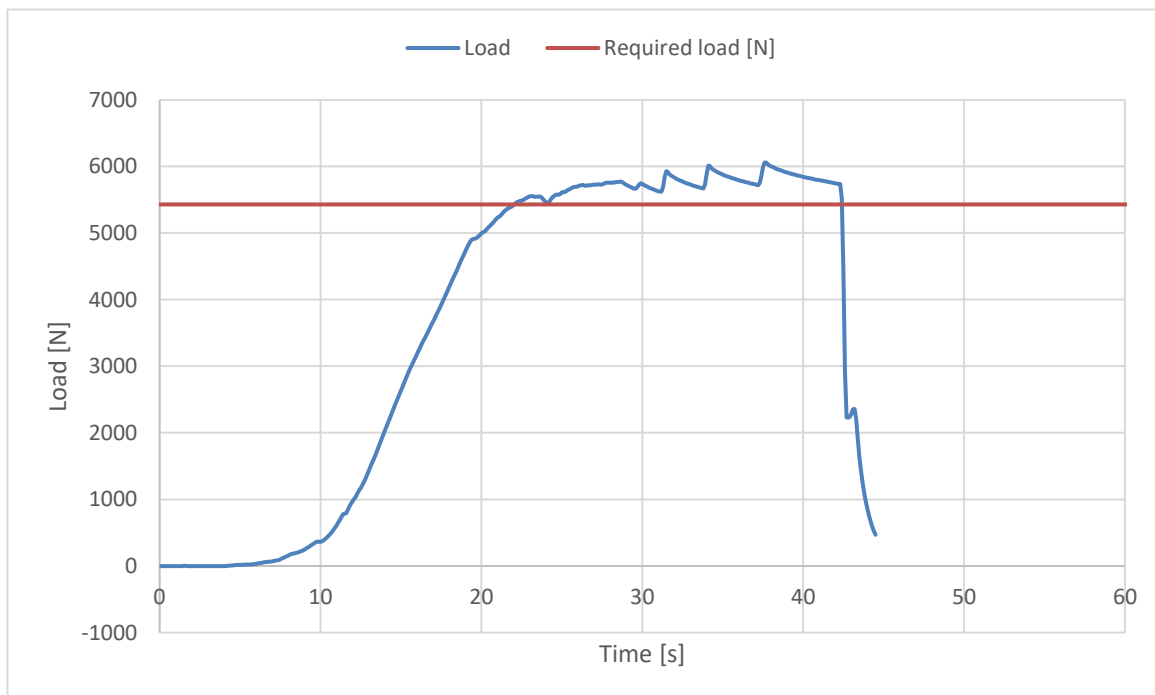
Test ID R10

Reference in standard	5.3.2.6	
Test setup	Asymmetric, negative	
Attachment points	One main riser attachment (3 or 4) downwards	
Anchor points	Dummy (9)	
Required load [g]	4.5	
Required load [N]	5400	
Minimum test duration [s]	10	
Result		
Test duration [s]	20.4	
Any signs of structural failure	No	
Test results	POSITIVE
