# Harness Structural test Report - EN

Inspection certificate number: **PH\_344.2021**

Name: **Duo**  
 Type: **ABS**  
 Size: **M**  
 Serial number: **HDO-TFM-21002**  
 Impact pad type: <sup>(1)</sup> **Airbag**  
 Clip-in weight [kg]: **120**  
 Date of test: **04.03.2021**

Air Turquoise SA, having thoroughly assessed the sample mentioned above, declare it was found conform with  
European Standard **EN1651:2018**, and **EN12491:2015**

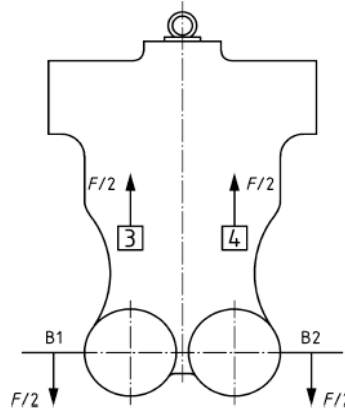
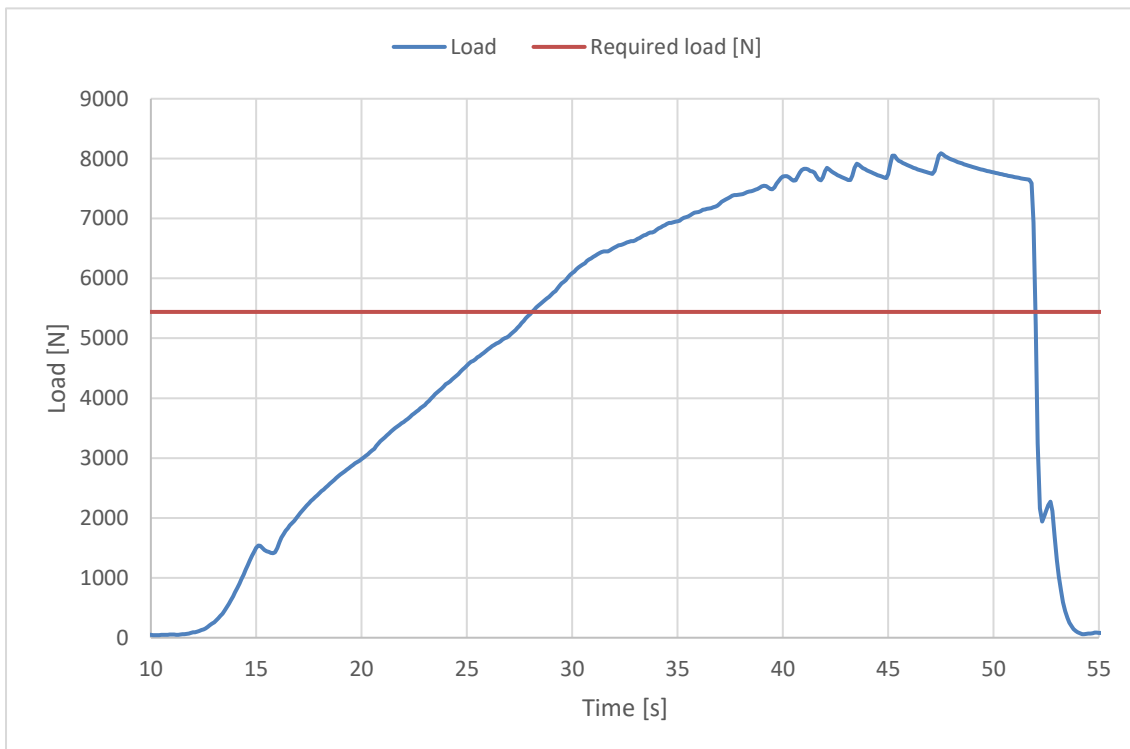
**Test ID 01**

Test duration [s] **23.8**  
 Any signs of structural failure **No**  
 Slippery test OK **Yes**  
 Test results **POSITIVE**

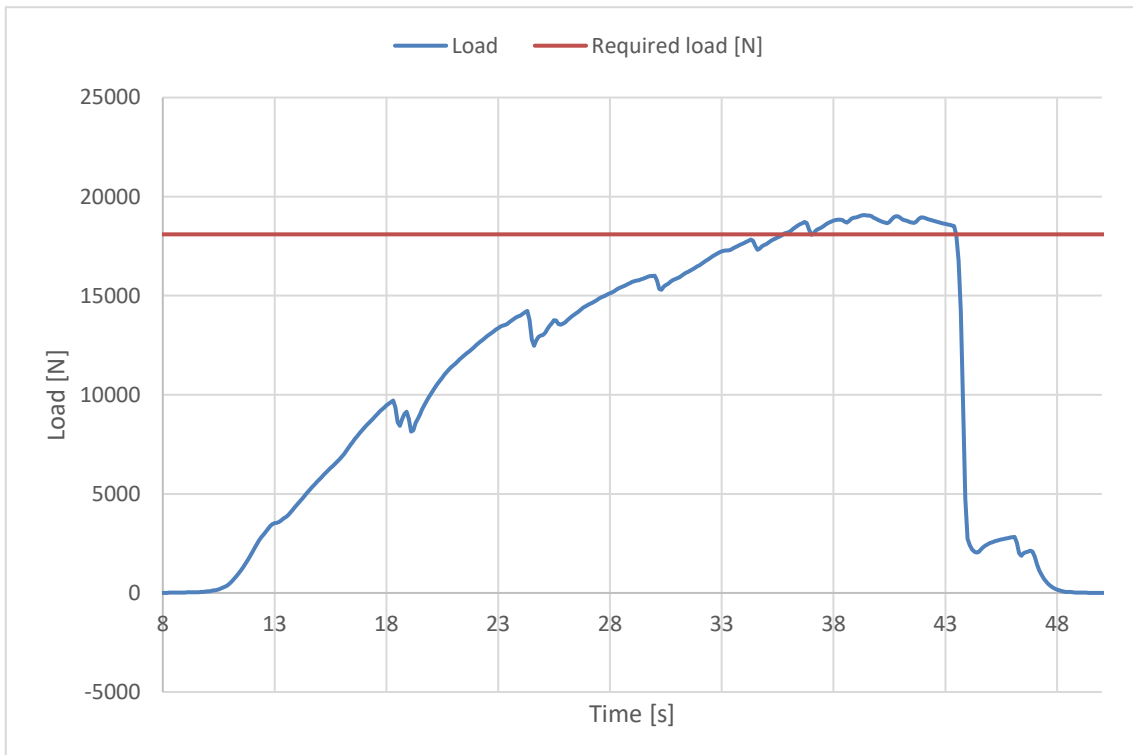
**Test ID 03**

Standard	<b>EN 1651</b>
Reference in standard	<b>5.5.1.1b</b>
Test setup	<b>Positive symmetric load</b>
Attachment points	<b>Both main riser attachment (3,4)</b>
Anchor points	<b>Dummy (B1, B2)</b>
Required load [g]	<b>15</b>
Required load [N]	<b>18000</b>
Minimum test duration [s]	<b>5</b>
<b>Result</b>	
Test duration [s]	<b>6.4</b>
Any signs of structural failure	<b>No</b>
Slippery test OK	<b>Yes</b>
Test results	<b>POSITIVE</b>

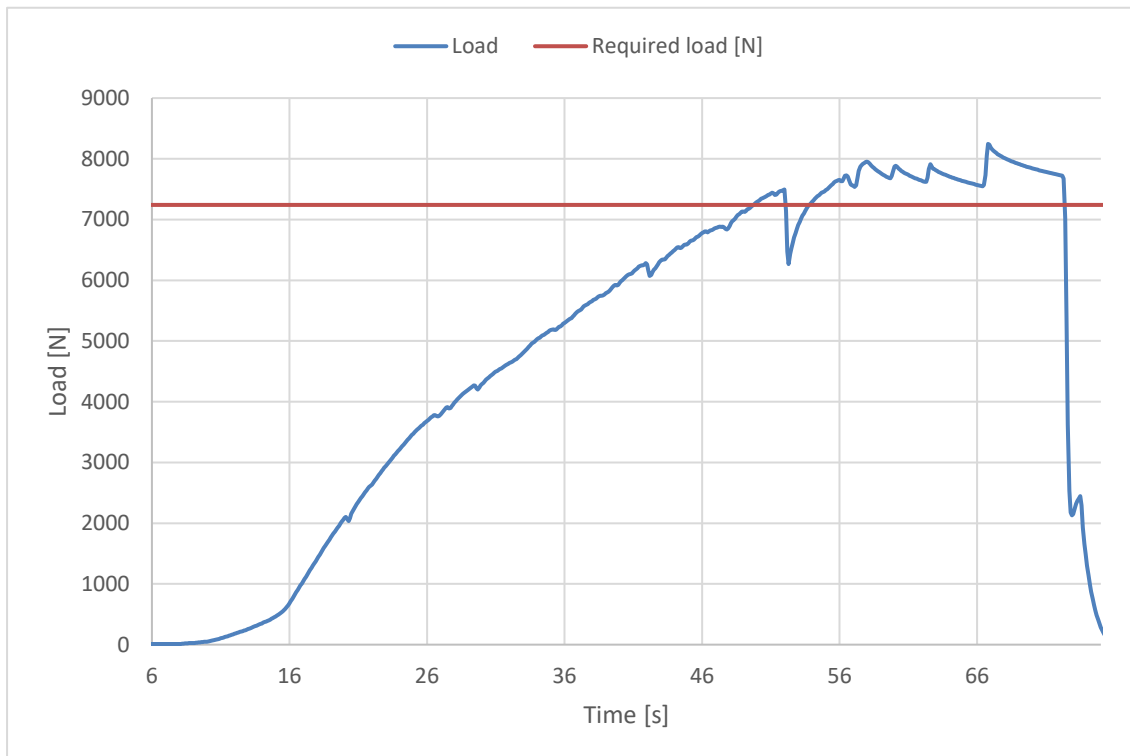
**Test ID 05**

Standard	<b>EN 1651</b>
Reference in standard	<b>5.5.1.2</b>
Test setup	<b>Positive asymmetric load</b>
Attachment points	<b>One riser attachment (3 or 4)</b>
Anchor points	<b>Dummy (C)</b>
Required load [g]	<b>6</b>
Required load [N]	<b>7200</b>
Minimum test duration [s]	<b>5</b>
<b>Result</b>	
Test duration [s]	<b>18.6</b>
Any signs of structural failure	<b>No</b>
Test results	<b>POSITIVE</b>

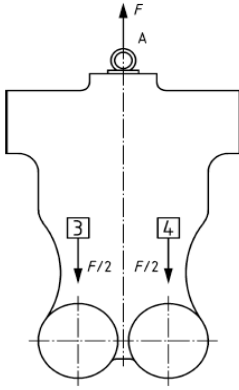
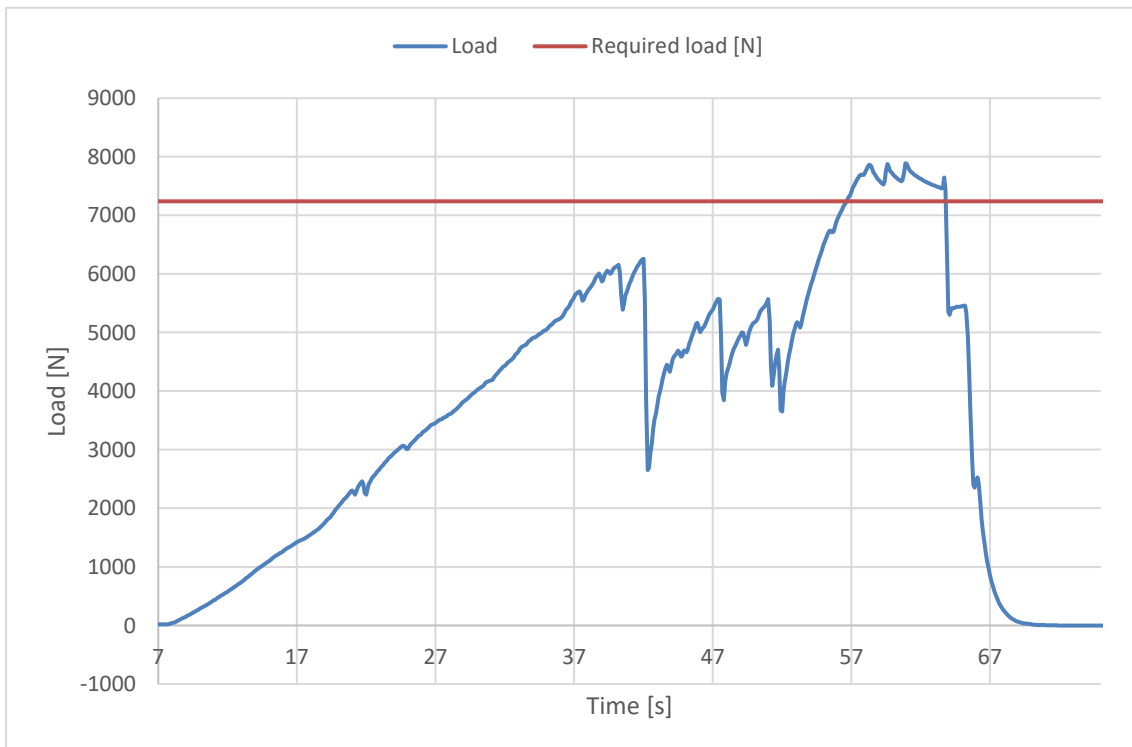
**Test ID 06**

Standard	<b>EN 1651</b>
Reference in standard	<b>5.5.1.6</b>
Test setup	<b>Negative symmetric load</b>
Attachment points	<b>Both main riser attachment (3,4)</b>
Anchor points	<b>Dummy (A)</b>
Required load [g]	<b>6</b>
Required load [N]	<b>7200</b>
Minimum test duration [s]	<b>5</b>
<b>Result</b>	
Test duration [s]	<b>7.2</b>
Any signs of structural failure	<b>No</b>
Test results	<b>POSITIVE</b>

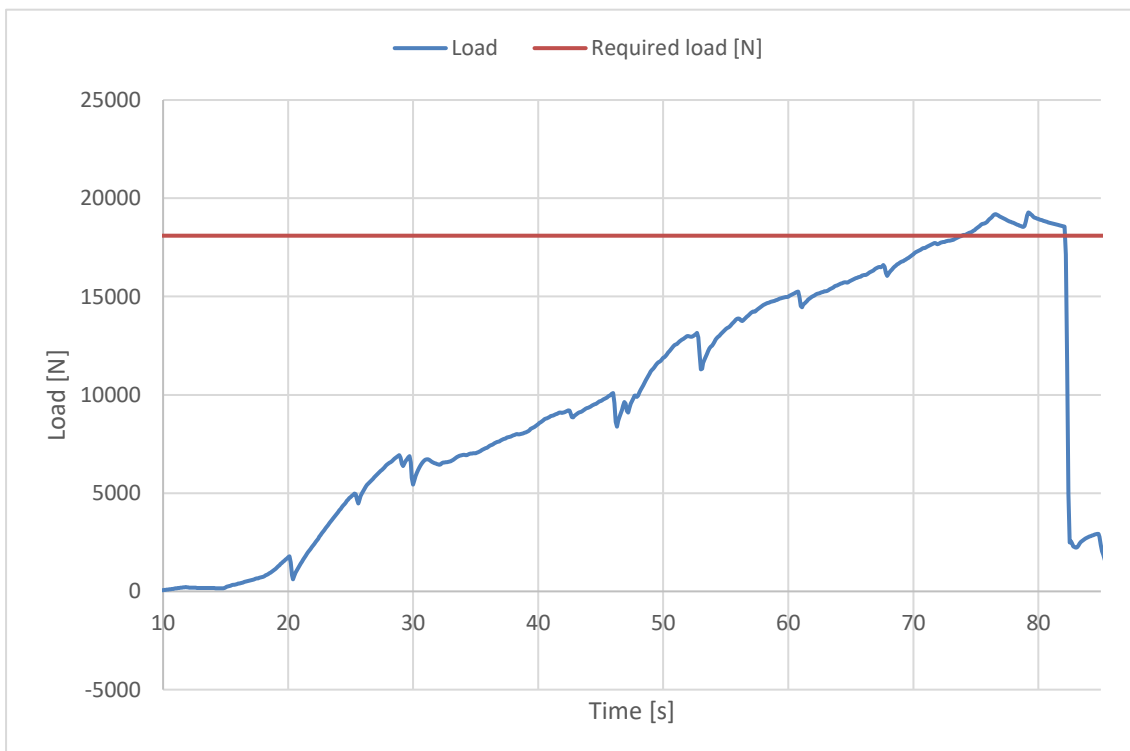
**Test ID 09**

Standard	<b>EN 1651</b>
Reference in standard	<b>5.5.1.3</b>
Test setup	<b>Positive symmetric load rescue points</b>
Attachment points	<b>Both main riser attachment (1,2)</b>
Anchor points	<b>Dummy (B1,B2)</b>
Required load [g]	<b>15</b>
Required load [N]	<b>18000</b>
Minimum test duration [s]	<b>5</b>
<b>Result</b>	
Test duration [s]	<b>8.3</b>
Any signs of structural failure	<b>No</b>
Slippery test OK	<b>Yes</b>
Test results	<b>POSITIVE</b>

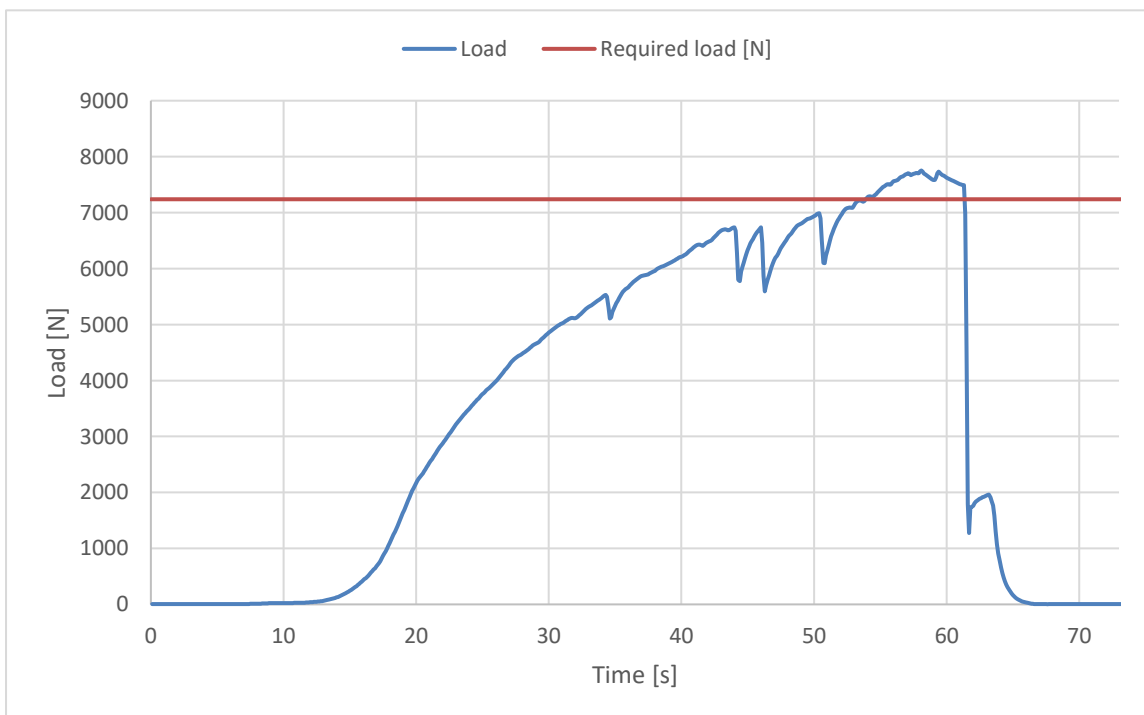
**Test ID 12**

Standard	<b>EN 1651</b>
Reference in standard	<b>5.5.1.7</b>
Test setup	<b>Upright (landing) position load</b>
Attachment points	<b>Both main riser attachment (3, 4)</b>
Anchor points	<b>Both legstrap of harness (no dummy)</b>
Required load [g]	<b>6</b>
Required load [N]	<b>7200</b>
Minimum test duration [s]	<b>5</b>
Harness type	<b>type a</b>
<b>Result</b>	
Test duration [s]	<b>7.4</b>
Any signs of structural failure	<b>No</b>
Slippery test OK	<b>Yes</b>
Test results	<b>POSITIVE</b>
