## Harness Structural test Report - NfL

Inspection certificate number: **PH\_344.2021**

Name: **Duo**  
 Type: **ABS**  
 Size: **M**  
 Serial number: **HDO-TFM-21002**  
 Impact pad type: <sup>(1)</sup> **Airbag**  
 Clip-in weight [kg]: **120**  
 Integrated container: **Yes**  
 Date of test: **04.03.2021**

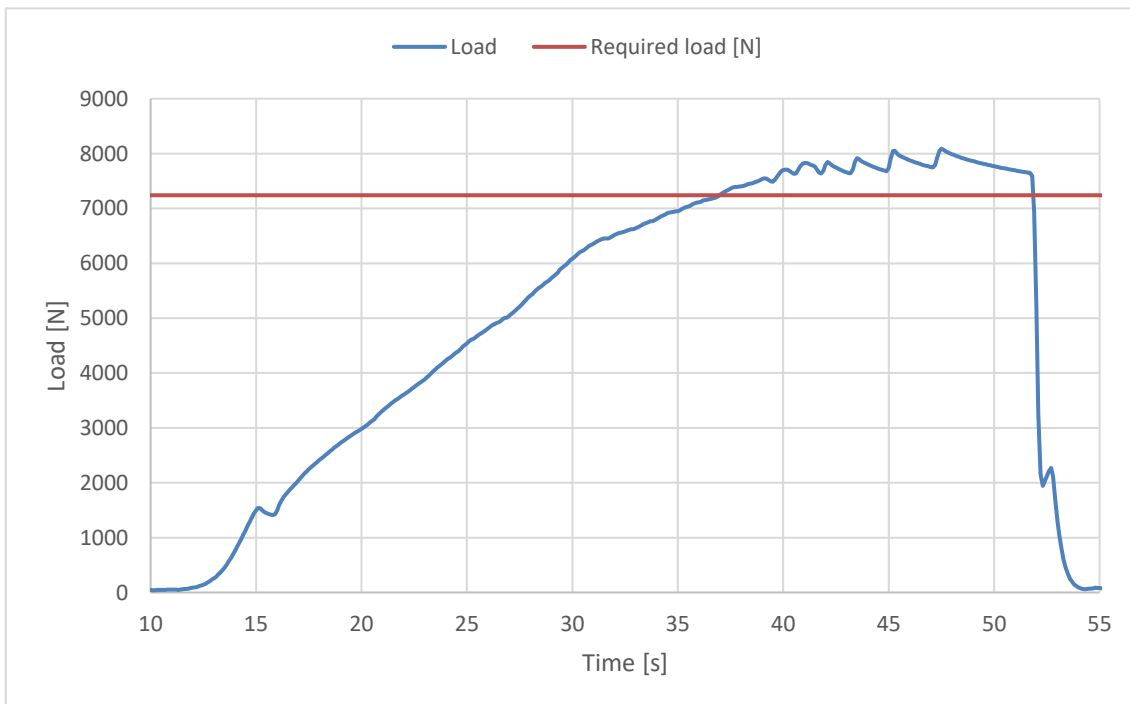
**Test ID 02**

Test duration [s] **14.9**  
 Any signs of structural failure **No**  
 Test results **POSITIVE**

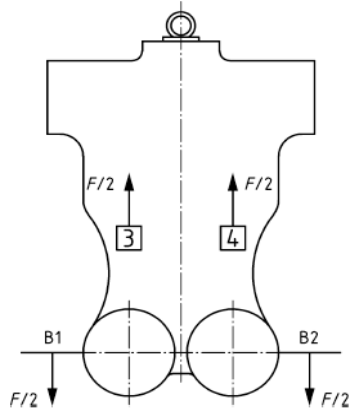
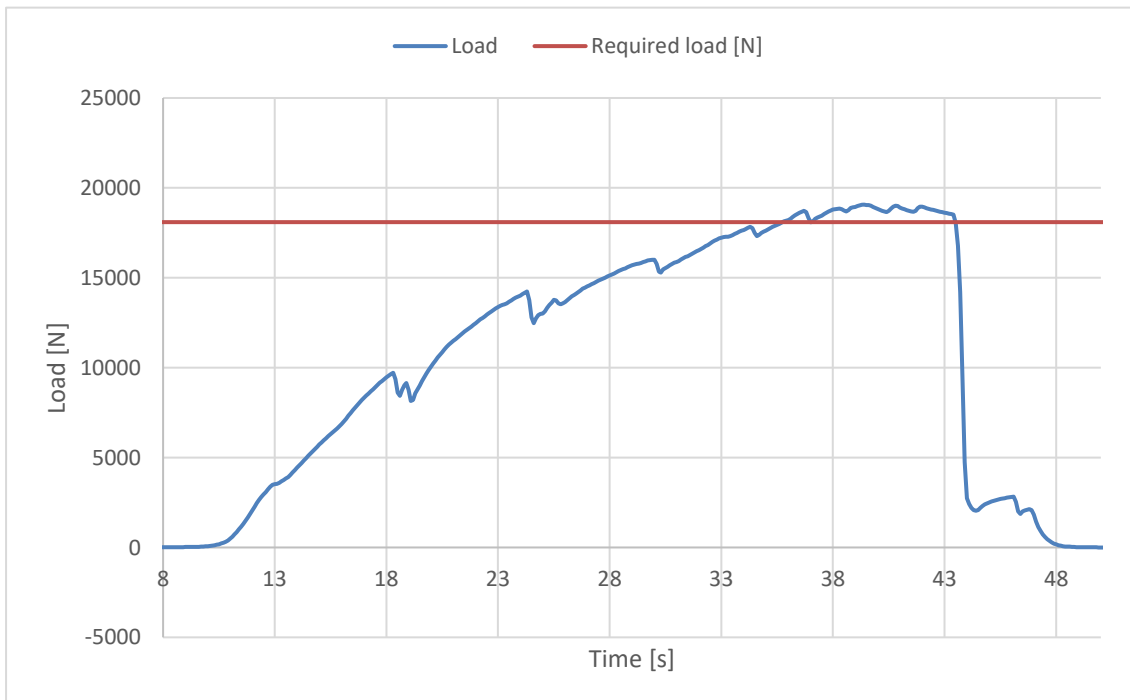
**Test ID 03**

Standard	<b>NfL 2-565-20</b>
Reference	<b>5.3.2.2</b>
Test setup	<b>Default flying position</b>
Attachment points	<b>Both main riser attachment (3,4)</b>
Anchor points	<b>Dummy (B1, B2)</b>
Required load [g]	<b>15</b>
Required load [N]	<b>18000</b>
Minimum test duration [s]	<b>5</b>
<b>Result</b>	
Test duration [s]	<b>6.4</b>
Any signs of structural failure	<b>No</b>
Test results	<b>POSITIVE</b>

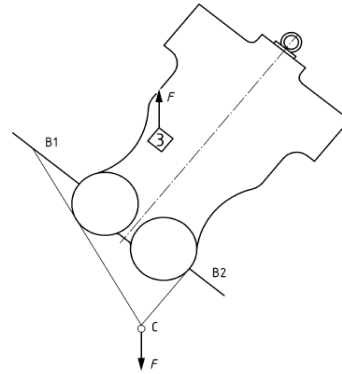
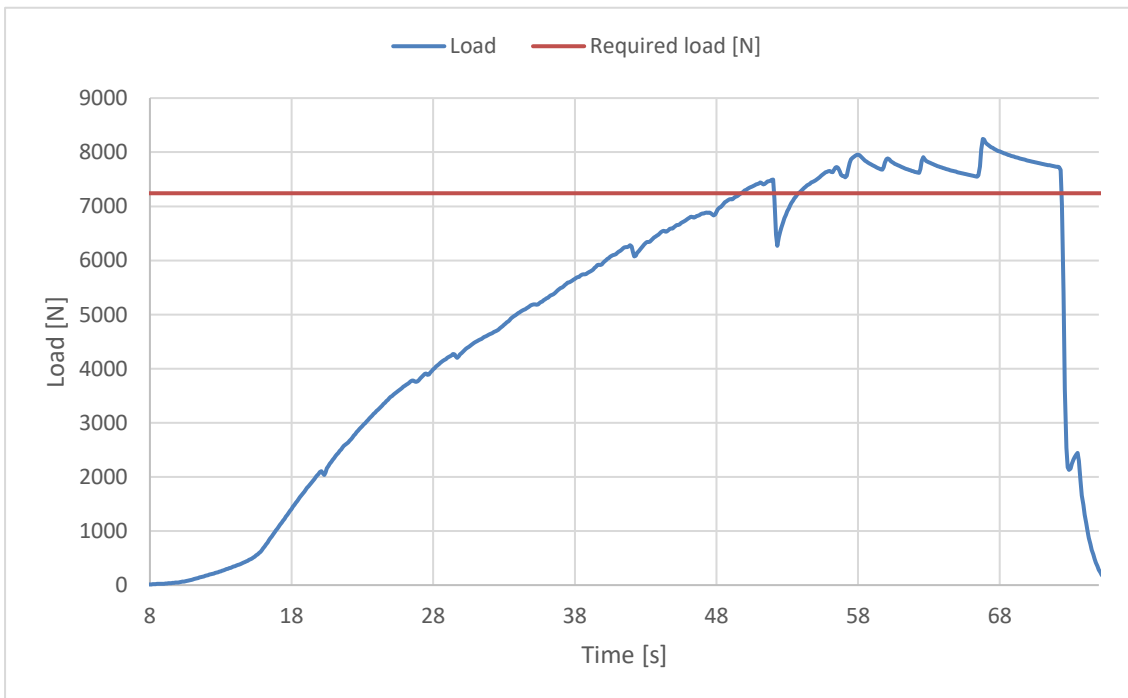
**Test ID 04**

Test duration [s] **18.6**  
 Any signs of structural failure **No**  
 Test results **POSITIVE**

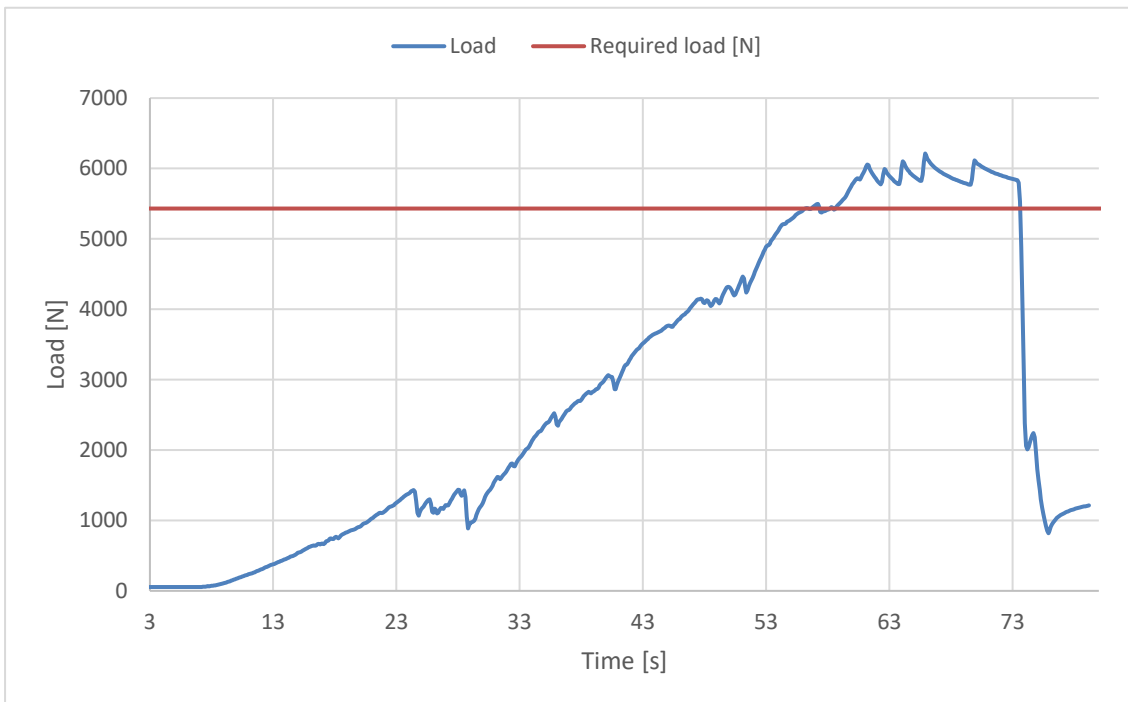
**Test ID 07**

Reference	<b>5.3.2.6</b>	
Test setup	<b>Asymmetric, negative</b>	
Attachment points	<b>One main riser attachment (3 or 4) downwards</b>	
Anchor points	<b>Dummy (9)</b>	
Required load [g]	<b>4.5</b>	
Required load [N]	<b>5400</b>	
Minimum test duration [s]	<b>10</b>	
<b>Result</b>		
Test duration [s]	<b>15</b>	
Any signs of structural failure	<b>No</b>	
Test results	<b>POSITIVE</b>

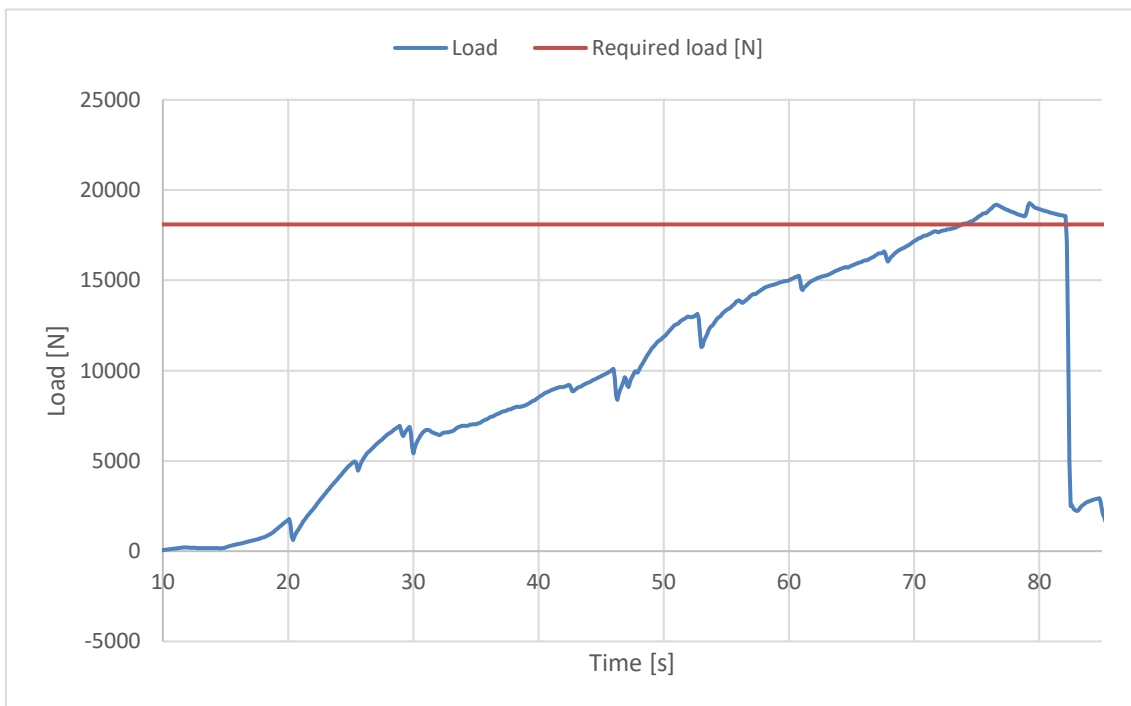
**Test ID 09**

Standard	<b>NfL 2-565-20</b>
Reference	<b>5.3.2.4</b>
Test setup	<b>Rescue attachments</b>
Attachment points	<b>Rescue riser attachment (1,2)</b>
Anchor points	<b>Dummy (B1,B2)</b>
Required load [g]	<b>15</b>
Required load [N]	<b>18000</b>
Minimum test duration [s]	<b>5</b>
<b>Result</b>	
Test duration [s]	<b>8.3</b>
Any signs of structural failure	<b>No</b>
Test results	<b>POSITIVE</b>

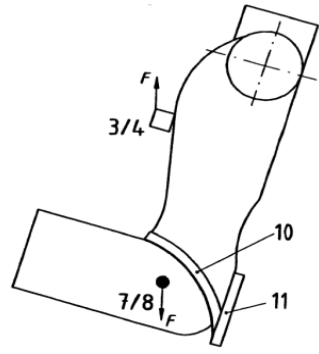
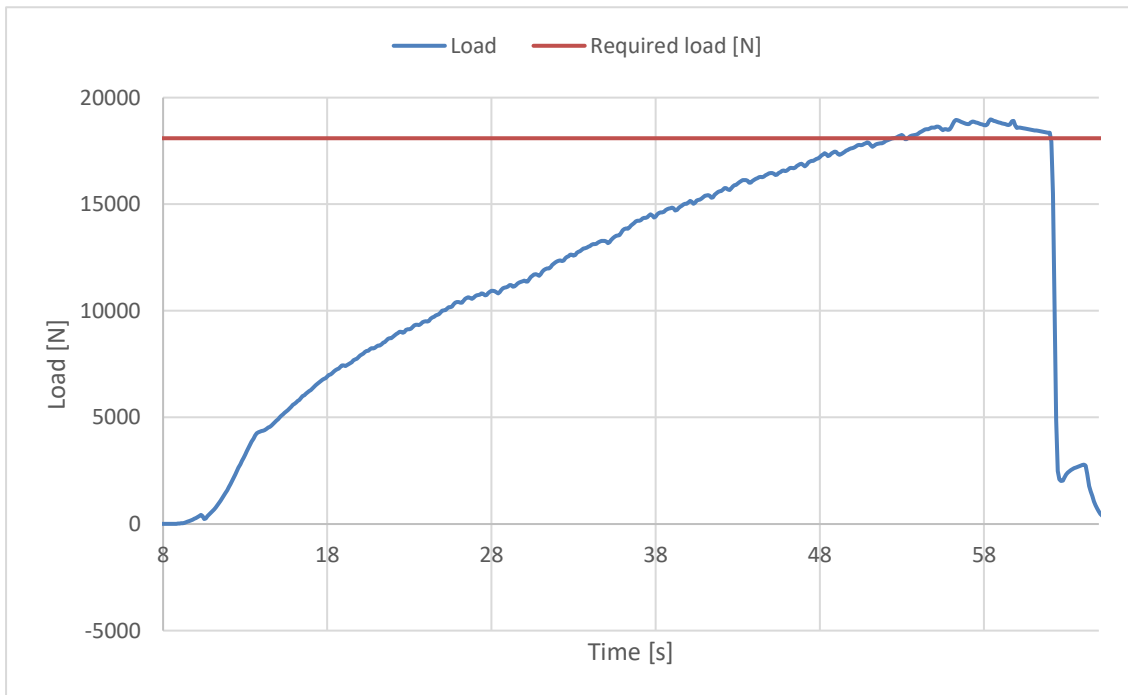
**Test ID 13**

Standard	<b>NfL 2-565-20</b>
Reference	<b>5.3.2.7</b>
Test setup	<b>Flying position before landing</b>
Attachment points	<b>Both main riser attachment (3,4)</b>
Anchor points	<b>Dummy (7,8)</b>
Required load [g]	<b>15</b>
Required load [N]	<b>18000</b>
Minimum test duration [s]	<b>5</b>
<b>Result</b>	
Test duration [s]	<b>8.7</b>
Any signs of structural failure	<b>No</b>
Test results	<b>POSITIVE</b>

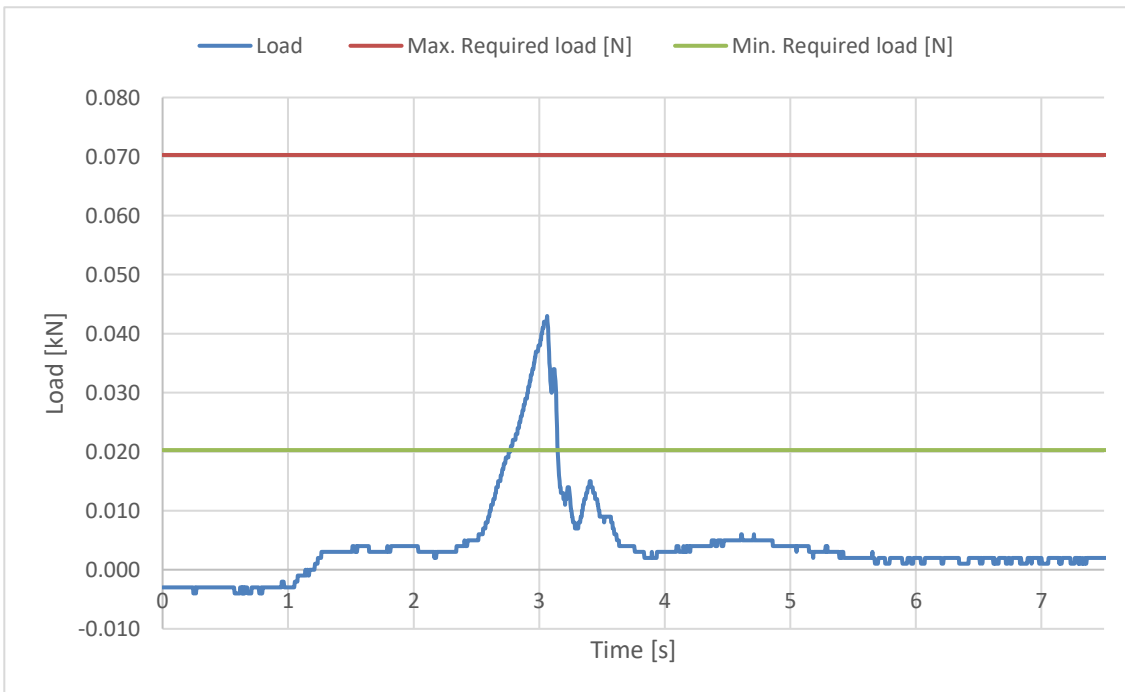
**Test ID RRDT**

Standard	<b>NfL 2-565-20</b>
Reference	<b>6.1.5</b>
Test setup	<b>Default flying position</b>
Attachment points	<b>Sensor connect to handle, and pull in opening direction</b>
	The test is to simulate the load required to open the emergency parachute(1st action).
Min. Required load [N]	<b>20</b>
Max. Required load [N]	<b>70</b>
<b>Result</b>	
Load for first action [N]	<b>42.71</b>
Test results	<b>POSITIVE</b>

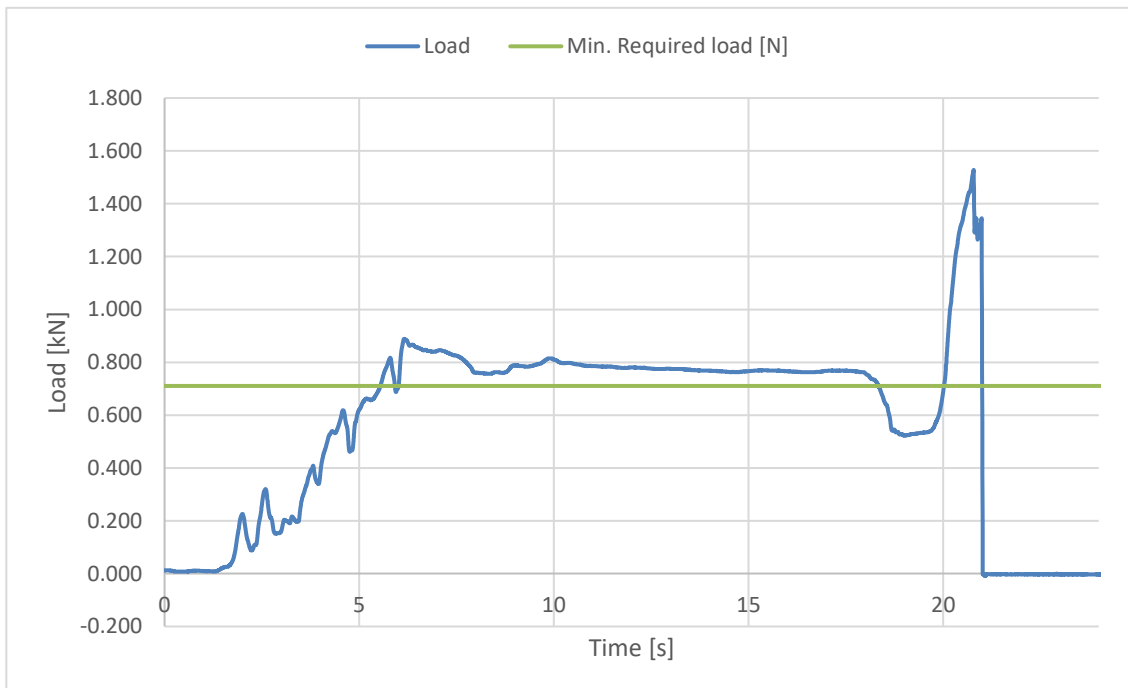
**Test ID RRST**

Standard	<b>EN12491:2015</b>
Reference in standard	<b>5.3.2</b>
Test setup	<b>Two end points of handle</b>
Attachment points	<b>Sensor connect to end of handle, pull on the other side</b>
	The handle must support min 700 N for 10 s, after measure breaking strength
Min. Required load [N]	<b>700</b>
Minimum test duration [s]	<b>10</b>
<b>Result</b>	
Test duration [s]:	<b>7.7</b>
Breaking strength [N]	<b>1517.85</b>
Test results	<b>POSITIVE</b>
