Harness Structural test Report - NfL

Inspection certificate number: **PH_345.2021**

Name: **Harmony Pilot**
 Type: **ABS**
 Size: **M-L**
 Serial number: **HHP-10003**
 Impact pad type: ⁽¹⁾ **Foam**
 Clip-in weight [kg]: **120**
 Integrated container: **Yes**
 Date of test: **22.07.2021**

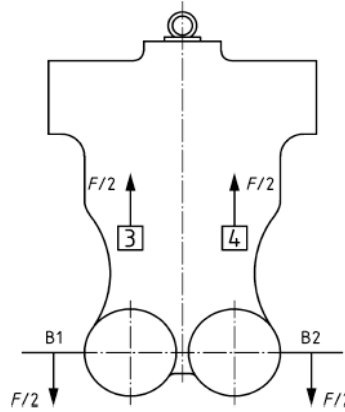
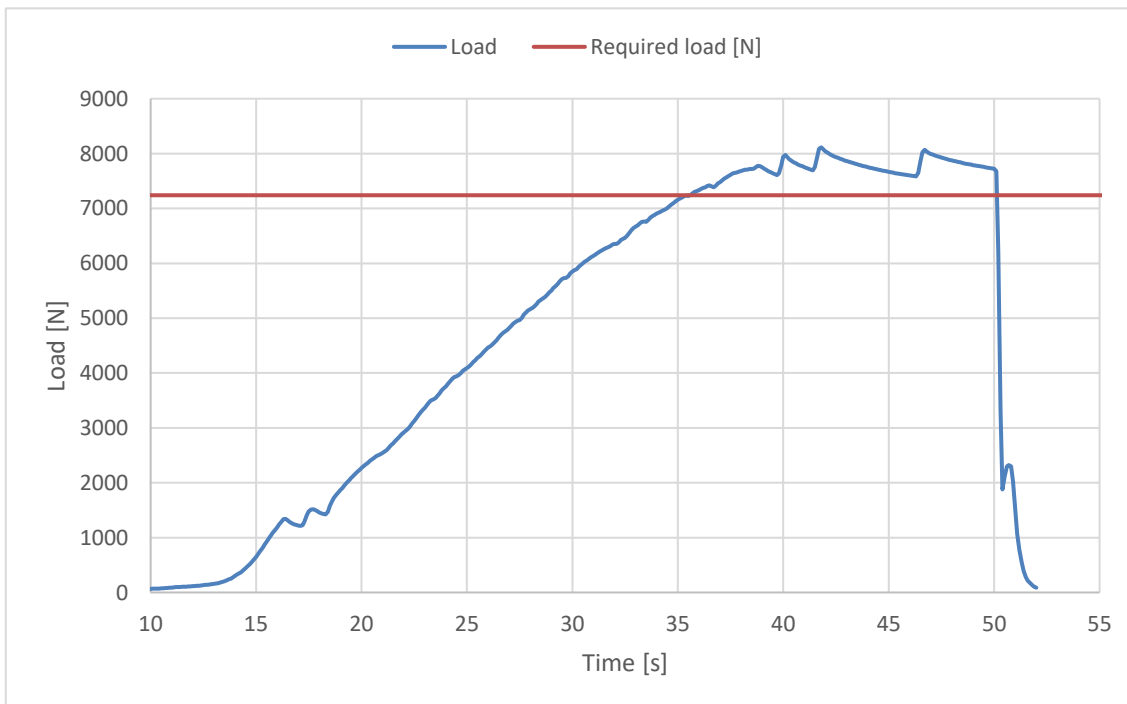
Test ID 02

Test duration [s] **14.6**
 Any signs of structural failure **No**
 Test results **POSITIVE**

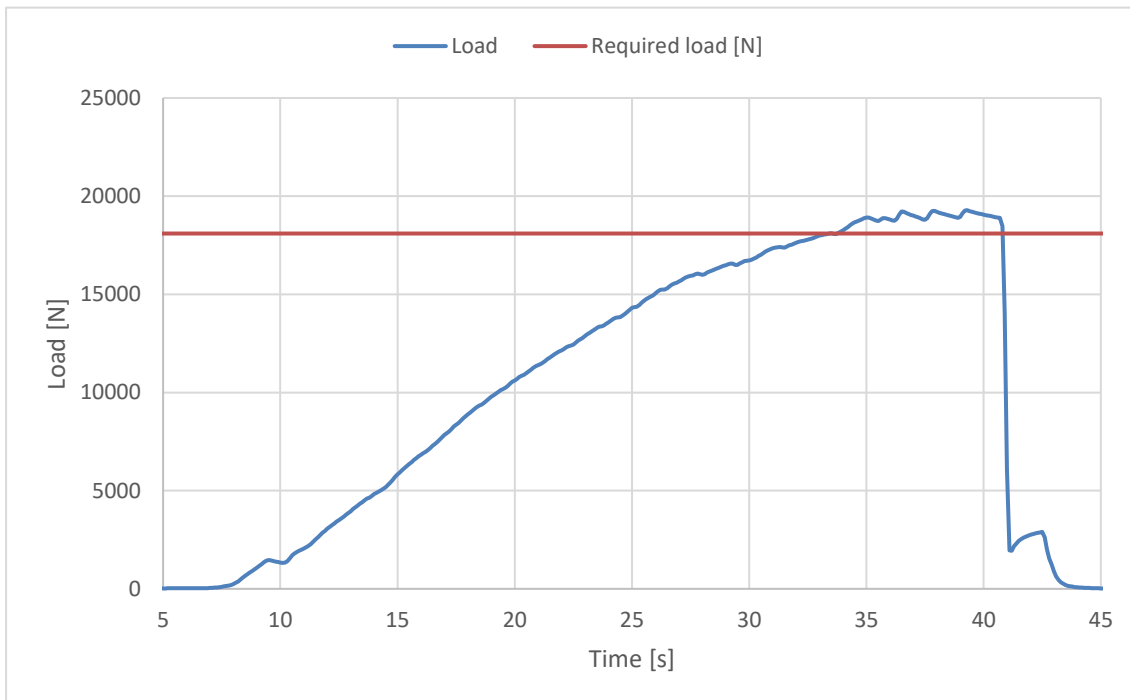
Test ID 03

Test duration [s] **7.1**
 Any signs of structural failure **No**
 Test results **POSITIVE**

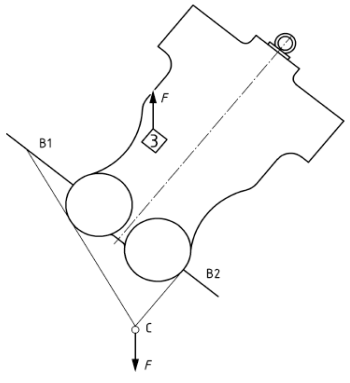
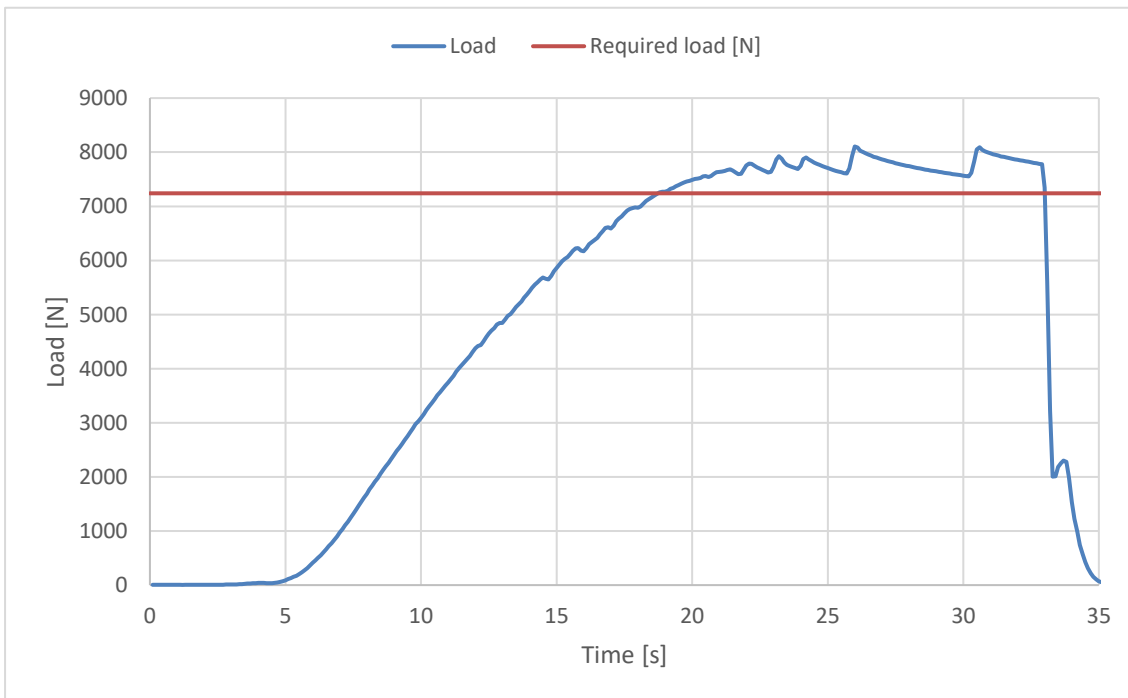
Test ID 04

Standard	NfL 2-565-20
Reference	5.3.2.3
Test setup	Asymmetric, one riser
Attachment points	One main riser attachment (3)
Anchor points	Dummy (B1,B2)
Required load [g]	6
Required load [N]	7200
Minimum test duration [s]	10
Result	
Test duration [s]	14.3
Any signs of structural failure	No
Test results	POSITIVE

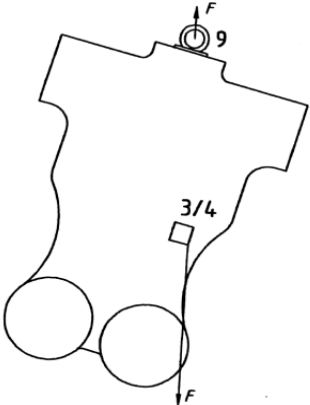
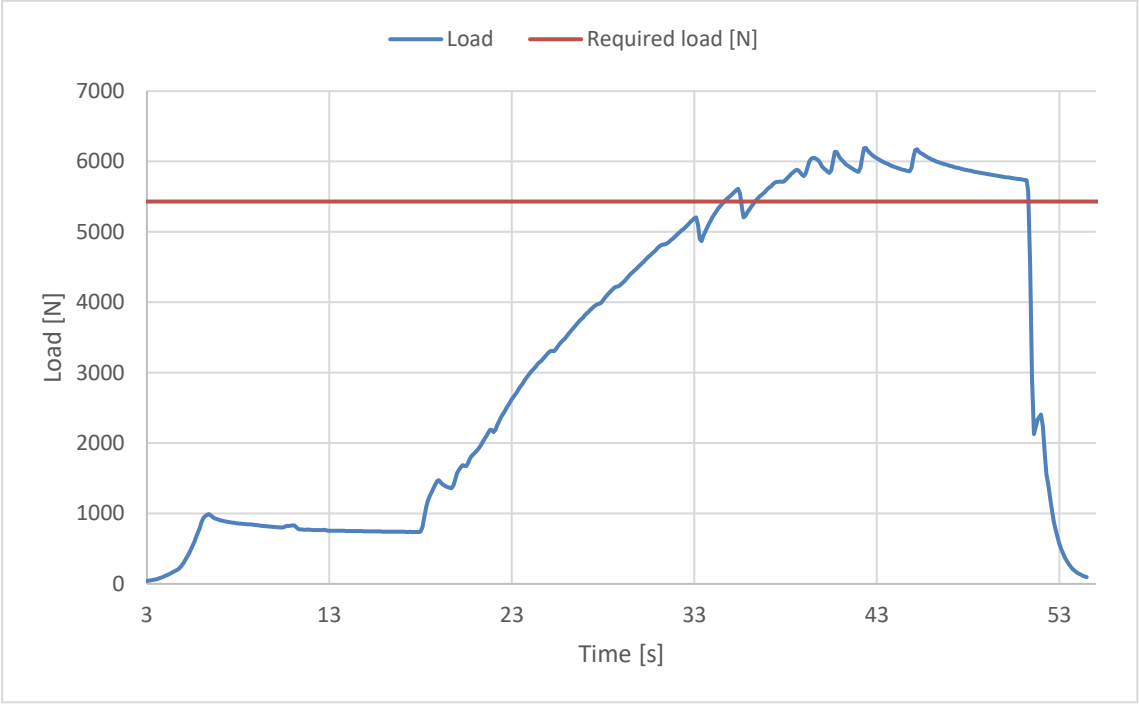
Test ID 07

Reference	5.3.2.6	
Test setup	Asymmetric, negative	
Attachment points	One main riser attachment (3 or 4) downwards	
Anchor points	Dummy (9)	
Required load [g]	4.5	
Required load [N]	5400	
Minimum test duration [s]	10	
Result		
Test duration [s]	15	
Any signs of structural failure	No	
Test results	POSITIVE

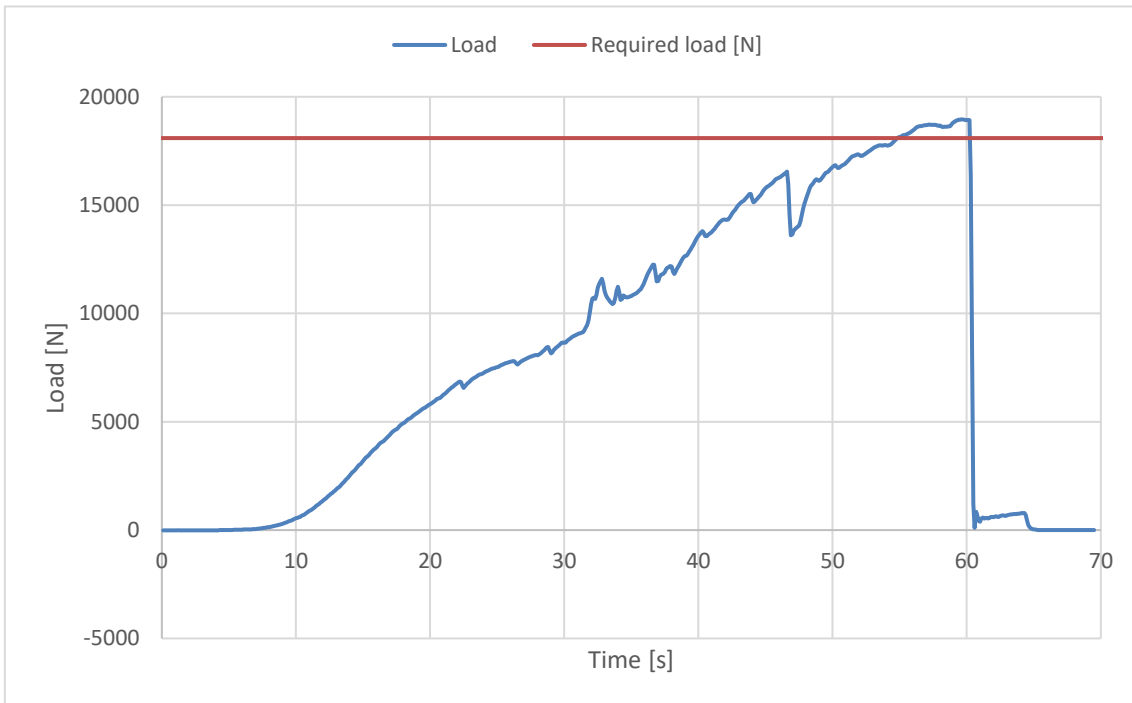
Test ID 09

Reference	5.3.2.4	
Test setup	Rescue attachments	
Attachment points	Rescue riser attachment (1,2)	
Anchor points	Dummy (B1,B2)	
Required load [g]	15	
Required load [N]	18000	
Minimum test duration [s]	5	
Result		
Test duration [s]	5.4	
Any signs of structural failure	No	
Test results	POSITIVE

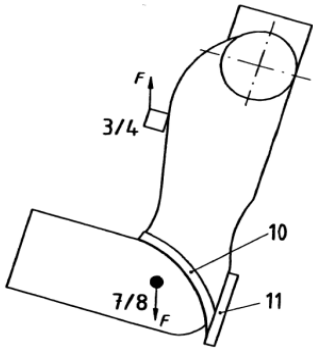
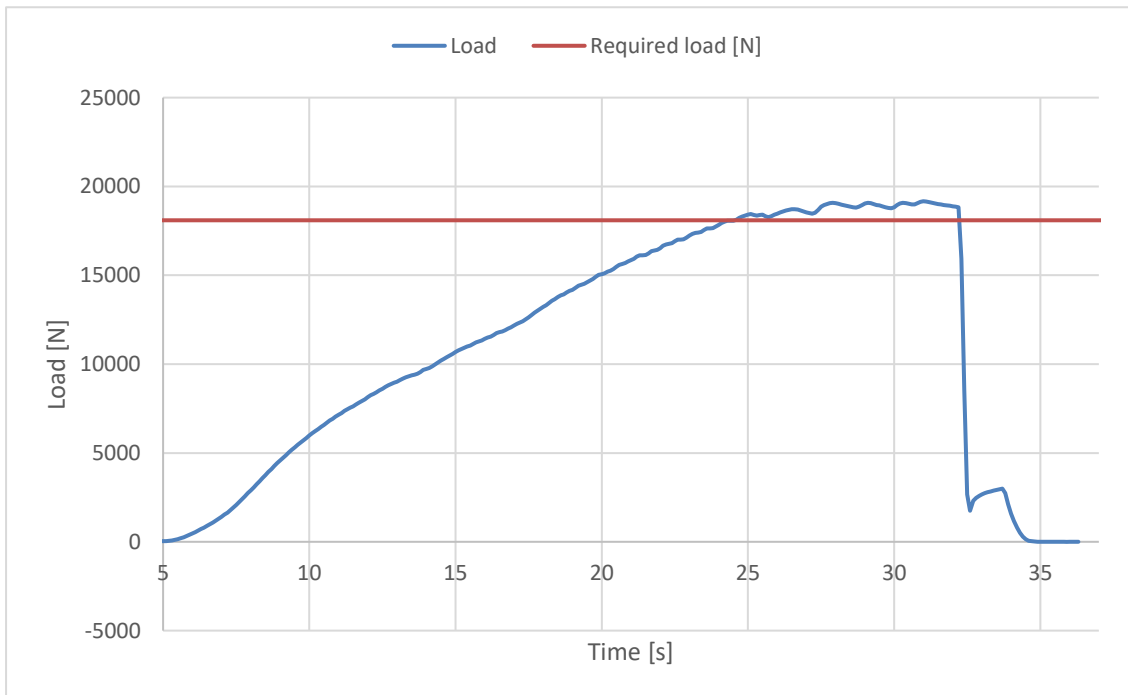
Test ID 13

Standard	NfL 2-565-20
Reference	5.3.2.7
Test setup	Flying position before landing
Attachment points	Both main riser attachment (3,4)
Anchor points	Dummy (7,8)
Required load [g]	15
Required load [N]	18000
Minimum test duration [s]	5
Result	
Test duration [s]	7.7
Any signs of structural failure	No
Test results	POSITIVE

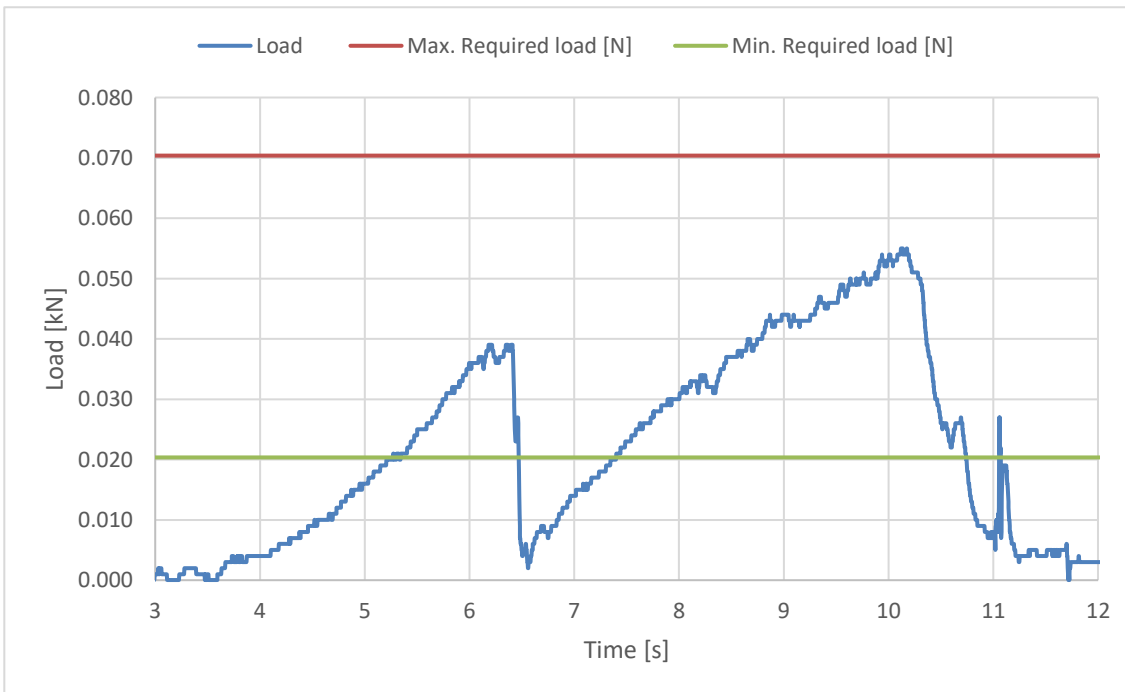
Test ID RRDT

Standard	NfL 2-565-20
Reference	6.1.5
Test setup	Default flying position
Attachment points	Sensor connect to handle, and pull in opening direction
	The test is to simulate the load required to open the emergency parachute(1st action).
Min. Required load [N]	20
Max. Required load [N]	70
Result	
Load for first action [N]	54.63
Test results	POSITIVE

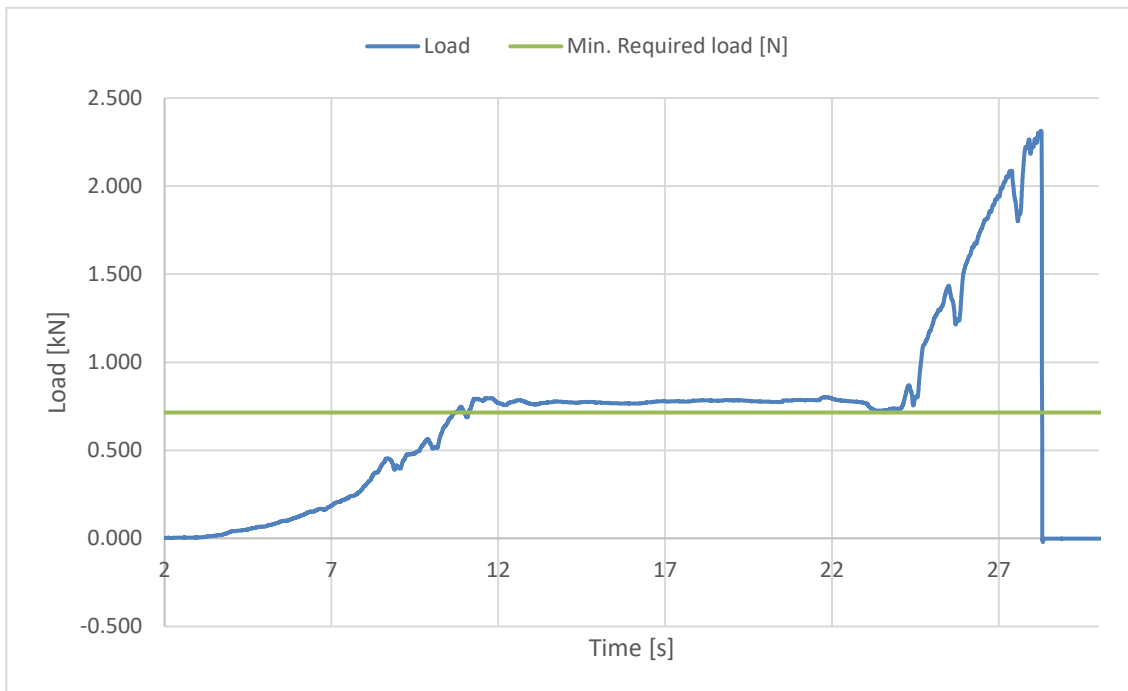
Test ID RRST

Standard	EN12491:2015
Reference in standard	5.3.2
Test setup	Two end points of handle
Attachment points	Sensor connect to end of handle, pull on the other side
	The handle must support min 700 N for 10 s, after measure breaking strength
Min. Required load [N]	700
Minimum test duration [s]	10
Result	
Test duration [s]:	17.2
Breaking strength [N]	2298.63
Test results	POSITIVE
