Harness Structural test Report - NfL

Inspection certificate number: PH_308.2020

Name: **Logo! Pro +**
 Type: **ABS**
 Size: **M**
 Serial number: **Rf-001-07-20**
 Impact pad type: ⁽¹⁾ **Foam**
 Clip-in weight [kg]: **140**
 Integrated container: **Yes**
 Date of test: **17.07.2020**

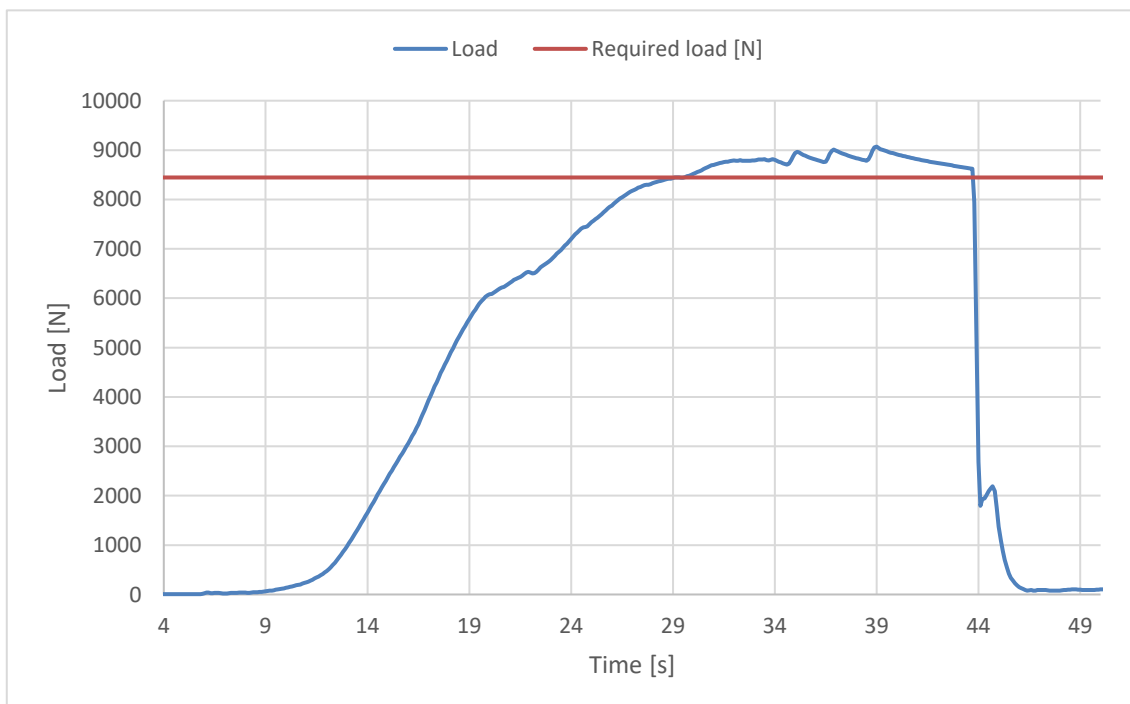
Test ID 02

Standard	NfL 2-565-20
Reference	5.3.2.1
Test setup	Default flying position
Attachment points	Both main riser attachment (3,4)
Anchor points	Dummy (B1, B2)
Required load [g]	6
Required load [N]	8400
Minimum test duration [s]	10
Result	
Test duration [s]	14.2
Any signs of structural failure	No
Test results	POSITIVE

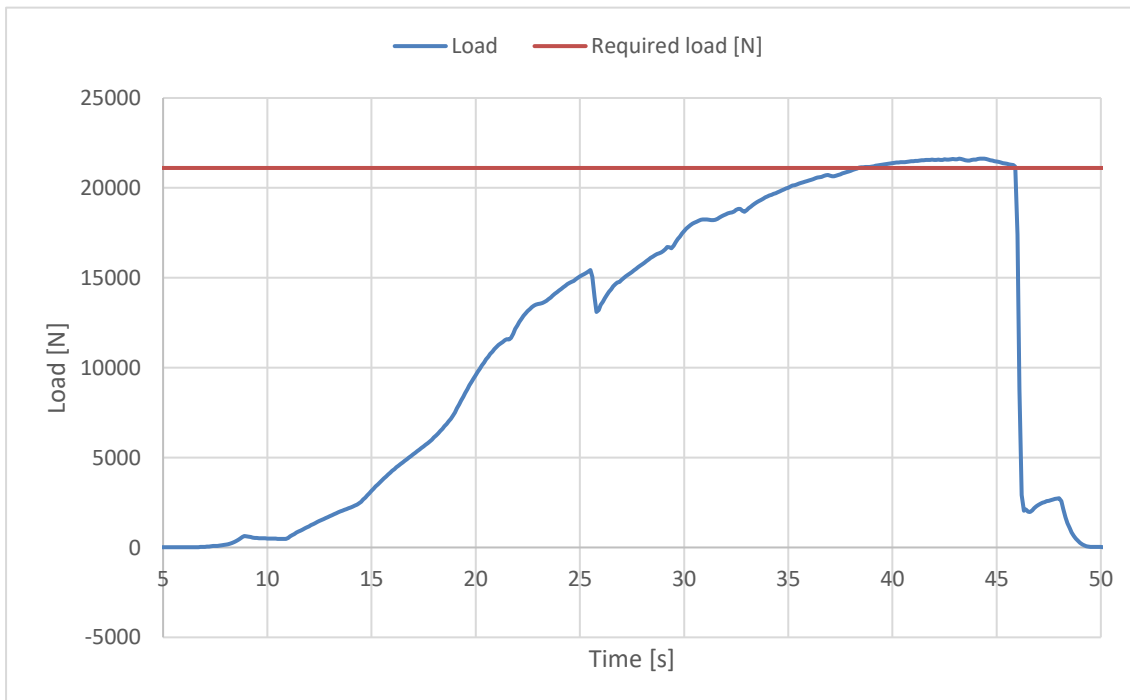
Test ID 03

Standard	NfL 2-565-20
Reference	5.3.2.2
Test setup	Default flying position
Attachment points	Both main riser attachment (3,4)
Anchor points	Dummy (B1, B2)
Required load [g]	15
Required load [N]	21000
Minimum test duration [s]	5
Result	
Test duration [s]	7.6
Any signs of structural failure	No
Test results	POSITIVE

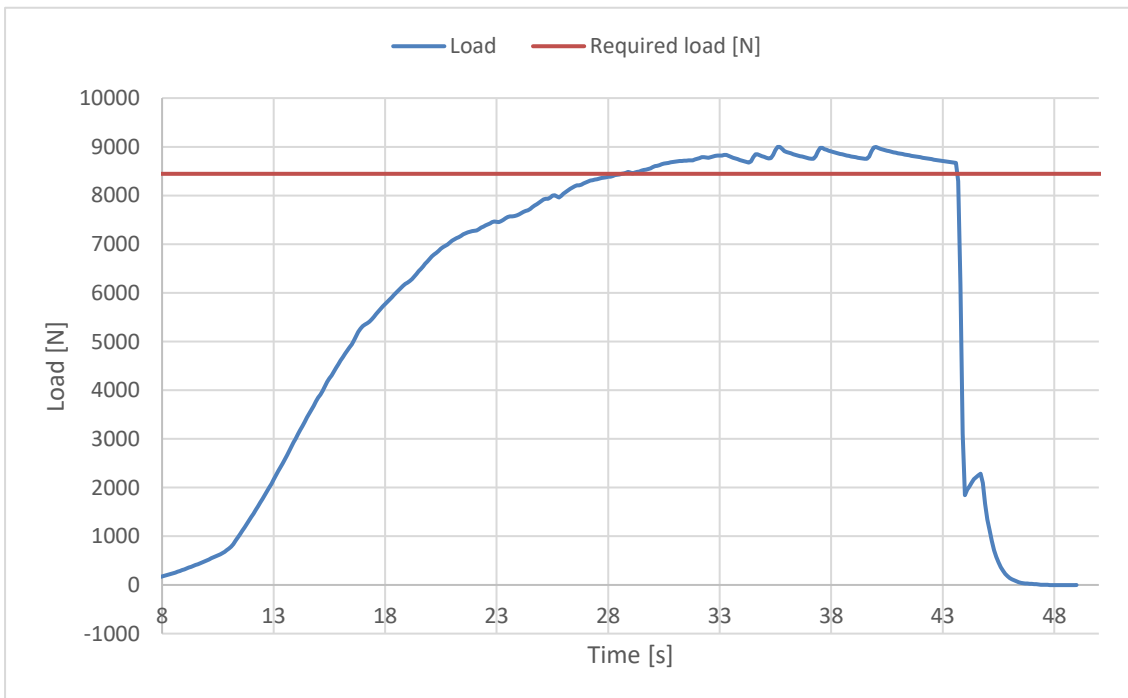
Test ID 04

Standard **NfL 2-565-20**
 Reference **5.3.2.3**
 Test setup **Asymmetric, one riser**
 Attachment points **One main riser attachment (3)**
 Anchor points **Dummy (B1,B2)**

Test duration [s] **15.1**
 Any signs of structural failure **No**
 Test results **POSITIVE**

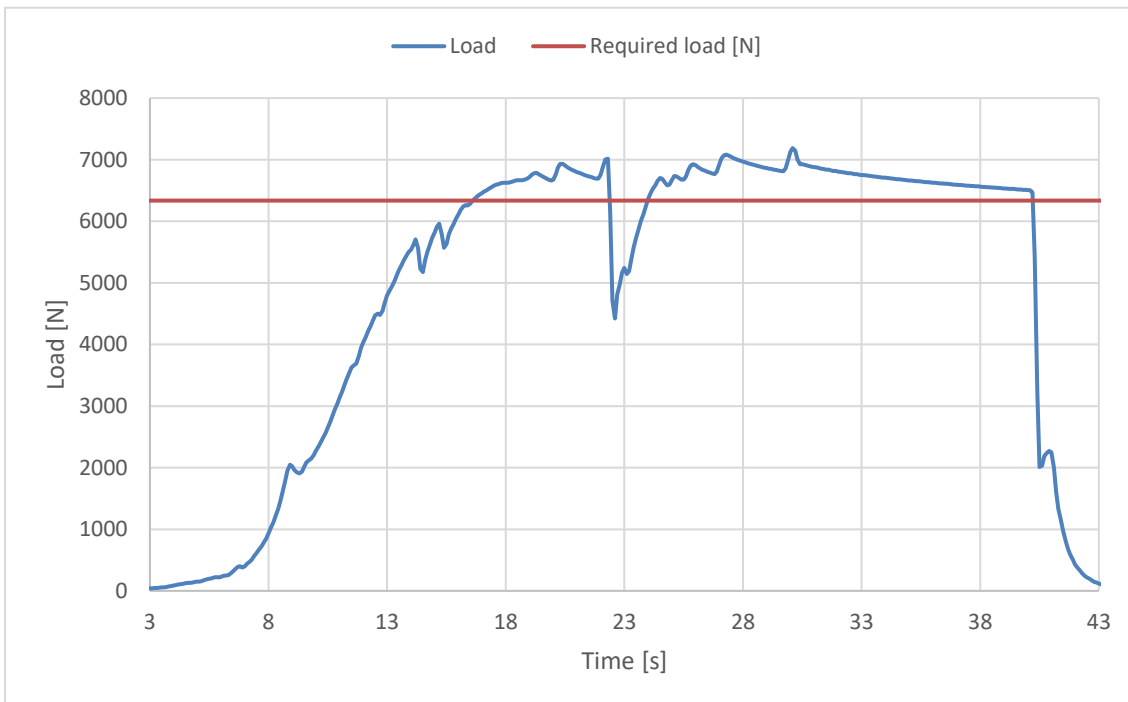
Test ID 07

Reference	5.3.2.6	
Test setup	Asymmetric, negative	
Attachment points	One main riser attachment (3 or 4) downwards	
Anchor points	Dummy (9)	
Required load [g]	4.5	
Required load [N]	6300	
Minimum test duration [s]	10	
Result		
Test duration [s]	16.3	
Any signs of structural failure	No	
Test results	POSITIVE

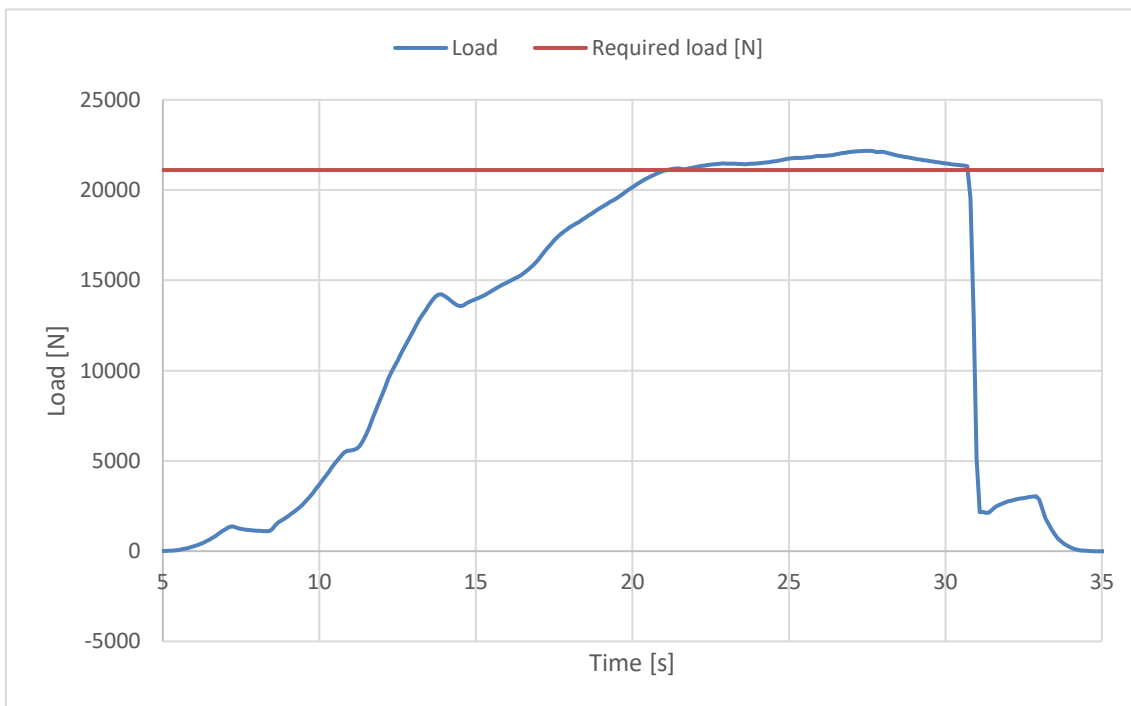
Test ID 09

Standard **NfL 2-565-20**
 Reference **5.3.2.4**
 Test setup **Rescue attachments**
 Attachment points **Rescue riser attachment (1,2)**
 Anchor points **Dummy (B1,B2)**

Test duration [s] **9.6**
 Any signs of structural failure **No**
 Test results **POSITIVE**

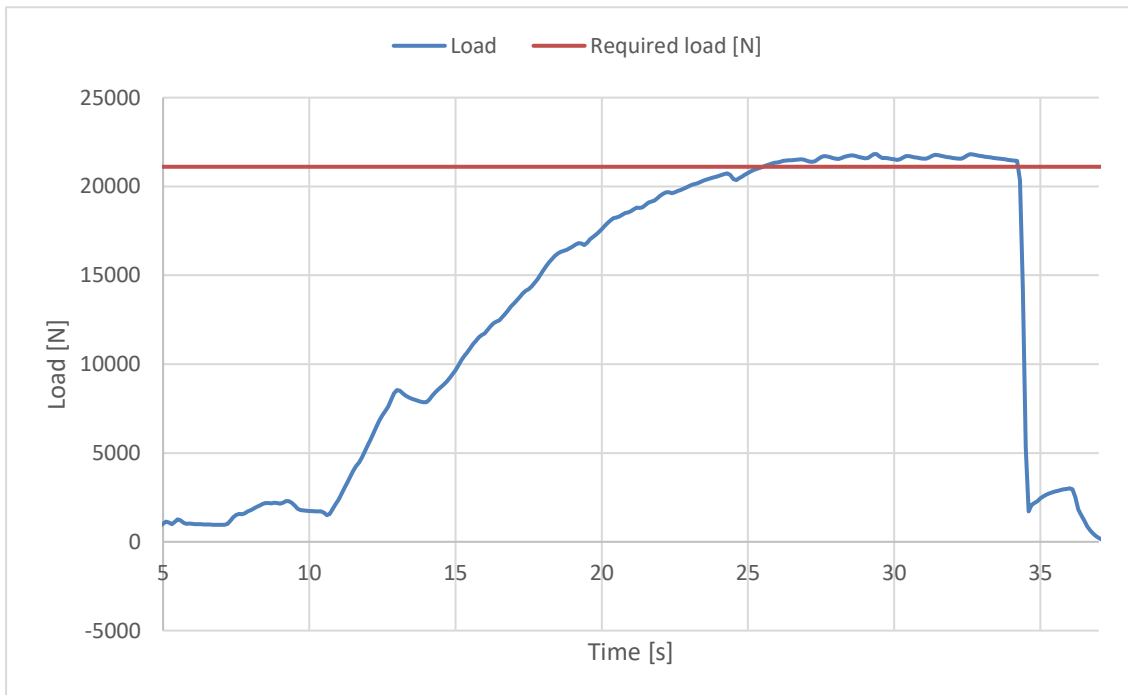
Test ID 13

Standard **NfL 2-565-20**
 Reference **5.3.2.7**
 Test setup **Flying position before landing**
 Attachment points **Both main riser attachment (3,4)**
 Anchor points **Dummy (7,8)**

Test duration [s] **8.7**
 Any signs of structural failure **No**
 Test results **POSITIVE**

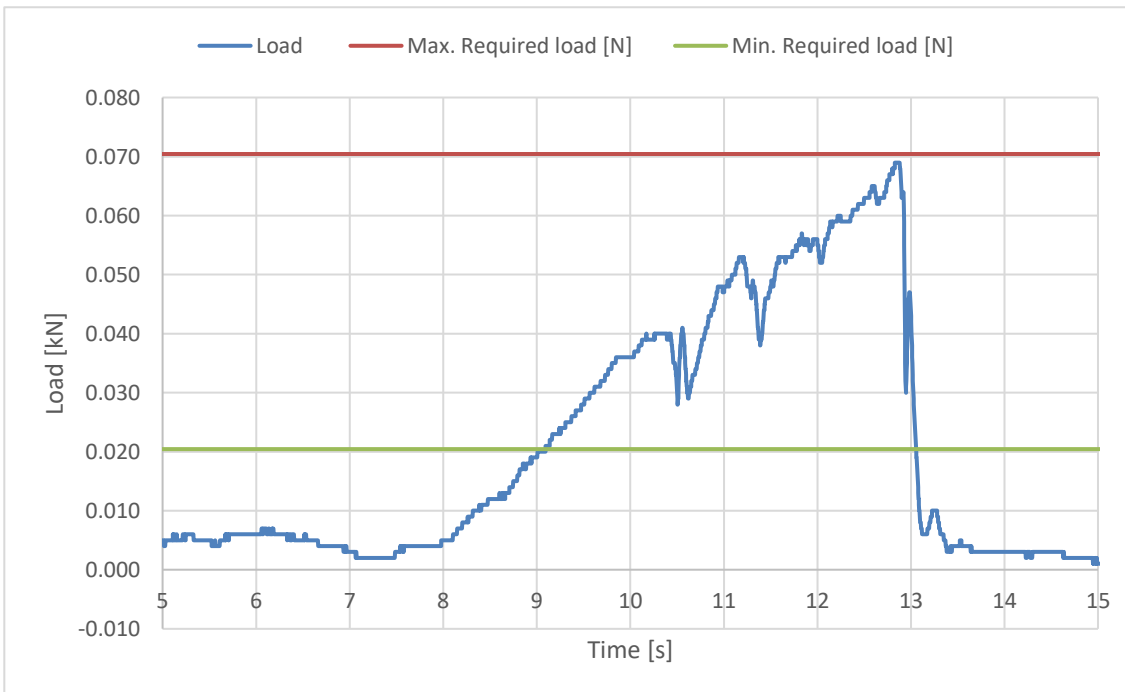
Test ID RRDT

Standard **NfL 2-565-20**
 Reference **6.1.5**
 Test setup **Default flying position**
 Attachment points **Sensor connect to handle, and pull in opening direction**
 The test is to simulate the load required to open the emergency parachute(1st action).

Load for first action [N] **68.54**
 Test results **POSITIVE**

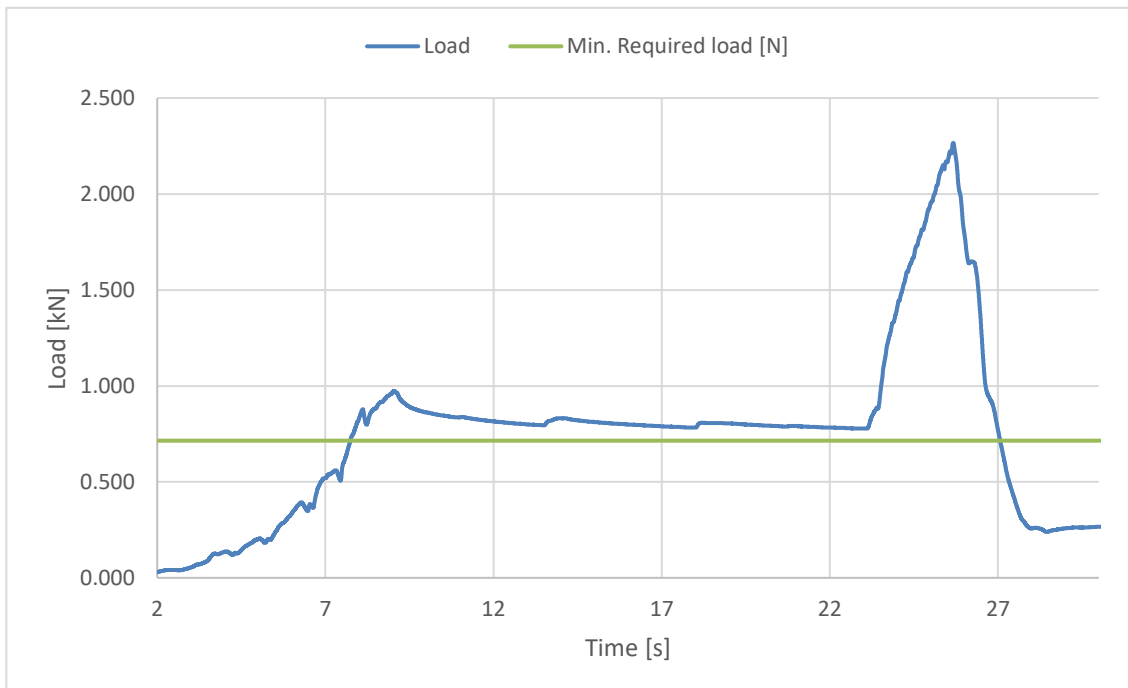
Test ID RRST

Standard	EN12491:2015
Reference in standard	5.3.2
Test setup	Two end points of handle
Attachment points	Sensor connect to end of handle, pull on the other side
	The handle must support min 700 N for 10 s, after measure breaking strength
Min. Required load [N]	700
Minimum test duration [s]	10
Result	
Test duration [s]:	19.3
Breaking strength [N]	2251.94
Test results	POSITIVE
