Harness Structural test Report - EN

Inspection certificate number: **PH_352.2022**

Name: **Karma 3**
 Type: **ABS**
 Size: **M**
 Serial number: **SS005**
 Impact pad type: ⁽¹⁾ **Airbag**
 Clip-in weight [kg]: **140**

Summary of Structural test

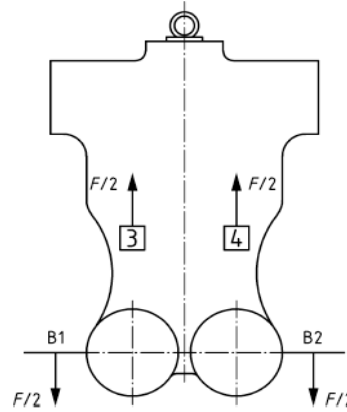
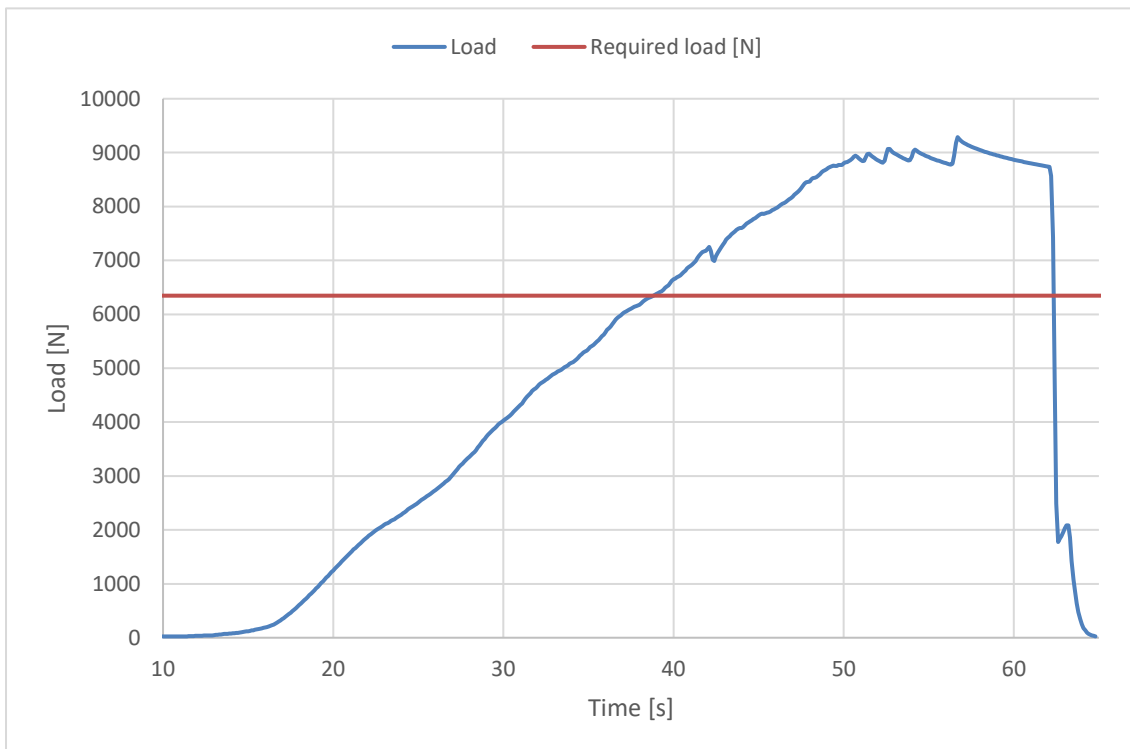
Test ID 01

Test duration [s] **23.5**
 Any signs of structural failure **No**
 Slippery test OK **Yes**
 Test results **POSITIVE**

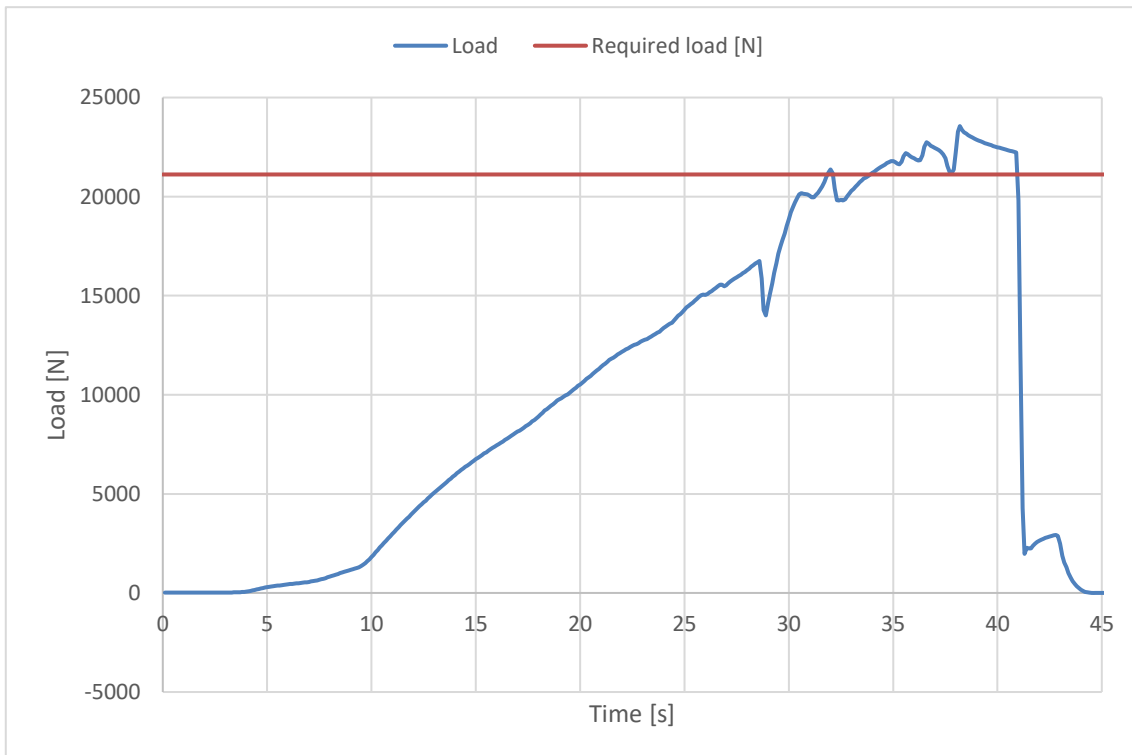
Test ID 03

Test duration [s] **7**
 Any signs of structural failure **No**
 Slippery test OK **Yes**
 Test results **POSITIVE**

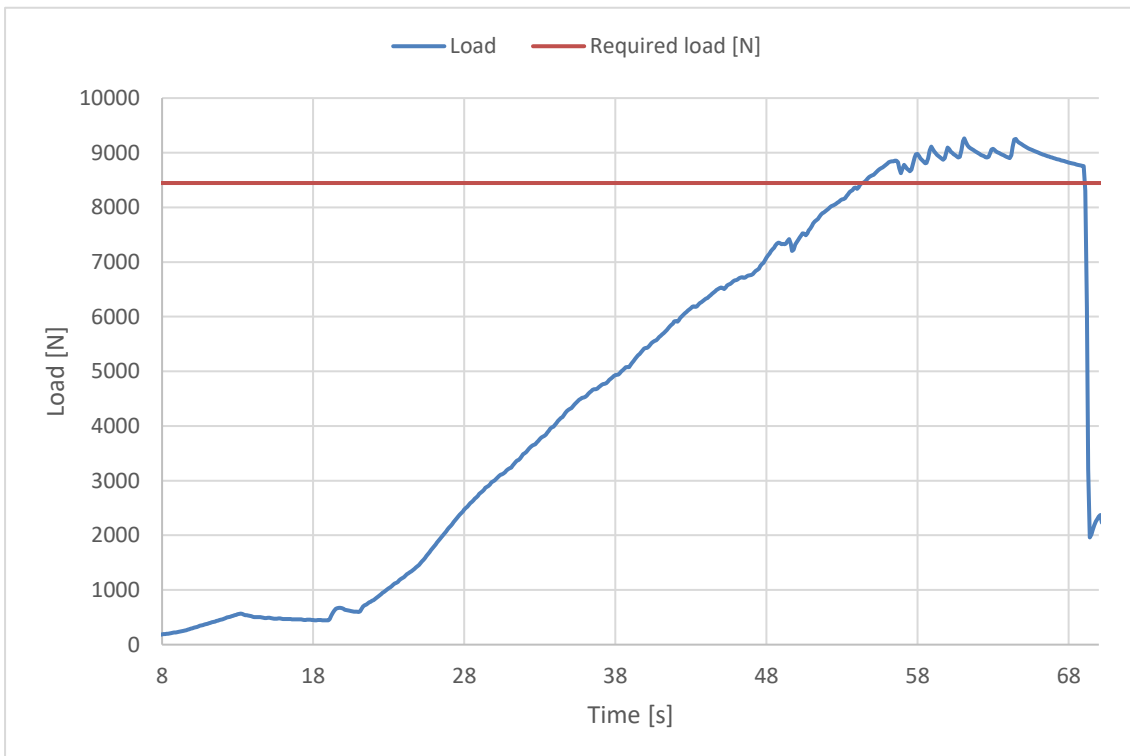
Test ID 05

Standard	EN 1651
Reference in standard	5.5.1.2
Test setup	Positive asymmetric load
Attachment points	One riser attachment (3 or 4)
Anchor points	Dummy (C)
Required load [g]	6
Required load [N]	8400
Minimum test duration [s]	5
Result	
Test duration [s]	14.7
Any signs of structural failure	No
Test results	POSITIVE

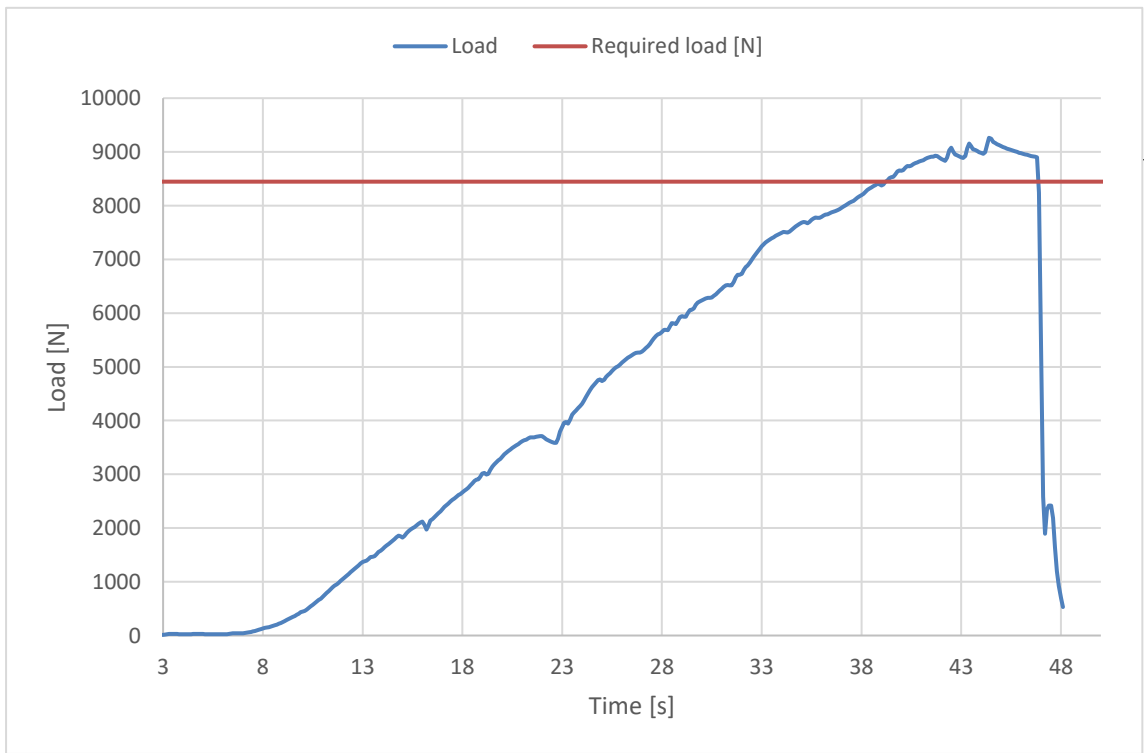
Test ID 06

Standard	EN 1651
Reference in standard	5.5.1.6
Test setup	Negative symmetric load
Attachment points	Both main riser attachment (3,4)
Anchor points	Dummy (A)
Required load [g]	6
Required load [N]	8400
Minimum test duration [s]	5
Result	
Test duration [s]	7.6
Any signs of structural failure	No
Test results	POSITIVE

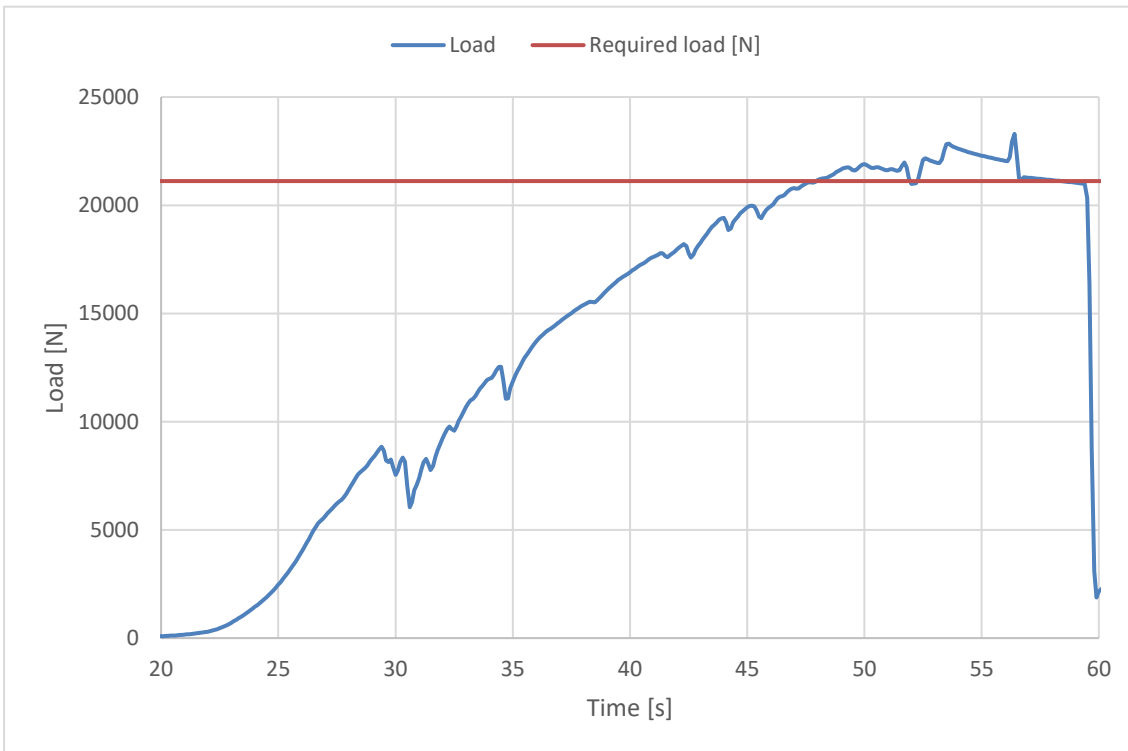
Test ID 09

Reference in standard	5.5.1.3	
Test setup	Positive symmetric load rescue points	
Attachment points	Both main riser attachment (1,2)	
Anchor points	Dummy (B1,B2)	
Required load [g]	15	
Required load [N]	21000	
Minimum test duration [s]	5	
Result		
Test duration [s]	6.1	
Any signs of structural failure	No	
Slippery test OK	Yes	
Test results	POSITIVE

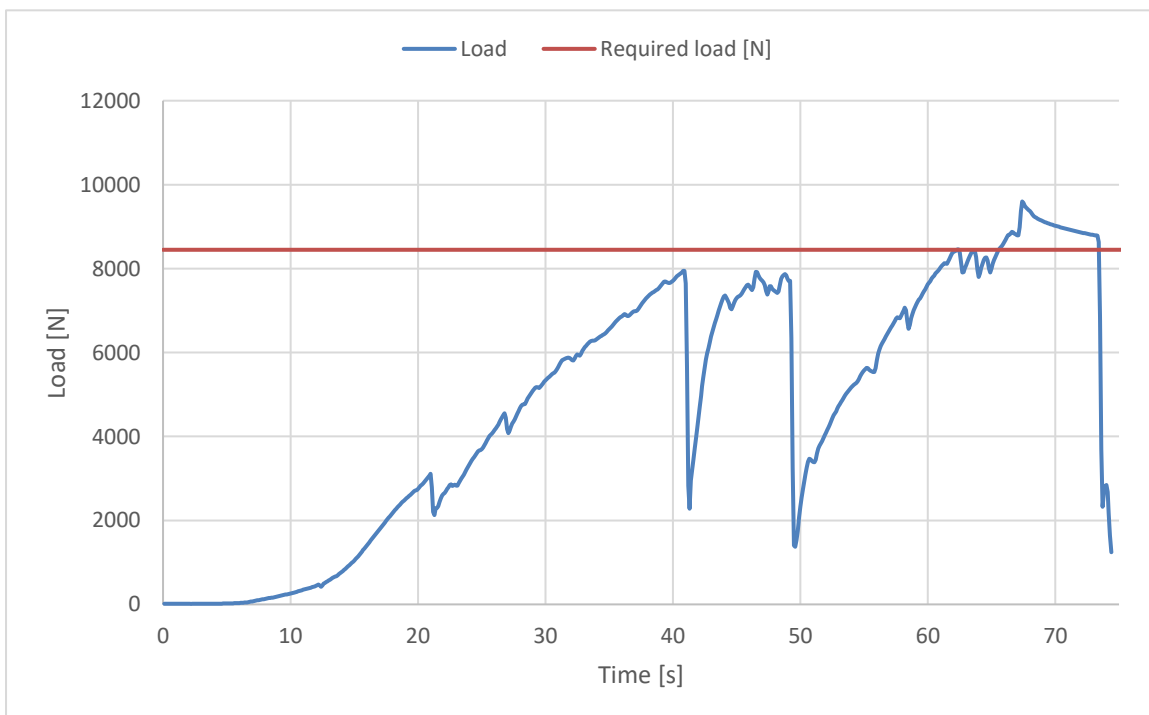
Test ID 12

Standard	EN 1651
Reference in standard	5.5.1.7
Test setup	Upright (landing) position load
Attachment points	Both main riser attachment (3, 4)
Anchor points	Both legstrap of harness (no dummy)
Required load [g]	6
Required load [N]	8400
Minimum test duration [s]	5
Harness type	type b
Result	
Test duration [s]	7.9
Any signs of structural failure	No
Slippery test OK	Yes
Test results	POSITIVE

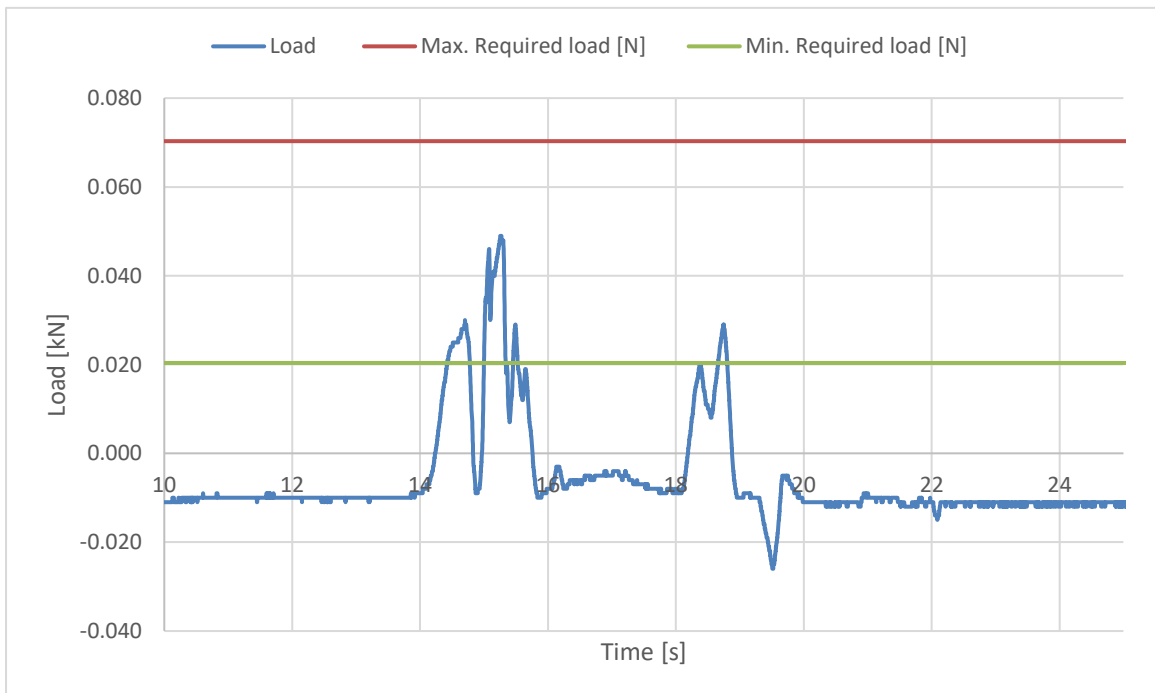
Test ID RRDT

Standard	LTF NfL II 91/09
Reference in standard	6.1.5
Test setup	Default flying position
Attachment points	Sensor connect to handle, and pull in opening direction
	The test is to simulate the load required to open the emergency parachute(1st action).
Min. Required load [N]	20
Max. Required load [N]	70
Result	
Load for first action [N]	48.67
Test results	POSITIVE

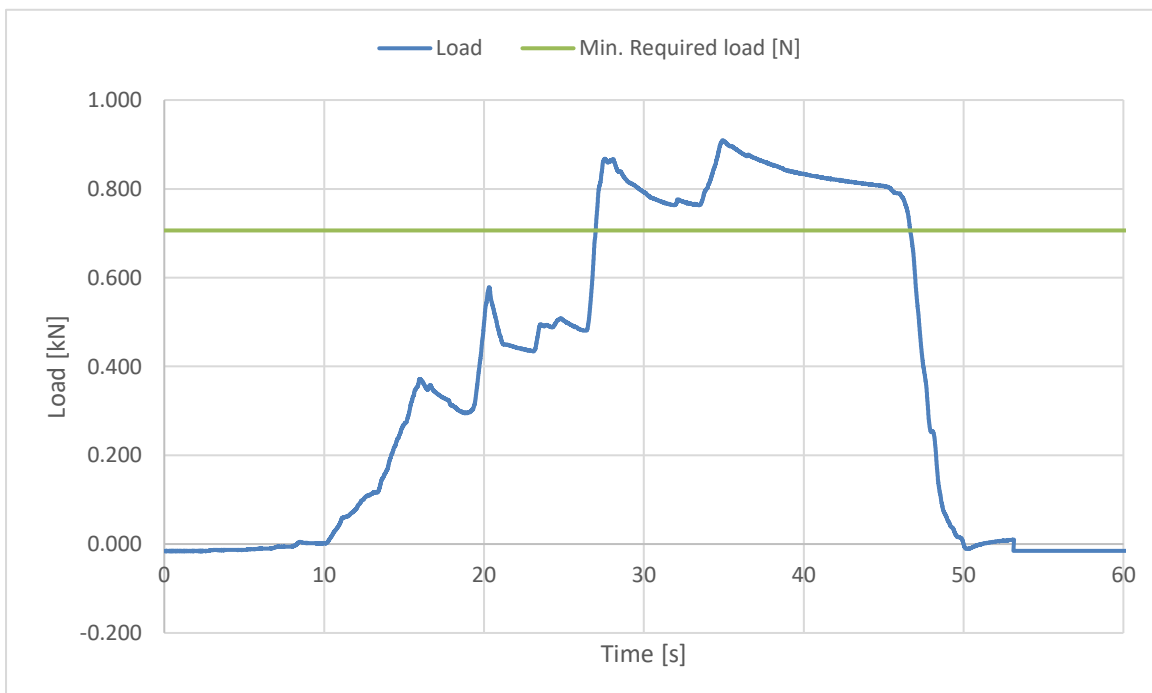
Test ID RRST

Standard	EN12491:2015
Reference in standard	5.3.2
Test setup	Two end points of handle
Attachment points	Sensor connect to end of handle, pull on the other side
	The handle must support min 700 N for 10 s, after measure breaking strength
Min. Required load [N]	700
Minimum test duration [s]	10
Result	
Test duration [s]:	19.7
Breaking strength [N]	903.96
Test results	POSITIVE
