Harness Structural test Report - NfL

Inspection certificate number: **PH_352.2022**

Name: **Karma 3**
 Type: **ABS**
 Size: **M**
 Serial number: **SS005**
 Impact pad type: ⁽¹⁾ **Airbag**
 Clip-in weight [kg]: **140**
 Integrated container: **Yes**
 Date of test: **23.07.2021**

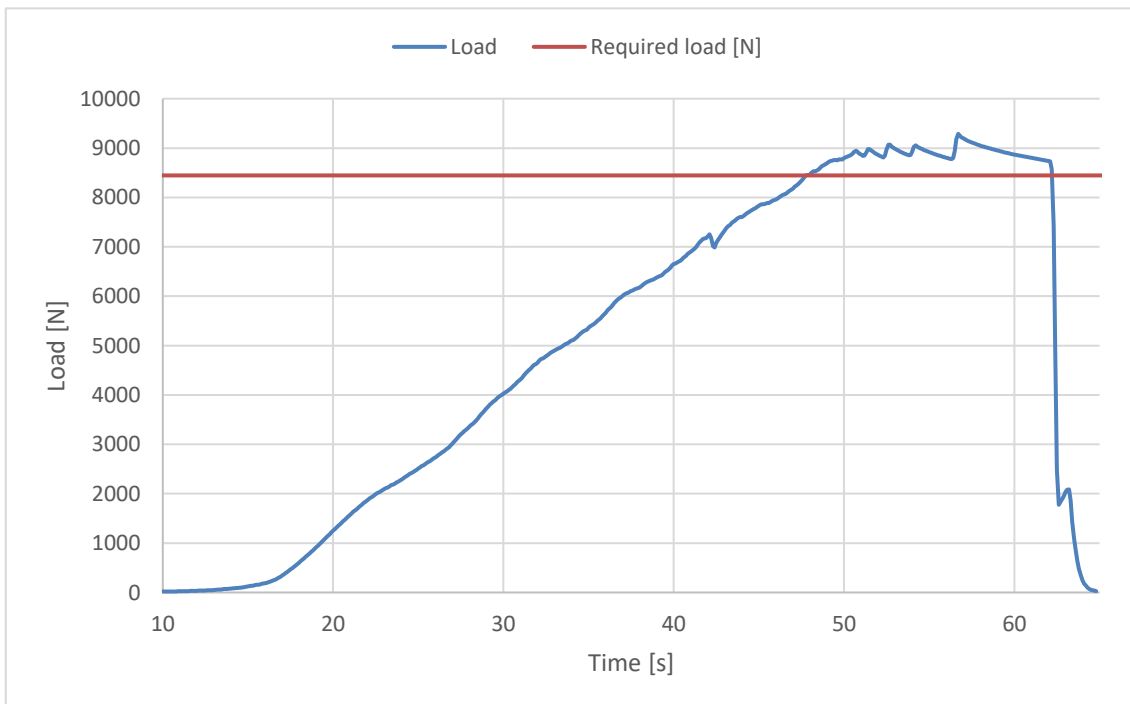
Test ID 02

Test duration [s] **14.5**
 Any signs of structural failure **No**
 Test results **POSITIVE**

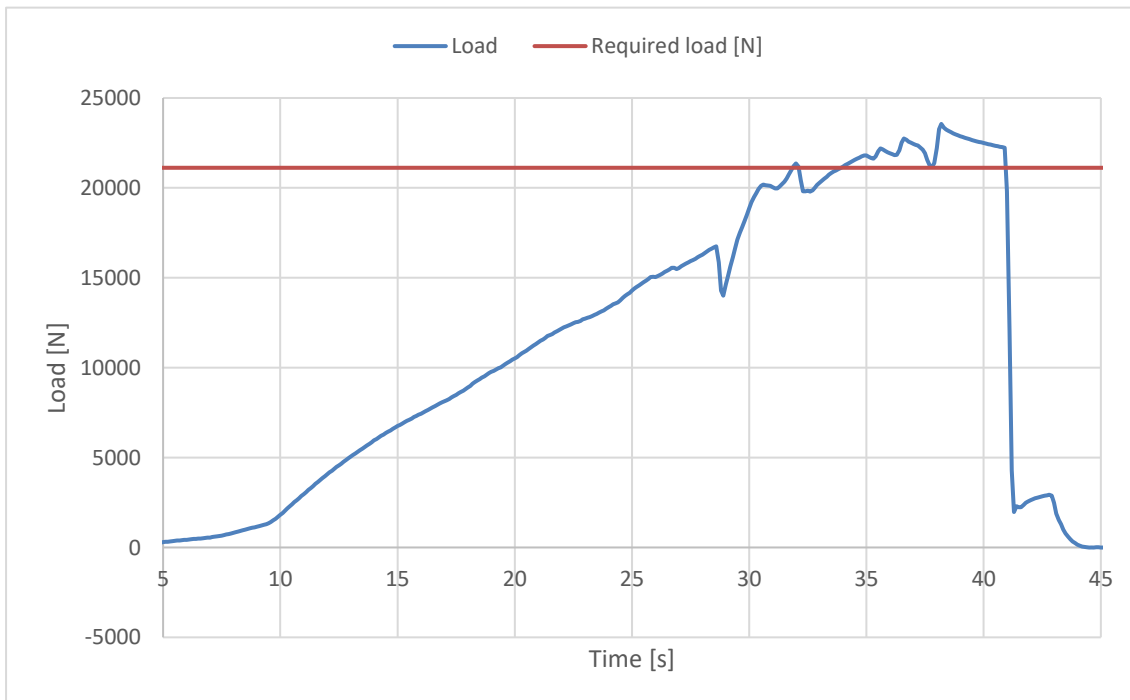
Test ID 03

Test duration [s] **7**
 Any signs of structural failure **No**
 Test results **POSITIVE**

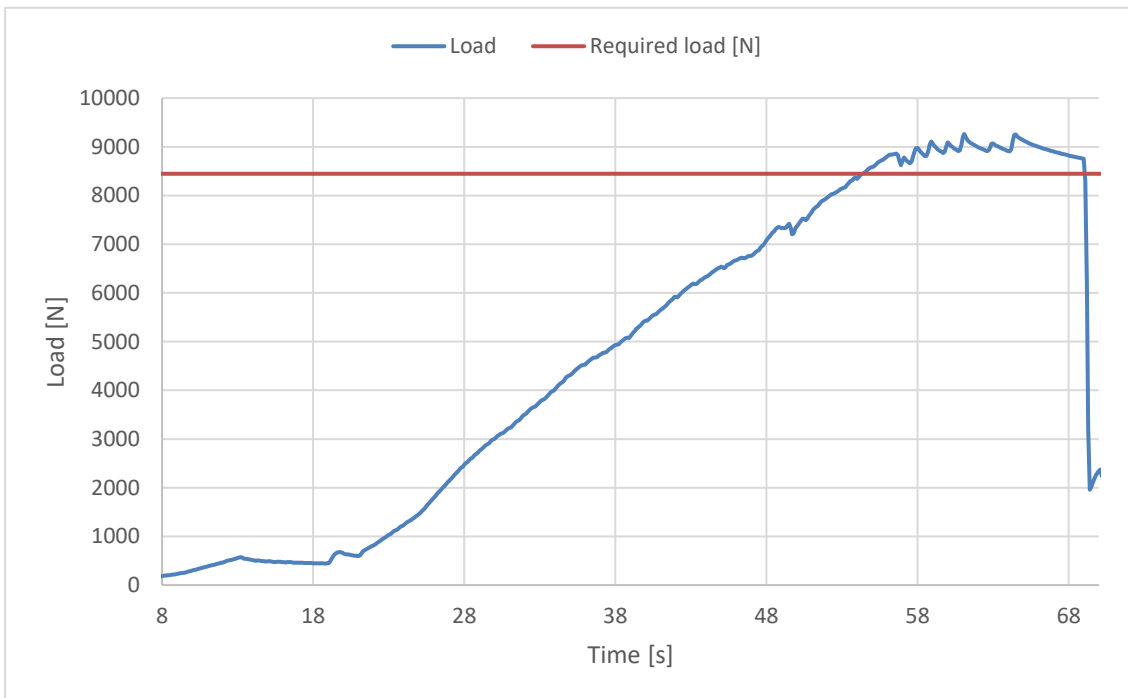
Test ID 04

Test duration [s] **14.7**
 Any signs of structural failure **No**
 Test results **POSITIVE**

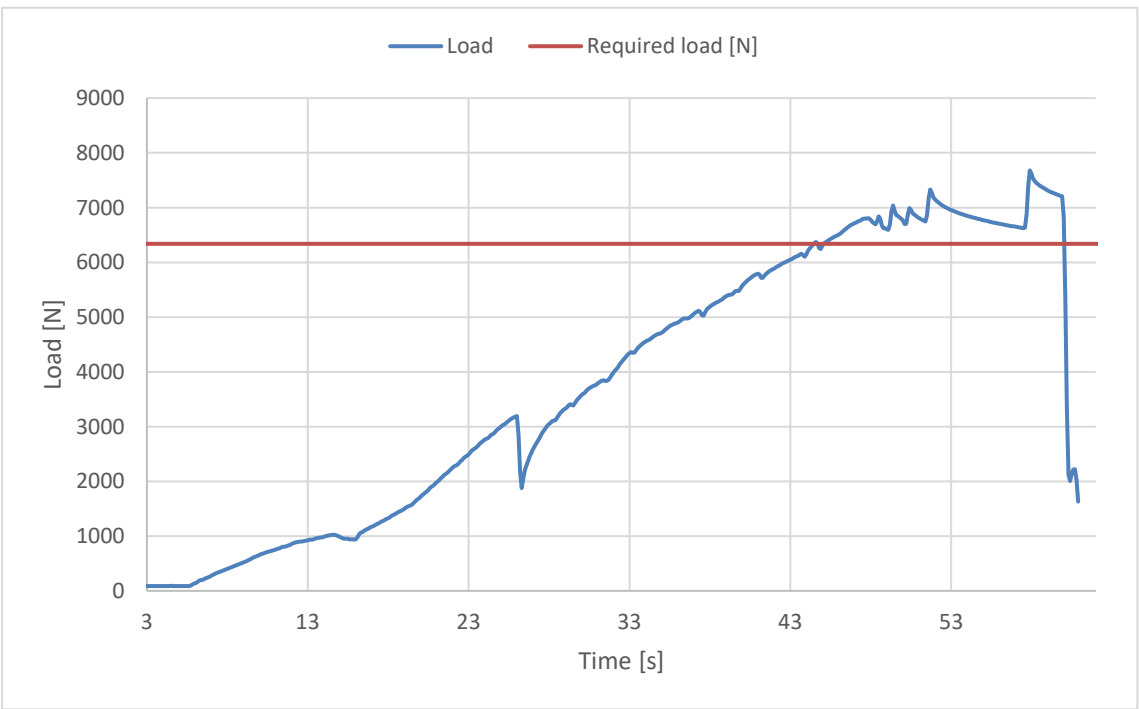
Test ID 07

Reference	5.3.2.6	
Test setup	Asymmetric, negative	
Attachment points	One main riser attachment (3 or 4) downwards	
Anchor points	Dummy (9)	
Required load [g]	4.5	
Required load [N]	6300	
Minimum test duration [s]	10	
Result		
Test duration [s]	15	
Any signs of structural failure	No	
Test results	POSITIVE

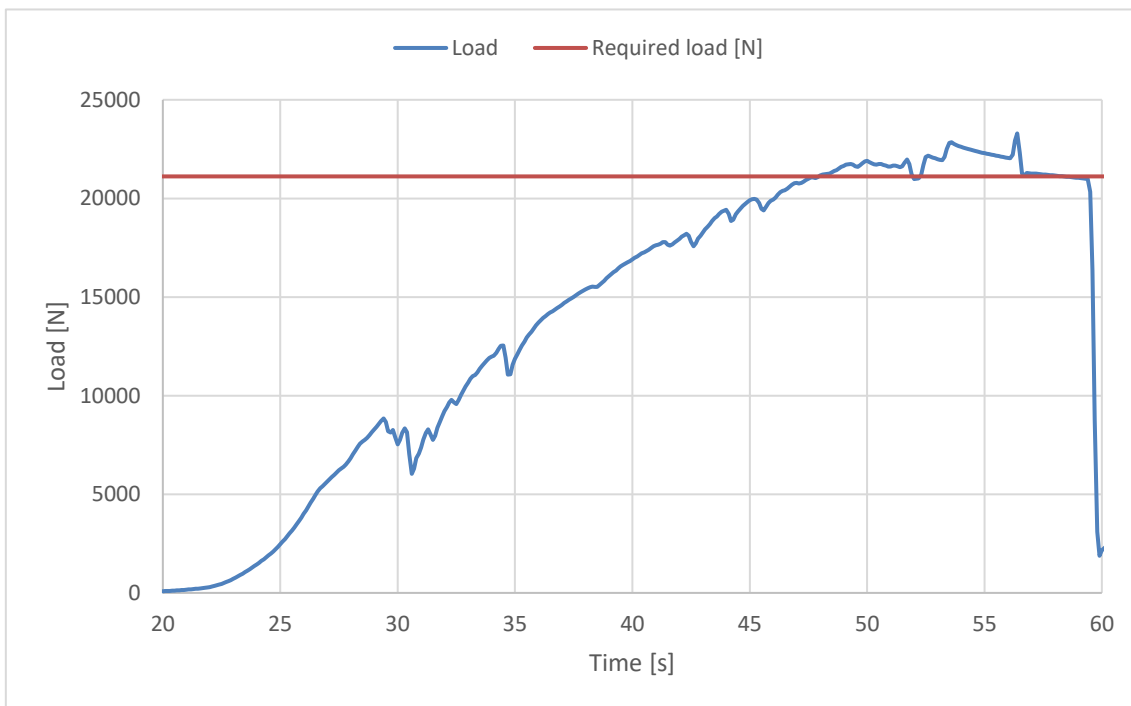
Test ID 09

Test duration [s] **6.1**
 Any signs of structural failure **No**
 Test results **POSITIVE**

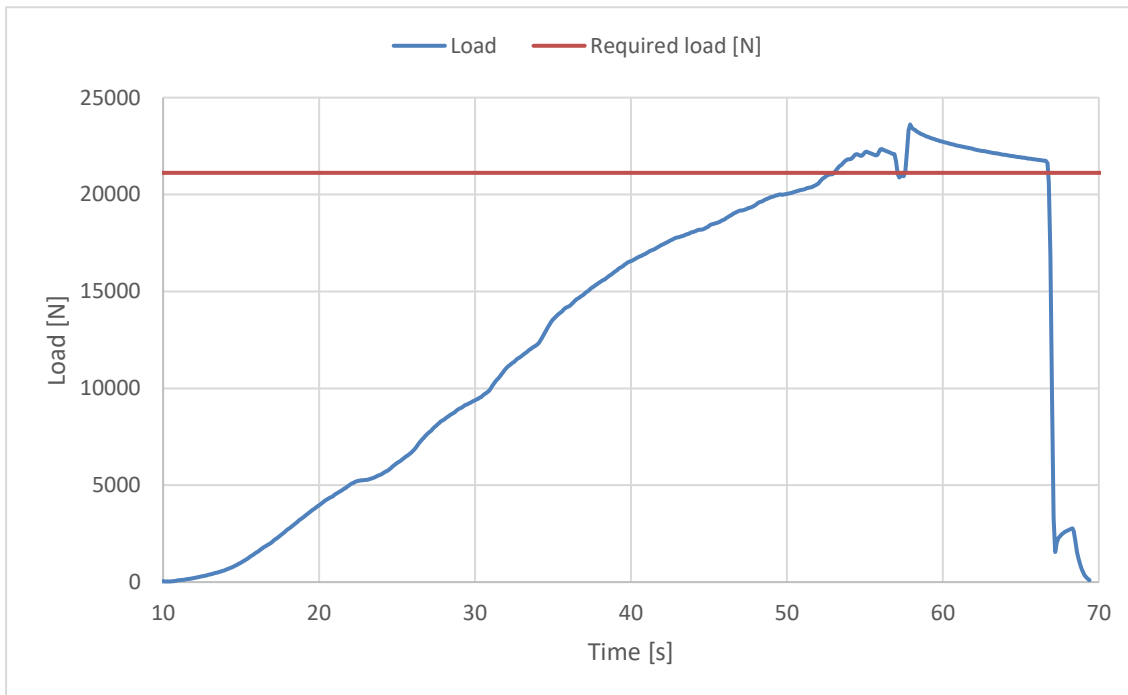
Test ID 13

Standard	NfL 2-565-20
Reference	5.3.2.7
Test setup	Flying position before landing
Attachment points	Both main riser attachment (3,4)
Anchor points	Dummy (7,8)
Required load [g]	15
Required load [N]	21000
Minimum test duration [s]	5
Result	
Test duration [s]	9.2
Any signs of structural failure	No
Test results	POSITIVE

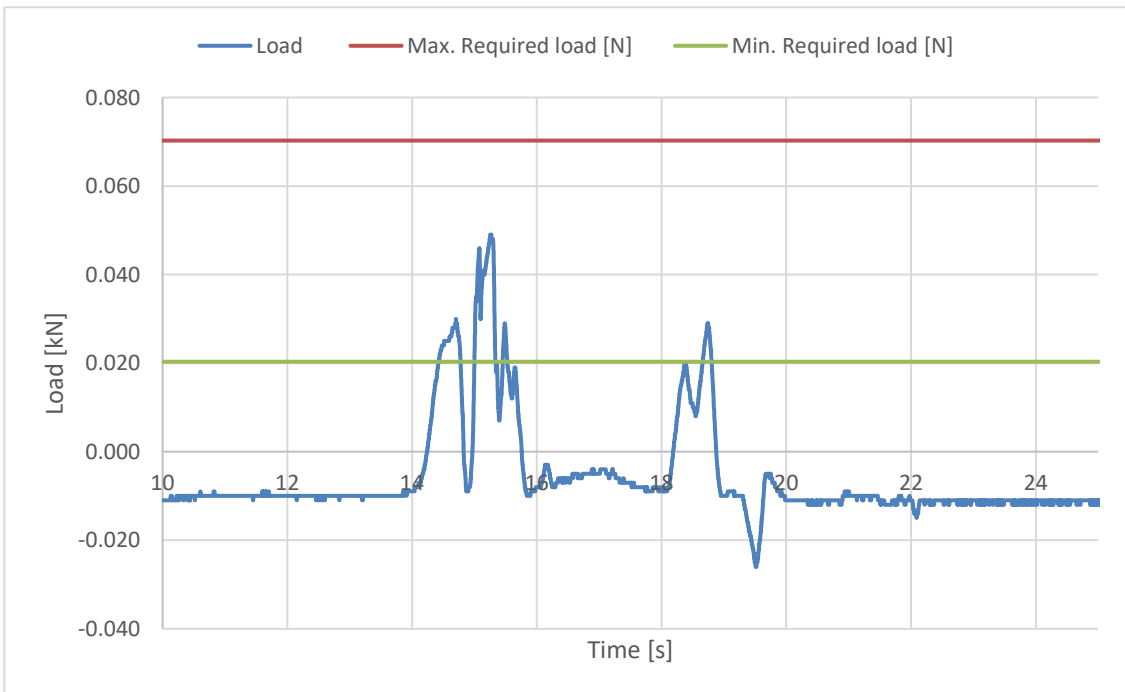
Test ID RRDT

Standard	NfL 2-565-20
Reference	6.1.5
Test setup	Default flying position
Attachment points	Sensor connect to handle, and pull in opening direction
	The test is to simulate the load required to open the emergency parachute(1st action).
Min. Required load [N]	20
Max. Required load [N]	70
Result	
Load for first action [N]	48.67
Test results	POSITIVE

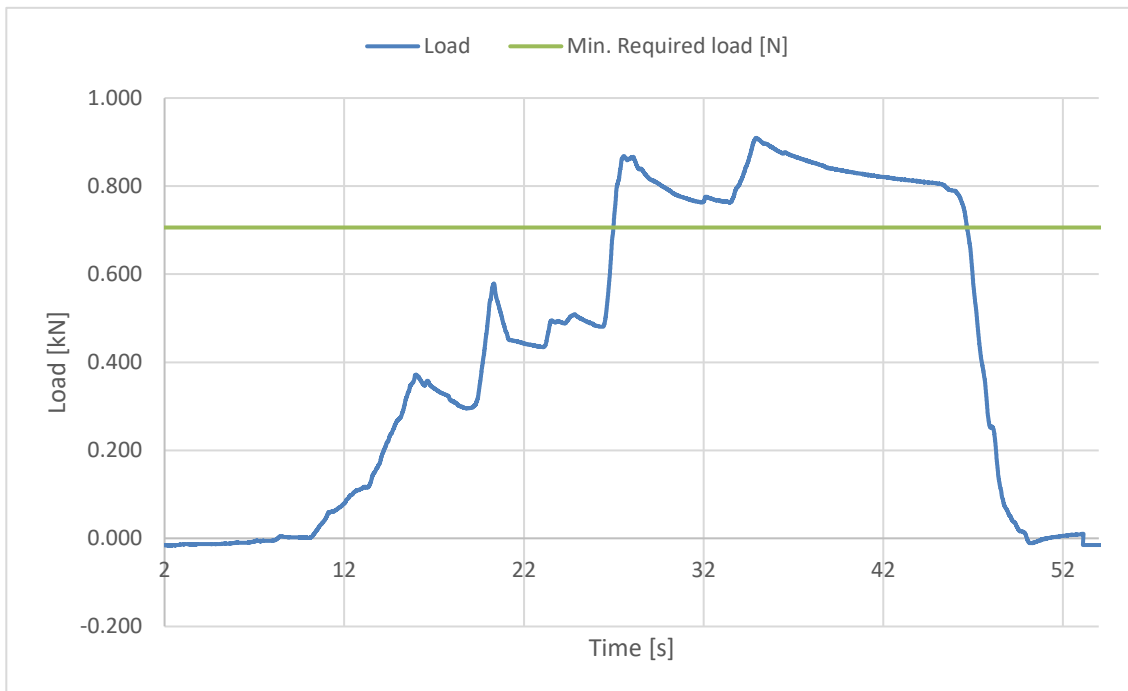
Test ID RRST

Standard	EN12491:2015
Reference in standard	5.3.2
Test setup	Two end points of handle
Attachment points	Sensor connect to end of handle, pull on the other side
	The handle must support min 700 N for 10 s, after measure breaking strength
Min. Required load [N]	700
Minimum test duration [s]	10
Result	
Test duration [s]:	19.7
Breaking strength [N]	903.96
Test results	POSITIVE
