Harness Structural test Report - EN

Inspection certificate number: **PH_349.2021**

Name: **Lullaby**
 Type: **ABS**
 Size: **Unique**
 Serial number: **HLB-10001**
 Impact pad type: ⁽¹⁾ **Foam**
 Clip-in weight [kg]: **100**

Summary of Structural test

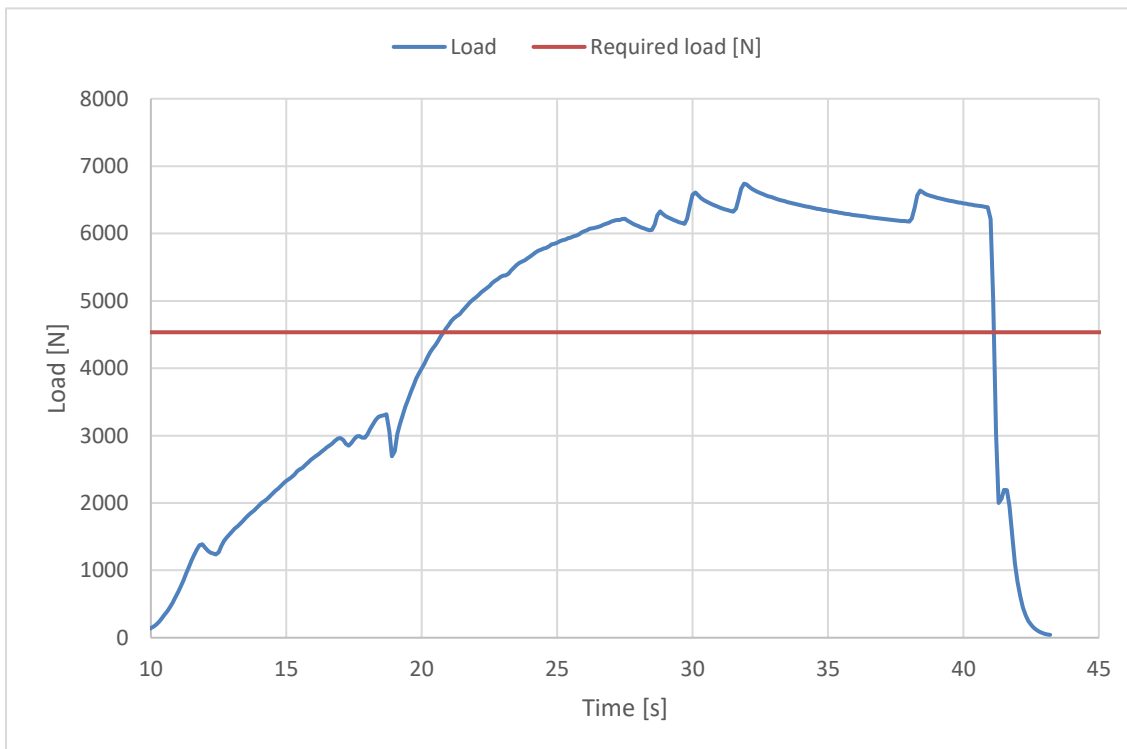
Test ID 01

Test duration [s] **20.3**
 Any signs of structural failure **No**
 Slippery test OK **Yes**
 Test results **POSITIVE**

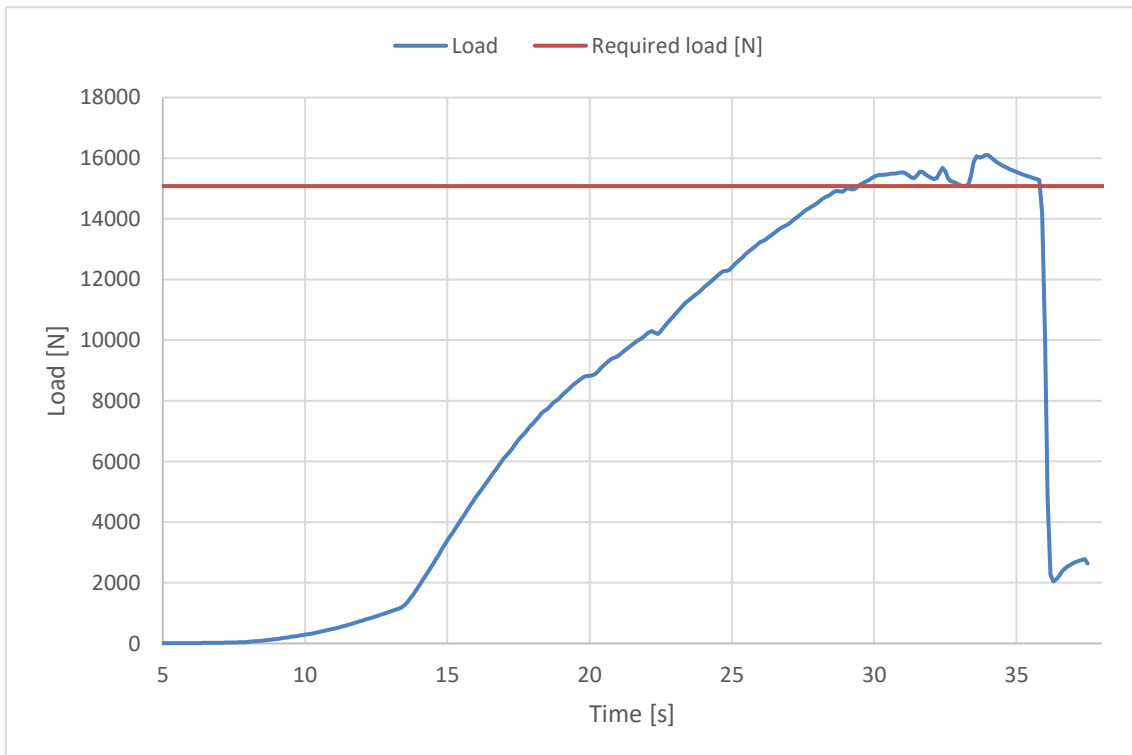
Test ID 03

Test duration [s] **6.4**
 Any signs of structural failure **No**
 Slippery test OK **Yes**
 Test results **POSITIVE**

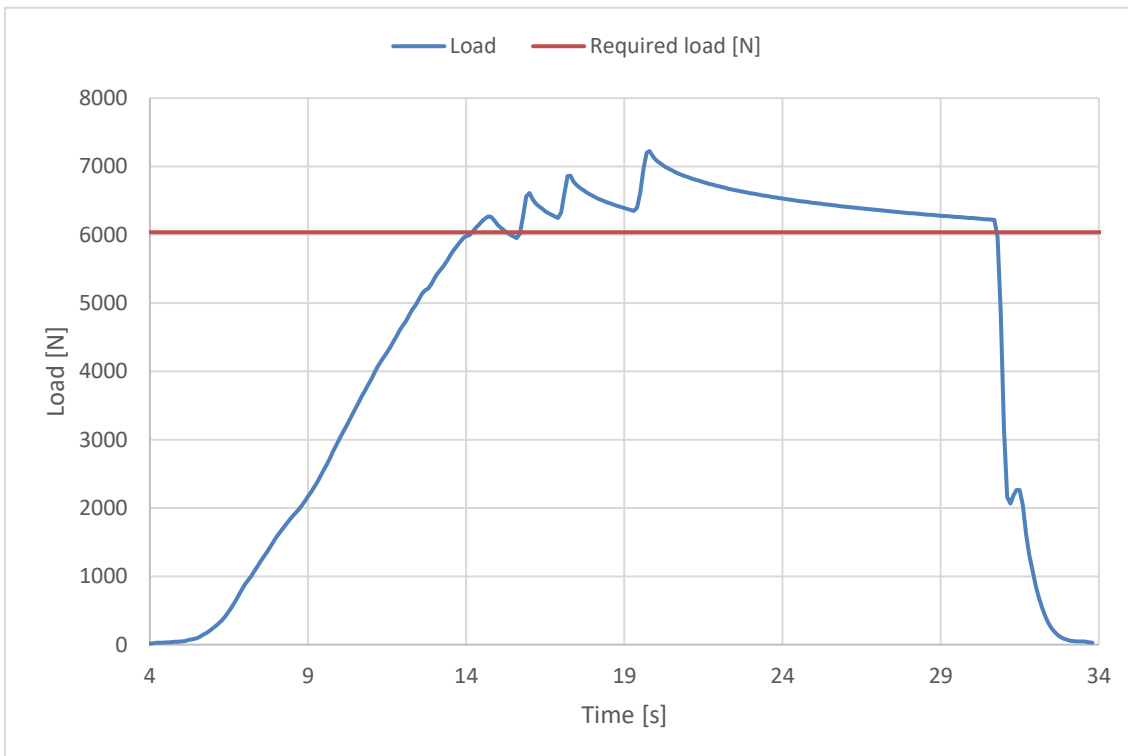
Test ID 05

Standard	EN 1651
Reference in standard	5.5.1.2
Test setup	Positive asymmetric load
Attachment points	One riser attachment (3 or 4)
Anchor points	Dummy (C)
Required load [g]	6
Required load [N]	6000
Minimum test duration [s]	5
Result	
Test duration [s]	15
Any signs of structural failure	No
Test results	POSITIVE

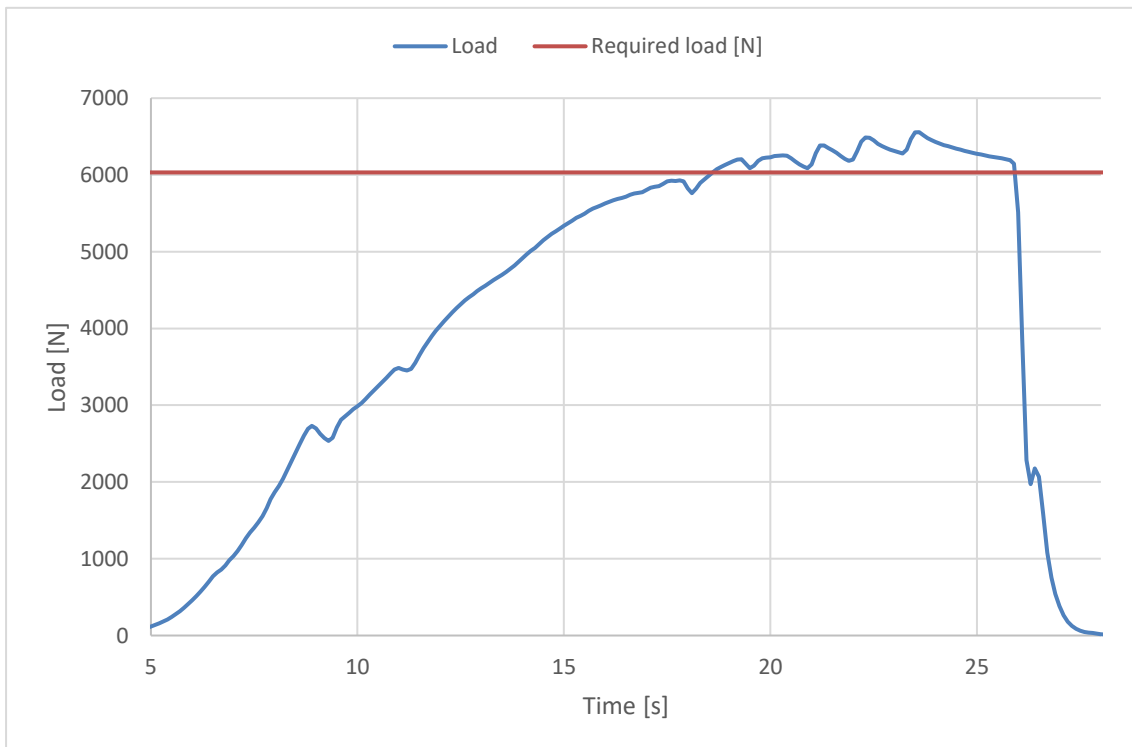
Test ID 06

Standard	EN 1651
Reference in standard	5.5.1.6
Test setup	Negative symmetric load
Attachment points	Both main riser attachment (3,4)
Anchor points	Dummy (A)
Required load [g]	6
Required load [N]	6000
Minimum test duration [s]	5
Result	
Test duration [s]	7.4
Any signs of structural failure	No
Test results	POSITIVE

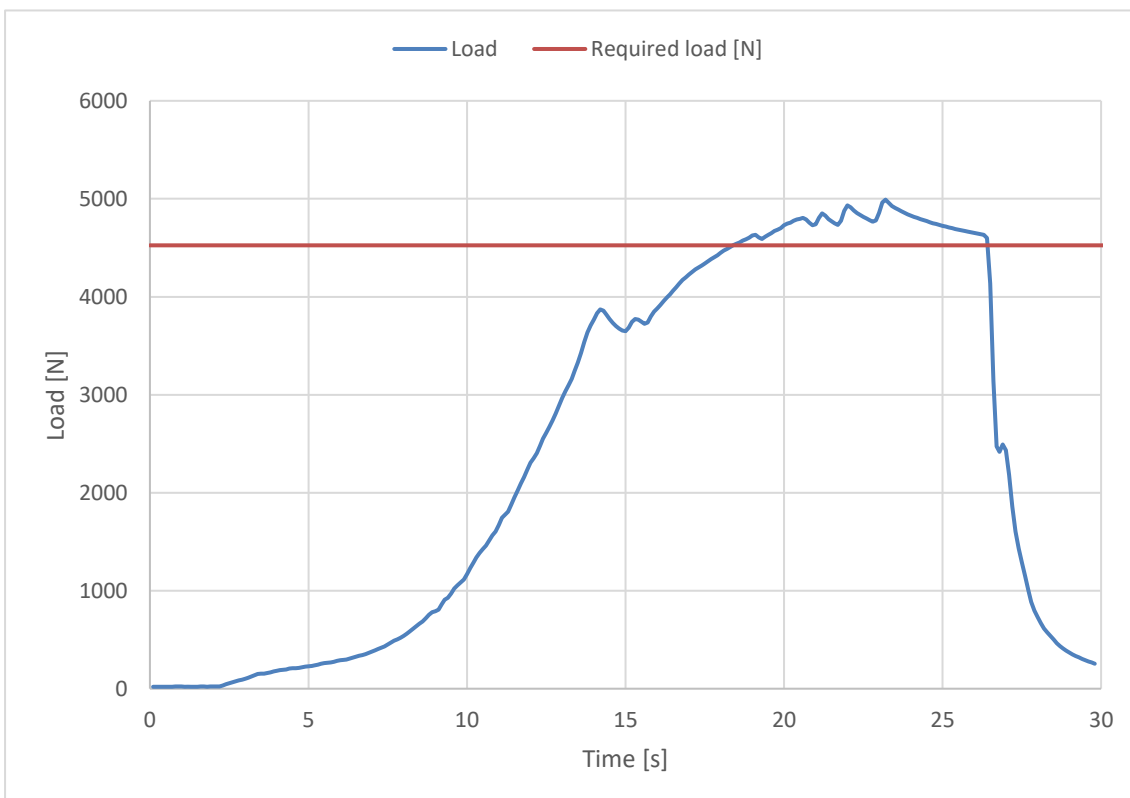
Test ID 08

Standard	EN 1651
Reference in standard	5.5.1.9
Test setup	Anti falling-out system
Attachment points	Around anti falling-out system
Anchor points	Both main riser attachment (no dummy)
Required load [g]	4.5
Required load [N]	4500
Minimum test duration [s]	5
Result	
Test duration [s]	8.1
Any signs of structural failure	No
Test results	POSITIVE

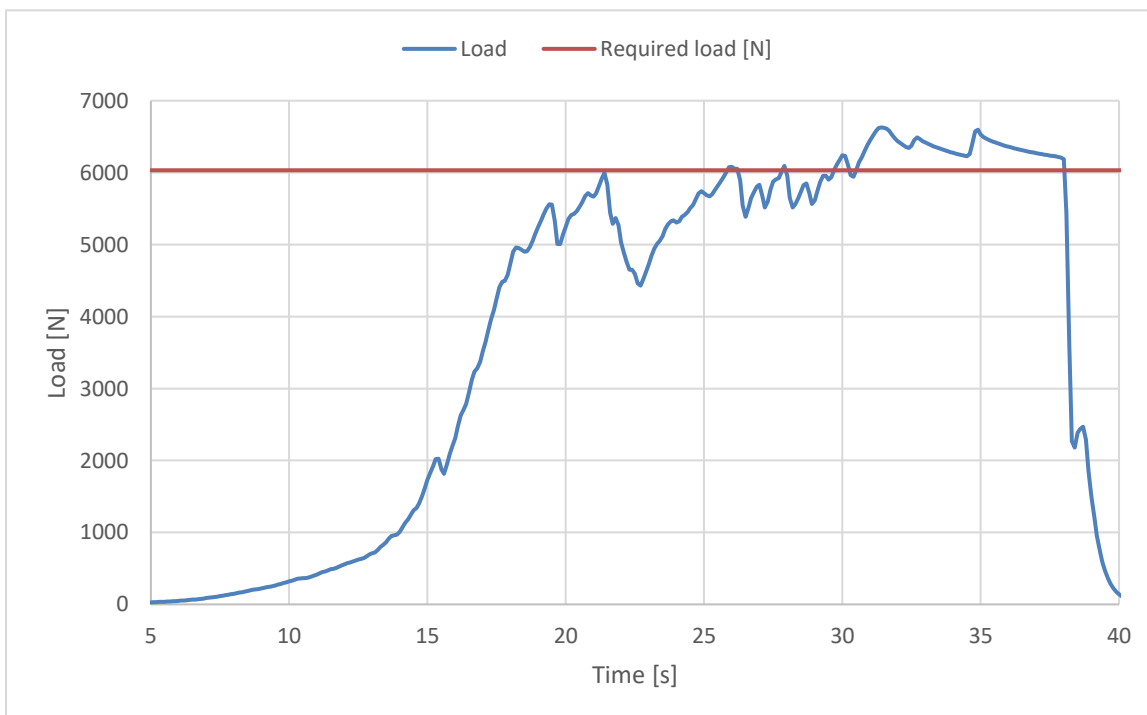
Test ID 12

Standard	EN 1651
Reference in standard	5.5.1.7
Test setup	Upright (landing) position load
Attachment points	Both main riser attachment (3, 4)
Anchor points	Both legstrap of harness (no dummy)
Required load [g]	6
Required load [N]	6000
Minimum test duration [s]	5
Harness type	type a
Result	
Test duration [s]	7.6
Any signs of structural failure	No
Slippery test OK	Yes
Test results	POSITIVE
