Harness Structural test Report - NfL

Inspection certificate number: **PH_349.2021**

Name: **Lullaby**
 Type: **ABS**
 Size: **Unique**
 Serial number: **HLB-10001**
 Impact pad type: ⁽¹⁾ **Foam**
 Clip-in weight [kg]: **100**
 Integrated container: **No**
 Date of test: **11.08.2021**

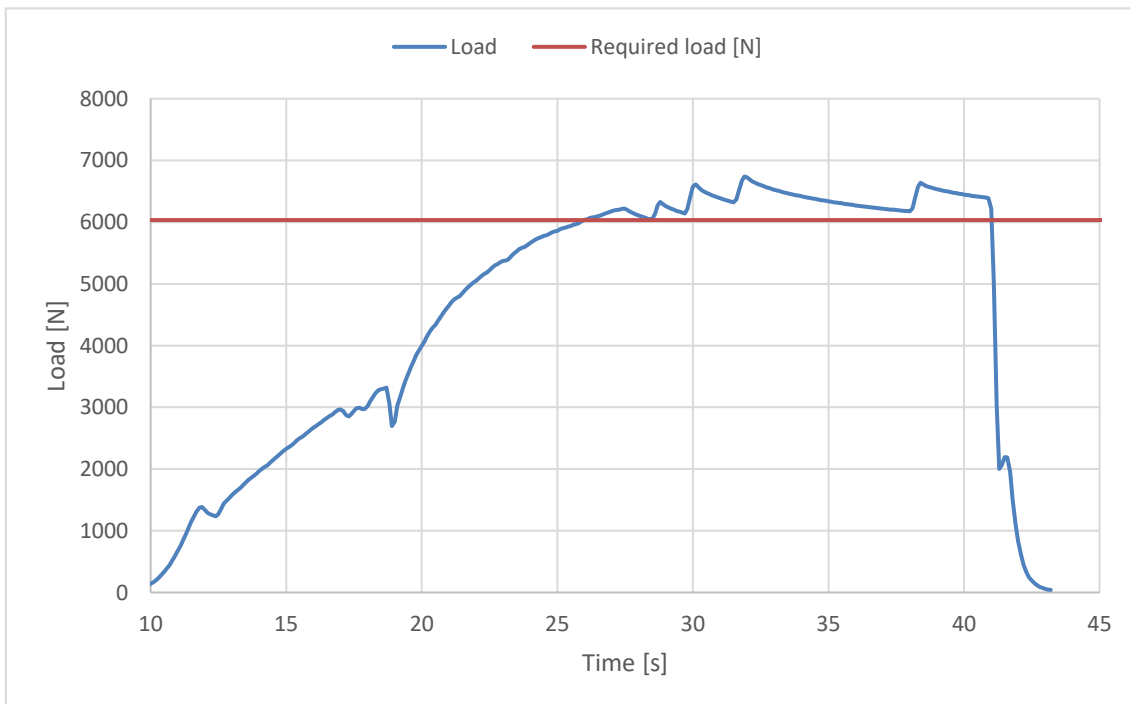
Test ID 02

Standard	NfL 2-565-20
Reference	5.3.2.1
Test setup	Default flying position
Attachment points	Both main riser attachment (3,4)
Anchor points	Dummy (B1, B2)
Required load [g]	6
Required load [N]	6000
Minimum test duration [s]	10
Result	
Test duration [s]	15
Any signs of structural failure	No
Test results	POSITIVE

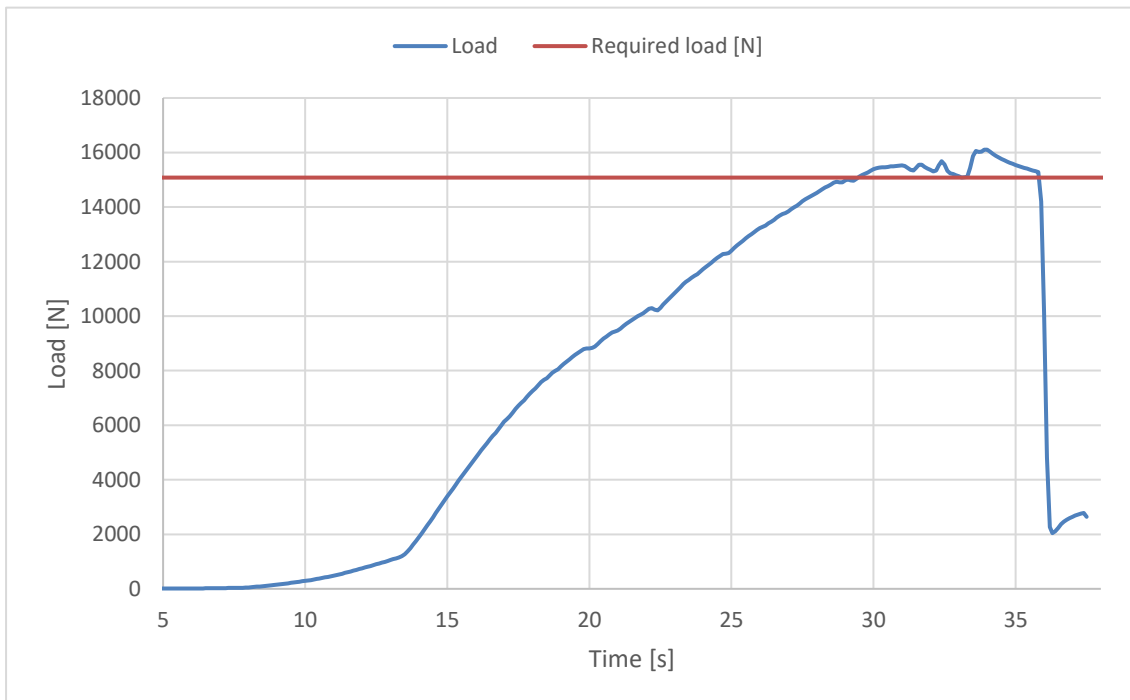
Test ID 03

Standard	NfL 2-565-20
Reference	5.3.2.2
Test setup	Default flying position
Attachment points	Both main riser attachment (3,4)
Anchor points	Dummy (B1, B2)
Required load [g]	15
Required load [N]	15000
Minimum test duration [s]	5
Result	
Test duration [s]	6.4
Any signs of structural failure	No
Test results	POSITIVE

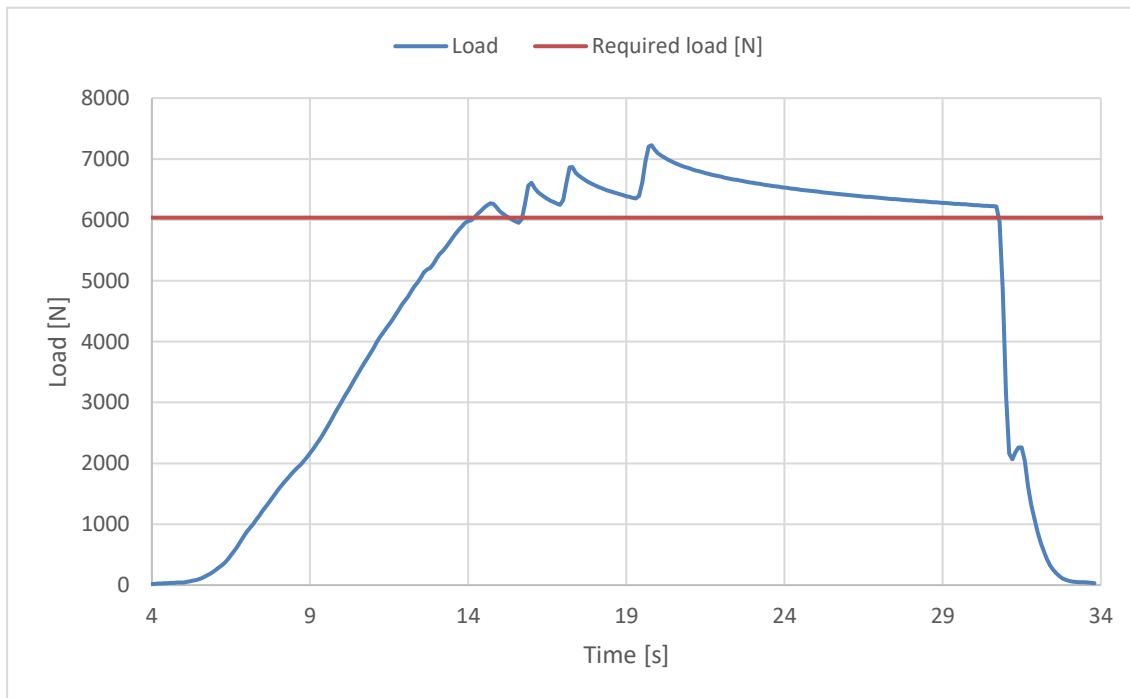
Test ID 04

Standard **NfL 2-565-20**
 Reference **5.3.2.3**
 Test setup **Asymmetric, one riser**
 Attachment points **One main riser attachment (3)**
 Anchor points **Dummy (B1,B2)**

Test duration [s] **15**
 Any signs of structural failure **No**
 Test results **POSITIVE**

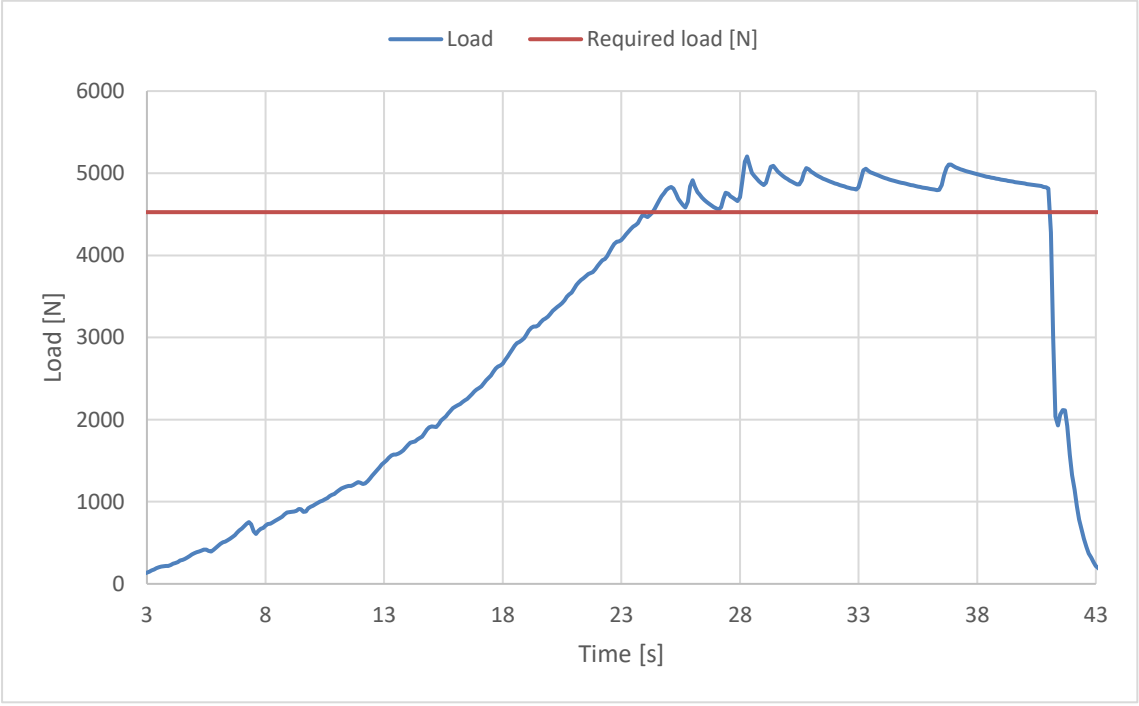
Test ID 07

Reference	5.3.2.6	
Test setup	Asymmetric, negative	
Attachment points	One main riser attachment (3 or 4) downwards	
Anchor points	Dummy (9)	
Required load [g]	4.5	
Required load [N]	4500	
Minimum test duration [s]	10	
Result		
Test duration [s]	16.7	
Any signs of structural failure	No	
Test results	POSITIVE

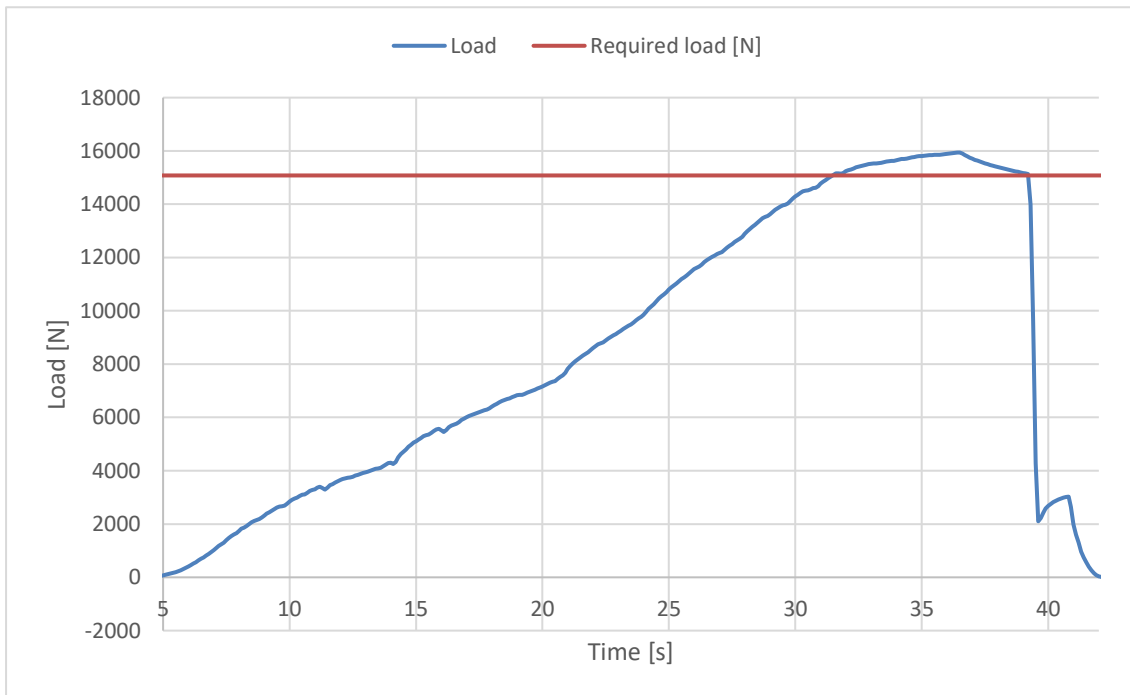
Test ID 13

Standard	NfL 2-565-20
Reference	5.3.2.7
Test setup	Flying position before landing
Attachment points	Both main riser attachment (3,4)
Anchor points	Dummy (7,8)
Required load [g]	15
Required load [N]	15000
Minimum test duration [s]	5
Result	
Test duration [s]	7.8
Any signs of structural failure	No
Test results	POSITIVE
