# Harness Structural test Report - EN

Inspection certificate number: **PH\_348.2021**

Manufacturer name: **Woody Valley srl**  
 Representative: **Simone Caldana**  
 Street: **Via Vienna 92**  
 Post code place: **30121 Trento**  
 Country: **Italy**

Name: **TransAlp 2**  
 Type: **ABS**  
 Size: **M**  
 Serial number: **10501150002**  
 Impact pad type: <sup>(1)</sup> **n/a**  
 Clip-in weight [kg]: **120**  
 Date of test: **23.09.2021**

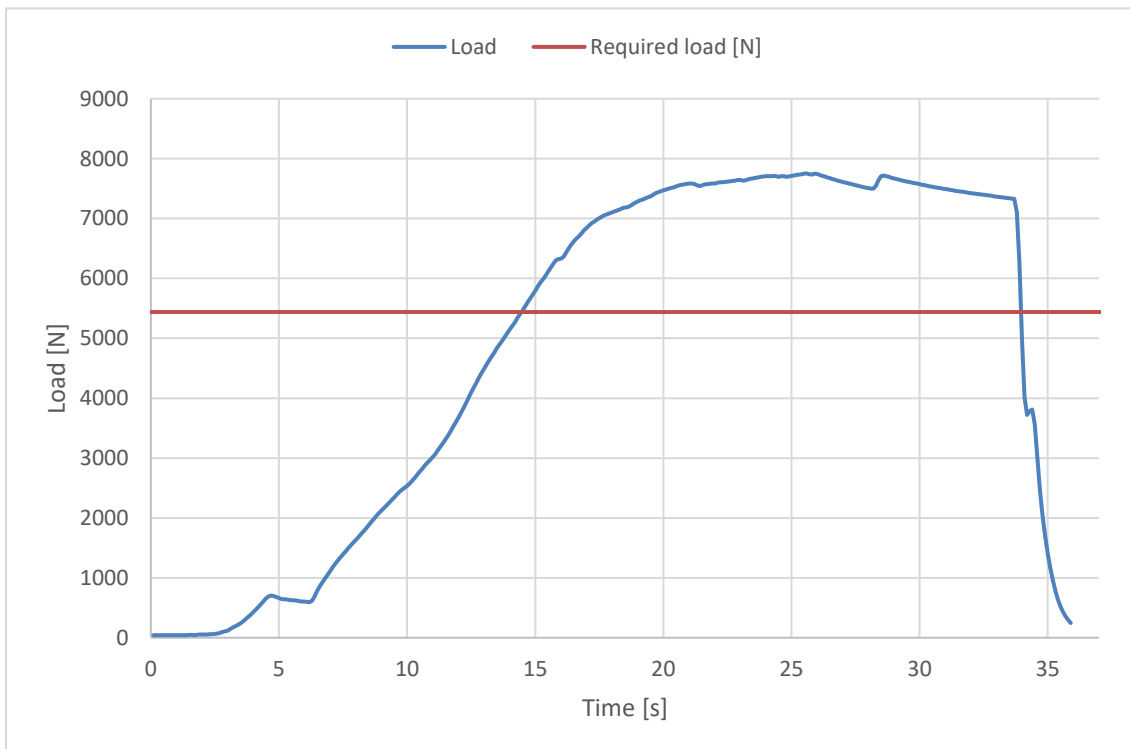
**Test ID 01**

Standard	<b>EN 1651</b>
Reference in standard	<b>5.5.1.1</b>
Test setup	<b>Positive symmetric load (Slippage)</b>
Attachment points	<b>Both main riser attachment (3,4)</b>
Anchor points	<b>Dummy (B1, B2)</b>
Required load [g]	<b>4.5</b>
Required load [N]	<b>5400</b>
Minimum test duration [s]	<b>5</b>
<b>Result</b>	
Test duration [s]	<b>19.5</b>
Any signs of structural failure	<b>No</b>
Slippery test OK	<b>Yes</b>
Test results	<b>POSITIVE</b>

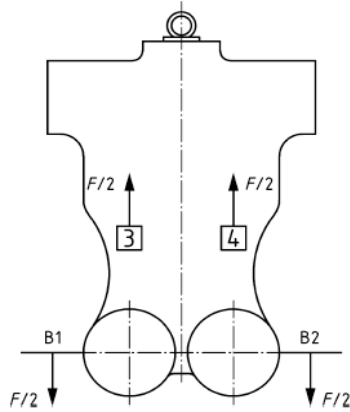
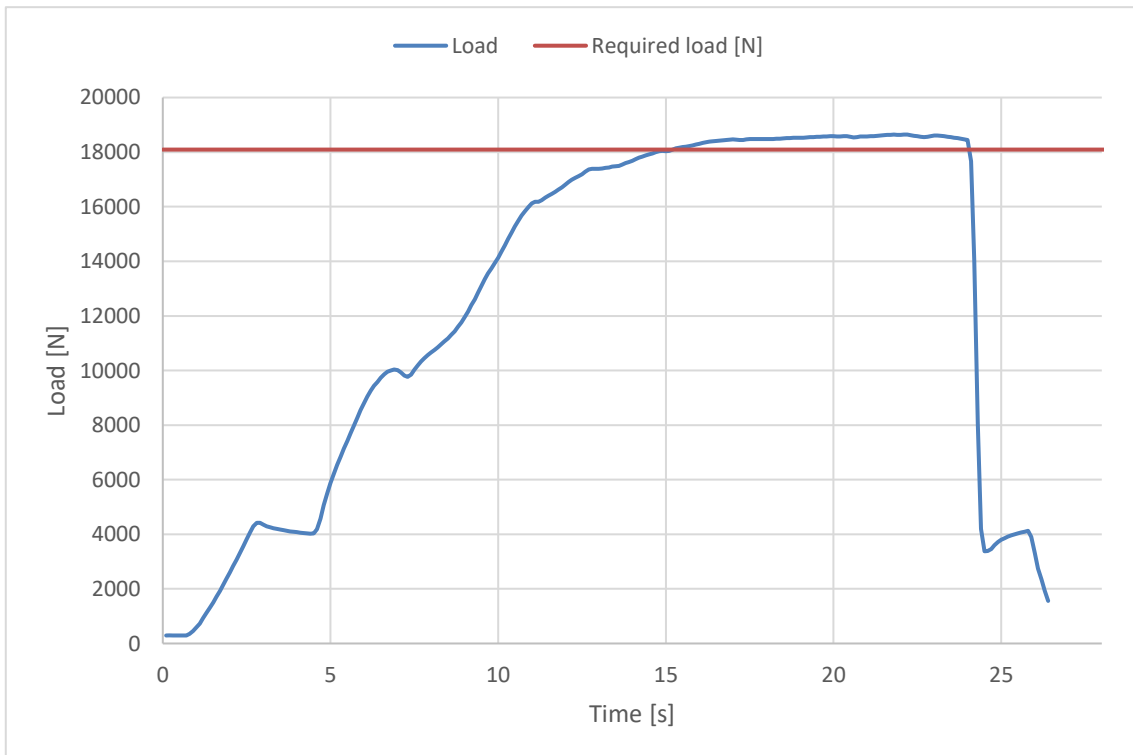
**Test ID 03**

Standard	<b>EN 1651</b>
Reference in standard	<b>5.5.1.1b</b>
Test setup	<b>Positive symmetric load</b>
Attachment points	<b>Both main riser attachment (3,4)</b>
Anchor points	<b>Dummy (B1, B2)</b>
Required load [g]	<b>15</b>
Required load [N]	<b>18000</b>
Minimum test duration [s]	<b>5</b>
<b>Result</b>	
Test duration [s]	<b>8.9</b>
Any signs of structural failure	<b>No</b>
Slippery test OK	<b>Yes</b>
Test results	<b>POSITIVE</b>

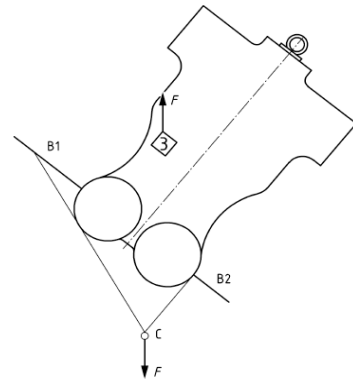
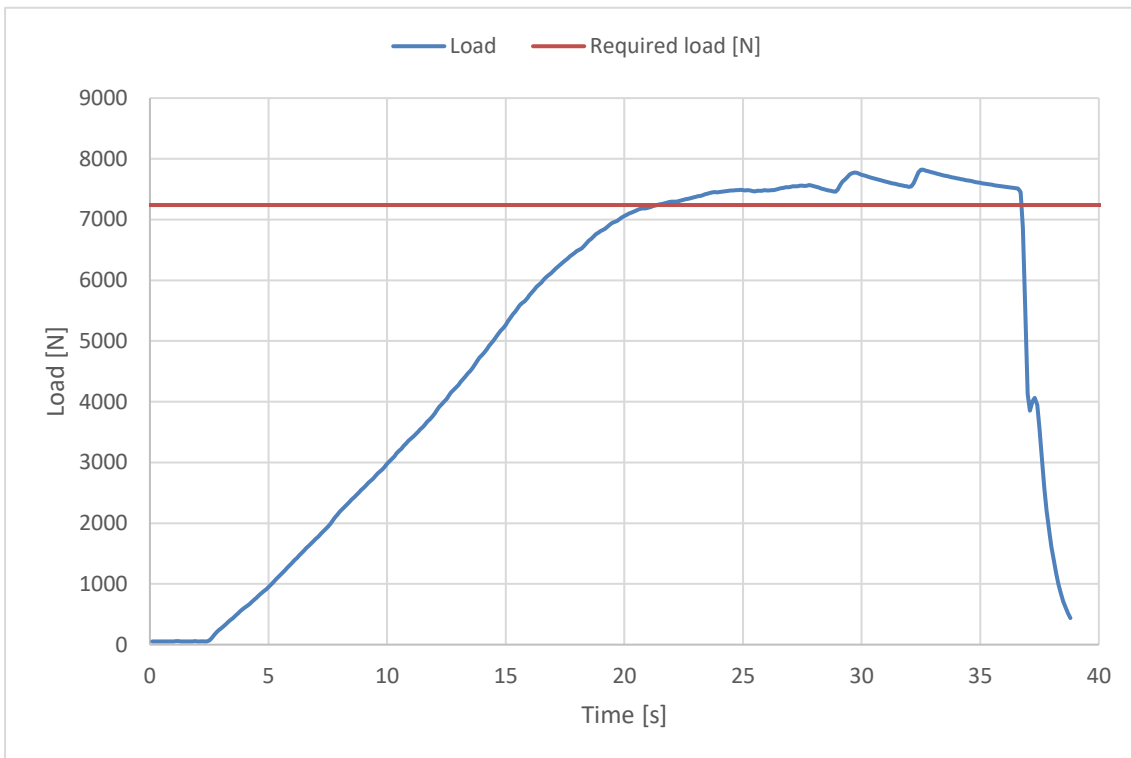
**Test ID 05**

Standard	<b>EN 1651</b>
Reference in standard	<b>5.5.1.2</b>
Test setup	<b>Positive asymmetric load</b>
Attachment points	<b>One riser attachment (3 or 4)</b>
Anchor points	<b>Dummy (C)</b>
Required load [g]	<b>6</b>
Required load [N]	<b>7200</b>
Minimum test duration [s]	<b>5</b>
<b>Result</b>	
Test duration [s]	<b>15.4</b>
Any signs of structural failure	<b>No</b>
Test results	<b>POSITIVE</b>

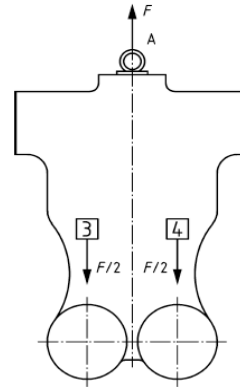
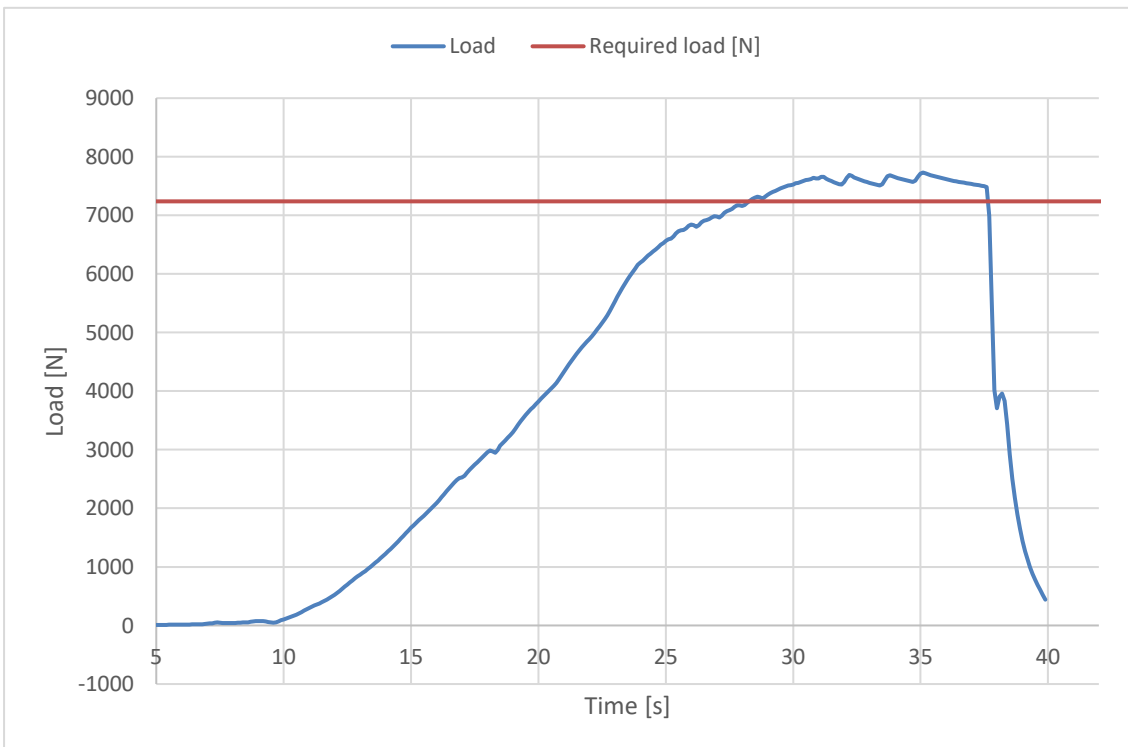
**Test ID 06**

Standard	<b>EN 1651</b>
Reference in standard	<b>5.5.1.6</b>
Test setup	<b>Negative symmetric load</b>
Attachment points	<b>Both main riser attachment (3,4)</b>
Anchor points	<b>Dummy (A)</b>
Required load [g]	<b>6</b>
Required load [N]	<b>7200</b>
Minimum test duration [s]	<b>5</b>
<b>Result</b>	
Test duration [s]	<b>9.4</b>
Any signs of structural failure	<b>No</b>
Test results	<b>POSITIVE</b>

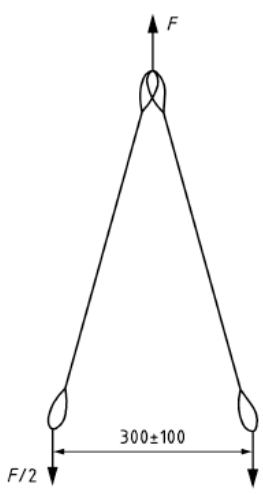
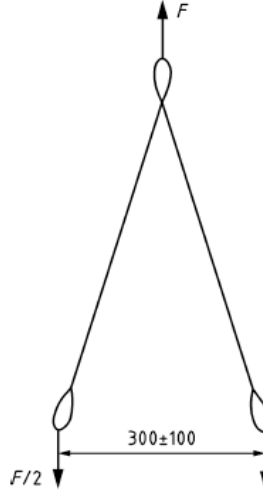
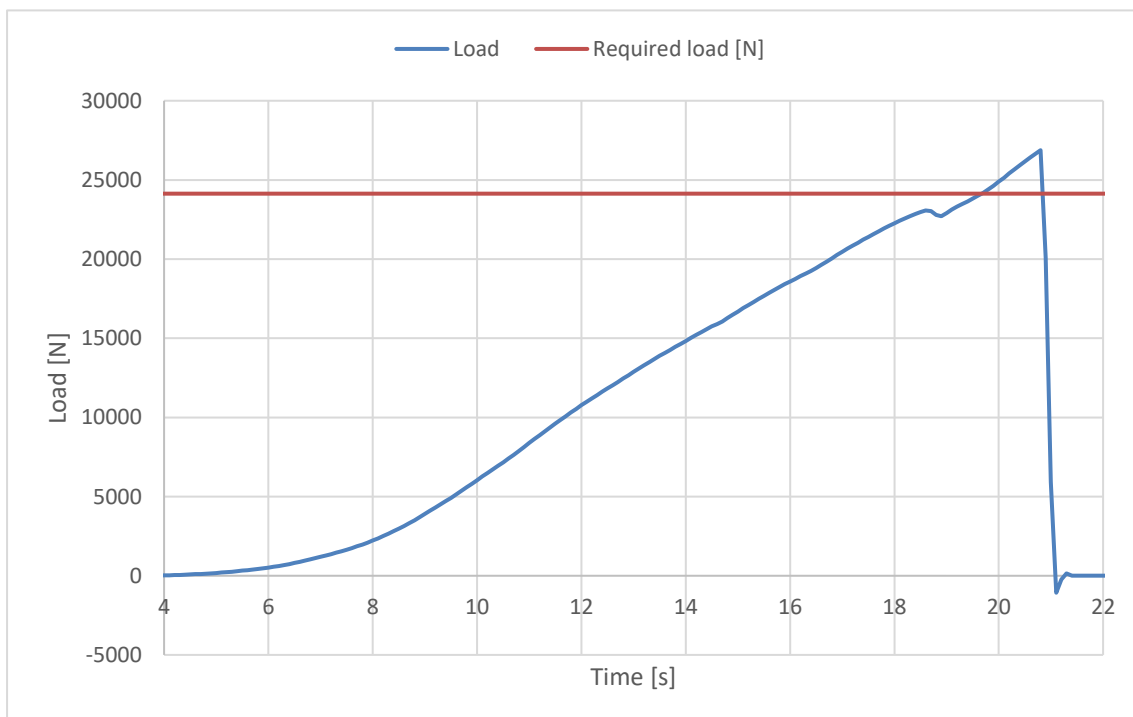
**Test ID 11**

Standard	<b>EN 1651</b>
Reference in standard	<b>5.5.1.8</b>
Test setup	<b>Connecting element for rescue</b>
Attachment points	<b>End point (emergency parachute)</b>
Anchor points	<b>Both attachment to harness</b>
Required load [g]	<b>n/a</b>
Required load [N]	<b>24000</b>
Minimum test duration [s]	<b>0.3</b>
Type of connecting element	<b>b) standard Y-bridle</b>
<b>Result</b>	
Test duration [s]	<b>1.2</b>
Any signs of structural failure	<b>No</b>
Test results	<b>POSITIVE</b>

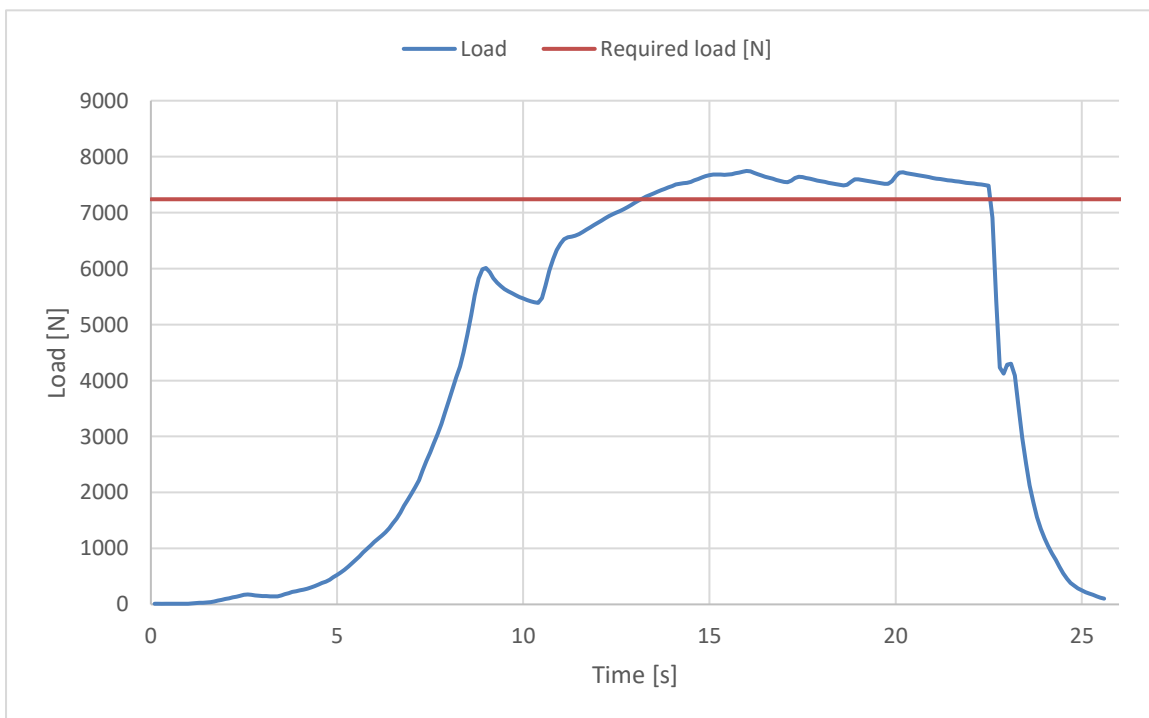
**Test ID 12**

Standard	<b>EN 1651</b>
Reference in standard	<b>5.5.1.7</b>
Test setup	<b>Upright (landing) position load</b>
Attachment points	<b>Both main riser attachment (3, 4)</b>
Anchor points	<b>Both legstrap of harness (no dummy)</b>
Required load [g]	<b>6</b>
Required load [N]	<b>7200</b>
Minimum test duration [s]	<b>5</b>
Harness type	<b>type c</b>
<b>Result</b>	
Test duration [s]	<b>9.4</b>
Any signs of structural failure	<b>No</b>
Slippery test OK	<b>Yes</b>
Test results	<b>POSITIVE</b>

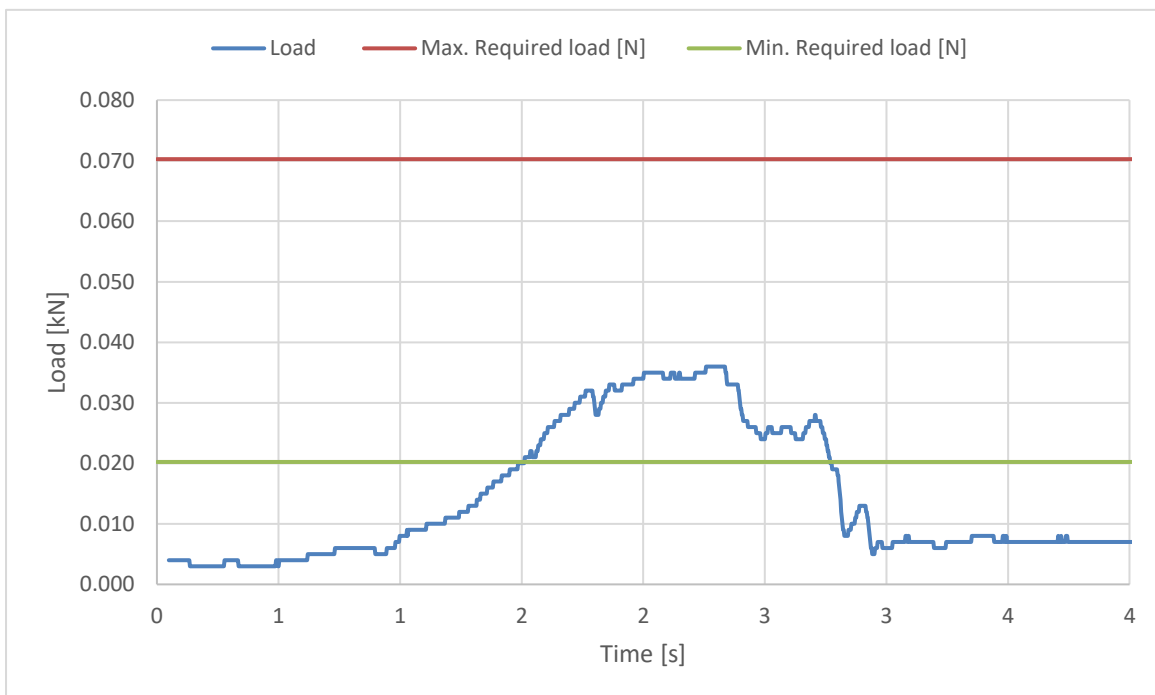
**Test ID RRDT**

Standard	<b>LTF NfL II 91/09</b>
Reference in standard	<b>6.1.5</b>
Test setup	<b>Default flying position</b>
Attachment points	<b>Sensor connect to handle, and pull in opening direction</b>
The test is to simulate the load required to open the emergency parachute(1st action).

Load for first action [N]	<b>35.76</b>
Test results	<b>POSITIVE</b>

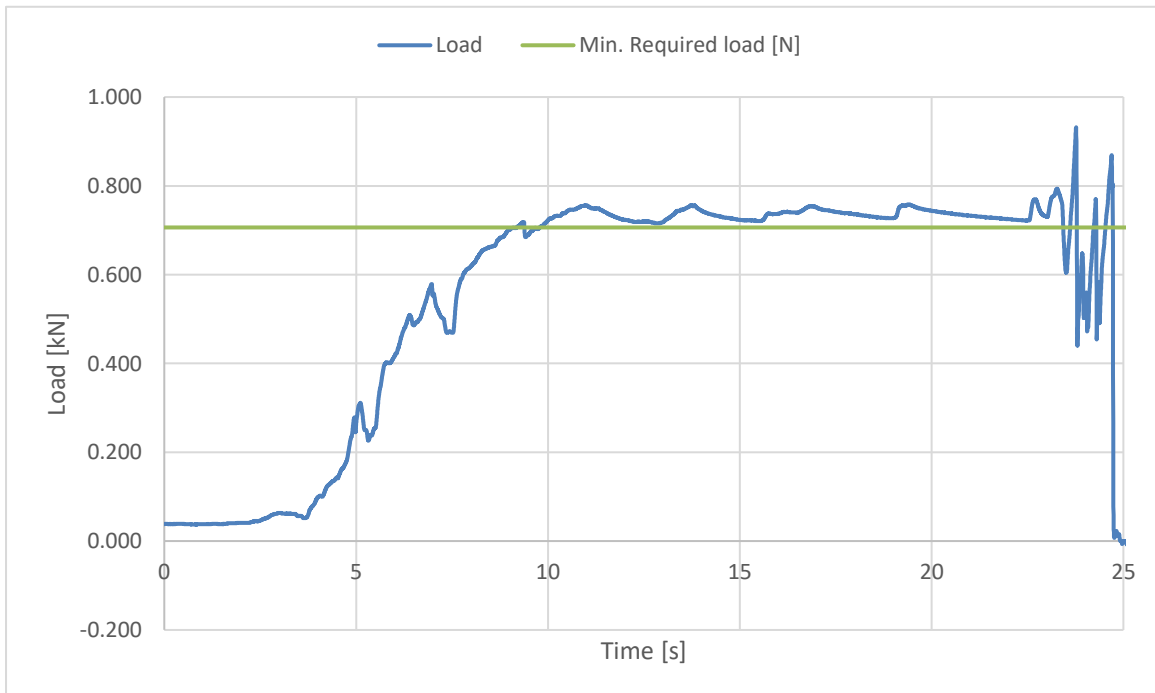
**Test ID RRST**

Standard	<b>EN12491:2015</b>
Reference in standard	<b>5.3.2</b>
Test setup	<b>Two end points of handle</b>
Attachment points	<b>Sensor connect to end of handle, pull on the other side</b>
	The handle must support min 700 N for 10 s, after measure breaking strength
Min. Required load [N]	<b>700</b>
Minimum test duration [s]	<b>10</b>
<b>Result</b>	
Test duration [s]:	<b>13.6</b>
Breaking strength [N]	<b>925.81</b>
Test results	<b>POSITIVE</b>
