Harness Structural test Report - LTF

Inspection certificate number: **PH_304.2020**

Name: **Core**
 Type: **ABS**
 Size: **M**
 Serial number: **SPHAWH01-4020-0001**
 Impact pad type: ⁽¹⁾ **Inflatable**
 Clip-in weight [kg]: **100**
 Date of test: **18.06.2020**

Air Turquoise SA, having thoroughly assessed the sample mentioned above, declare it was found conform with
 Airworthiness Requirements **LTF nFL II 91/09 - EN12491:2015 5.3.2**

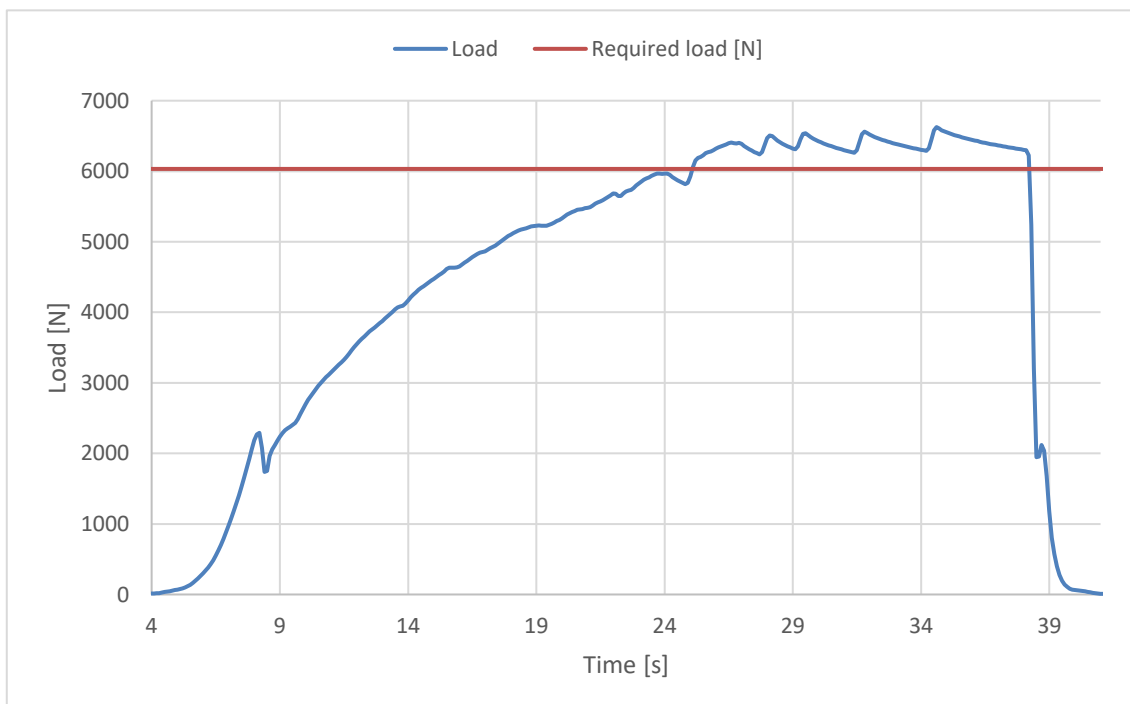
Test ID 02

Standard	LTF NfL II 91/09
Reference	5.3.2.1
Test setup	Default flying position
Attachment points	Both main riser attachment (3,4)
Anchor points	Dummy (B1, B2)
Required load [g]	6
Required load [N]	6000
Minimum test duration [s]	10
Result	
Test duration [s]	13.2
Any signs of structural failure	No
Test results	POSITIVE

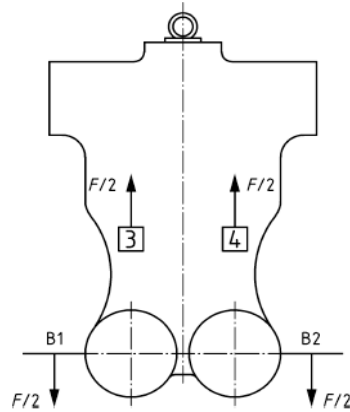
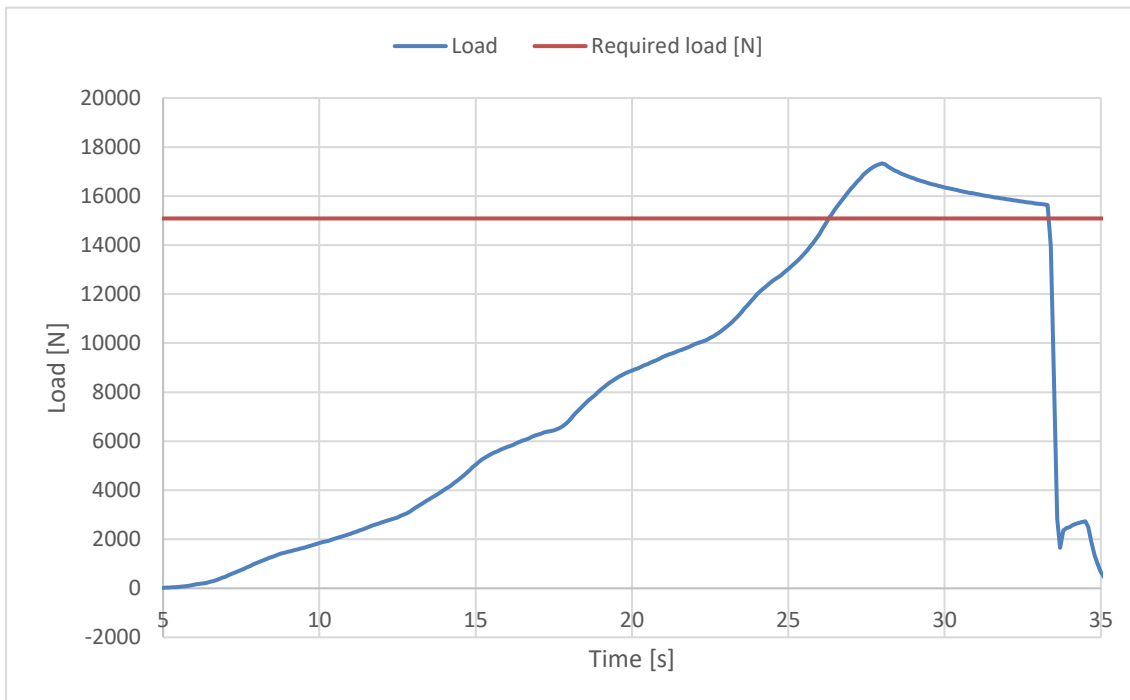
Test ID 03

Test duration [s] **7.1**
 Any signs of structural failure **No**
 Test results **POSITIVE**

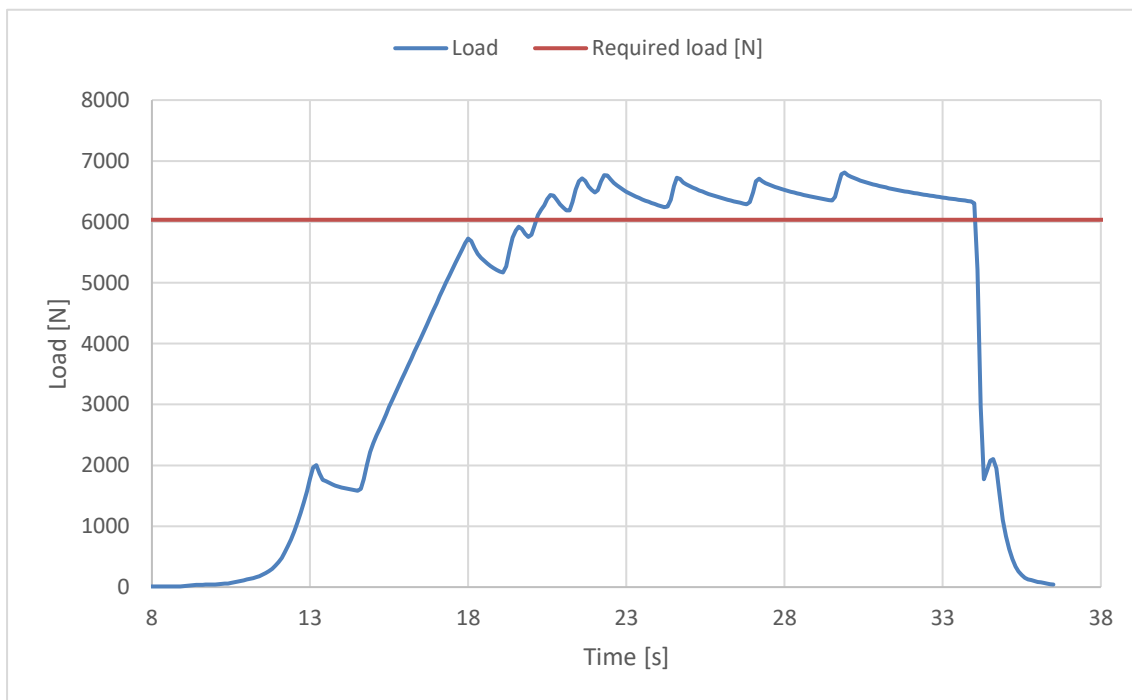
Test ID 04

Standard	LTF NfL II 91/09
Reference	5.3.2.3
Test setup	Asymmetric, one riser
Attachment points	One main riser attachment (3)
Anchor points	Dummy (B1,B2)
Required load [g]	6
Required load [N]	6000
Minimum test duration [s]	10
Result	
Test duration [s]	13.9
Any signs of structural failure	No
Test results	POSITIVE

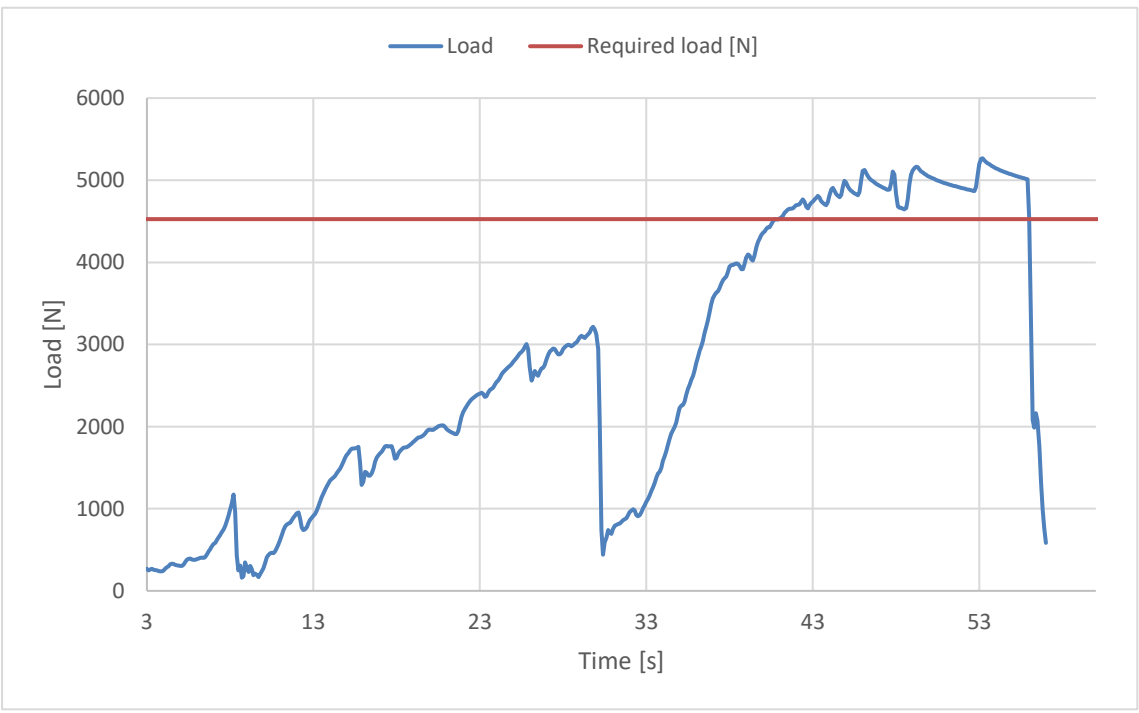
Test ID 07

Reference	5.3.2.6	
Test setup	Asymmetric, negative	
Attachment points	One main riser attachment (3 or 4) downwards	
Anchor points	Dummy (9)	
Required load [g]	4.5	
Required load [N]	4500	
Minimum test duration [s]	10	
Result		
Test duration [s]	15.1	
Any signs of structural failure	No	
Test results	POSITIVE

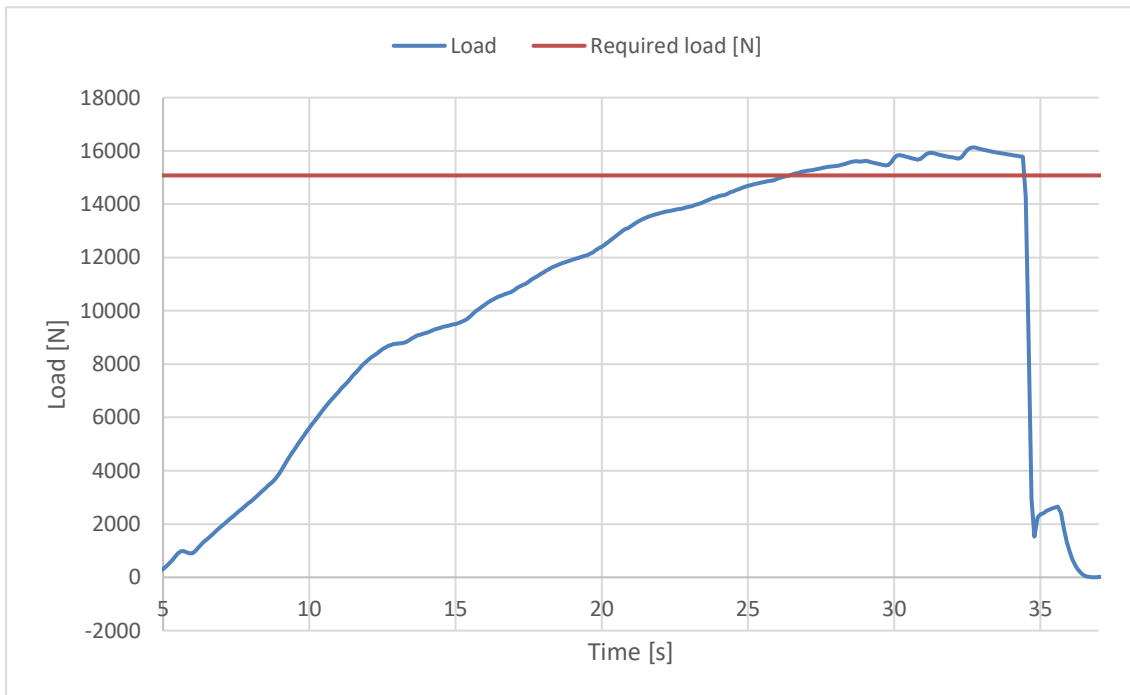
Test ID 13

Standard	LTF NfL II 91/09
Reference in standard	5.3.2.7
Test setup	Flying position before landing
Attachment points	Both main riser attachment (3,4)
Anchor points	Dummy (7,8)
Required load [g]	15
Required load [N]	15000
Minimum test duration [s]	5
Result	
Test duration [s]	8
Any signs of structural failure	No
Test results	POSITIVE
