Harness Structural test Report - EN

Inspection certificate number: **PH_343.2021**

Name: **Contour**
 Type: **ABS**
 Size: **M**
 Serial number: **SPHAWH01-4020-0001**
 Impact pad type: ⁽¹⁾ **Inflatable**
 Clip-in weight [kg]: **100**
 Date of test: **18.06.2020**

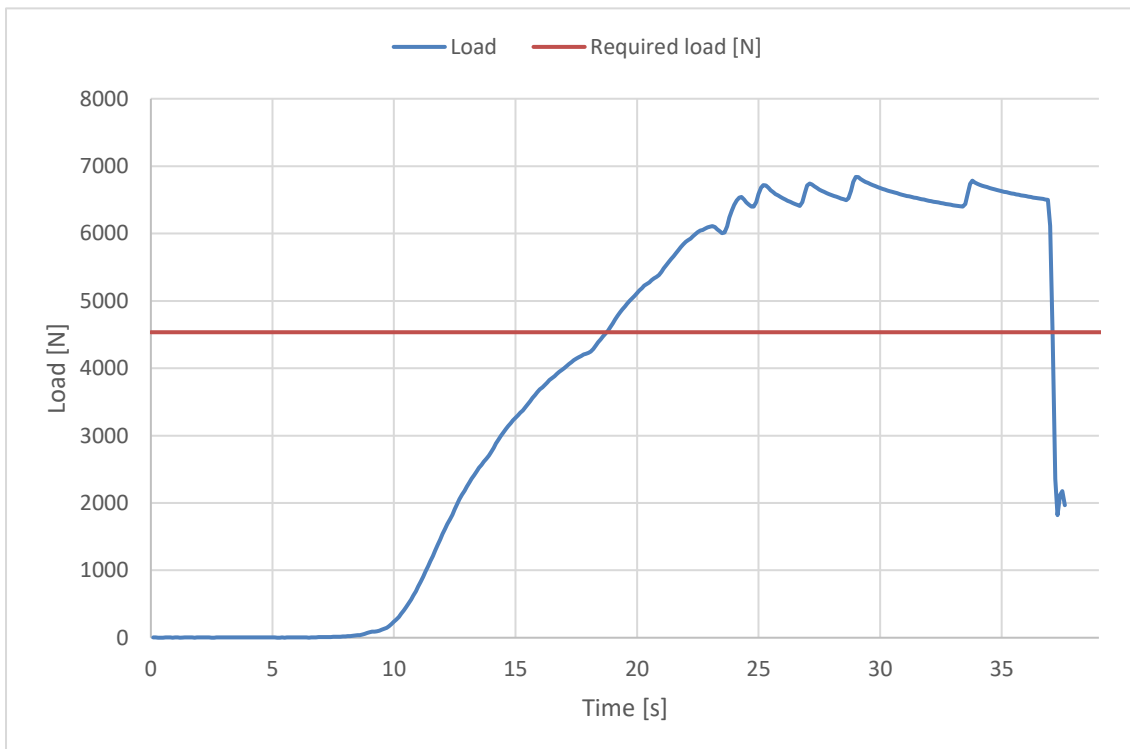
Test ID 01

Test duration [s] **18.3**
 Any signs of structural failure **No**
 Slippery test OK **Yes**
 Test results **POSITIVE**

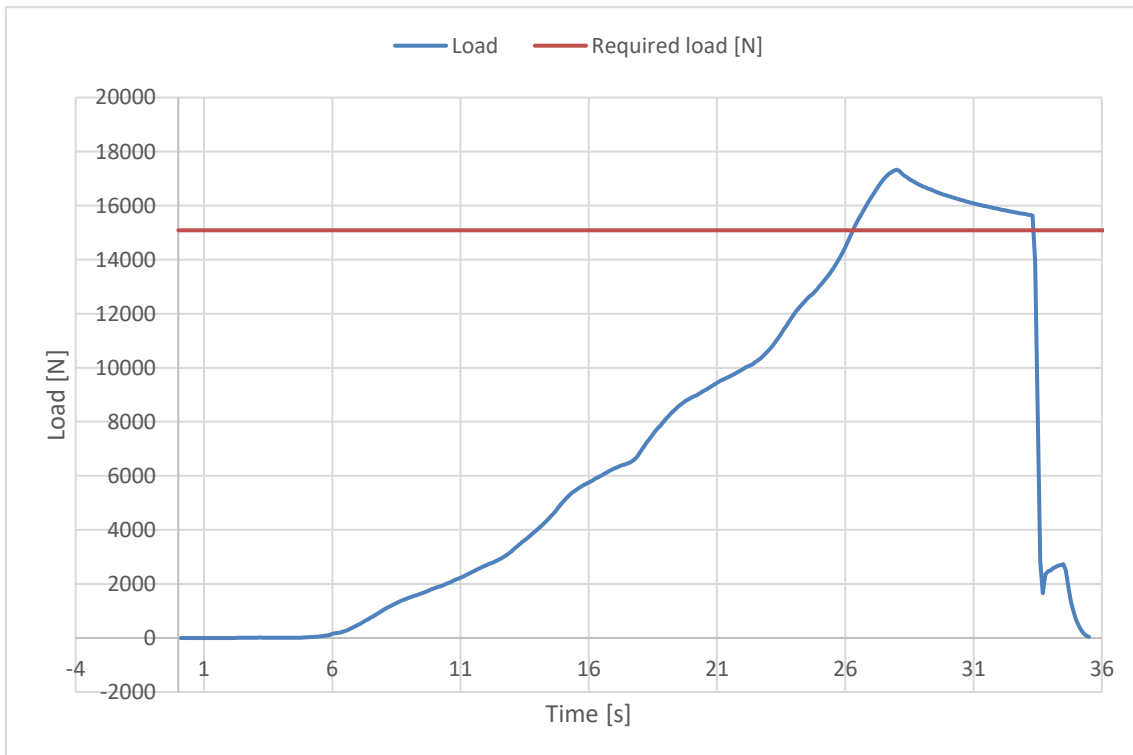
Test ID 03

| Any signs of structural failure | No |
| Slippery test OK | Yes |
| Test results | POSITIVE |

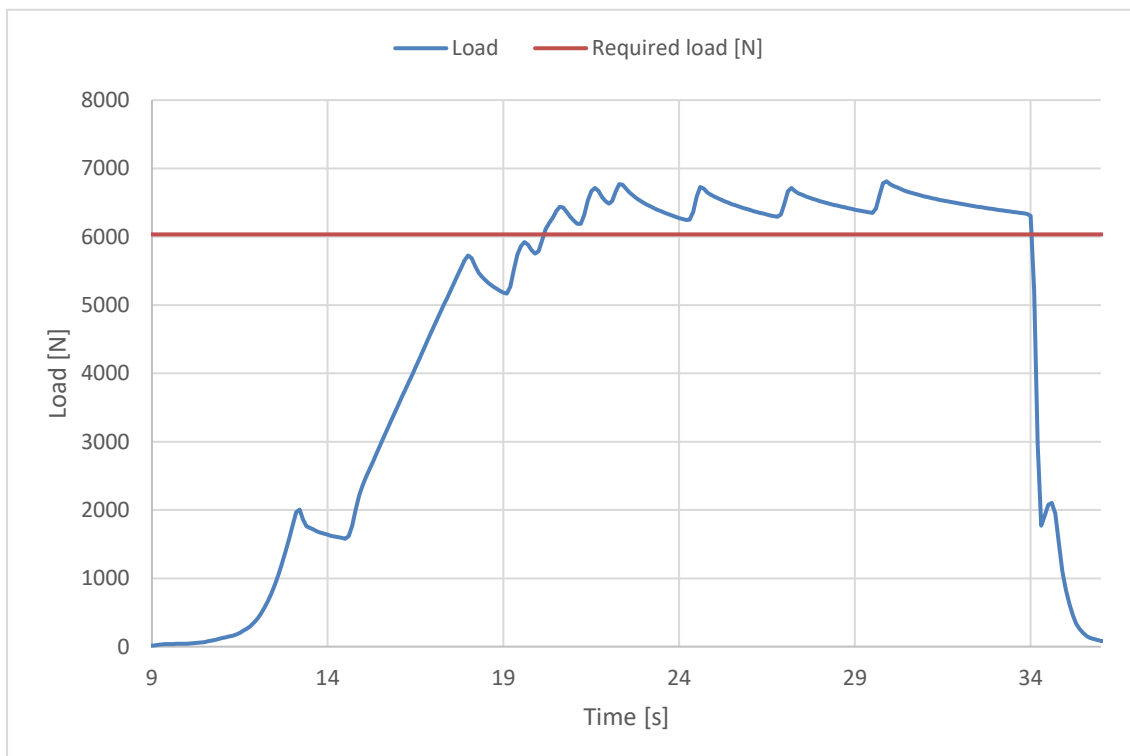
Test ID 05

| Any signs of structural failure | No |
| Test results | POSITIVE |

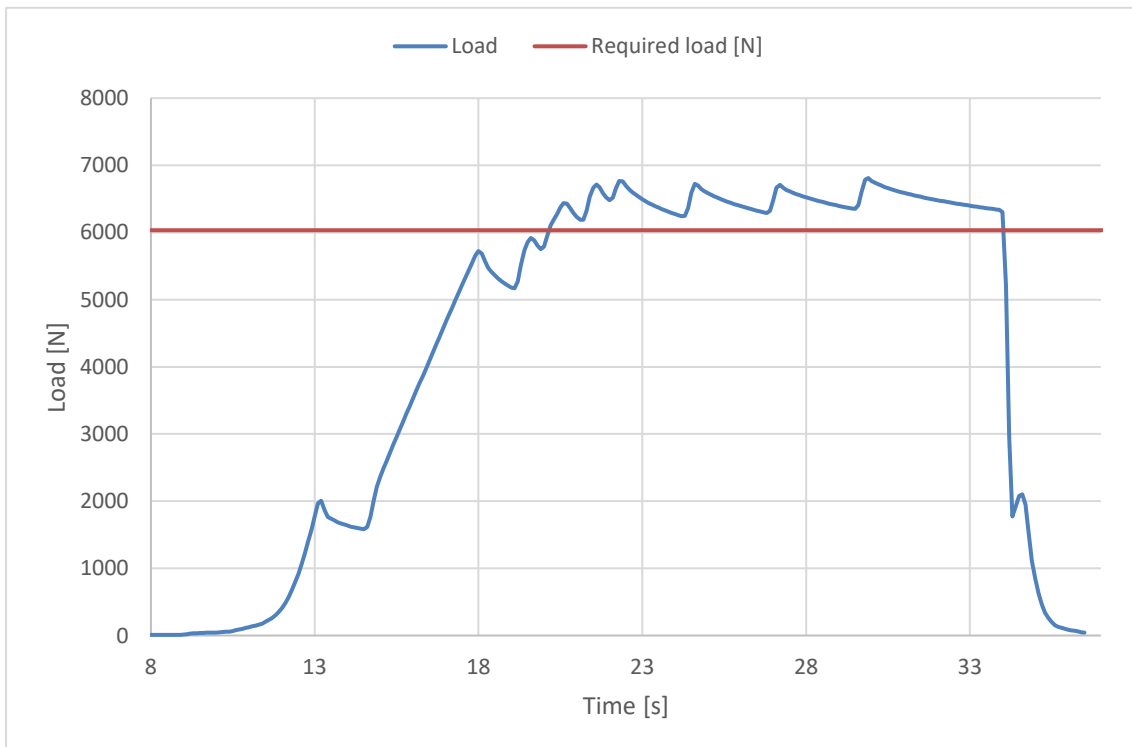
Test ID 06

| Any signs of structural failure | No |
| Test results | POSITIVE |

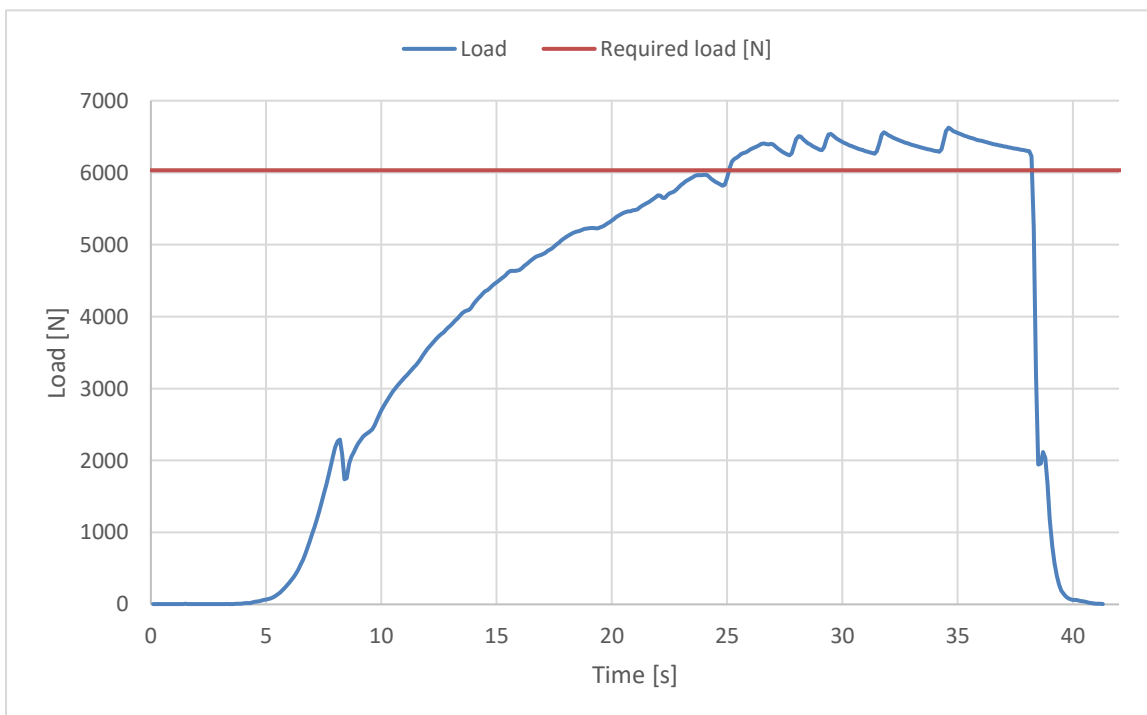
Test ID 12

| Any signs of structural failure | No |
| Slippery test OK | Yes |
| Test results | POSITIVE |
