Harness Structural test Report - NfL

Inspection certificate number: **PH_343.2021**

Name: **Contour**
 Type: **ABS**
 Size: **M**
 Serial number: **SPHAWH01-4020-0001**
 Impact pad type: ⁽¹⁾ **Inflatable**
 Clip-in weight [kg]: **100**
 Integrated container: **No**
 Date of test: **18.06.2020**

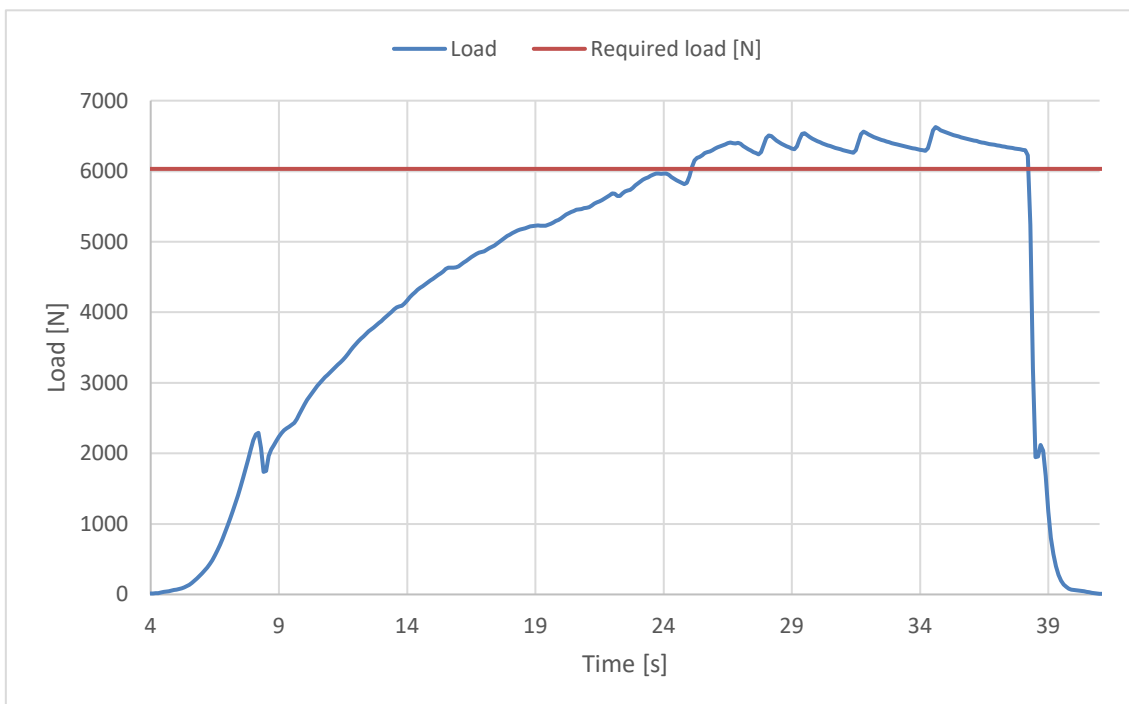
Test ID 02

Reference	5.3.2.1	
Test setup	Default flying position	
Attachment points	Both main riser attachment (3,4)	
Anchor points	Dummy (B1, B2)	
Required load [g]	6	
Required load [N]	6000	
Minimum test duration [s]	10	
Result		
Test duration [s]	13.2	
Any signs of structural failure	No	
Test results	POSITIVE

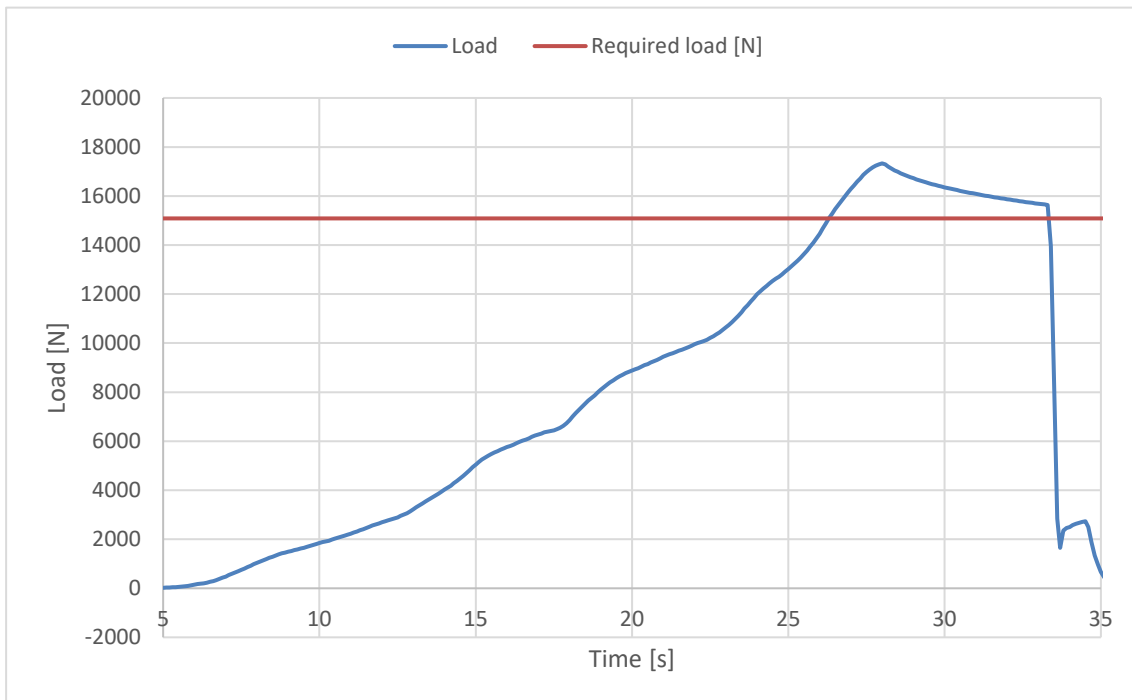
Test ID 03

Reference	5.3.2.2	
Test setup	Default flying position	
Attachment points	Both main riser attachment (3,4)	
Anchor points	Dummy (B1, B2)	
Required load [g]	15	
Required load [N]	15000	
Minimum test duration [s]	5	
Result		
Test duration [s]	7.1	
Any signs of structural failure	No	
Test results	POSITIVE

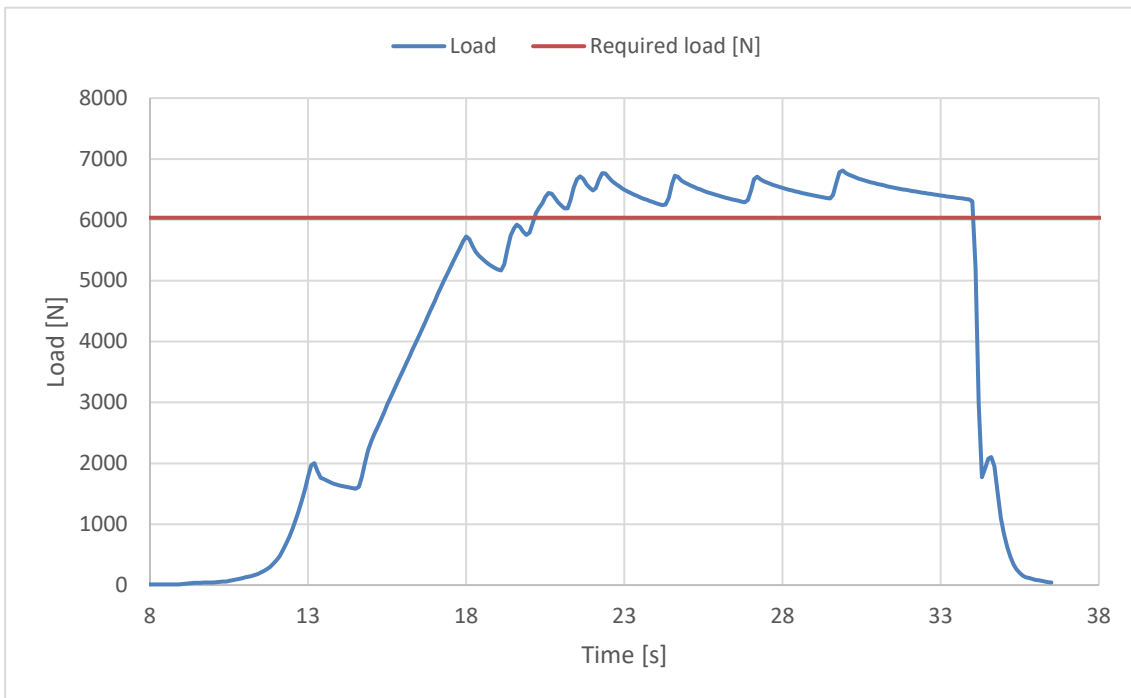
Test ID 04

Standard	NfL 2-565-20
Reference	5.3.2.3
Test setup	Asymmetric, one riser
Attachment points	One main riser attachment (3)
Anchor points	Dummy (B1,B2)
Required load [g]	6
Required load [N]	6000
Minimum test duration [s]	10
Result	
Test duration [s]	13.9
Any signs of structural failure	No
Test results	POSITIVE

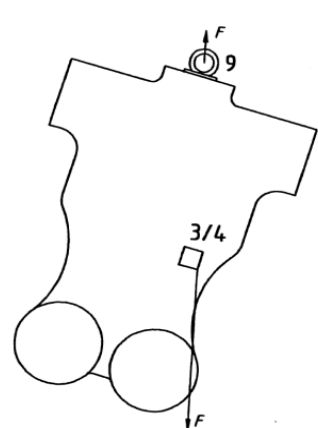
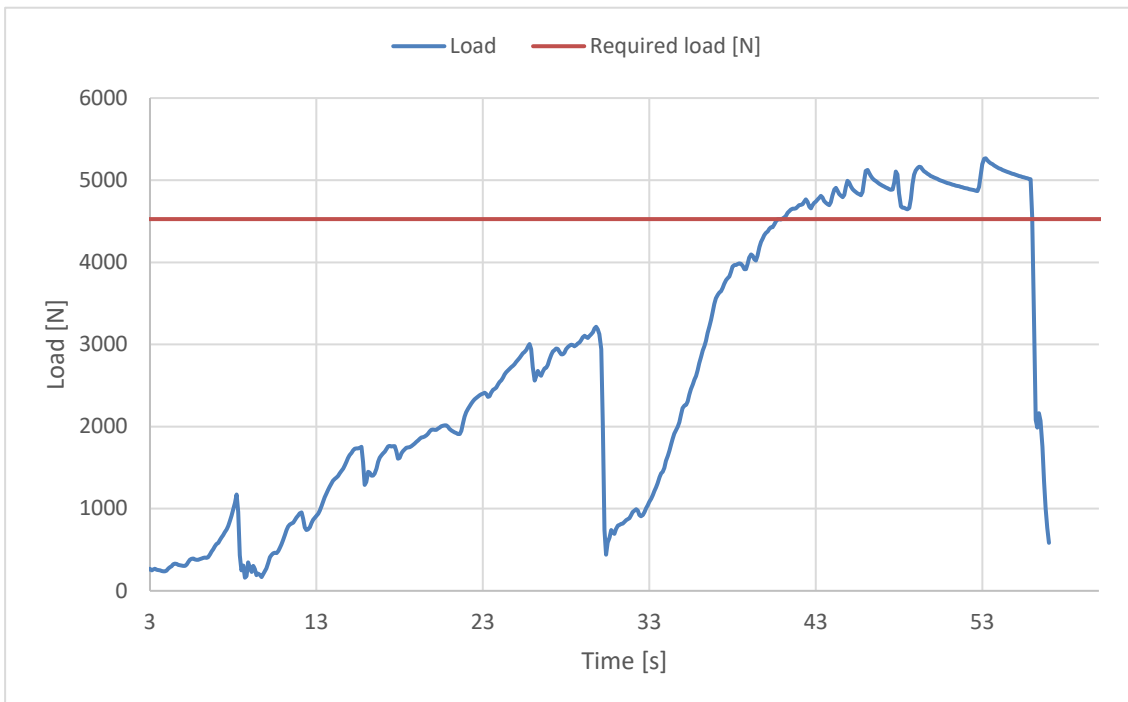
Test ID 07

Reference	5.3.2.6	
Test setup	Asymmetric, negative	
Attachment points	One main riser attachment (3 or 4) downwards	
Anchor points	Dummy (9)	
Required load [g]	4.5	
Required load [N]	4500	
Minimum test duration [s]	10	
Result		
Test duration [s]	15.1	
Any signs of structural failure	No	
Test results	POSITIVE

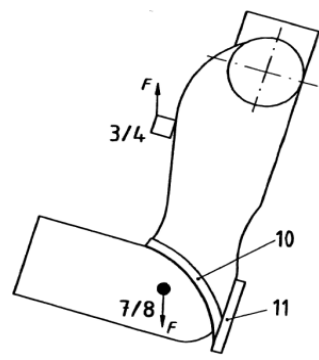
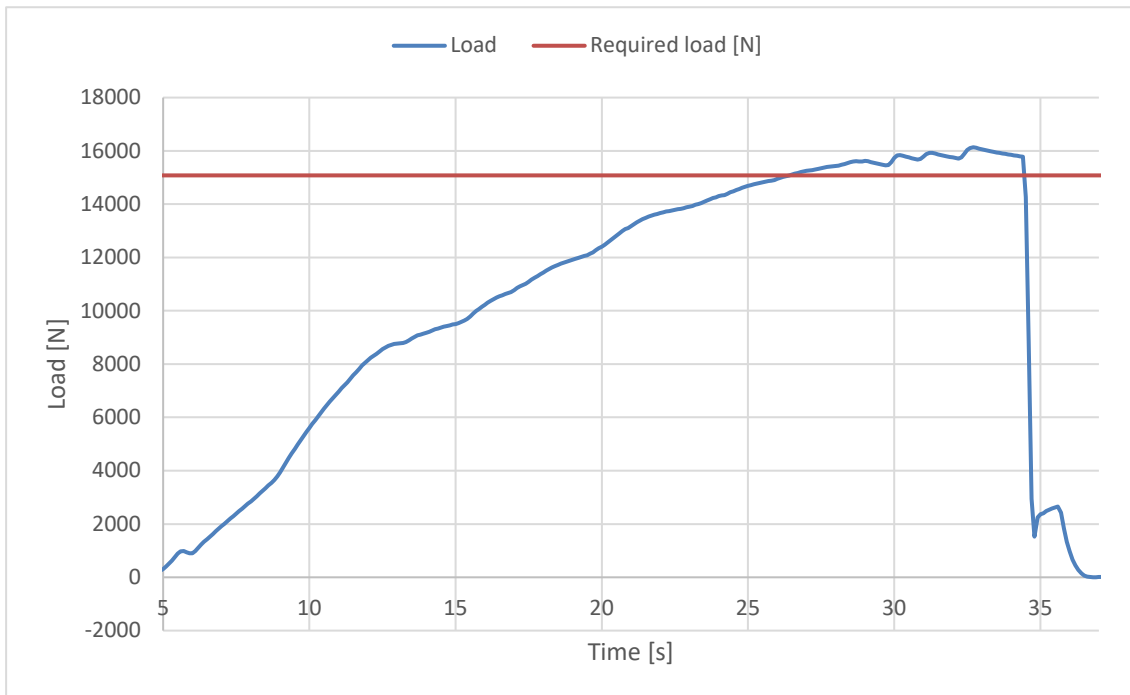
Test ID 13

Standard	NfL 2-565-20
Reference	5.3.2.7
Test setup	Flying position before landing
Attachment points	Both main riser attachment (3,4)
Anchor points	Dummy (7,8)
Required load [g]	15
Required load [N]	15000
Minimum test duration [s]	5
Result	
Test duration [s]	8
Any signs of structural failure	No
Test results	POSITIVE
