## Harness Structural test Report - LTF

Inspection certificate number: **PH\_334.2021**

Name: **Airtrek 2**  
 Type: **ABS**  
 Size: **L**  
 Serial number: **ATL-L\_VS.1**  
 Impact pad type: <sup>(1)</sup> **Airbag**  
 Clip-in weight [kg]: **120**

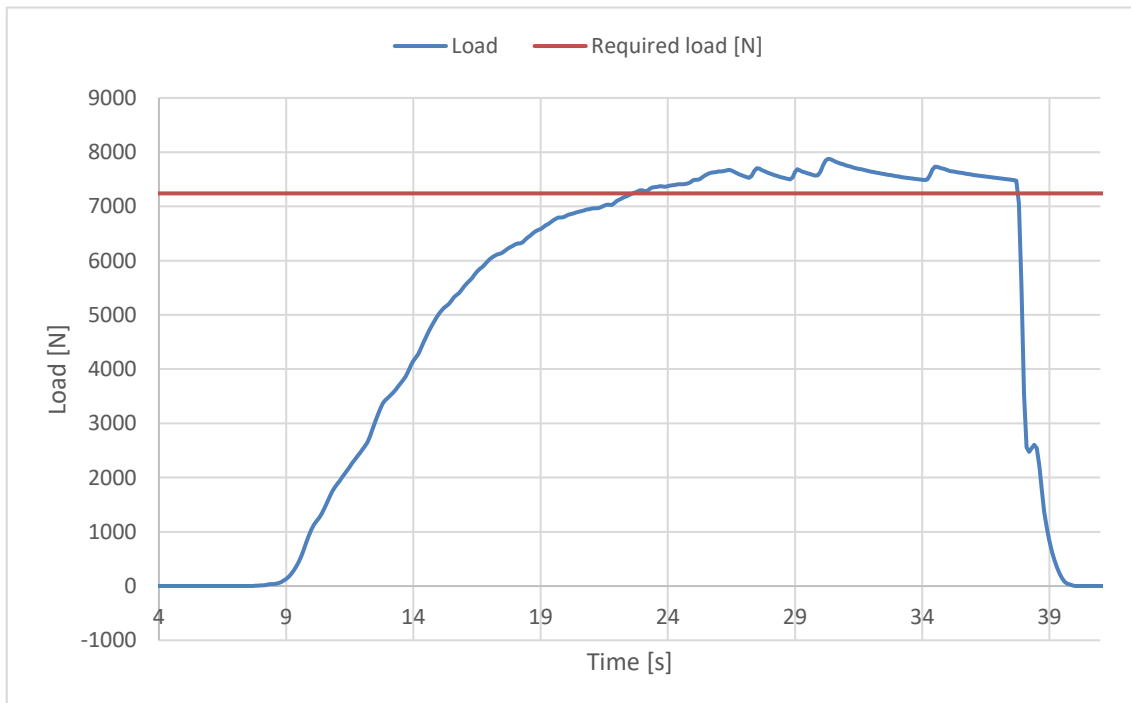
**Test ID 02**

Test duration [s] **15.1**  
 Any signs of structural failure **No**  
 Test results **POSITIVE**

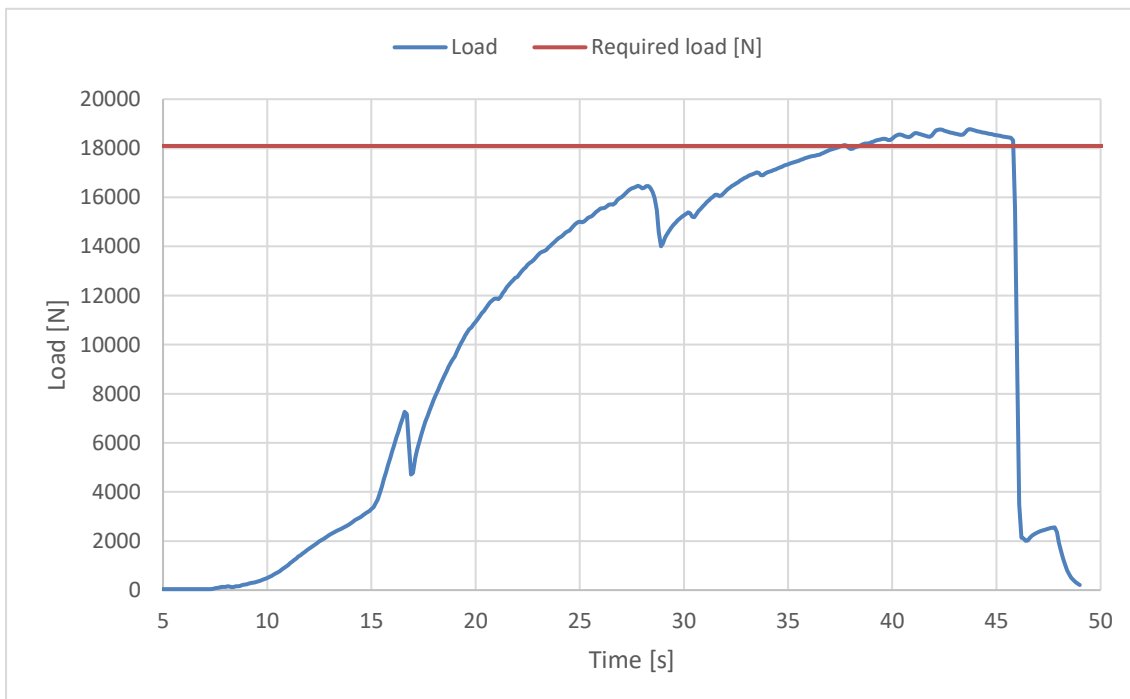
**Test ID 03**

Standard	<b>LTF NfL II 91/09</b>
Reference	<b>5.3.2.2</b>
Test setup	<b>Default flying position</b>
Attachment points	<b>Both main riser attachment (3,4)</b>
Anchor points	<b>Dummy (B1, B2)</b>
Required load [g]	<b>15</b>
Required load [N]	<b>18000</b>
Minimum test duration [s]	<b>5</b>
<b>Result</b>	
Test duration [s]	<b>7.4</b>
Any signs of structural failure	<b>No</b>
Test results	<b>POSITIVE</b>

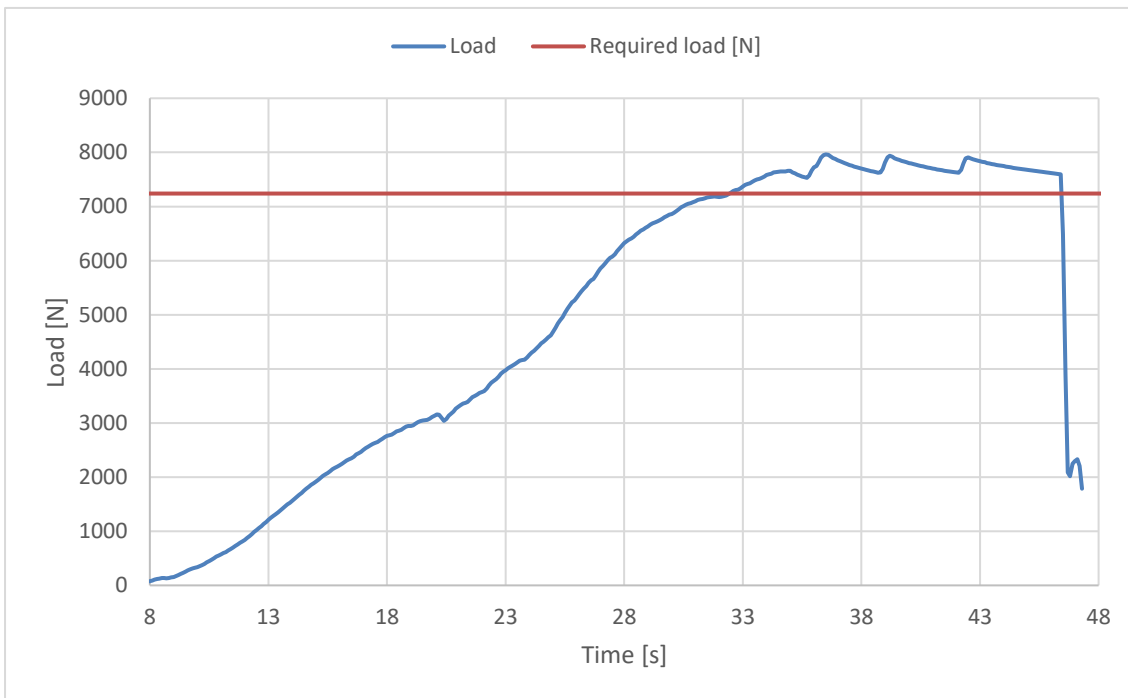
**Test ID 04**

Test duration [s] **14**  
 Any signs of structural failure **No**  
 Test results **POSITIVE**

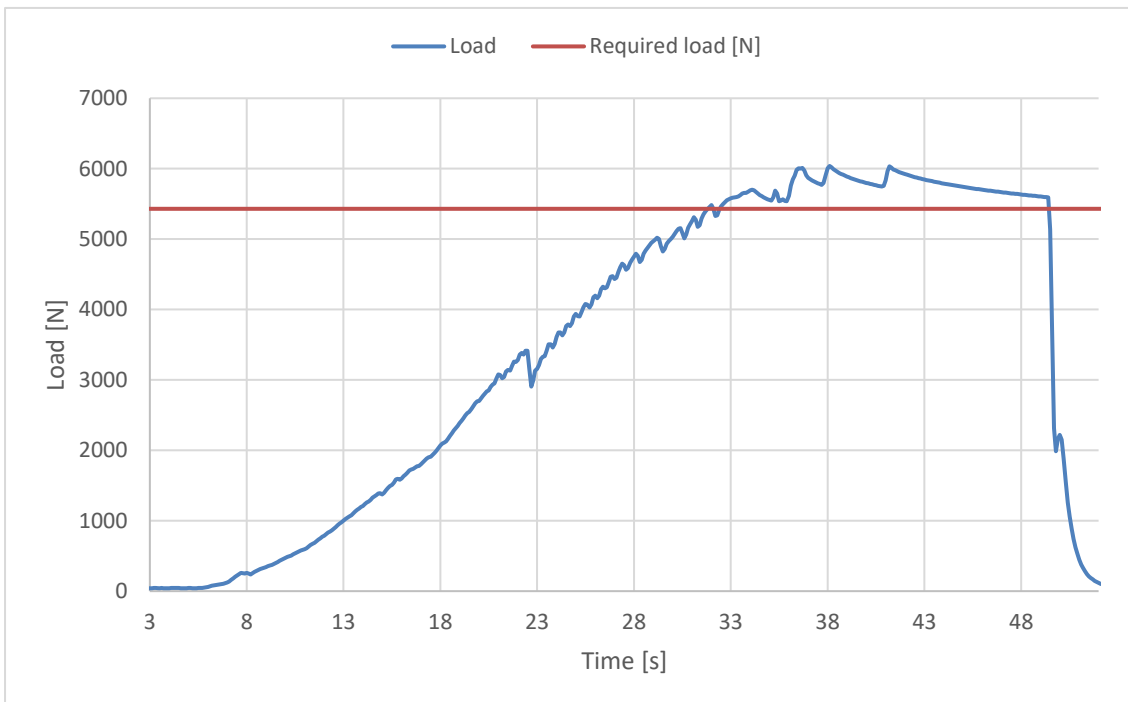
**Test ID 07**

Reference	<b>5.3.2.6</b>	
Test setup	<b>Asymmetric, negative</b>	
Attachment points	<b>One main riser attachment (3 or 4) downwards</b>	
Anchor points	<b>Dummy (9)</b>	
Required load [g]	<b>4.5</b>	
Required load [N]	<b>5400</b>	
Minimum test duration [s]	<b>10</b>	
<b>Result</b>		
Test duration [s]	<b>17</b>	
Any signs of structural failure	<b>No</b>	
Test results	<b>POSITIVE</b>

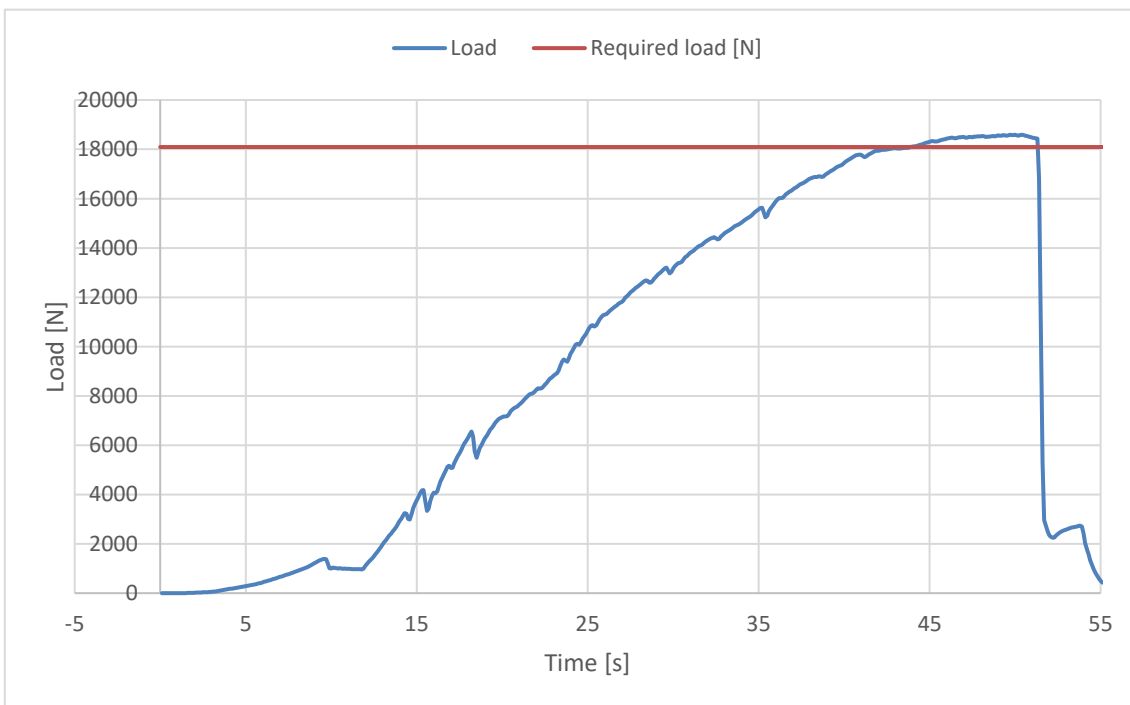
**Test ID 09**

Test duration [s] **7.5**  
 Any signs of structural failure **No**  
 Test results **POSITIVE**

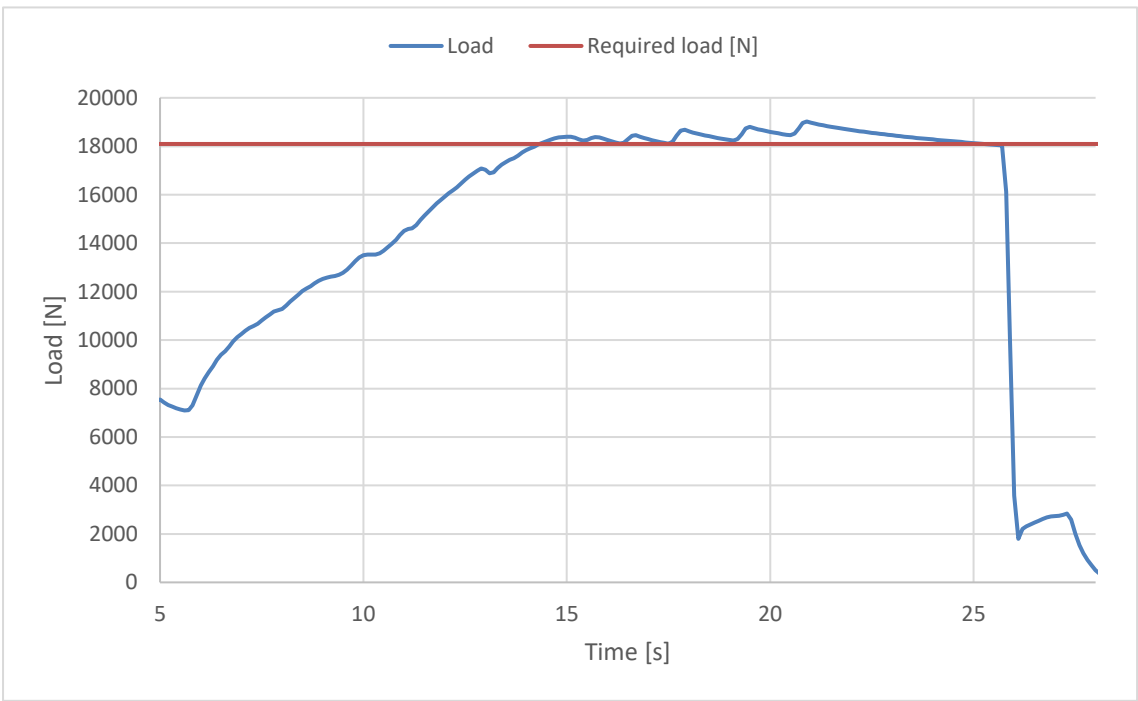
**Test ID 13**

Standard	<b>LTF NfL II 91/09</b>
Reference	<b>5.3.2.7</b>
Test setup	<b>Flying position before landing</b>
Attachment points	<b>Both main riser attachment (3,4)</b>
Anchor points	<b>Dummy (7,8)</b>
Required load [g]	<b>15</b>
Required load [N]	<b>18000</b>
Minimum test duration [s]	<b>5</b>
<b>Result</b>	
Test duration [s]	<b>10.9</b>
Any signs of structural failure	<b>No</b>
Test results	<b>POSITIVE</b>

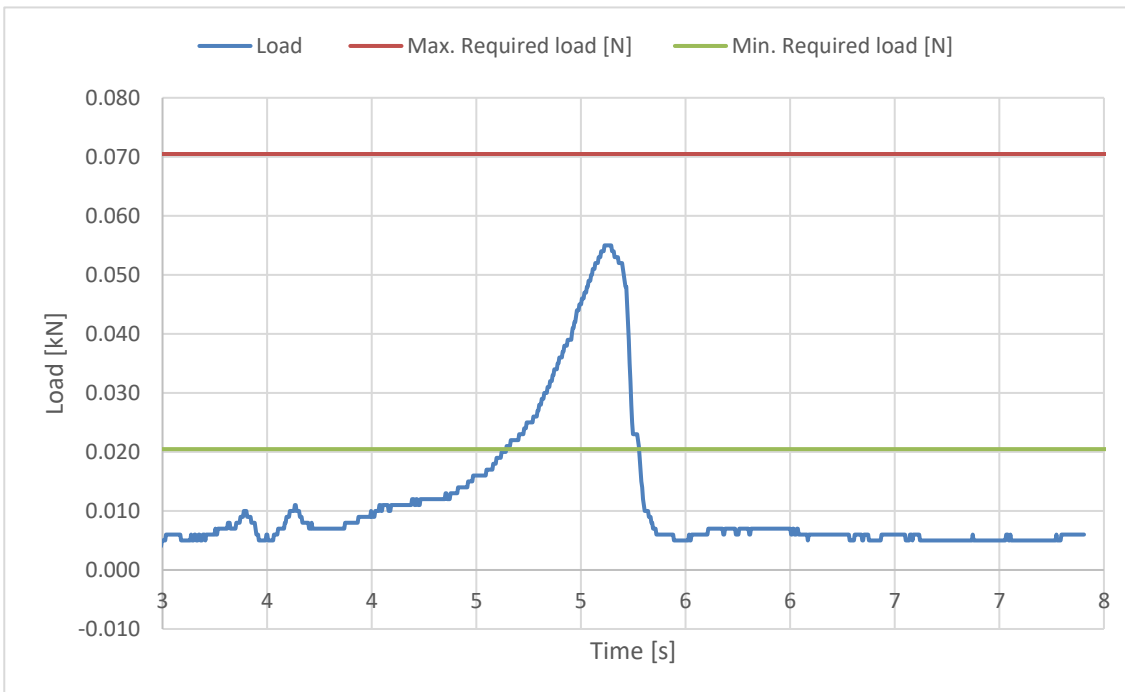
**Test ID RRDT**

Standard	<b>LTF NfL II 91/09</b>
Reference	<b>6.1.5</b>
Test setup	<b>Default flying position</b>
Attachment points	<b>Sensor connect to handle, and pull in opening direction</b> The test is to simulate the load required to open the emergency parachute(1st action).
Min. Required load [N]	<b>20</b>
Max. Required load [N]	<b>70</b>
<b>Result</b>	
Load for first action [N]	<b>54.52</b>
Test results	<b>POSITIVE</b>

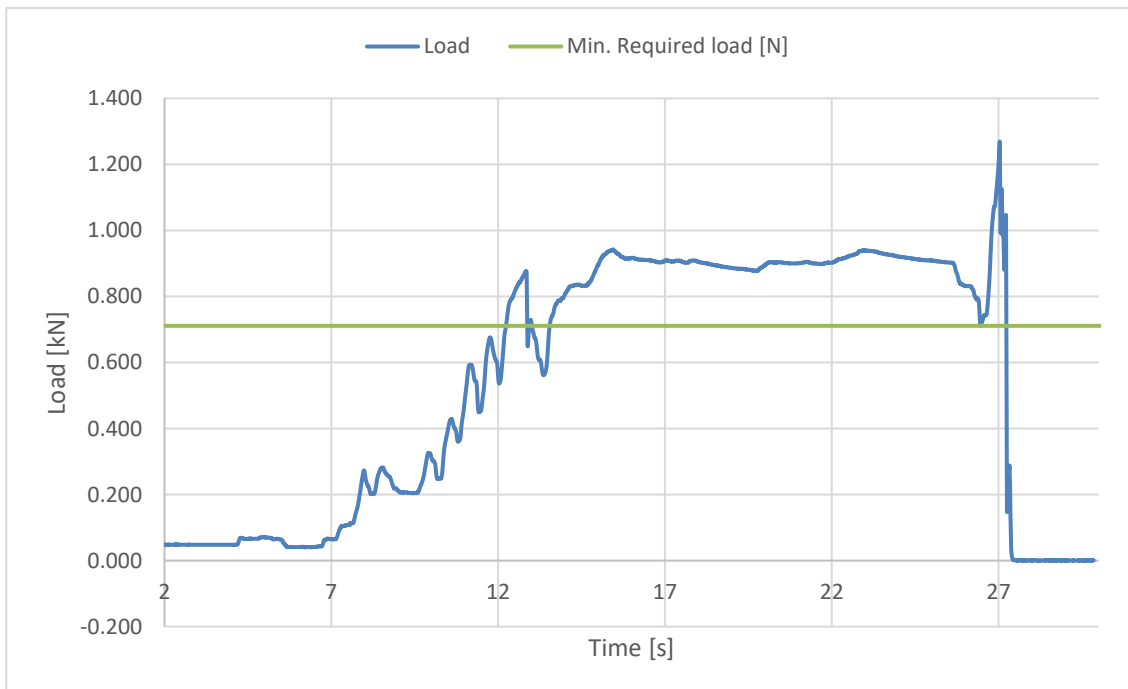
**Test ID RRST**

Standard	<b>EN12491:2015</b>
Reference in standard	<b>5.3.2</b>
Test setup	<b>Two end points of handle</b>
Attachment points	<b>Sensor connect to end of handle, pull on the other side</b> The handle must support min 700 N for 10 s, after measure breaking strength
Min. Required load [N]	<b>700</b>
Minimum test duration [s]	<b>10</b>
<b>Result</b>	
Test duration [s]:	<b>12.8</b>
Breaking strength [N]	<b>1258.00</b>
Test results	<b>POSITIVE</b>
